**BARNBURGH LANE, GOLDTHORPE PH.2
for Gleeson Homes & Regeneration**

TREE SURVEY

DRAWING: 2595/1 (EXISTING TREES ON SITE)

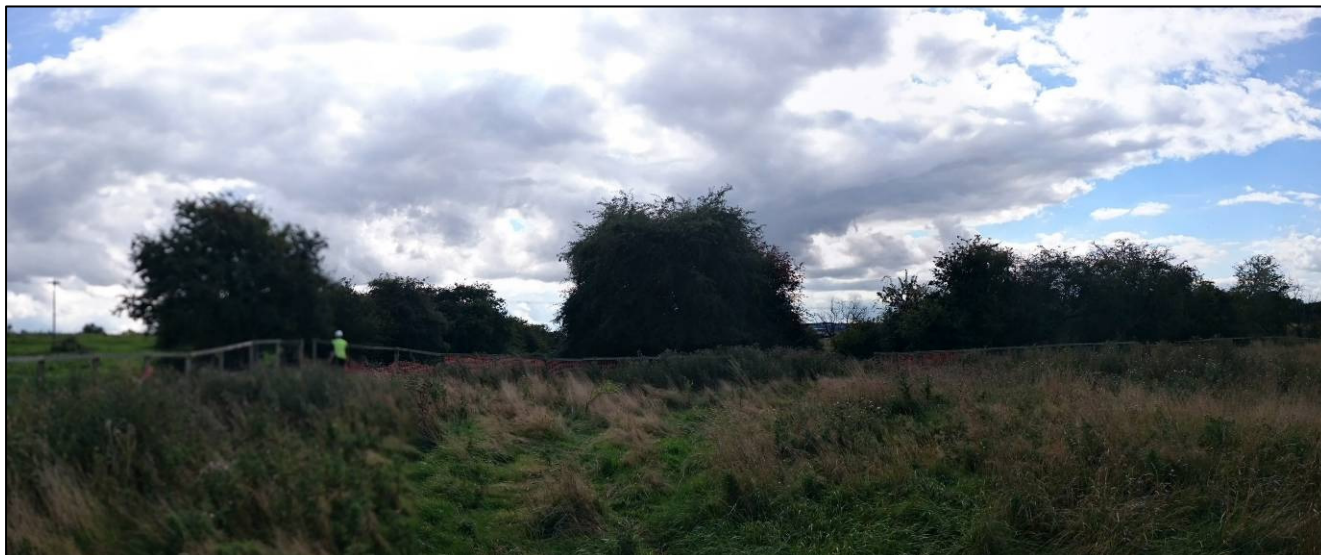
Photo 1:

- 3.1 The most visually-prominent trees are the mature Hawthorn (T2, T3 and G4) along the southern boundary. These only reach a height of around 7m but their local prominence relates as much to their presence as a group as their height.
- 3.2 Other than the above the only vegetation consists of hedging along most of the site boundaries. Although the individual specimens contained therein are only of modest quality and height (around 7 m maximum) these do provide dense screening at lower levels from offsite views.
- 3.3 The hedgerows are generally unmaintained features but could be brought back into management relatively easily.

View south showing groups of mature Hawthorns that lie just beyond the southern boundary – T2 left, G3 centre and G4 right.

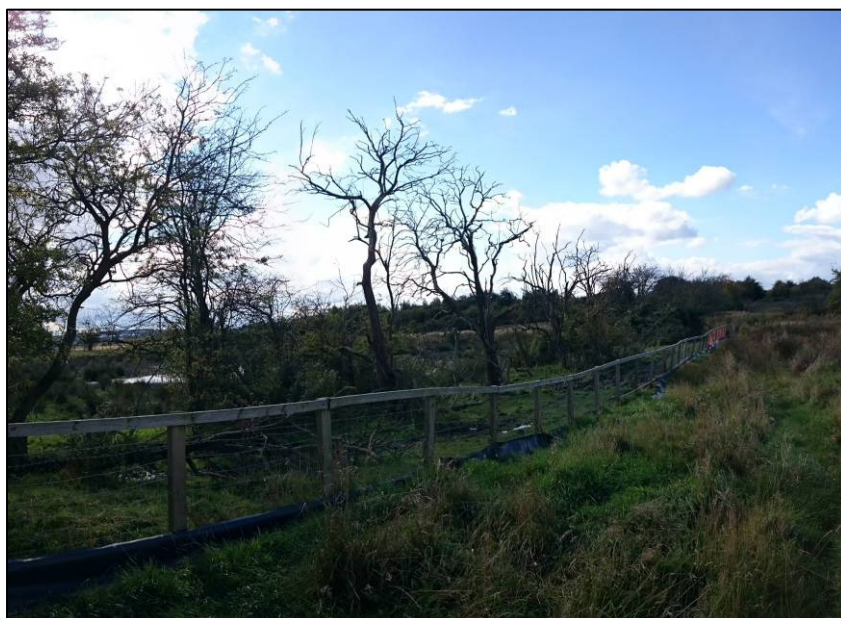
Photo 2:

- 4.1 The majority of trees surveyed fall within the 'Early mature' and 'Mature' categories and all but one are in Fair or Good condition with no action required in the main.
- 4.2 There is only group of dead trees on site (G4) – probably due to poor ground conditions as a result of waterlogging from the adjacent pond. Their removal will visually marginally benefit the area as a whole.

G5	Hawthorn	7	18	As plan	D	0	Dead	<10	U	Line of dead or dying trees on edge of wetland area/pond.	Remove
H6	Hawthorn	7	13	As plan	M	0	Fair	10-20	C	Overgrown field hedgerow has been left unmaintained for some time. Dense foliage to ground level.	No action
H7	Hawthorn	<7	10	As plan	SM	0	Fair	10-20	C	Unmaintained field hedgerow contains occasional larger individual specimens.	No action

View south west showing line of dead Hawthorns (G5) with glimpse of pond beyond.

Remove all 'U' category trees including those approved for removal in relation to approved development. Erect a robust fence to protect not only the retained trees themselves, but also the rooting zones at limit of canopy spread or in accordance with BS 5837:2012.

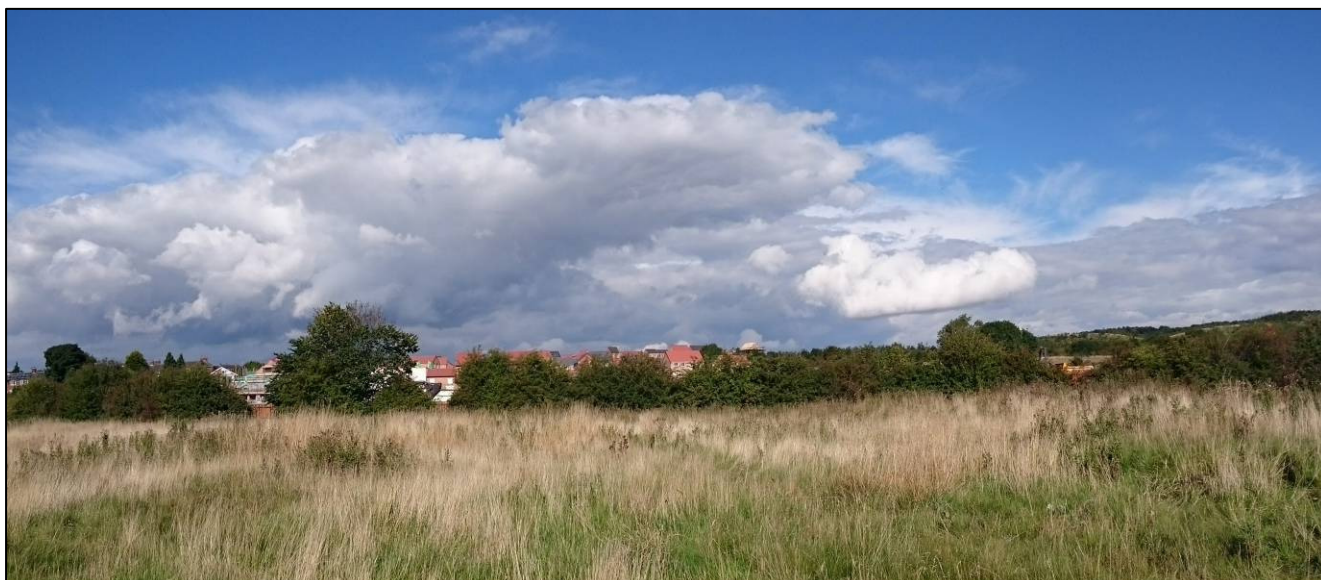
Photo 3:

View north showing hedge H7 – typical of hedging along most site boundaries.
