19th April 2019

Ref: AWA2665

Arboricultural Report

'Plot 2', Delf Garth, High Street, Dodworth, Barnsley

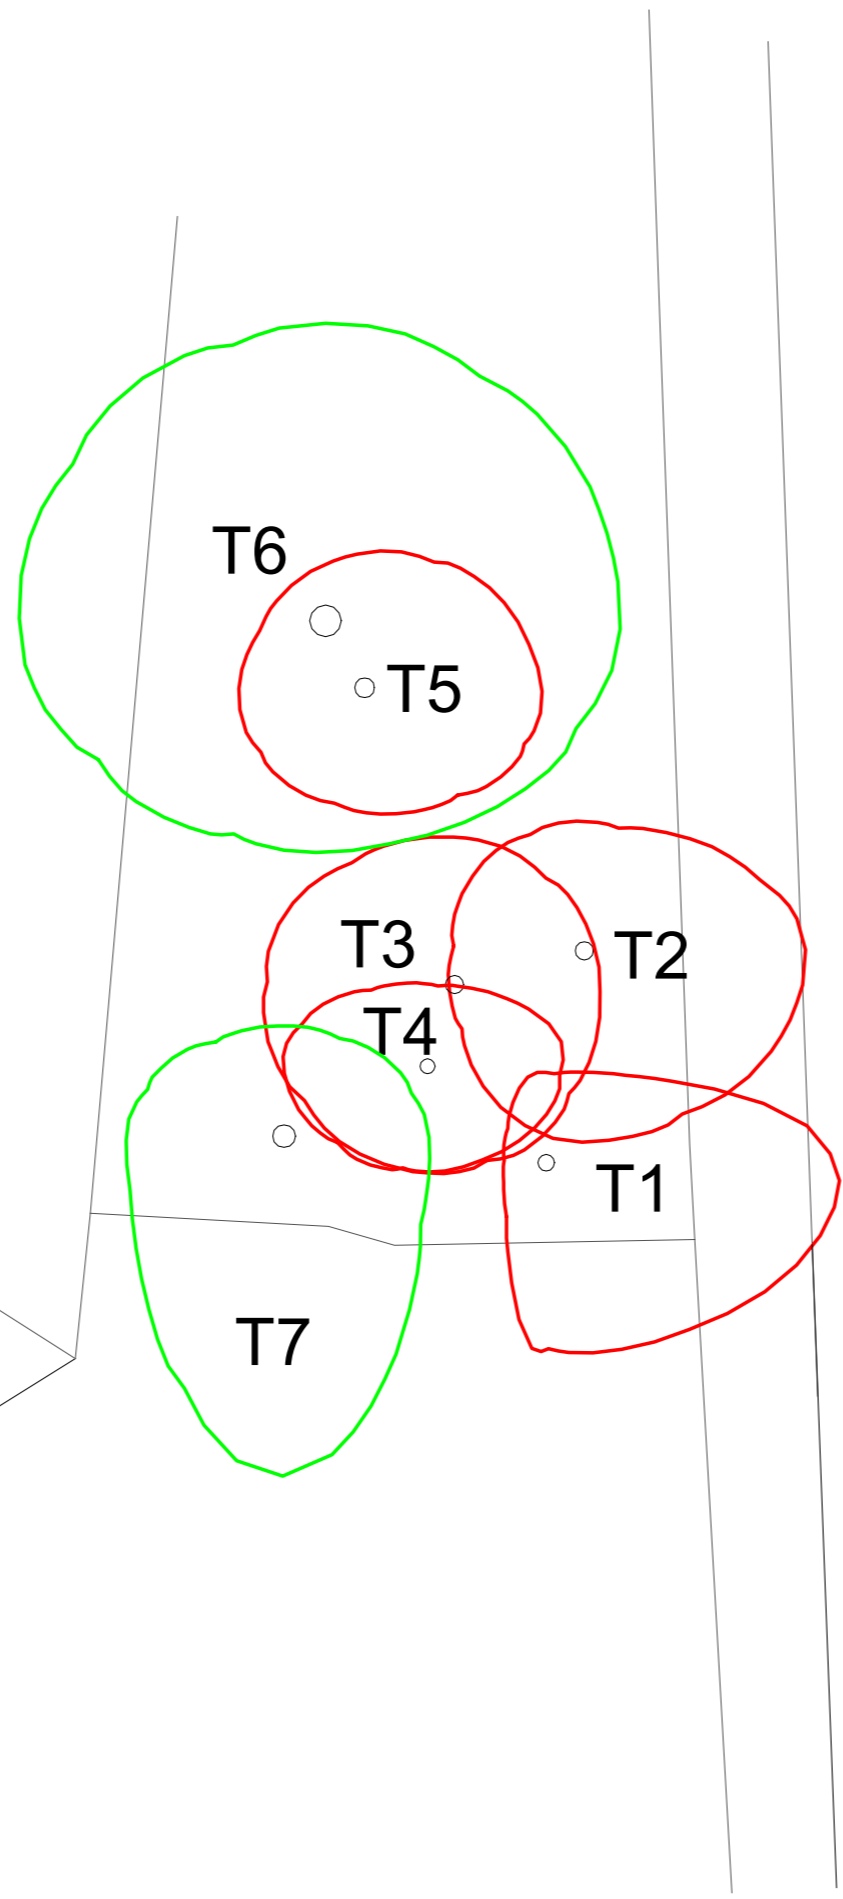
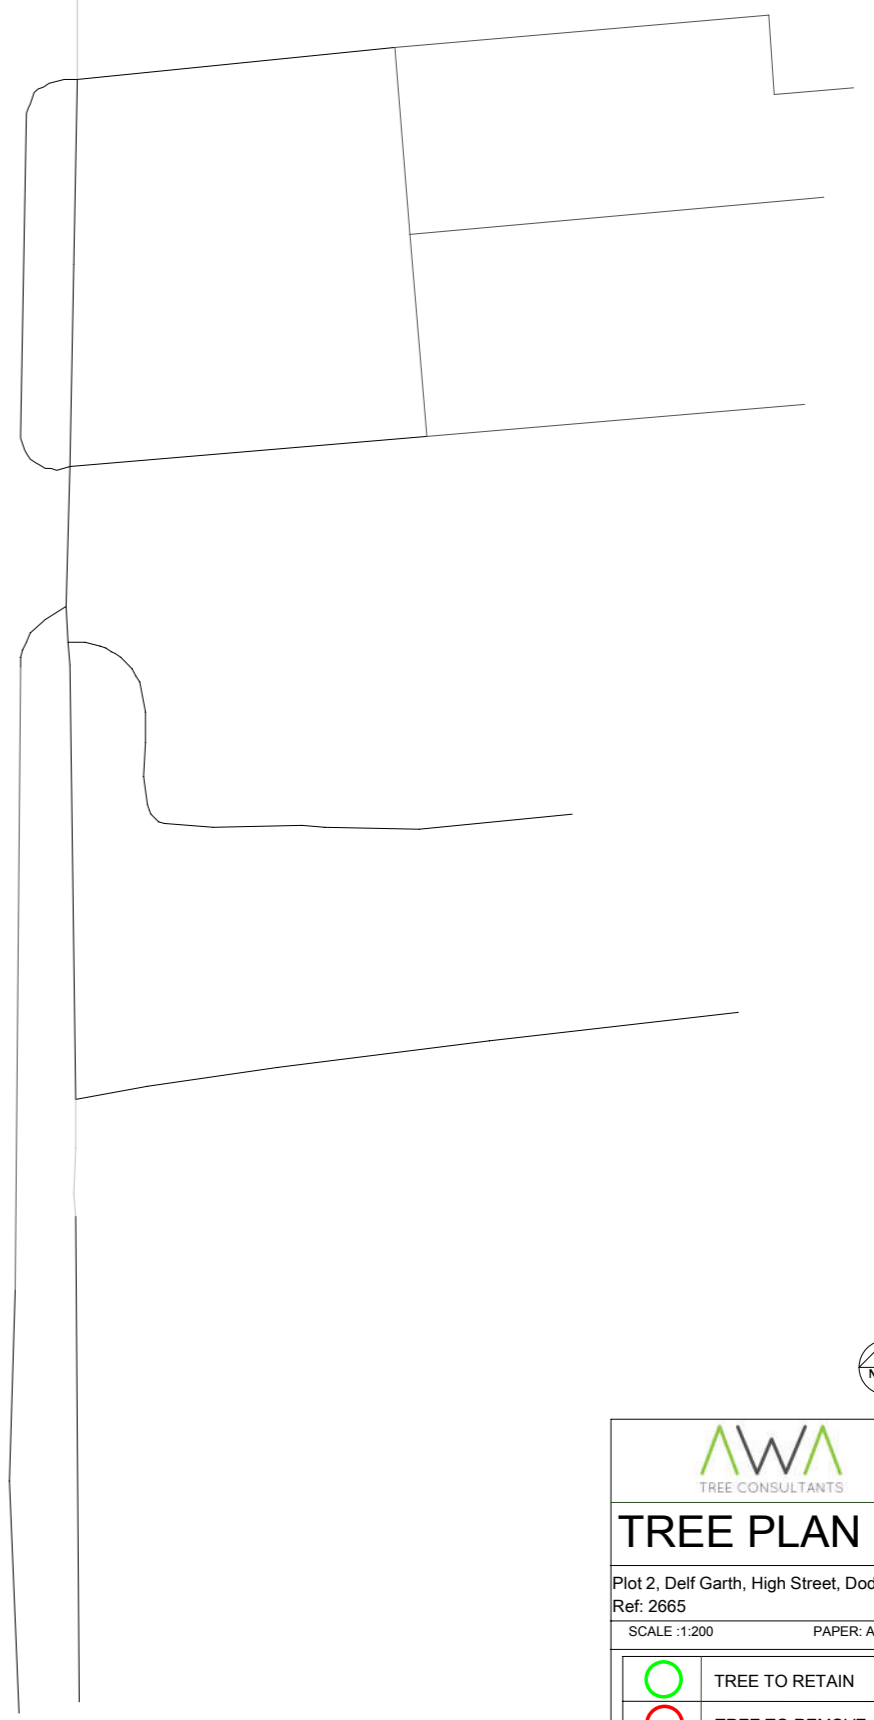
TREE PLAN

The site forms part of a wider development site area known as Delf Garth. The site is at a higher level than the adjacent public footpath and road. A boundary wall drops down to the footpath along High Street. The site contains seven significant trees, numbered **T1** to **T7** on the attached plan. The tree data collected at the site visit is detailed on the attached Tree Data Schedule and the tree locations are plotted on the attached Tree Plan.

It is very likely that roots from the tree T1 to T2 will be growing up to and along the boundary wall. It is also probable that roots from the trees T3 to T5 will be growing up to the boundary wall. It is likely that the roots of T1 to T5 will have contributed to the damaged the boundary wall, from the result of the direct pressure of the tree roots pressing against the retaining wall. In the future, as the tree roots continue to grow, it is foreseeable that the damage to the wall will increase. Trees T6 and T7 are situated further away from the damaged wall and so will be less likely to have impacted upon the walls poor condition.

It is likely that the trees T1 to T5 are contributing to the current damage to the boundary wall, and it is foreseeable this will increase over time. The excavations required to repair the wall will result in the severing of tree roots. It is likely this will lead to a loss of tree vigour of trees T1 to T5 and make the trees T1 and T2 unstable. As such, it is recommended to remove trees T1 to T5 prior to repairing the wall and to undertake suitable replacement planting.
