Change of Use Feasibility Report

SITE NAME: LOWER EASTFIELD FARM, THURGOLAND

PREPARED FOR: MR P. MILLER

DATE: 19.03.2025

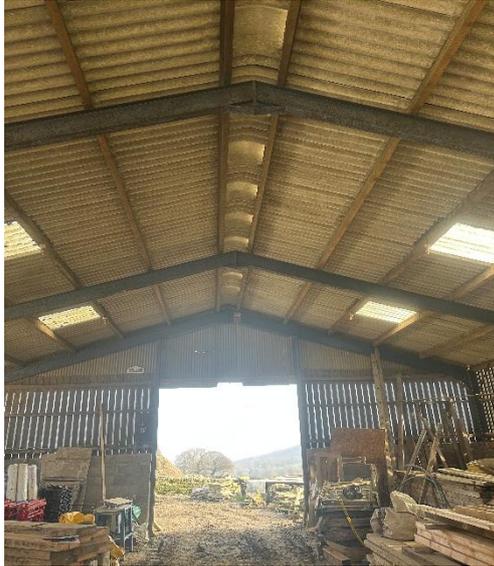
Internal view of NW Direction

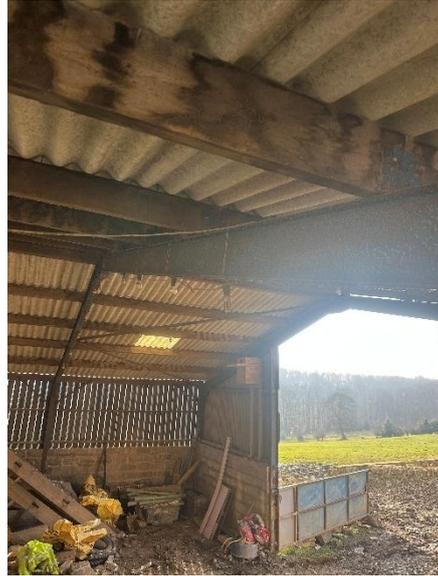
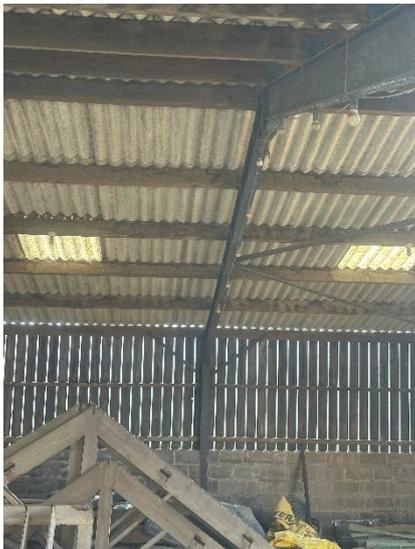
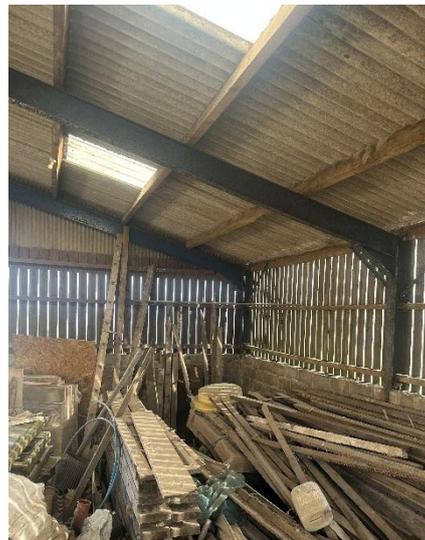
Portal Frame

The steel portal frames comprising the agricultural building or shed are in overall good condition, with the structural elements showing no signs of significant deterioration. The vertical members are 203x133 Universal Beams (UBs), and the rafters are 254x102 UBs, set at a 15-degree gradient. The frames are spaced at 4.56-meter centres, and the eaves and ridge areas feature haunches that help resist the moment forces, with each haunch secured by four bolt fixings.

The structural integrity of the steelwork remains sound, with no evidence of section loss or a reduction in strength. The coating finishes have, however, experienced significant weathering due to exposure to environmental elements. Despite this degradation of the coatings, the structural integrity of the steelwork is not thought to have been compromised.

The degraded finishes should be addressed to prevent further deterioration. This involves cleaning the surface to remove any dirt, rust, or contaminants, followed by reapplication of protective coatings to restore the steel's resistance to corrosion and extend the service life of the frame.

- 6. Steelwork Condition:** While the steel portal frames are structurally sound, their surfaces show significant signs of degradation. It is recommended that the steel surfaces be retreated as part of the refurbishment process.

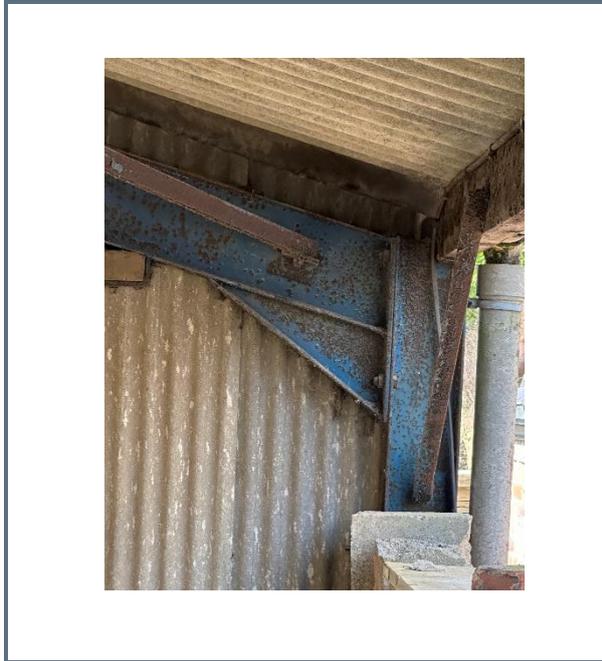
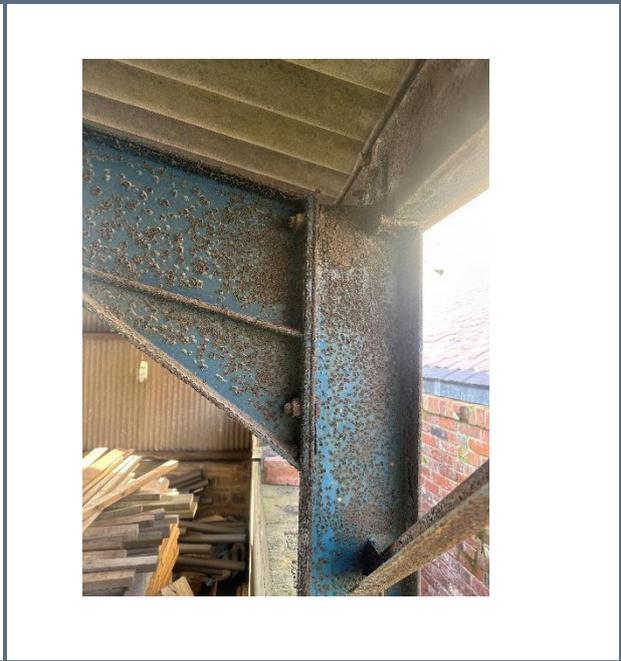
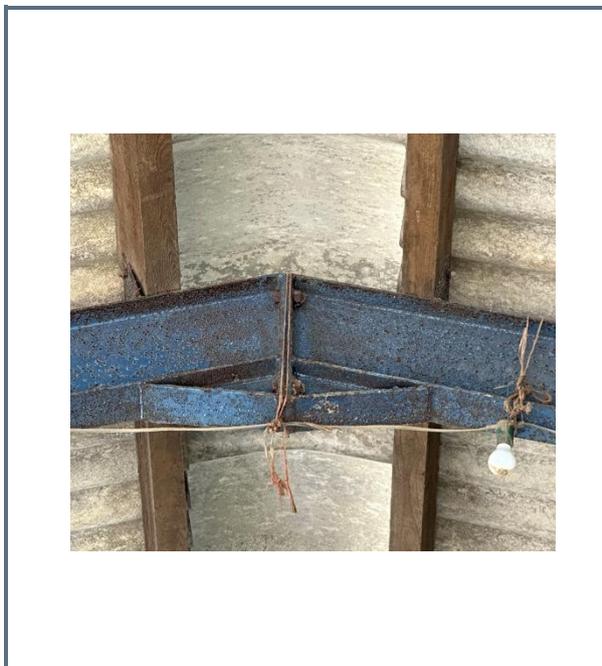
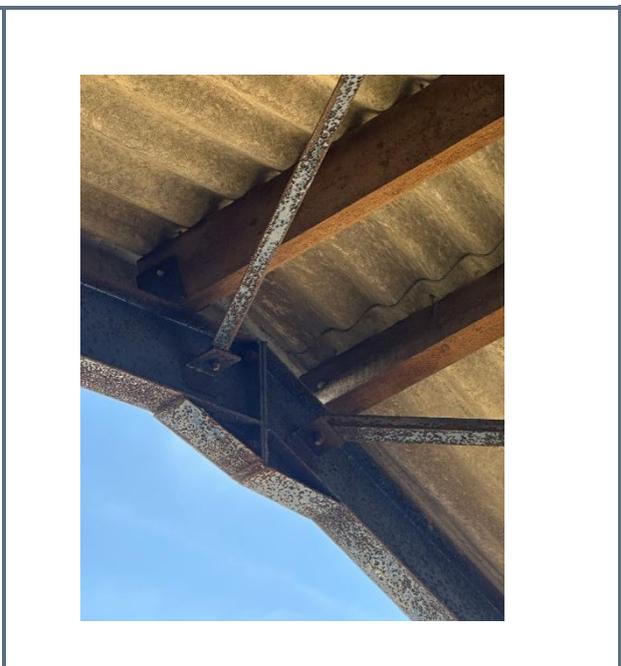
Portal Frame – Eaves Haunch 1

Portal Frame – Eaves Haunch 2

Portal Frame - Ridge Haunch 1

Portal Frame - Ridge Haunch

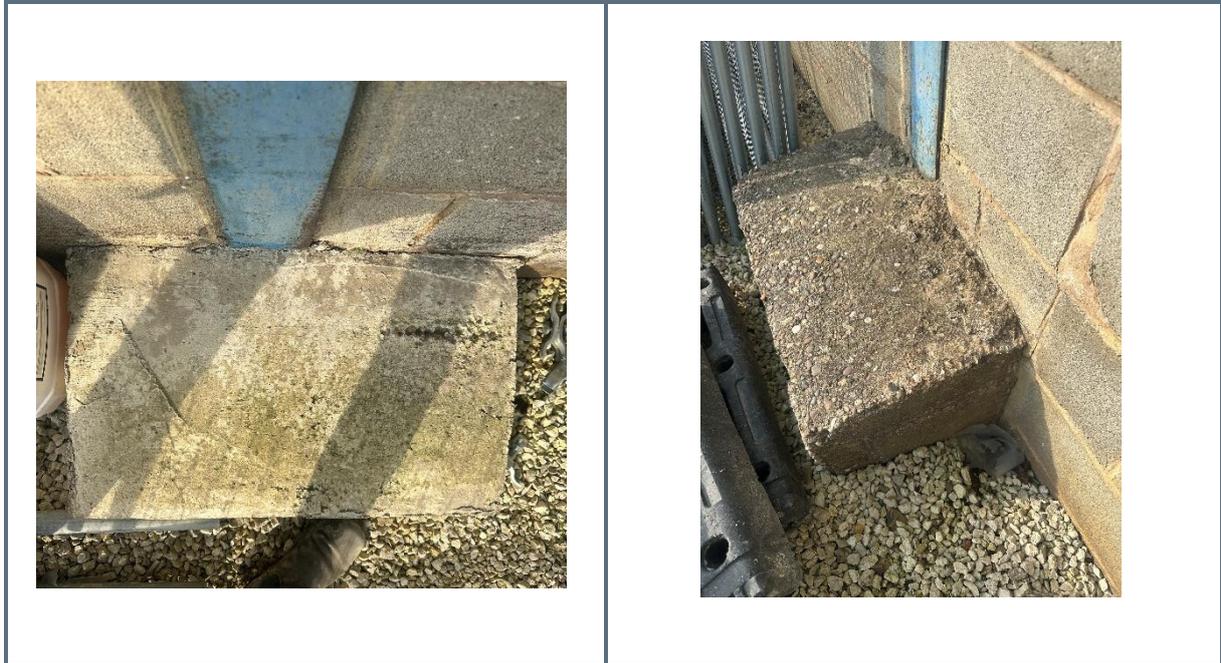
Whilst the extents of the foundations are unknown, there were some pad footings that were visible above ground level on the South East elevation. Foundation heights above ground level varies, however it was possible to determine that the pads were 800mm square with the posts embedded into the concrete. Although there is some minor deterioration to the outer faces of the pad footings, due to its exposure, this is not considered to be of structural detriment.

South West Elevation – Pad Footing 1

South West Elevation – Pad Footing 2

- 3. Party Wall:** A new blockwork party wall is needed between the two properties, this too will also provide support for the mezzanine floor.
- 4. Foundations:** New strip foundations are required for both the external walls and the internal party wall. The existing footings must be exposed and inspected before construction begins.
