**Tree Survey:** Site at Greenbottom Farm,  
Hoylandswaine, Barnsley.

**Client:** David Poisson Esq.

**Date of Survey:** April 17<sup>th</sup> 2019.

**Report author:** W L Anderson. Dip Arb.(RFS) M.Arbor.A.

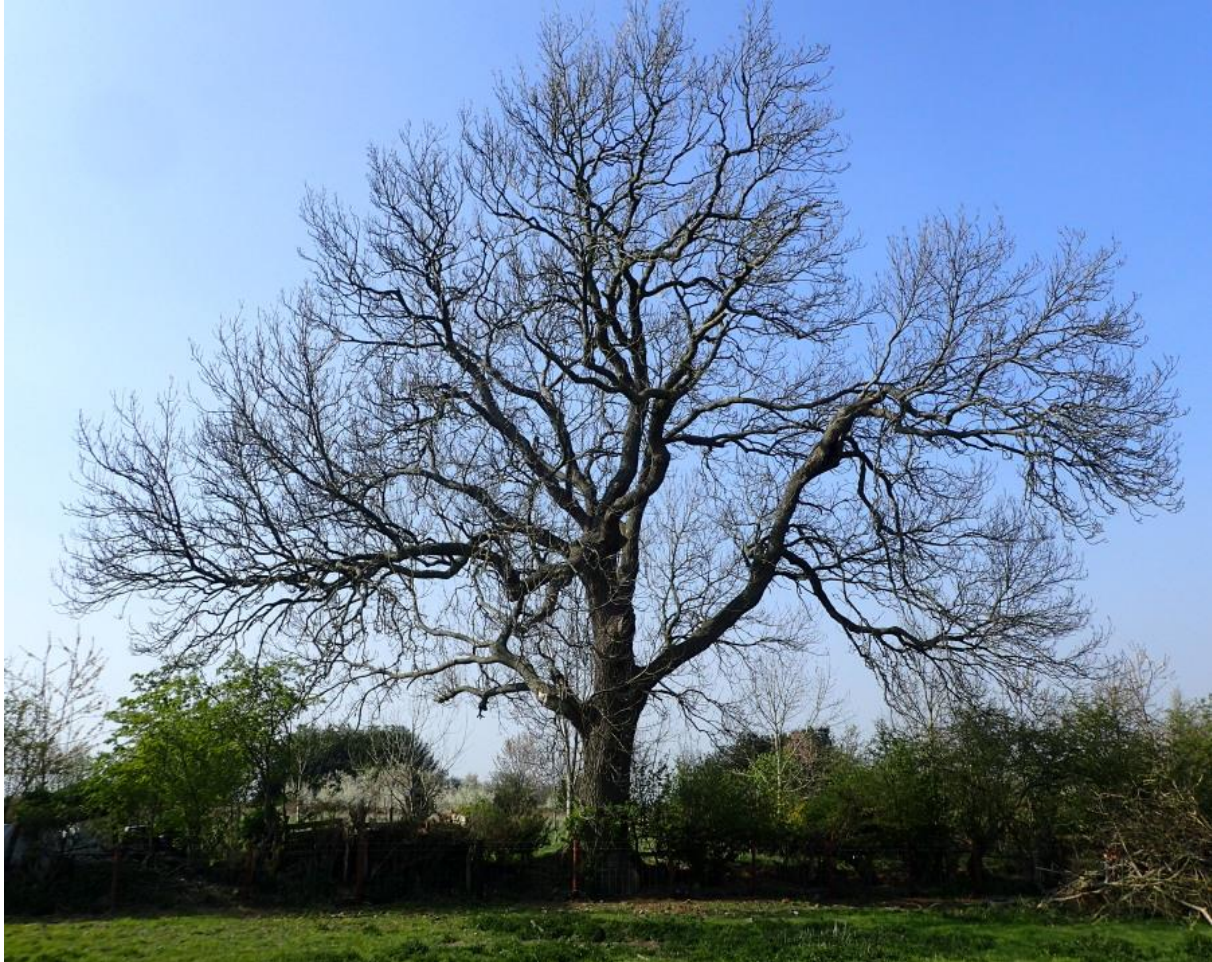
Photograph 1.

Photograph 1 shows the tree from within the site looking roughly west. I measured the tree using a laser device as 18 metres tall, and using a tape measure I measured its crown to reach 10 metres into the site. From afar its crown appears roughly symmetrical so my measurements appear reasonably accurate. Trees have a habit of appearing much larger than they really are and this one can reasonably be described as an imposing specimen.

There is some debris on the ground to the right, which may be broken branches from the tree. In the crown there are signs of branches having been lost and the large branch at the right, which reaches well into the site, is in fairly decrepit condition. In fact it is sufficiently decrepit that if it extended over a road, a Highway Safety Officer would justifiably be demanding something be done about it. However it is not over a road and at the moment there are only a few sheep. Although the sheep clearly have a value, the risk of any being beneath the tree when the branch collapses is low, and the cost of doing something about the branch (probably £500.00 plus tax) would probably outweigh the value of the sheep.

It would be perfectly feasible to prune this tree to reduce the weight of the crown and thus the mechanical burden on the compromised structure, but this would cost a lot of money, say £1200 or so, and then it would require regular repetition, at lesser but not insignificant expense. Environmentally it would be prudent to simply let it collapse and eventually rot back into the ground. The biodiversity value of this is probably

I think this is probably sufficient discussion about what to do with this tree, especially as it is not actually Mr Poisson's tree. Suffice to say that avoiding making the area beneath and around it more intensely used would be prudent. For example building a garden feature beneath it would be to increase the risk of injury or damage, which would require the owner to take action to reduce the risk. I regard avoiding this potential problem as prudent to all concerned.

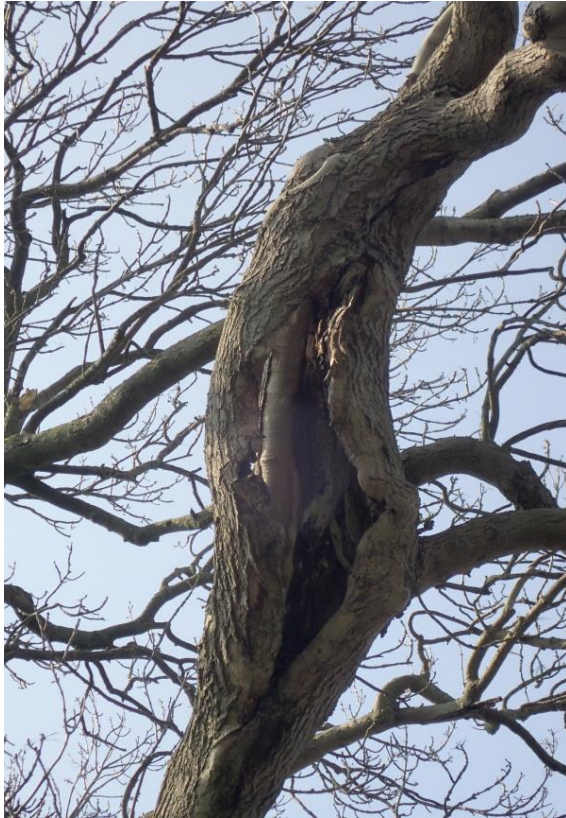
Photograph 2.

Photograph 2 is a view of the right hand branch in which the damaged and decayed part can be seen. In photograph 1 it seems that the branch beyond this point is subsiding, which has left the tree's crown with something of an unnatural gap between this branch and the rest of the crown. Photograph 3 shows the wound left from another broken branch, the owl box can just be seen in the main fork as can a cavity above it in the rearmost branch. Defects like these provide nesting and roosting places for birds and bats, and are known as "niche-habitats" and are the reason veteran trees are important.

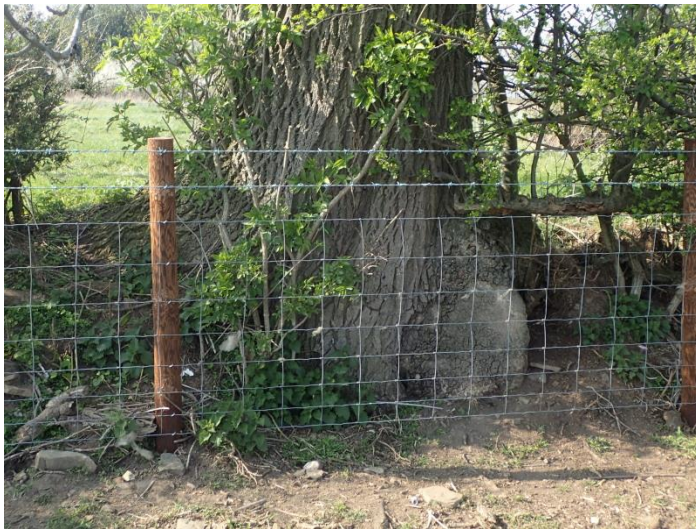
Photograph 4.

Photograph 4 shows the base of tree 1. My presumption is that the fence is the site's boundary. The fence and the hedge prevented me from putting a tape measure around the tree but my estimate of it being a metre through is reasonable.

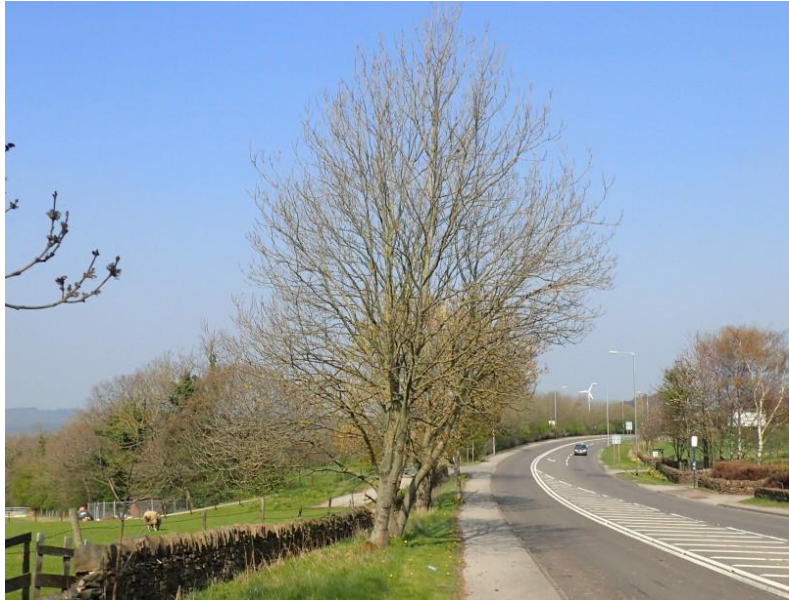
Photograph 5.

Photograph 5 is a view looking north along the highway; tree 5 is the first tree in the row, hiding trees 2 to 4. The proposed driveway will emerge through this row of trees.

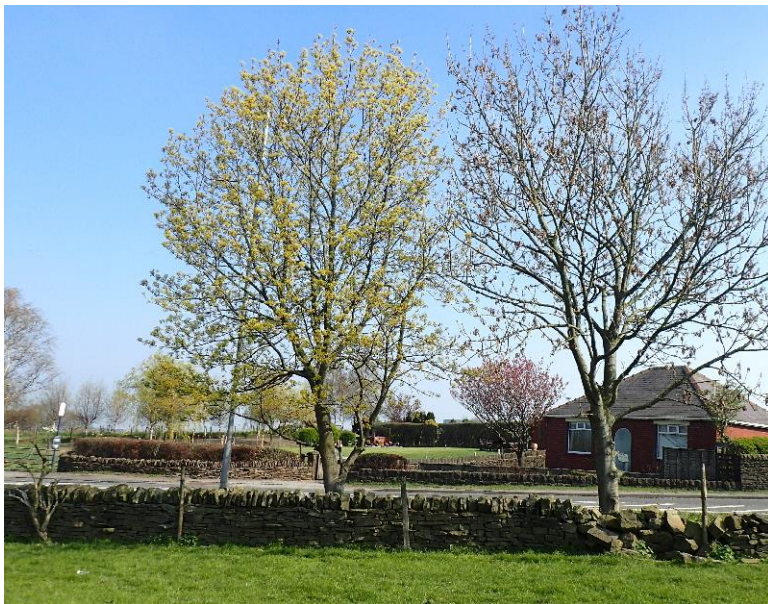
Photograph 6.

Photograph 6 is a view of tree 4 at the left, and 5 at the right. The driveway is planned to be to the left of the street light.

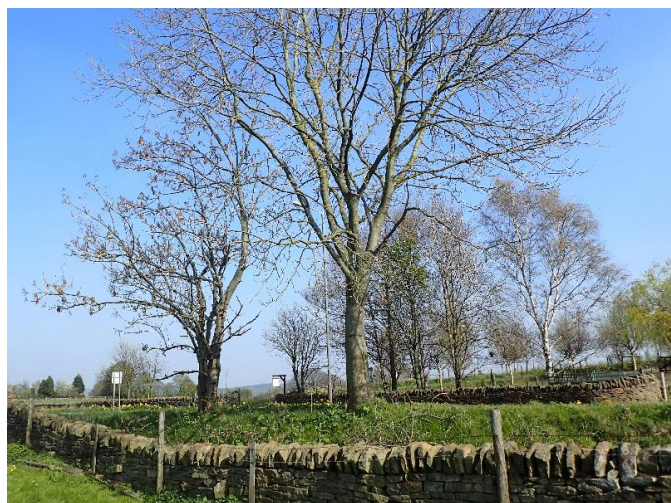
Photograph 7.

Photograph 7 shows tree 2 in the left background and tree 3 to the right. It also shows the difference in levels between the highway (beyond the trees) and the site. the driveway is planned to be to the right of this photo.

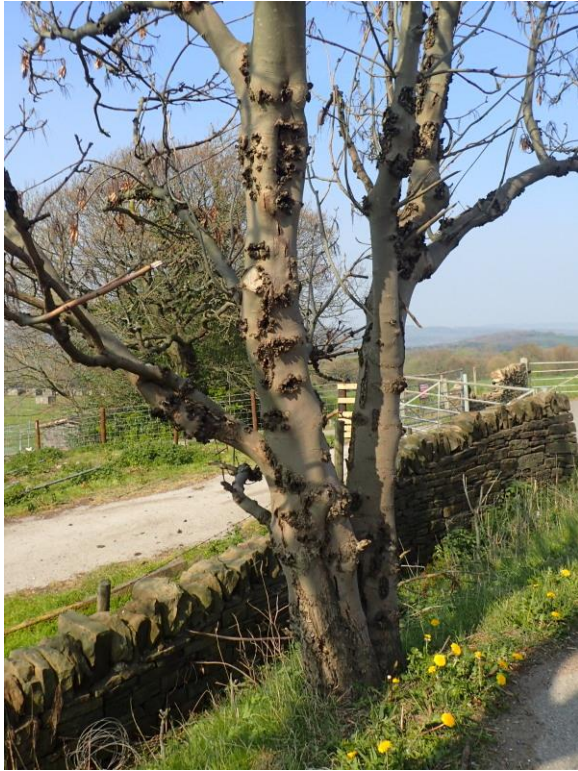
Photograph 8.

| Tree No. | Species. | Ht | TD | Age class | Category | Comments. | RPA |
|---|---|---|---|---|---|---|---|
| 2. | Ash | 7 | 310 | M | C1 | In the highway verge, 2 stems heavily infected with Ash canker (Bacterial Knot). One sided crown due to competing with tree 3. | 41 |

Photograph 8 is a view of tree 2. I took this to show the extent of the Canker infection. Although this appears fairly dreadful, plenty of ash trees seem to survive with this infection for many years. Nonetheless it is not the sort of tree that should stand in the way of anything.

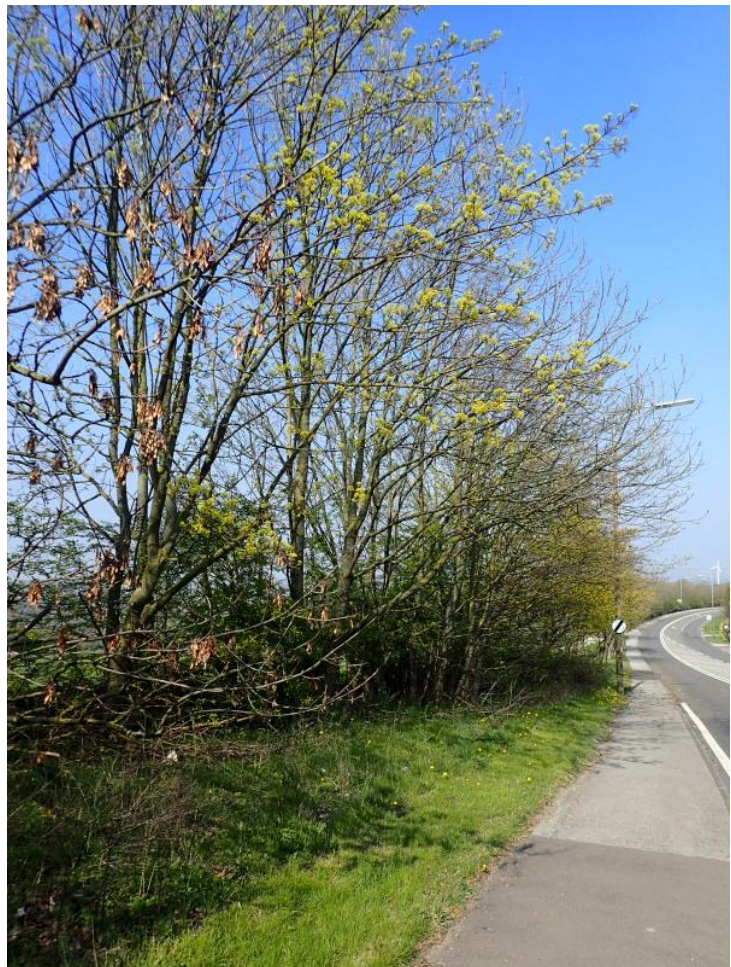
Photograph 8.

Photograph 8 is a view of tree group 8, also looking northwards. This group appears to be some planted trees and some colonised ones. Together they form a useful screen.

I do not think these trees and shrubs will be affected by this proposal.

Roadside groups like this are frequently largely unmanaged and will most likely be left alone until the highways maintenance contractors decide that something must be done. At that point some trees will be cut, some shrubs will be flailed (with a tractor mounted machine) and then the group will be left alone again. This might be environmentally better than a more intensive, annual-trimming approach.

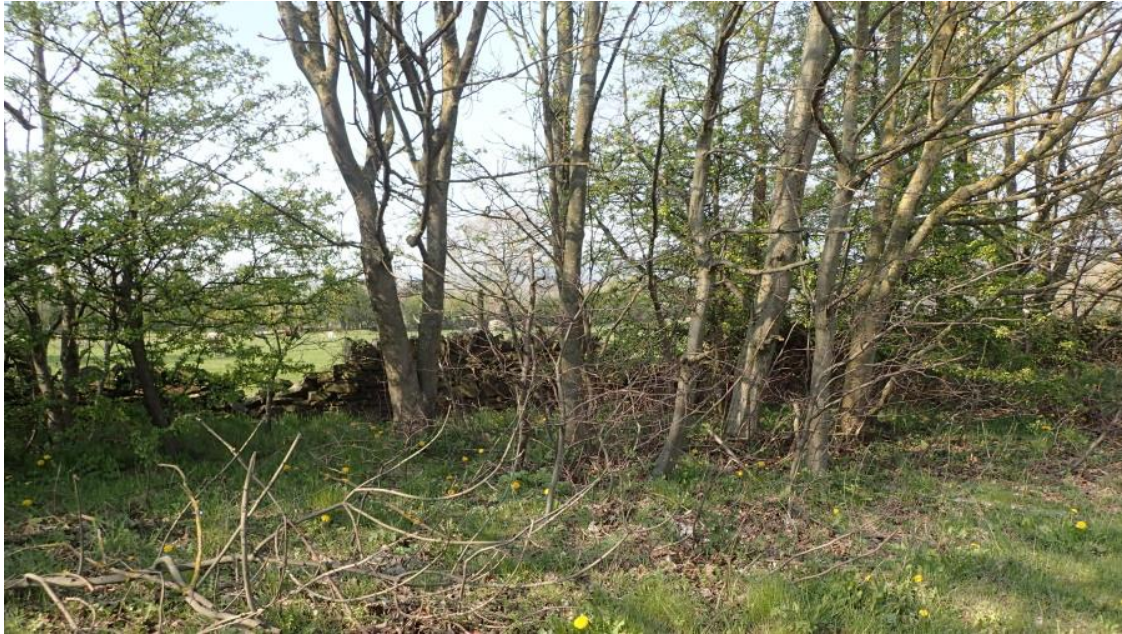
Photograph 9.

Photograph 9 is another view of group 8. There is something to be said for managing verges like this to maintain a screen at ground level. Phased Coppice management of the trees would be appropriate, and ought to be economical.

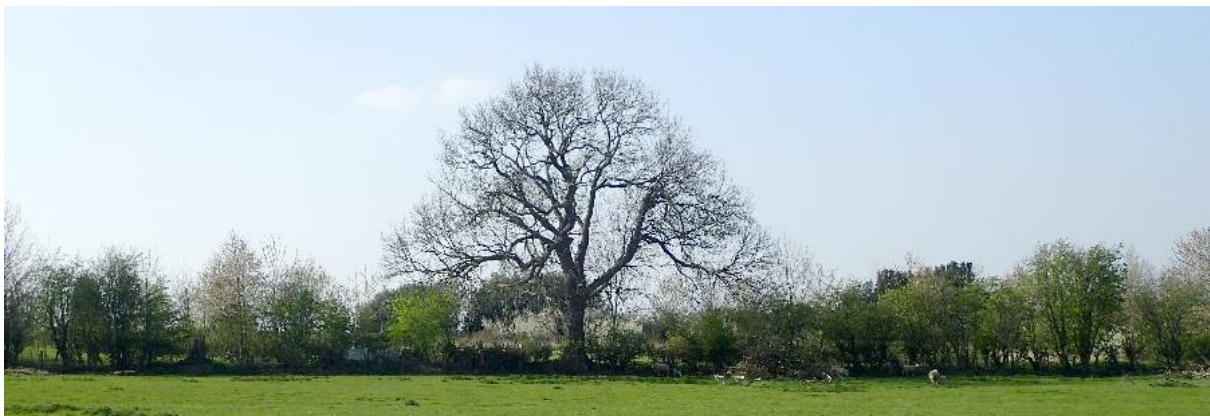
Photograph 10.

I've included photograph 10 in an attempt to show the hedgerow along the western boundary. Tree 1 is in the centre.

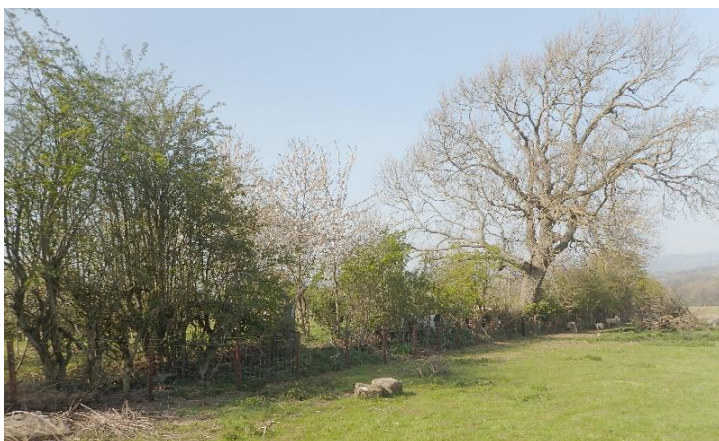
Photograph 11.

Photograph 11 is another view of the hedgerow with tree 1. This is looking roughly north.

In this case as the management seems to have been neglected over recent years, the main concern is that the proposal will make future management unnecessarily arduous. In reality I think this means that the proposal should be designed to ensure that a tractor mounted hedge-clipping (flailing) machine can still access the hedgerow. Although responsibility for hedgerow management must fall to the owner of the hedge, a certain amount of neighbourliness is pragmatic.

As an aside, this hedgerow appears to have been reinforced by planting some species that are now seen as invasive pests. In particular I noticed Box-leafed Honeysuckle (*Lonicera nitida*), which is becoming something of a pest in some areas.
