**Preliminary Tree Survey  
Whites Bakery  
Worsborough  
Barnsley**

Report reference: R-2032-01  
March 2015

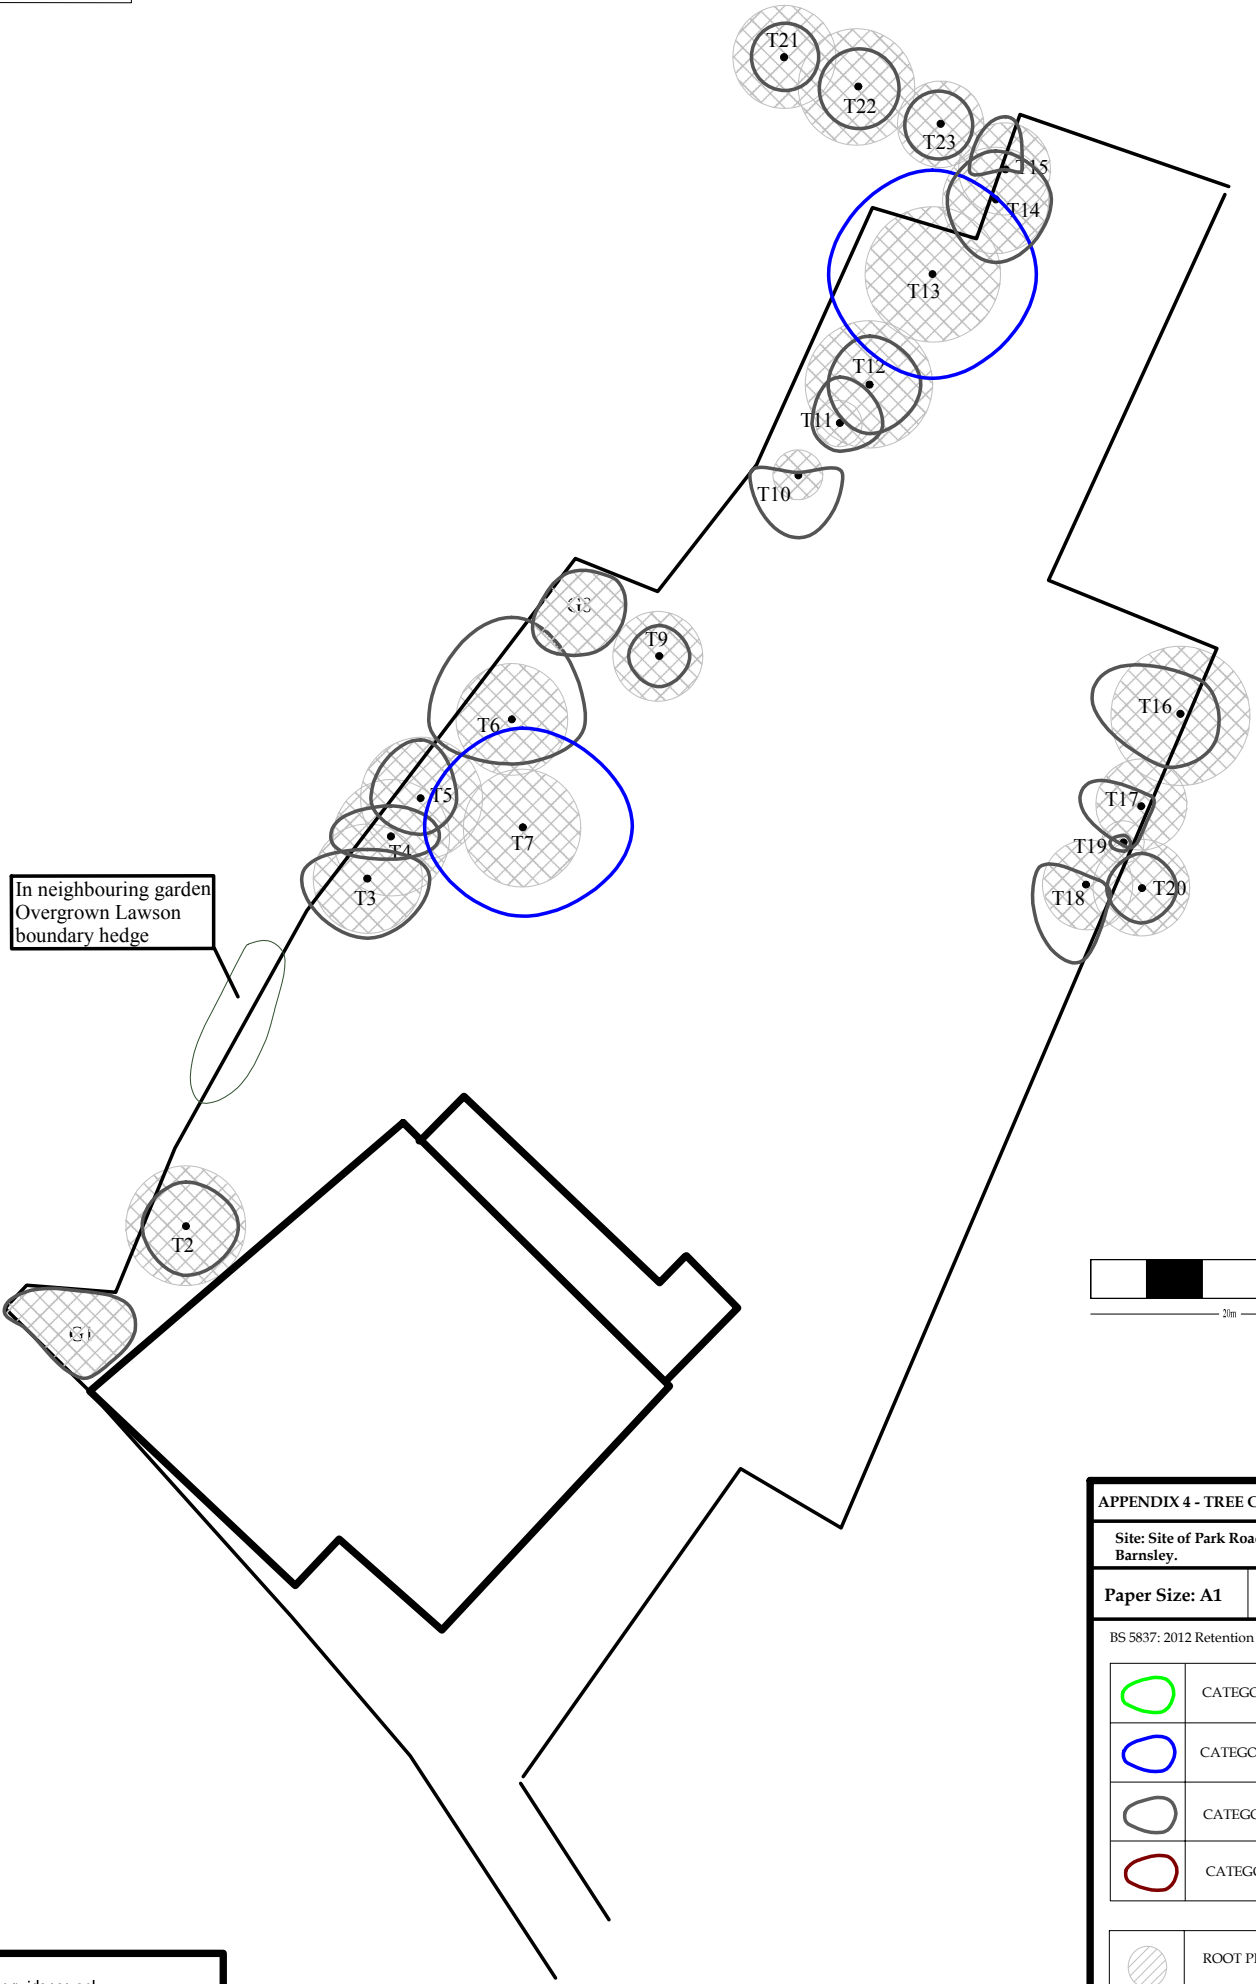
#### **Appendix 4:** Tree Constraints Plan

In neighbouring garden  
Overgrown Lawson  
boundary hedge
