## **Structural Inspection Report**

**Trunce Farm, Green Moor, Wortley, S35 7DQ**

**Document No. – R2246-001**

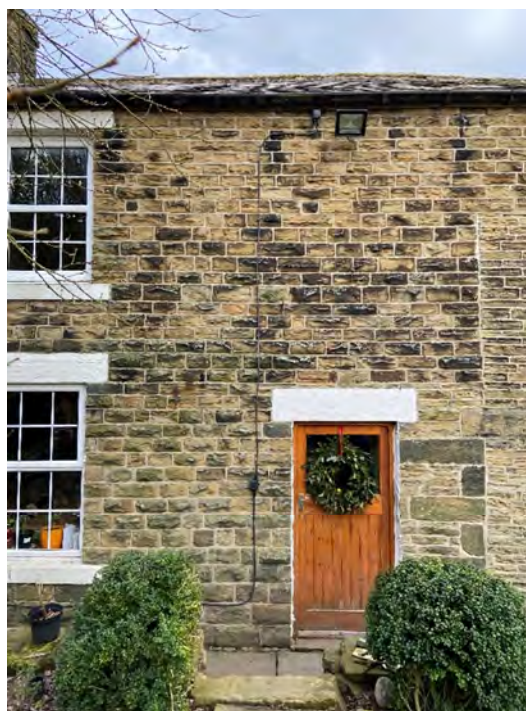
**Figure 3: Front Elevation 2**

The front elevation consists of a single doorway, 2 ground-floor and 2 first floor windows. It appears the farmhouse has been extended due to the presence of a vertical joint and the use of a different stone masonry depth (Figure 3). This also correlates with stone quoins observed in between the current and previous doorway (which has been infilled) which would suggest this was once the location of an end gable wall.

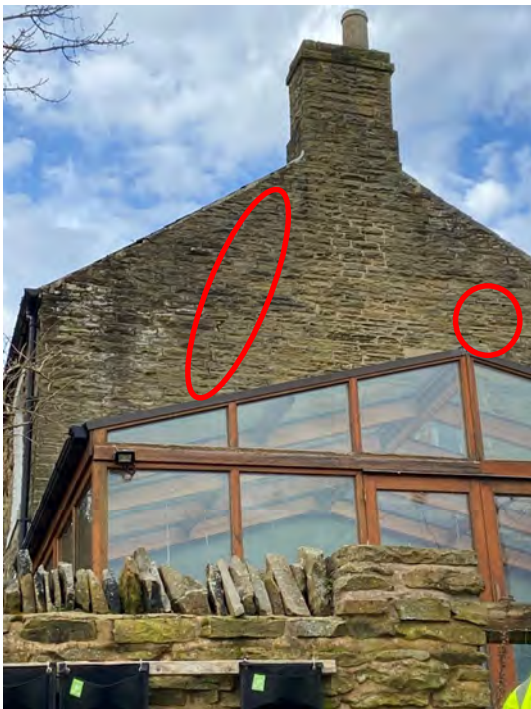
**Figure 6: Farmhouse Side Elevation (Crack Locations Circled)**

Stepped vertical cracks were observed in the mortar joints at two locations (Figure 6). The face of the stonework towards the centre of the elevation is also weathered and pitted; most likely a result of driving rain eroding the face of the stonework.

4. Cracks in the existing Farmhouse walls should be raked out, brushed and repointed. The continued weathering of the stonework on the side gable will be prevented once the extension is built. However, if the extension is not built then this should be monitored for any signs of deterioration since although it is currently only superficial, if the erosion persists this could lead to water ingress into the building.

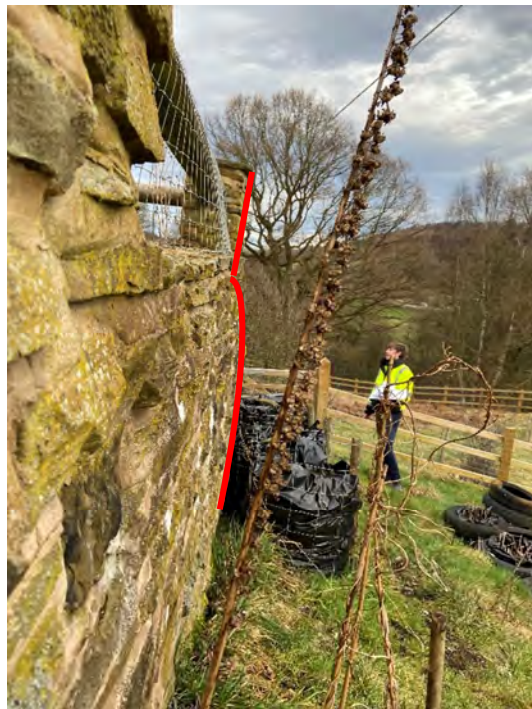
**Figure 7: Patio Retaining Wall (Wall Profile Highlighted)**

Movement in the retaining walls supporting the external patio/ terrace area was also observed with the walls settling in the corner where the two walls meet (Figure 7). The walls are bowing with a large open crack observed in the longitudinal wall as it falls away at its end (Figure 8). This in return has caused the patio to drop at the interface with the stone wall. In its current state, the wall is inadequate for retaining the ground.

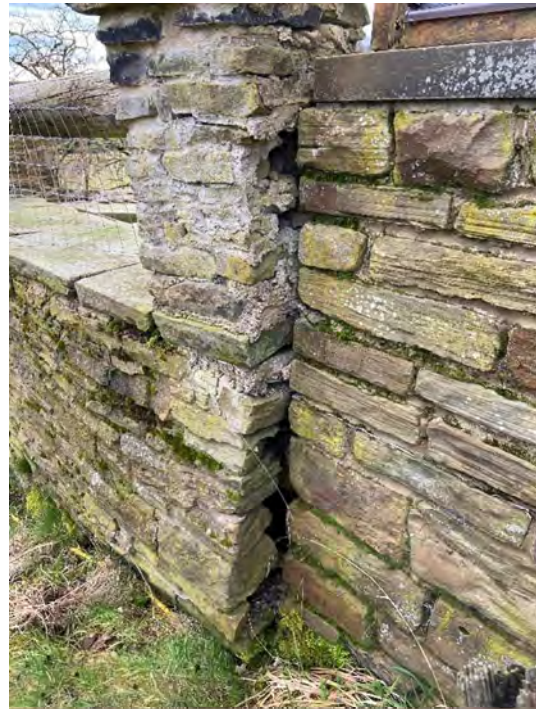
**Figure 9: Interface Between the Patio and Conservatory Retaining Wall**

The external wall supporting the conservatory is in a reasonable condition without any observed structural defects (Figure 9). It is unknown whether it is retaining any ground beneath the conservatory floor.

2. Although the external walls supporting the conservatory are in a reasonable condition, an assessment will need to be made on whether they can support the increased loads from the new two-storey extension. A more robust engineered solution may be required such as new foundations.

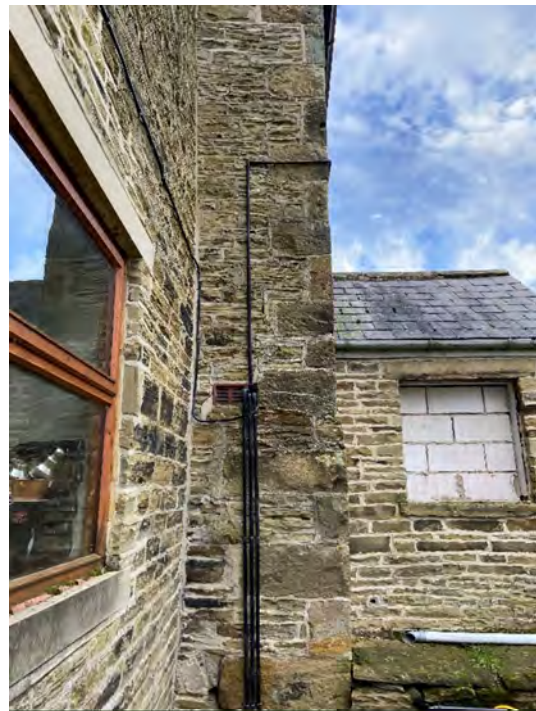
**Figure 11: Farmhouse Step in Rear Elevation**

The east elevation of the stepped wall was observed to have a slight bow at its base (Figure 11). However, rather than a result of movement in the wall, this is believed to be from its original construction. This should be monitored in future for any changes in the walls condition.

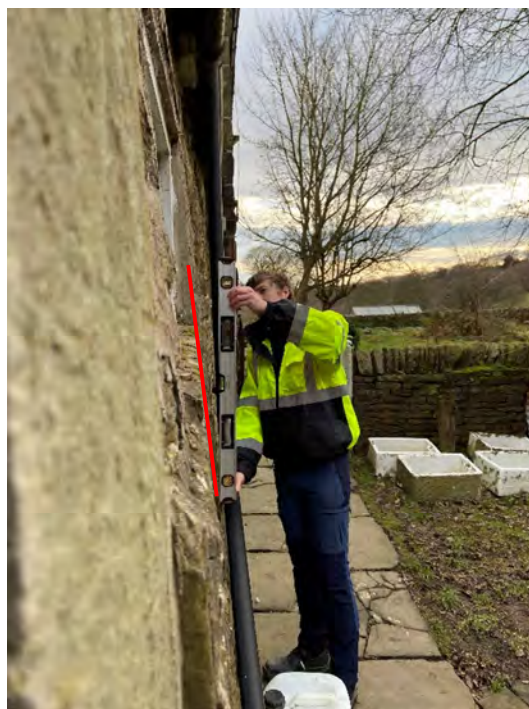
**Figure 13: Front Elevation Wall Deviation**

Overall, the front elevation is in a poor condition. The wall was observed to be leaning in plane and bowing out of plane with a deflection of 95mm recorded over a 925mm length into the room measured in the middle of the wall (Figure 13). As a result, timber packing has been used to prop the roof gutter and downpipe. The exact cause for this movement could not be determined, however, the bowing of the wall requires attention to prevent the movement getting any worse.

7. The front elevation as mentioned in Section 2.2.1 is bowing significantly. The wall should be demolished and rebuilt regardless of any proposed works. This could be conducted following the removal of the existing roof structure otherwise the roof will need to be propped. The wall will need to be founded on new footings and the potential leaks from the drain and internal taps investigated and repaired as necessary. Rebuilding the wall will also address the issues associated with the rotten timber lintels, the door mullions and the leaking gutters.

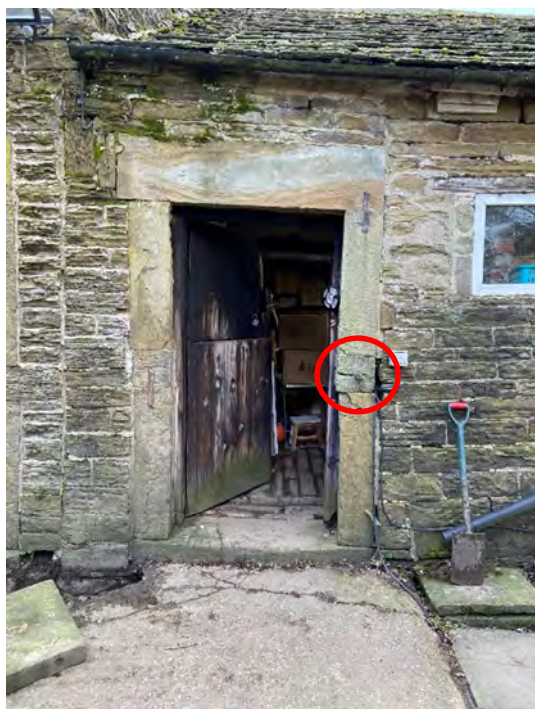
**Figure 14: Front Elevation Doorway**

It was also noticed that the stone mullions to the right of the door frame are skewed and need to be reset (Figure 14). The stone lintel above the door has also dropped at one end. Leaks from the gutter have resulted in staining of the stonework.

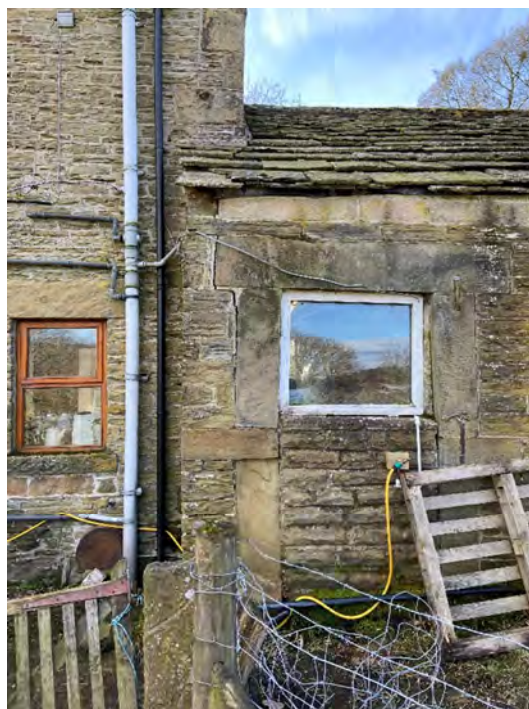
**Figure 15: Rear Elevation Window**

The stone lintels and mullions around the left-hand window were noticed to be skewed with a diagonal crack propagating from the left-hand mullion to the top corner of the wall (Figure 15).

However, if it is not removed as part of any redevelopment, the lintels should be replaced and the mullions re-set around the rear window.

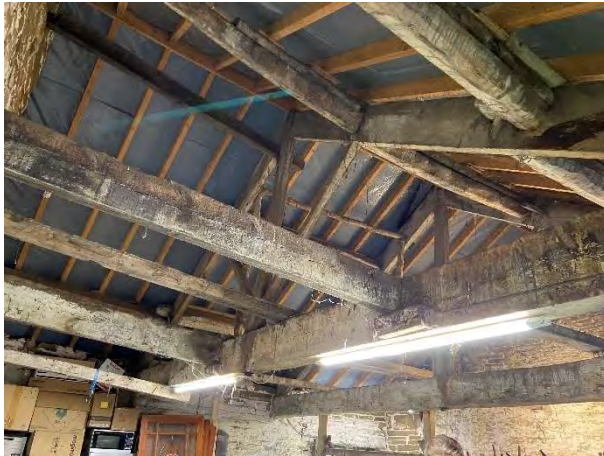
**Figure 16: Workshop Roof Structure**

The rafters are in a reasonable condition and all of them appear to have been replaced recently. The two king post trusses also appear in a reasonable condition. However, the historic purlins are bowing downwards, with the newer timber roof rafters supported off timber packing plates onto the purlins (Figure 16).

5. The whole roof structure is to be replaced (including the rafters, purlins and trusses) with a new asymmetrical duo-pitched roof with a new aluminium standing seam roof. However, if the roof is not replaced, the roof tiles, should be re-set and cleaned of moss.
6. The rear elevation wall is to be demolished as part of the redevelopment, and the Workshop extended with the external walls founded on new footings.

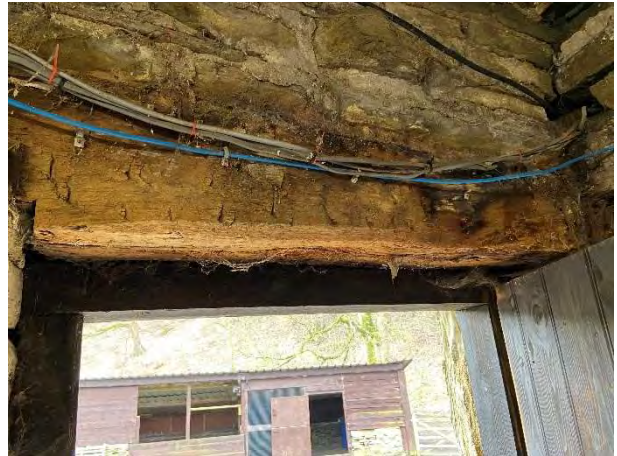
**Figure 17: Workshop Rotten Door Lintel**

The timber lintel above the external door at the front of the elevation is rotten and should be replaced (Figure 17). The most western king post truss bears onto the external masonry wall directly above the window adjacent to the door. As a result of the movement in the wall identified in Section 2.2.1, the lintel has been propped with a masonry stub in the window opening supporting the reaction from the king post truss.

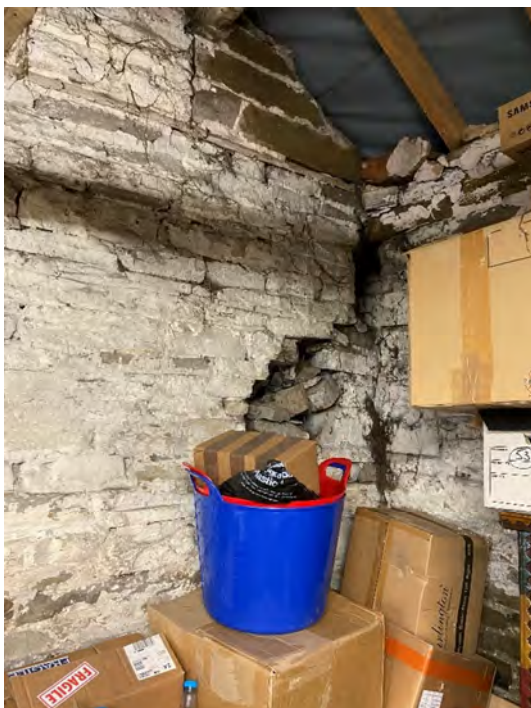
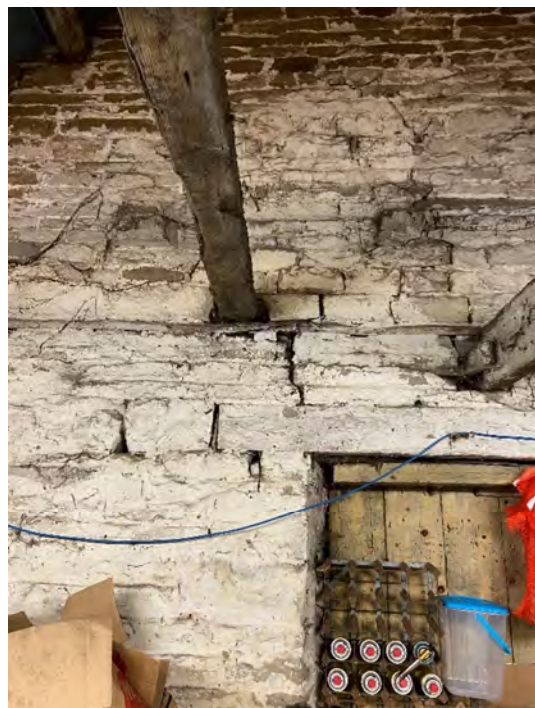
The top right corner of the dividing wall between the Workshop and Barn has dropped resulting in a large open crack in the wall with loose masonry (Figure 18). Further cracks can be observed towards the centre of the wall which propagate from where the timber beams bear on to the wall (Figure 19).

8. The wall between the Workshop and Barn has numerous cracks, particularly at its Northern end with a large open crack observed. Cracks also extend to the external Barn gable when observed from outside. At the very least the wall should be locally rebuilt at the Northern end, with the loose masonry reinstated. Remaining cracks should then be raked out, brushed and repointed. However, it may be more efficient to rebuild the whole wall, especially if the roof structures of the Workshop and Barn are to be replaced.

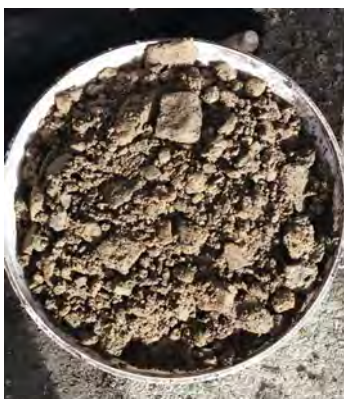
**Figure 20: Trial Pit 2 Arisings**

In accordance with Trial Pit 2, the workshop is founded on a stone footing approximately 500mm below existing ground level. The arisings suggest the founding strata is a clayey sandy gravel (Figure 20), however this will need to be determined by testing.

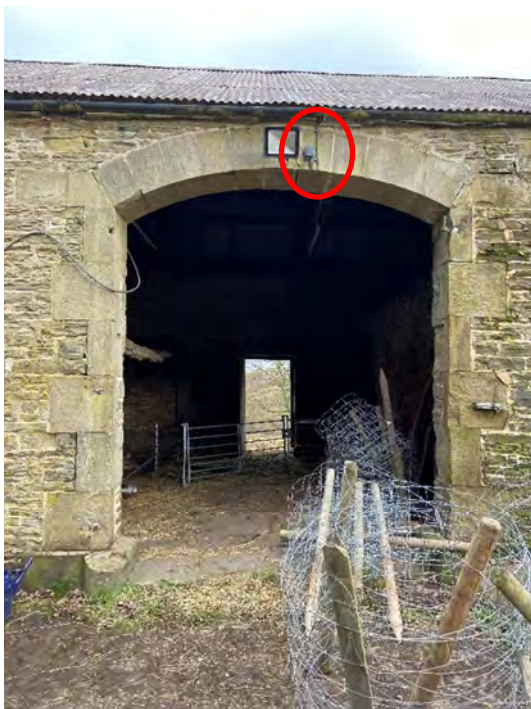
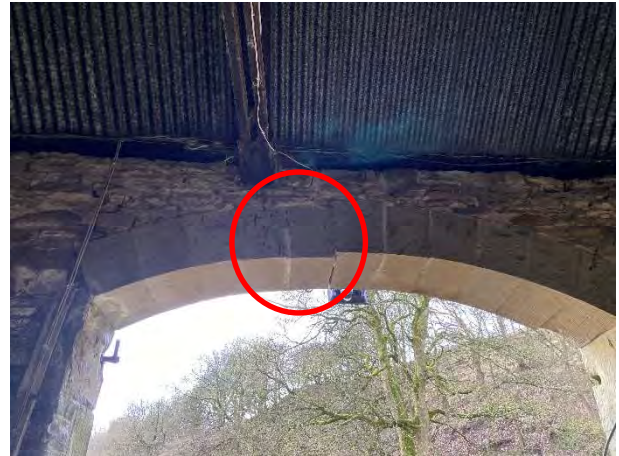
The key stone to the right of the centre of the arch to the building entrance has dropped under the bearing from the roof truss (Figure 21Figure 28). This has resulted in a small diagonal crack from the right end propagating diagonally through the mortar.

13. The external buttress should be rebuilt with the tree and vegetation removed.
14. The arch key stones should be taken down and rebuilt. The roof structure of the barn is to be replaced as part of the proposed works and the trusses are to be removed to allow for a first-floor mezzanine. This would mean the truss bearing above the arch key stone will have been removed. The arch could then be taken down and rebuilt. However, if the roof structure is not replaced, the truss will need to be propped before the arch can be rebuilt. This requires the mortar to be raked out, the arch realigned and then repointed. Scaffolding, access, and formwork may be required to rebuild the arch at high level.

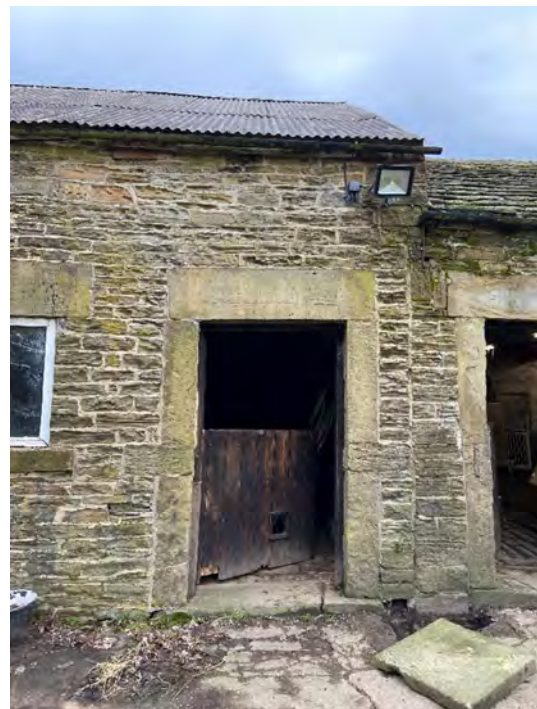
**Figure 22: Barn Personnel Door Entrance**

The stone mullions and lintel to the entrance to the smaller section of barn is skewed slightly to the right, and there is localised damage to the stonework which should be repaired (Figure 22).

9. The rotten and propped existing timber mezzanine in the smaller section of the Barn should be removed and replaced.
10. The rotten lintels and loose masonry above the window and door should be replaced. The stone mullions to the doorway should also be realigned. Any moss/ vegetation should be removed and the area cleaned.

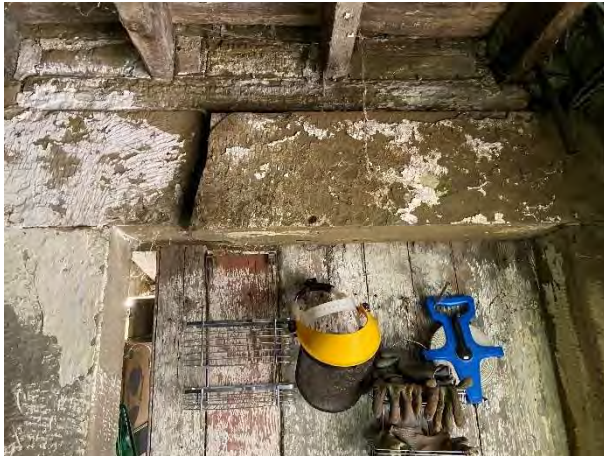
**Figure 23: Barn Internal Cracked Lintel**

The stone lintel over the door from the Barn into the Workshop is cracked and sheared in half (Figure 23). The timber lintels supporting the inner leaf of the external walls over the external door and window in the smaller section of the Barn are also rotten and should be replaced (Figure 24). The lintel over the window in particular is bowing and has split under the weight of masonry above which is loose with open bed joints (Figure 25). The roof structure in this section of the barn could not be observed during the visit due to the presence of the timber mezzanine. Several timber joists are rotten and/or splitting under the floor load above. These have previously been propped with timber posts (Figure 26 & Figure 27).

11. The existing doorway between the Barn and Workshop with the cracked stone lintel above is to be infilled and as such the lintel does not need to be replaced. If the doorway is not infilled, then the lintel should be replaced.

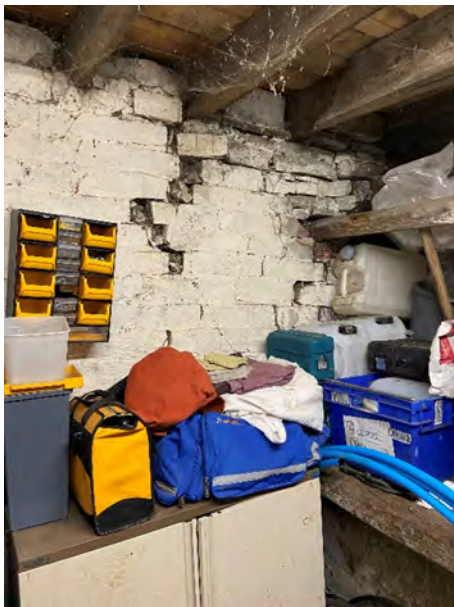
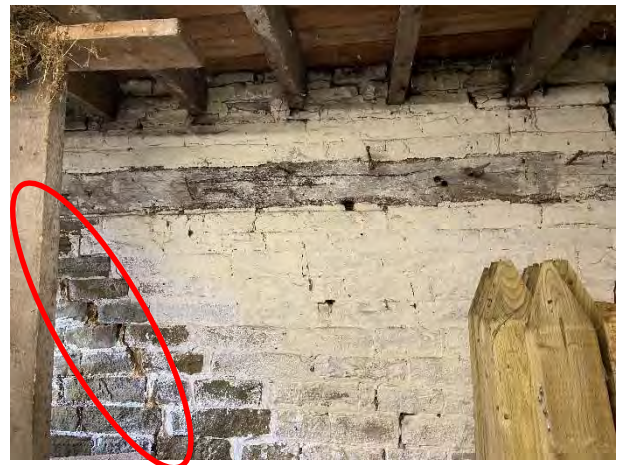
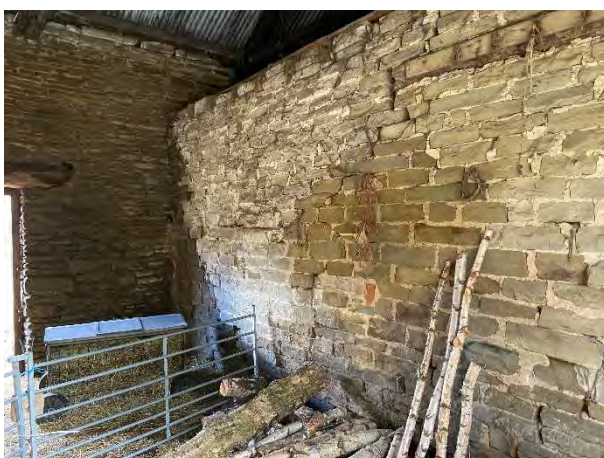
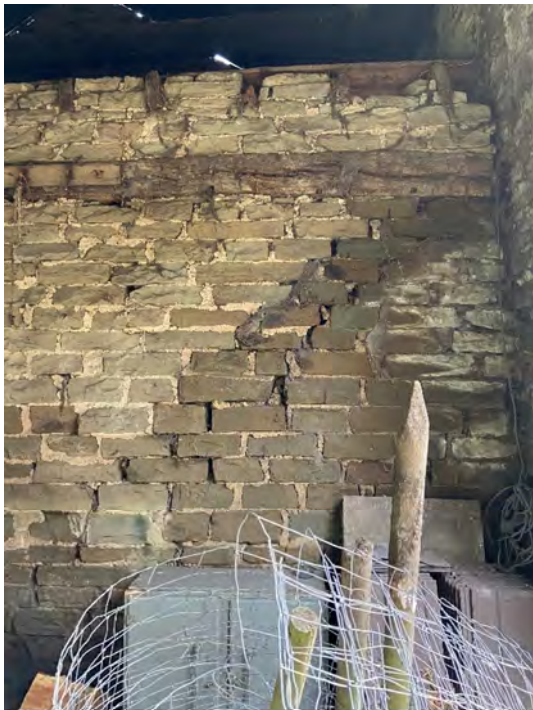
Large cracks were observed in the dividing wall between the two sections of the Barn. These are typically diagonal in nature through mortar joints and tend to propagate from the ends of the timber beam bonded into the wall. Previous re-pointing repairs were also noted to have been carried out on the wall owing to the differing colours in mortar (Figure 29, Figure 30, Figure 31, Figure 32).

12. The dividing wall between the two sections of the Barn has large cracks propagating from a timber beam bonded into the wall. It is also thought to be propped by the existing timber floor and will become unstable when this is removed. The wall should be replaced/ rebuilt as part of the proposed works.

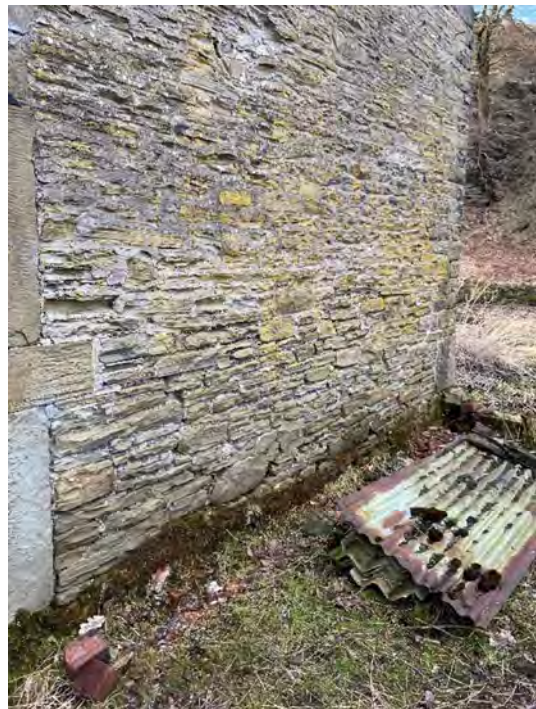
**Figure 35: Barn Rear Wall 1**

In general, the rear elevation is in a reasonable visible condition. The masonry in lower right-hand corner of the elevation should be repointed (Figure 35). The stonework is also pitted and weathered which is most probably a result of driving rain. There is a localised area at the head of the wall which is saturated with vegetation (moss) growing (Figure 36). The wall appears to be bowing by approximately 25mm over a length of 925mm in the middle of the wall at the rear door location.

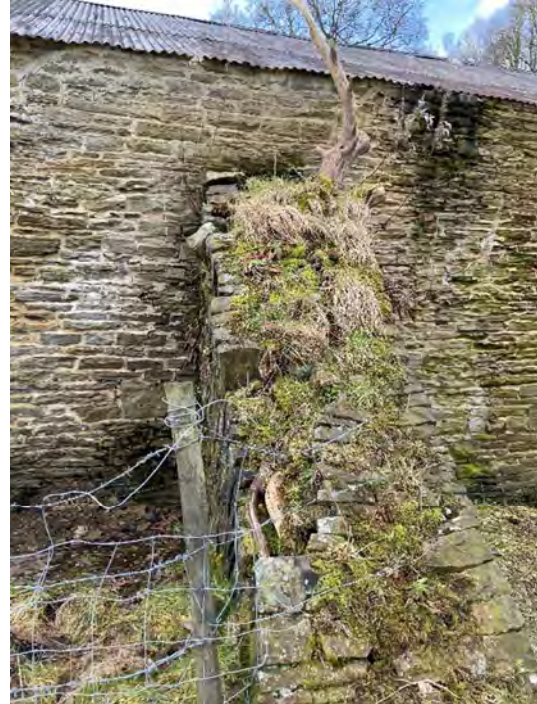
**Figure 37: Barn Rear Buttress**

The stone buttress abutting the wall is in a poor condition with gaps in the mortar. There is also significant vegetation growth on the buttress with a tree growing through the middle of it (Figure 37). The foundations of the buttress could not be determined during the visit. Adjacent to the buttress, the rear wall was recorded to be bowing by approximately 80mm over a length of 925mm when measured in the middle of the wall.

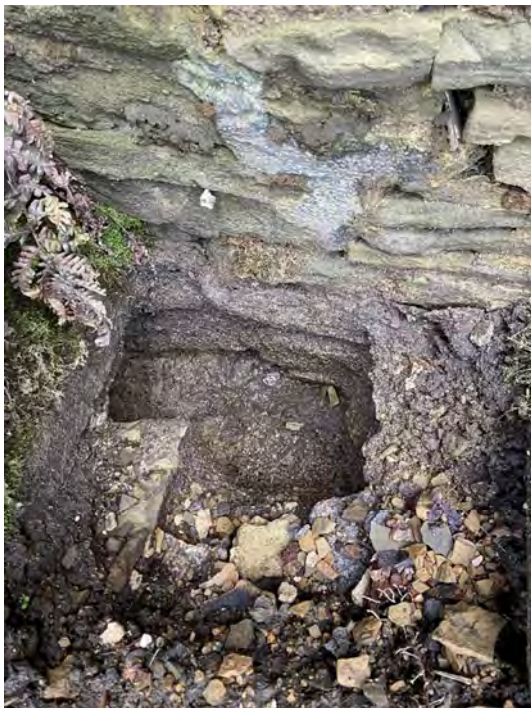
**Figure 38: Barn Trial Pit 4 Arisings**

In accordance with Trial Pit 4, the stone footing is approximately 550mm below existing ground level (Figure 38). Its composition is inconclusive and it is recommended that it is sent for testing. Although predominantly gravel, it is possible that clay is present in the arisings.

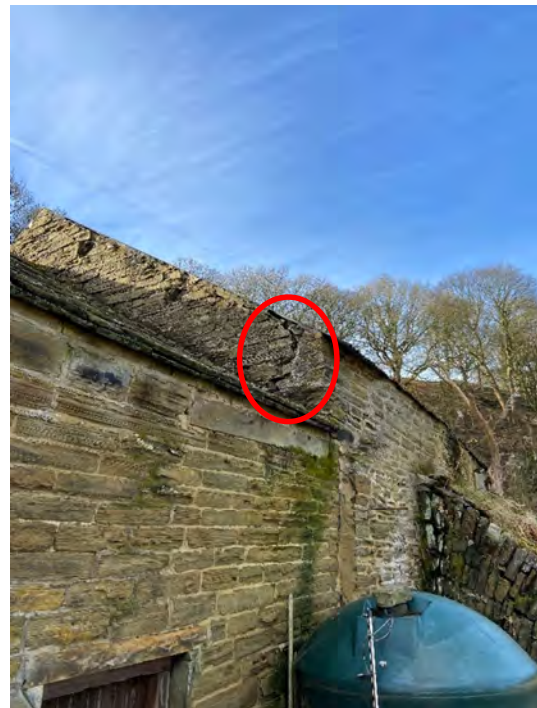
**Figure 39: Barn Crack in Gable (Cracks Highlighted)**

In the top left corner of the elevation, on the return wall, a vertical crack in the mortar joints is observed from the barn roof to the workshop (Figure 39). This is in accordance with the crack large crack observed in the internal Workshop wall which has dropped, as highlighted in Section 2.2.3.

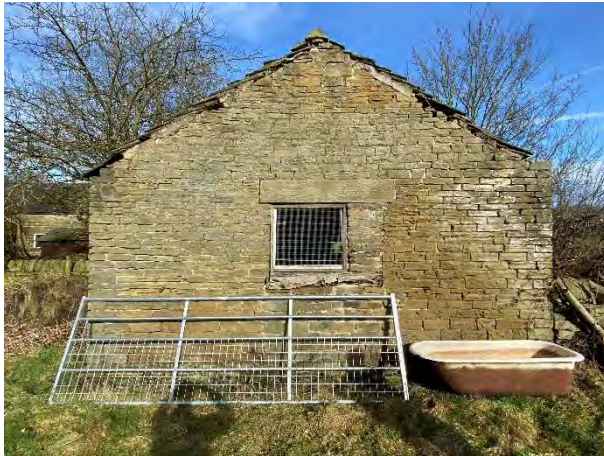
**Figure 42: Slaughterhouse Southern Elevation**

Overall, the walls are in a reasonable condition. However, some defects are present. The stonework is badly weathered on the North elevation which is most likely a result from driving rain and wind (Figure 41). The timber lintel over the entrance (Figure 45) and the timber sill on the Southern elevation are also rotten and need replacing (Figure 42).

17. The roof structure which is bowing and spread should be removed and replaced regardless of any proposed works.
18. The rotten lintels and sills should be replaced.

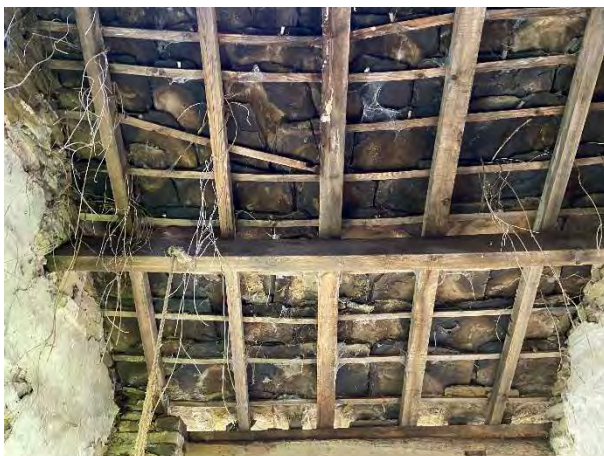
**Figure 44: Slaughterhouse Roof 2**

The canted timber purlins were also observed to be bowing in both directions resulting in roof spread at the eaves (Figure 44). This ridge is sagging, and daylight can be seen through the roof tiles (Figure 43). The roof spread has caused some cracking and deviation at the head of the external walls. Otherwise, they were found to be plumb.
