# Arboricultural Report

## Tolson Court - Penistone

| Report Ref: | TCPB01-21 | Report Date: | 20th July 2021 |

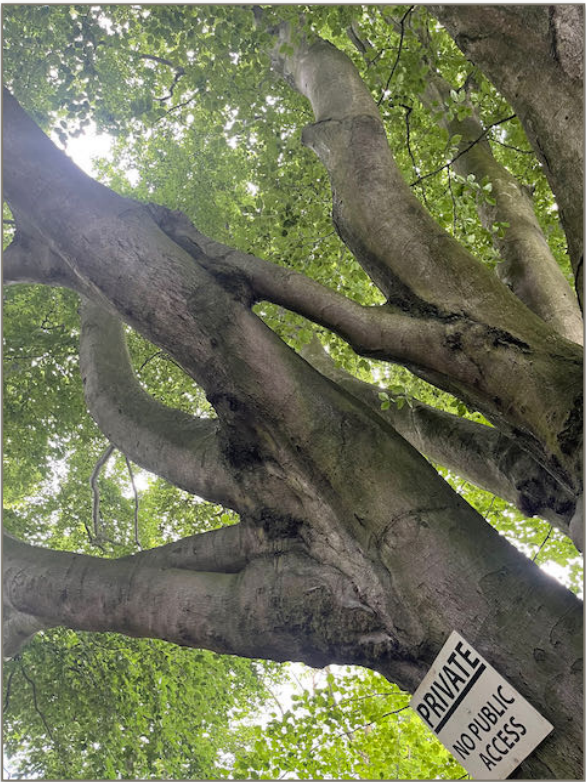
Figure 2.

The mature Beech (T1) is in excellent condition for its age with only very minor defects observed. These are predominantly focused around tight unions, many of which have become naturally braced (Figure 2) and some instances of minor deadwood, however this is as a result of self shading and not due to crown dieback. Minor pruning wounds are visible which are assumed to be part of on-going management in order to facilitate canopy clearance over the highway, driveway and footpath. These wounds are showing signs of occlusion growth.

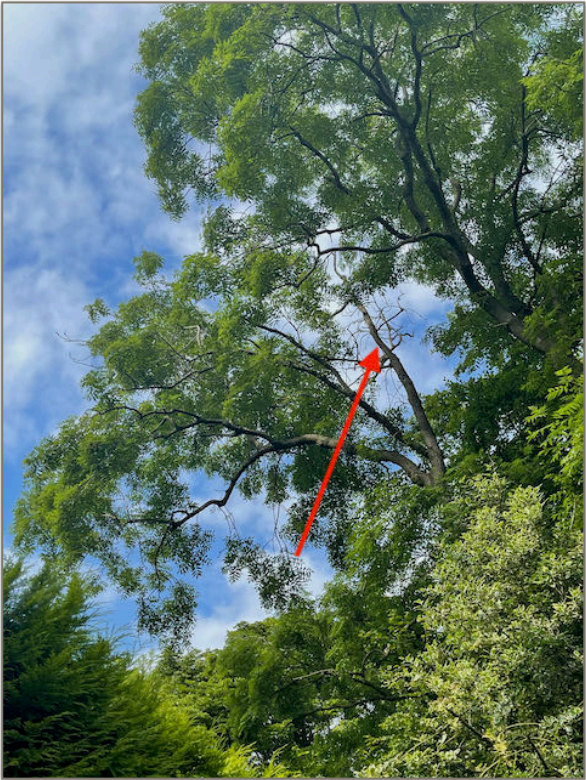
Figure 4.

The Ash tree (T2) is suffering from the early signs of Ash Dieback and is considered to be at class 2 level infection using the categories from The Tree Council's document "Ash dieback disease: a guide for tree owners". While this isn't justification for action per se, the large diameter deadwood at the crown (Figure 4) suggests that this tree was already in a natural decline before infection. This is further compounded by the desiccated fungal body at the base, assumed to be Dryad's Saddle (*Polyporus squamosus*). The presence of this fungi along with the stem swelling would point towards internal cavitation. In respect of these three findings alongside the tree's position with large limbs extending towards the highway and a stem lean over the small garden, the justification for retention is somewhat limited.

| Tree ID | Age Class | Species | Height (m) | Diameter (mm) | N E S W | Observations | Recommendations | Priority |
|---|---|---|---|---|---|---|---|---|
| T2 | Over Mature | Ash ( <i>Fraxinus excelsior</i> ) | 20 | 950 | 9, 7.5, 3, 9 | Old occluded pruning wounds around the base with decicated fruiting bodies. High volume of internal epicormic growth with apical dieback suggest early signs of ADB (Class 2) with associated deadwood. Large dead central leader. One limb extends towards the highway. Main stem leans towards the house. | Fell | Medium |

T2 is considered no longer suitable for retention due to the high likelihood for further decline, compromising site safety.

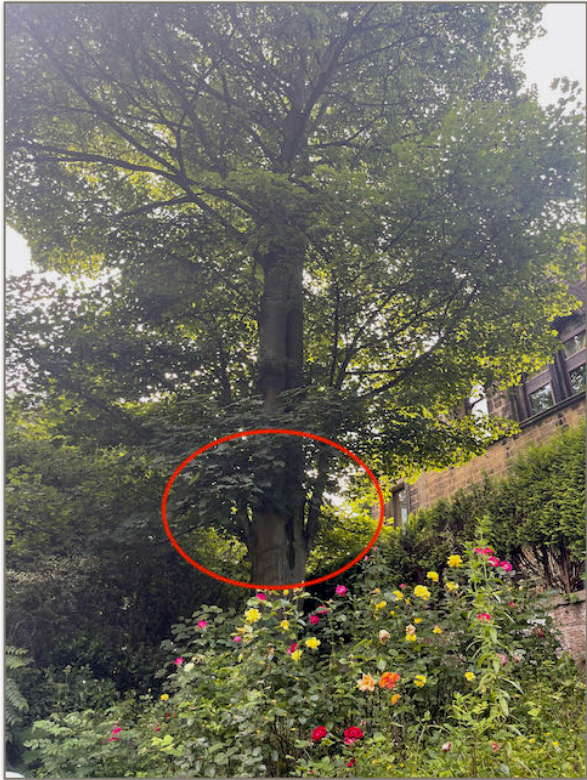
Figure 5.

T3 is a relatively well-formed tree in close proximity to the building. The union at the main bifurcation is becoming tight with a minor bark inclusion, however Sycamore trees are typically more resilient to this form of defect and the lack of swelling around the union would suggest that stress or strain at this point is minimal. The canopy is in good health with no observed significant deadwood, however, the health of this canopy is causing some complaints from the occupant, stating that the tree is blocking a considerable volume of light from the lower windows. This could easily be remedied by removing the lower three limbs to generate a 4m canopy raise (Figure 5).

| Tree ID | Age Class | Species | Height (m) | Diameter (mm) | N E S W | Observations | Recommendations | Priority |
|---|---|---|---|---|---|---|---|---|
| T3 | Over Mature | Sycamore ( <i>Acer pseudoplatanus</i> ) | 20 | 730 | 4, 6, 6.5, 5 | Bifurcation of main stem at 2.5m with a tight union. Minimal signs of stress at the union. Branches are well developed with adequate unions. Unmanaged epicormic growth has developed into three lower branches at 2m which extend vertically upwards into the crown with wide spreading lateral shoots. These limbs are blocking a significant amount of light from the building. | Remove lower three limbs to lift the canopy by 4m | Low |

T3's lowest three limbs have developed from epicormic growth and are out of character with the 'typical' growth form. Furthermore they are blocking light from the ground floor of the building. These limbs should be removed to improve form and improve light penetration. Pruning wounds would be small and likely to fully occlude before decay can become established.
