**Tree Impacts Plan**

35 Belvedere Drive, Darfield, Barnsley  
Ref: AWA2181

BRITISH STANDARD 5837:2012  
SCALE: 1:200 PAPER: A3

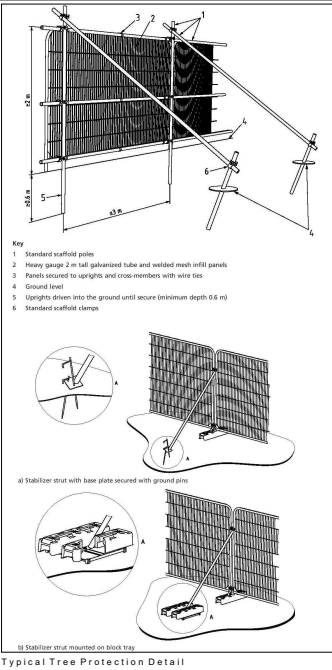
Protective measures to be taken around these trees.

Prune back hedge G1 as required
