IPD-22-580 – SHAW LANE, CARLTON, BARNESLEY.

ROAD SAFETY AUDIT – STAGE ONE DESIGNER’S RESPONSE REPORT.

Project Information	
Infrastructure Planning and Design Ltd. The Hayloft Barn Borough Hill Farm Walton-on-Trent Derbyshire DE12 8LL Tel: 01283 716869 Mob: info@ipd-ltd.com	
Job No.	IPD-22-580
Report No.	R.001
Prepared By	BO / SEF
Checked By	CLP
Approved By	RNP
Status	FINAL
Issue No.	-
Date	16.02.2023

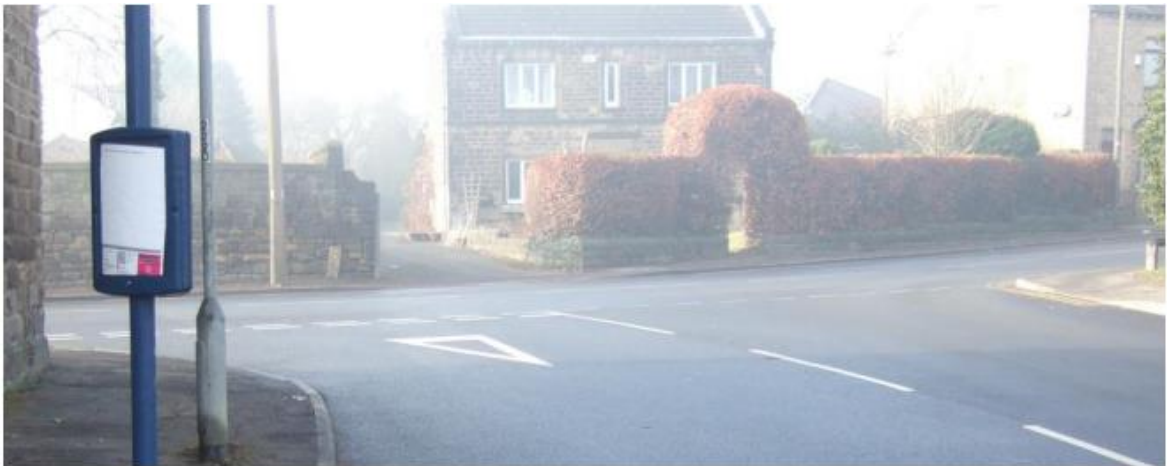
Location: Junction of Shaw Lane, Church Street and Fish Dam Lane

Problem Summary: The controlled crossing on the north side of the junction conflicts with a private driveway.

- 3.1 *PROBLEM 1-* “It is proposed to signalise the existing priority junction where Shaw Lane meets Church Street and Fish Dam Lane. The proposal includes controlled pedestrian crossings on Shaw Lane and Church Street to the east and north side of the junction respectively. On the western side of the junction is a private driveway. The western end of the pedestrian crossing on Church Street will result in the red blister tactile paving being laid within the width of the vehicular crossing across the footway. This will result in a risk to waiting or crossing pedestrians being struck by a vehicle emerging from, or turning into, the driveway. The associated signal pole, supporting the push button and pedestrian indicator, will restrict vehicular access to the driveway making access more hazardous, resulting in the manoeuvre to and from the driveway taking longer and increasing the risk of a sideswipe collision with passing vehicles.”

“It is recommended that the location and orientation of the controlled crossing of Church Street is amended to avoid any conflict with the driveway.”

Due to the very tight constraints of the junction visibility splay, and the walls at the rear of highway land, inserting a signal junction with two crossings is complex. To enable the design to continue to retain two crossings, (and avoid the drive crossing – not shown on topo) the design would need to deviate away from the design standards and have the crossing positioned not parallel to the stop line. (If this acceptable to Barnsley Council). If not this cross would need to be removed.

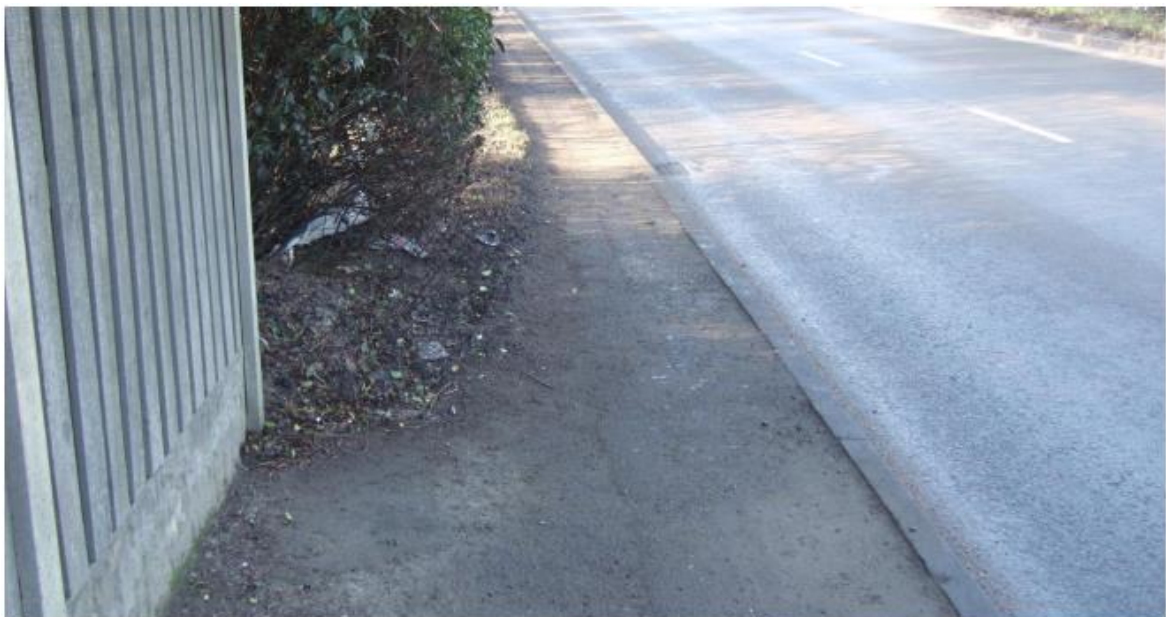
Location: Shaw Lane west of development access- proposed toucan crossing

Problem Summary: The use of the southern footway by cyclists may lead to conflict with pedestrians

- 3.5 *PROBLEM 5-* "A Toucan crossing is being provided to the west of the proposed site access junction. This will provide a crossing for pedestrians and cyclists from the site to cross onto the southern footway along Shaw Lane. To the west of the toucan crossing the footway width reduces to as little as 700mm measured on site. This footway is insufficiently wide enough to accommodate both users without the potential for collisions between them."

“It is recommended that the designer review the route for cyclists to and from the western side of the proposed development.”

“Footway improvements are being proposed along the whole stretch of Shaw Lane, from the new priority T-Junction to the Shaw Lane/Church Street/ Fish Dam Lane Junction to the west. The improvements include widening of the footway to a minimum of 2m along the whole southern side of Shaw Lane. The improvements can be seen on drawing ref: IPD-22-580-105, IPD-22-580-106 and IPD-22-580-107.” Cyclists will not be able to ride on the footway and must use the carriageway.
