## Princess Theatre, Hoyland

### Bat Survey Report

7<sup>th</sup> August 2026

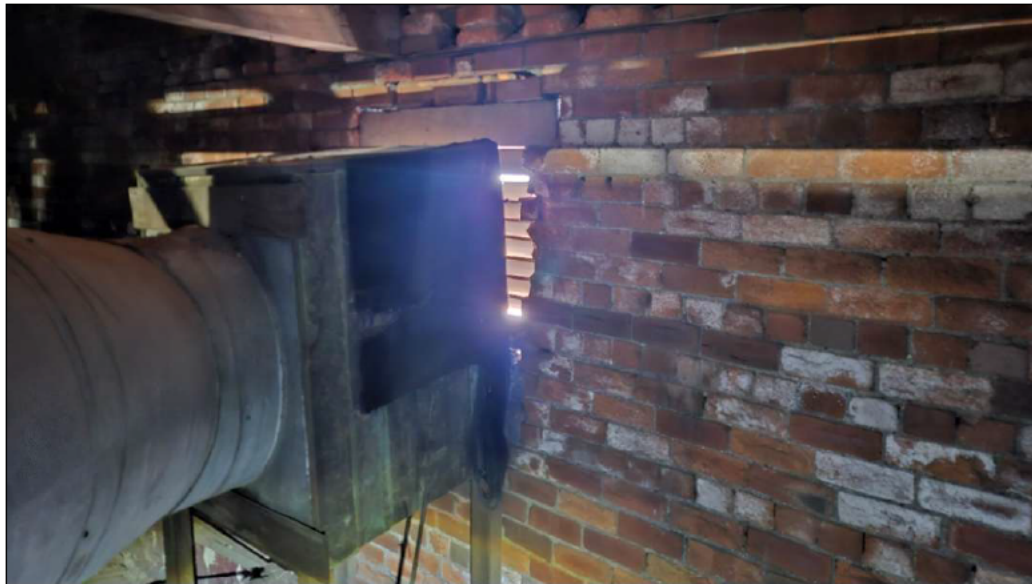
**Plate 5. The louvred vent at the southern end of the building**

- 5.2.4 A square timber louvred vent was present on the southern gable, providing ventilation to a series of metal pipes within the building. Internally, a large gap was present between the vent and the associated pipework (Plate 5).

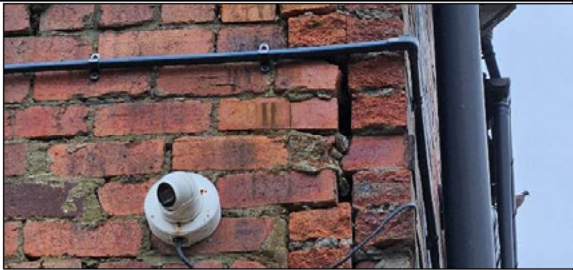
| PRF | Example Photo | Description |
|---|---|---|
| A | | Gap in the masonry. |

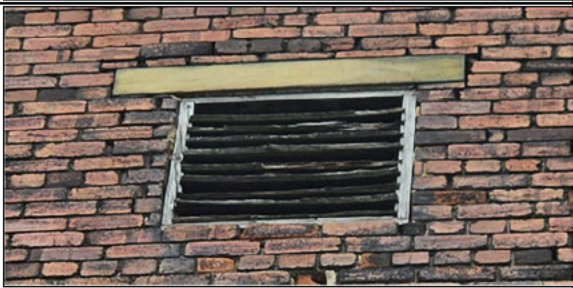
| PRF | Example Photo | Description |
|---|---|---|
| B | | Louvred vent. |

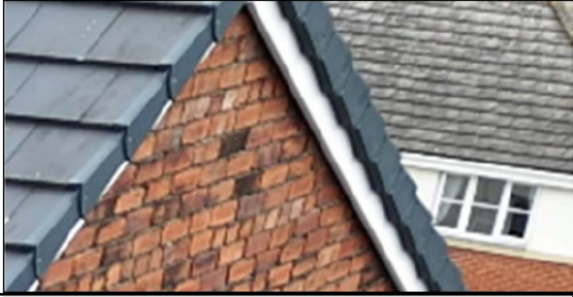
| PRF | Example Photo | Description |
|---|---|---|
| C | | Gap behind barge board. |

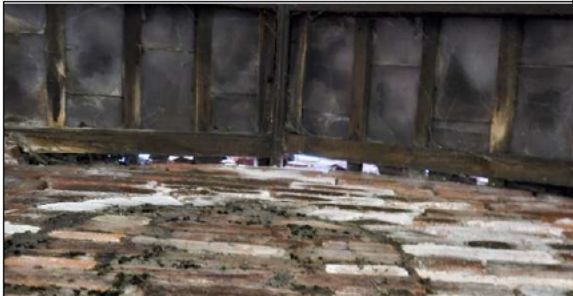
| PRF | Example Photo | Description |
|---|---|---|
| D | | Gap between ridge and coping stones (viewed from inside the roof void). |

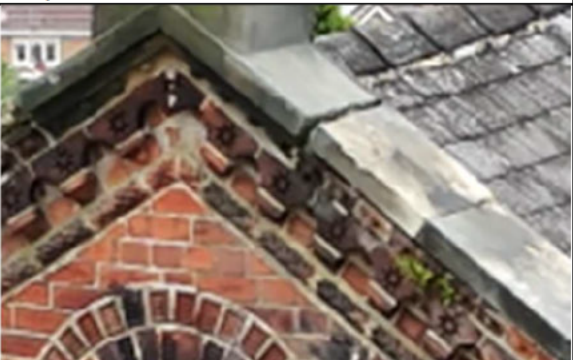
| PRF | Example Photo | Description |
|---|---|---|
| F | | Gap between coping stones. |

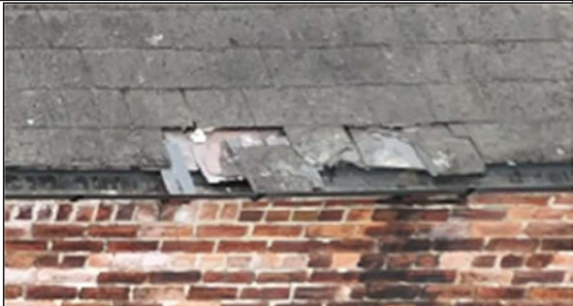
| PRF | Example Photo | Description |
|---|---|---|
| G | | Slipped/missing slate. |

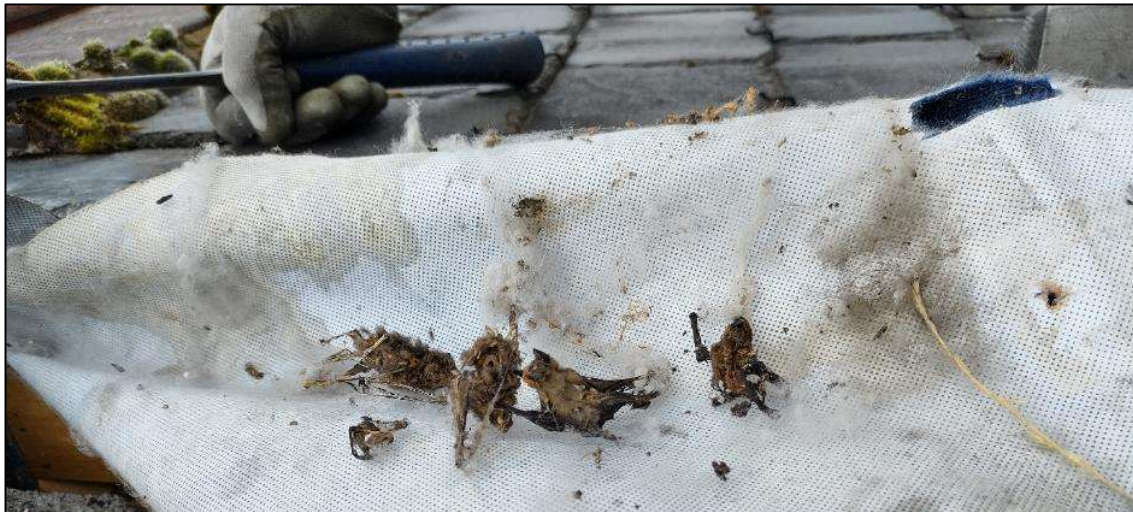
Standard non-bitumen coated membranes (including almost all breathable membranes) used below roof slates and tiles present a significant problem for bats. Over time, strands are pulled away from the surface of these materials as bats crawl over them. These fuzzy strands are very strong and can tangle and trap bats, sometimes causing the death of bats over multiple years<sup>2</sup>.

One example we have encountered comprised a pipistrelle roost which formed in a building extension constructed in 2009. Over the course of just 13 years the roofing felt degraded to the extent that it trapped and killed more than 10 bats. Fortunately, the problem in this roost was identified and remedial work was undertaken to replace the roofing membrane in 2022.

#### Plate A2.1. Four dead pipistrelles tangled in breathable roofing membrane

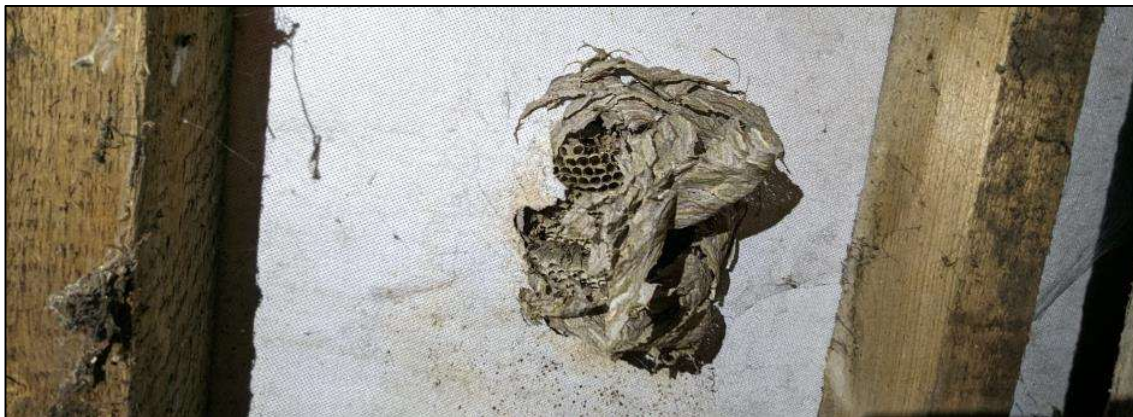
In recent years a fairly substantial proportion of the lofts we have surveyed which had existing breathable felt, were found to have been damaged by wasps (Plate A2.2). The wasps appear to have chewed holes in the felt and formed nests. This doesn't appear to be a problem associated with traditional bitumen coated roofing felt. Any holes within roofing felt are likely to significantly reduce its functionality as a secondary weather barrier. Where bats or birds come into contact with breathable roofing membranes, they can also damage it causing it to leak, they can also significantly reduce the breathability of the felt in that location.

**Plate A2.2. Damage to a breathable roofing membrane adjacent to a wasp nest**
