**Whitcher Wildlife Ltd.
Wildlife Consultants.**

OAKS FARM, DARTON.

BAT SURVEY.

Ref No:- 141030.

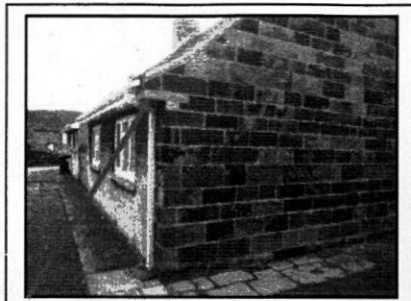
3.2.2.2. The gable ends are mostly well pointed with one small gap on the western gable end. There are plastic soffits and fascia boards around the building which are mostly tight fitting. However, there are two small areas where there is a gap leading underneath the Rosemary roof tiles. There is also a gap underneath the soffit on the western gable end and an area of lifted lead flashing on the eastern chimney. These areas will provide possible access for bats.

3.2.2.3. The aerial photograph below shows the location of the identified gaps.

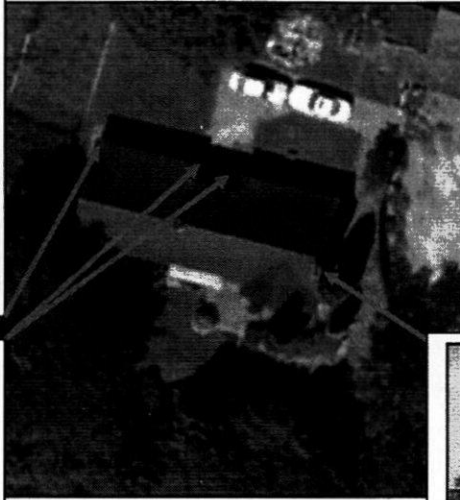
Western gable end.

4.1. The Bungalow will provide a low potential for roosting bats. This is due to a gap being identified in the western gable end, two gaps in the northern fascia boards and an area of raised flashing on the eastern chimney. No bat roosts or bat field signs were identified internally or externally during this survey. However, if these locations are used during the summer months during the bat activity season and field signs are not currently present there could be an impact on bats.

5.1. It is recommended that further surveys are carried out of the Bungalow and Building D as a low roosting potential has been identified during this survey.

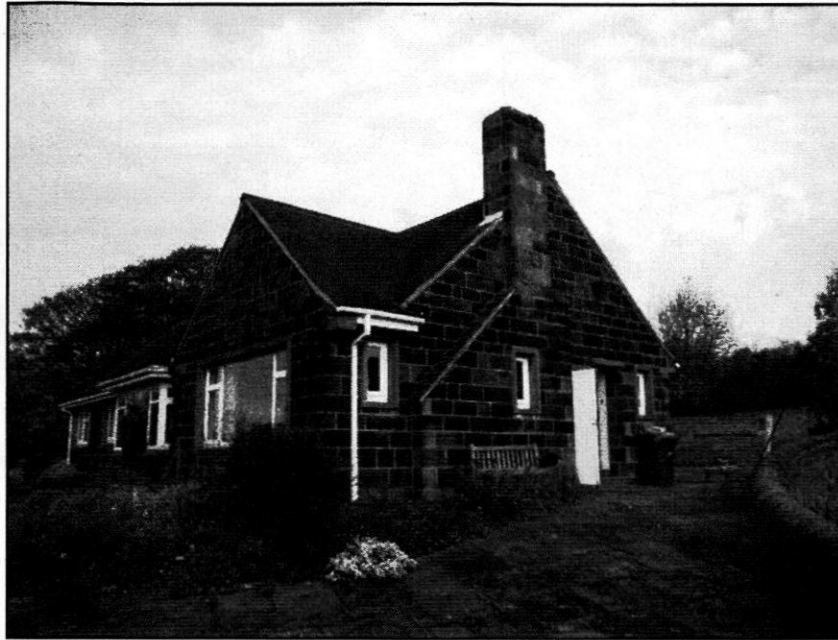
3.2.2.7. The photograph below shows the south eastern elevation of the Bungalow.

3.2.2. **The Bungalow** is a single storey stone structure with a pitched roof. The dressed stone walls are well pointed with no mortar loss or missing stonework.

3.2.2.1. The roof of the building is pitched and covered with Rosemary tiles. There are some areas where the tiles have cracked in half, but these do not provide access for bats into the loft space or the cavity between the lining and the Rosemary tiles.

3.2.2.6. No bat field signs were identified internally or externally during this survey.

5.2. One further dusk/dawn survey will be required in line with the Bat Conservation Trust Bat Survey Good Practice Guidelines. This survey is required to prove or disprove the presence of roosting bats within the Bungalow and Building D. This survey will need to be carried out during the bat activity season which extends from May to August, weather dependent.

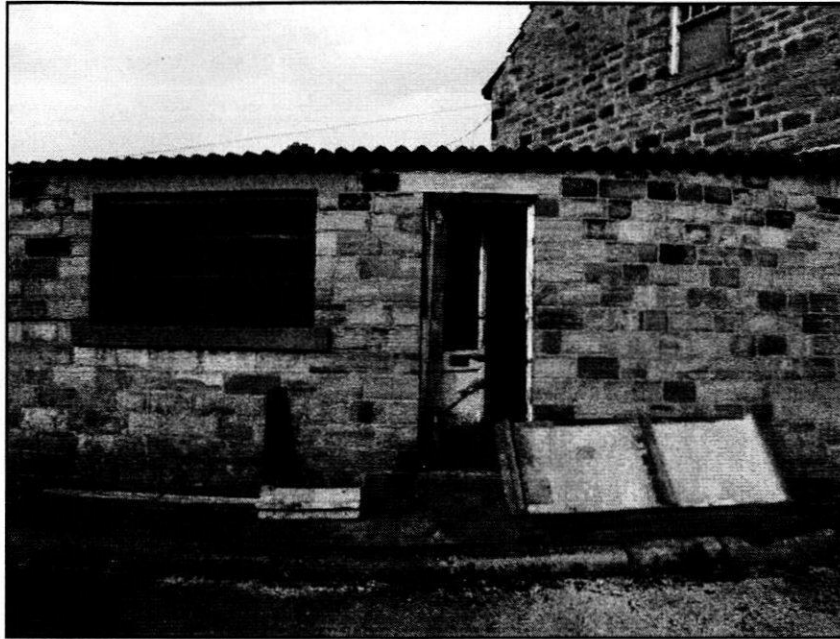
3.2.3.4. The photograph below shows the southern elevation of Building A.

3.2.3. **Building A** is attached to Building B on the northern elevation. Building A is a single storey stone structure with a single pitch roof. The dressed stone walls are well pointed with no mortar loss or missing stonework.

3.2.3.3. No bat field signs were identified internally or externally during this survey.

4.2. Building A will not provide a suitable habitat for roosting bats as there are no suitable roosting points and no bat field signs were identified internally or externally during this survey. The proposed works will have no impact on roosting bats.

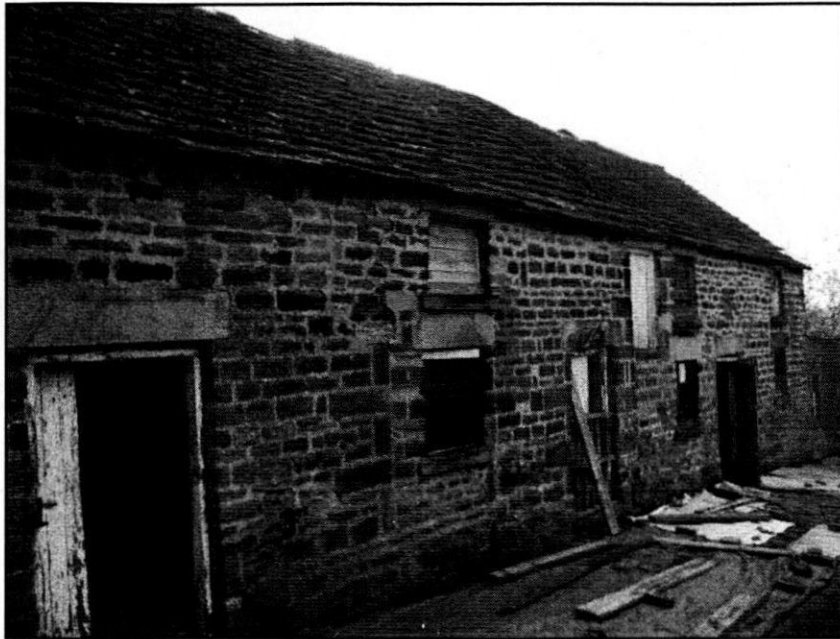
3.2.4.5. The photograph below shows the western elevation of Building B.

3.2.4. **Building B** is connected to Building A on the southern elevation and Building H on the eastern elevation. Building B is a two storey stone structure with a pitched roof. The dressed stone walls are well pointed with some mortar loss and a small area of cracked stonework.

3.2.4.1. The roof of the building is pitched and covered with stone roof tiles. The roof is generally in a good state of repair. However, there are some areas where the stone roof tiles have slipped as the timber is deteriorating. Due to the nature of the stone roof tiles there are gaps between the roof tiles which will provide access for bats.

4.3. Building B will not provide a suitable habitat for roosting bats as there are no suitable roosting points as the building is very exposed and rapidly deteriorating. No bat field signs were identified internally or externally during this survey and the proposed works will have no impact on roosting bats.

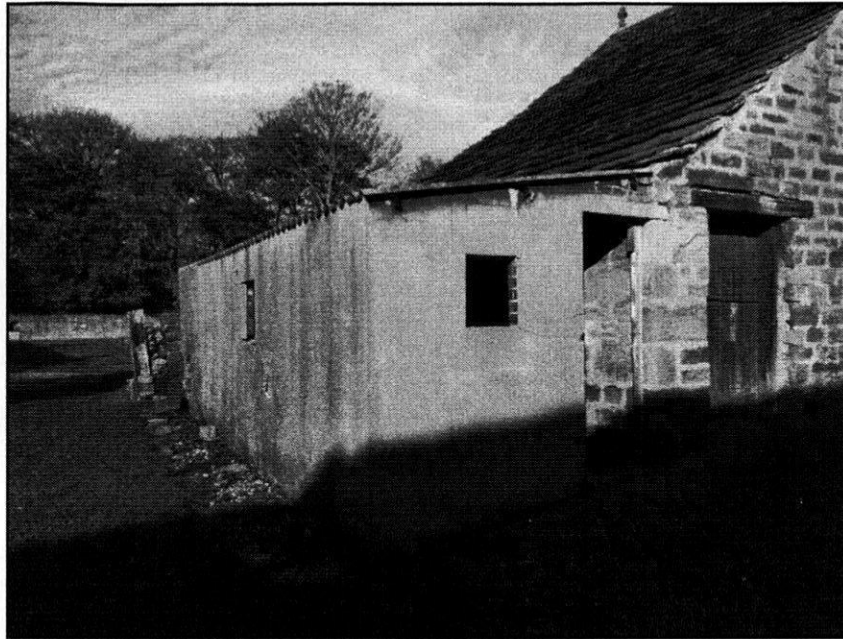
3.2.5.4. The photograph below shows the southern and eastern elevations of Building C.

3.2.5. **Building C** is attached to Building D on the northern elevation. Building C is a single storey brick structure with rendered external walls and a single pitch roof. The rendered walls are in a good condition with no cracks or gaps.

3.2.5.2. There are windows and doors on the southern and eastern elevation of the building which are open which will provide access into the building.

4.4. Building C will not provide a suitable habitat for roosting bats as there are no suitable roosting points and no bat field signs were identified internally or externally during this survey. The proposed works will have no impact on roosting bats.

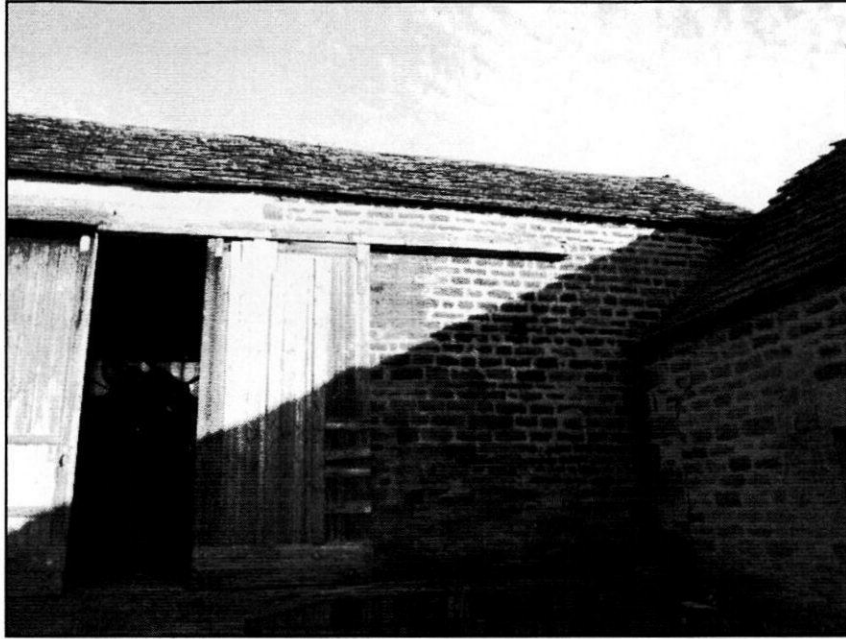
3.2.6.5. The photograph below shows the southern elevation of Building D.

3.2.6. **Building D** is attached to Building C on the southern elevation Building E and F on the northern elevation and Building G on the eastern elevation. Building D is a two storey stone structure with a pitched roof. The dressed stone walls are well pointed with some shallow mortar loss.

3.2.6.1. The roof of the building is pitched and covered with stone roof tiles on the southern elevation and blue slate on the northern elevation. The roof is generally in a good state of repair. However, there are some areas where the stone roof tiles have slipped. Due to the nature of the stone roof tiles there are gaps between the roof tiles which will provide access for bats.

4.5. Building D will provide a low potential for roosting bats as there are some areas of missing mortar and opportunities for bats to roost within the roof timbers. No bat roosts or bat field signs were identified internally or externally during this survey. However, if these locations were in use when the works are carried there will be an impact on bats.

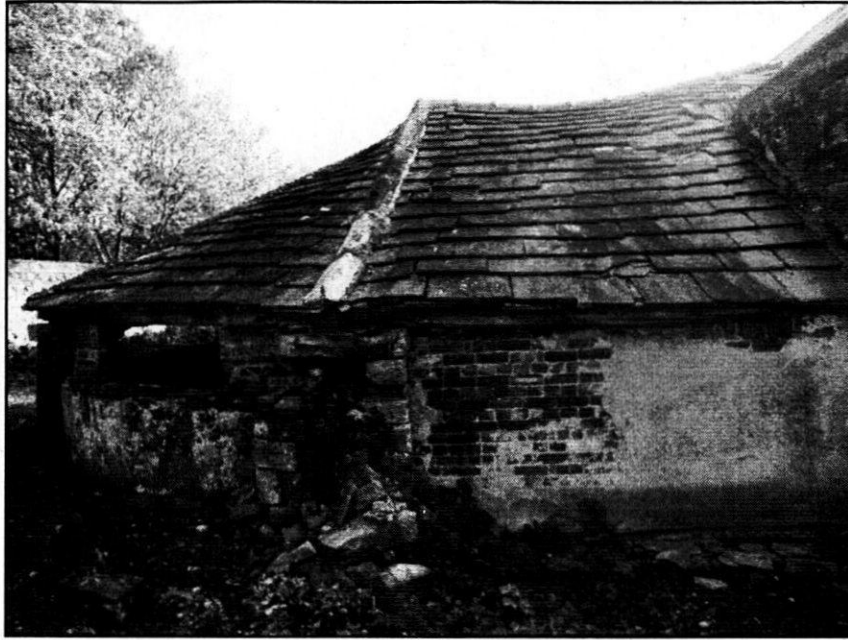
3.2.7.5. The photograph below shows the western elevation of Building E.

3.2.7. **Building E** is attached to Building D on the northern elevation. Building E is a single storey stone, brick and rendered structure with a semicircular hipped pitched roof. The walls are well pointed with some shallow mortar loss.

3.2.7.1. The roof of the building is covered with a semicircular hipped pitched roof and covered with stone roof tiles. All the ridge tiles are in place. However, there are several areas of mortar loss. The roof is generally in a good state of repair. However, there are some areas where the stone roof tiles have slipped due to the deteriorating timbers. Due to the nature of the stone roof tiles there are gaps between the roof tiles which will provide access for bats.

3.2.7.3. There are windows and doors on the eastern, northern and western elevation of the building which are all open providing access for bats.

4.6. Building E will not provide a suitable habitat for roosting bats as there are no suitable roosting points and no bat field signs were identified internally or externally during this survey. The proposed works will have no impact on roosting bats.

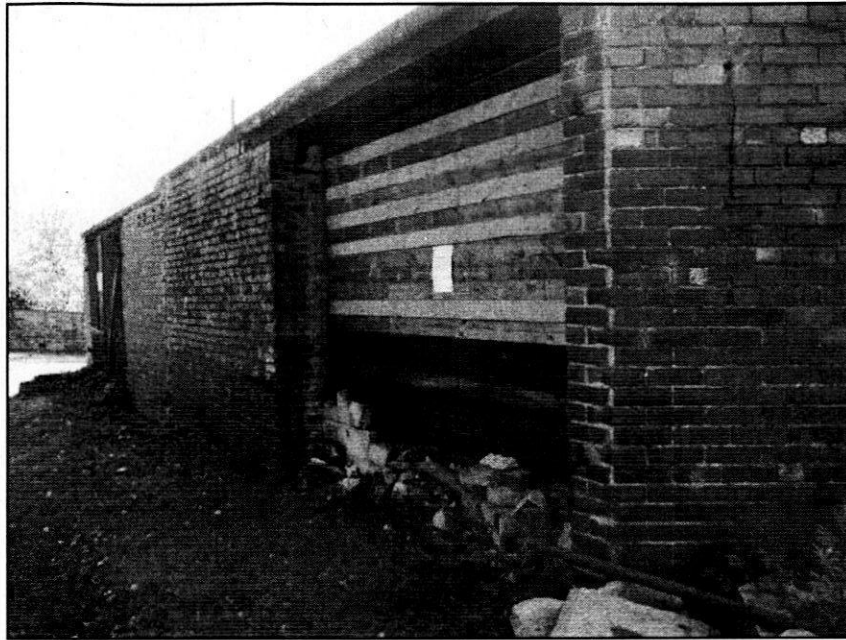
3.2.8.4. The photograph below shows the northern elevation of Building F.

3.2.8. **Building F** is attached to Building D and Building G on the southern elevation. Building F is a single storey brick structure with a flat concrete roof. The brickwork is in a good condition with no cracks or crevices.

3.2.8.2. There are windows and doors on the northern, eastern and southern elevation of the building which are sealed with no access for bats.

4.7. Building F will not provide a suitable habitat for roosting bats as there are no suitable roosting points and no bat field signs were identified internally or externally during this survey. The proposed works will have no impact on roosting bats.

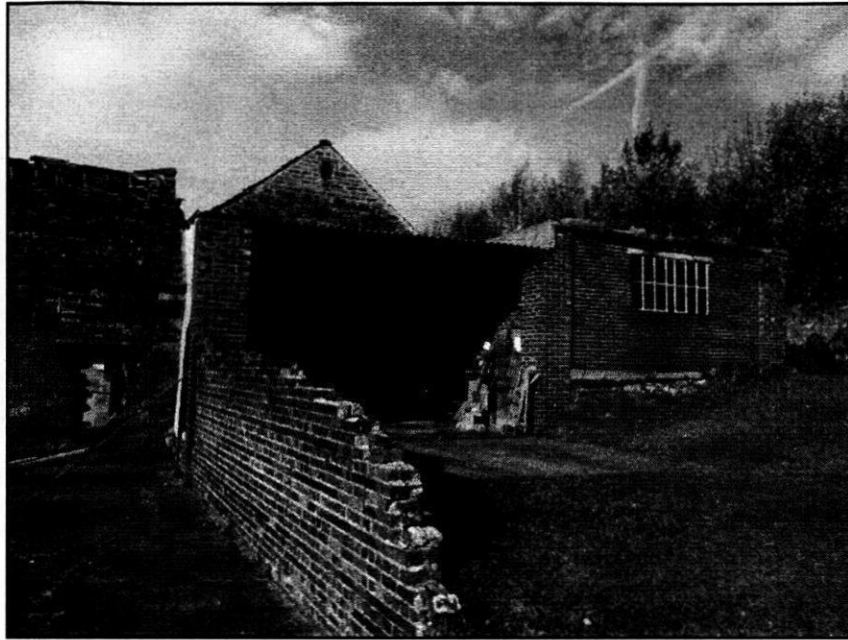
3.2.9.4. The photograph below shows the eastern elevation of Building G.

3.2.9. **Building G** is attached to Building F on the northern elevation and Building D on the western elevation and Building B on the southern elevation. Building G is a single storey brick structure with a single pitch roof. The brickwork is in a good condition with no cracks or crevices.

3.2.9.2. The front of the building is fully open with constant access for bats.

4.8. Building G will not provide a suitable habitat for roosting bats as there are no suitable roosting points and no bat field signs were identified internally or externally during this survey. The proposed works will have no impact on roosting bats.

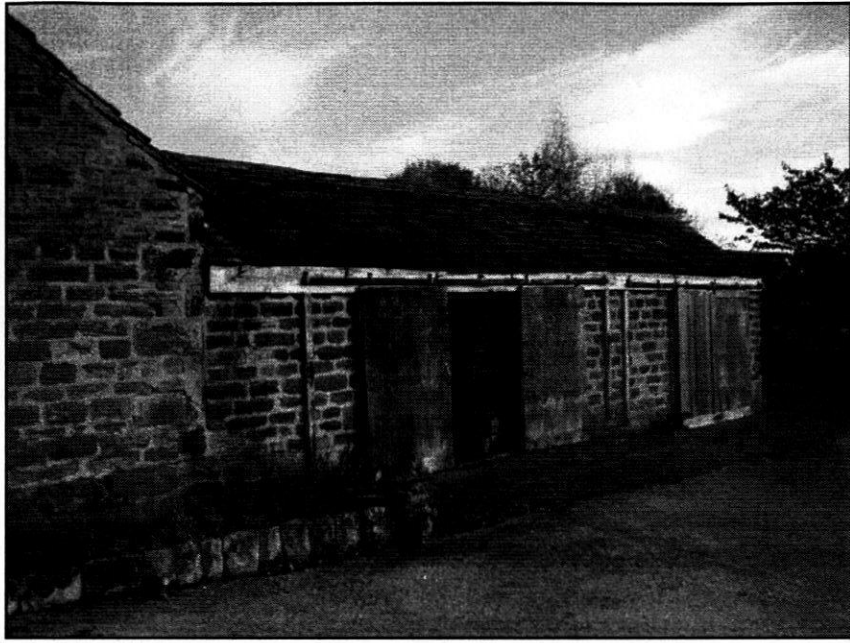
3.2.10.5. The photograph below shows the southern elevation of Building H.

3.2.10. **Building H** is connected to Building B on the eastern elevation. Building H is a single storey stone structure with a pitched roof. The dressed stone walls are well pointed with some minor mortar loss.

3.2.10.1. The roof of the building is pitched and covered with stone roof tiles. The roof is generally in a good state of repair. Due to the nature of the stone roof tiles there are gaps between the roof tiles which will provide access for bats.

4.9. Building H will not provide a suitable habitat for roosting bats as there are no suitable roosting points and no bat field signs were identified internally or externally during this survey. The proposed works will have no impact on roosting bats.
