# **ARBORICULTURAL REPORT**

### **to BS5837:2012 at:**

***Coach House,  
Doncaster Road,  
Barnsley,  
South Yorkshire  
S71 5EZ***

Reference: *AWA2458*

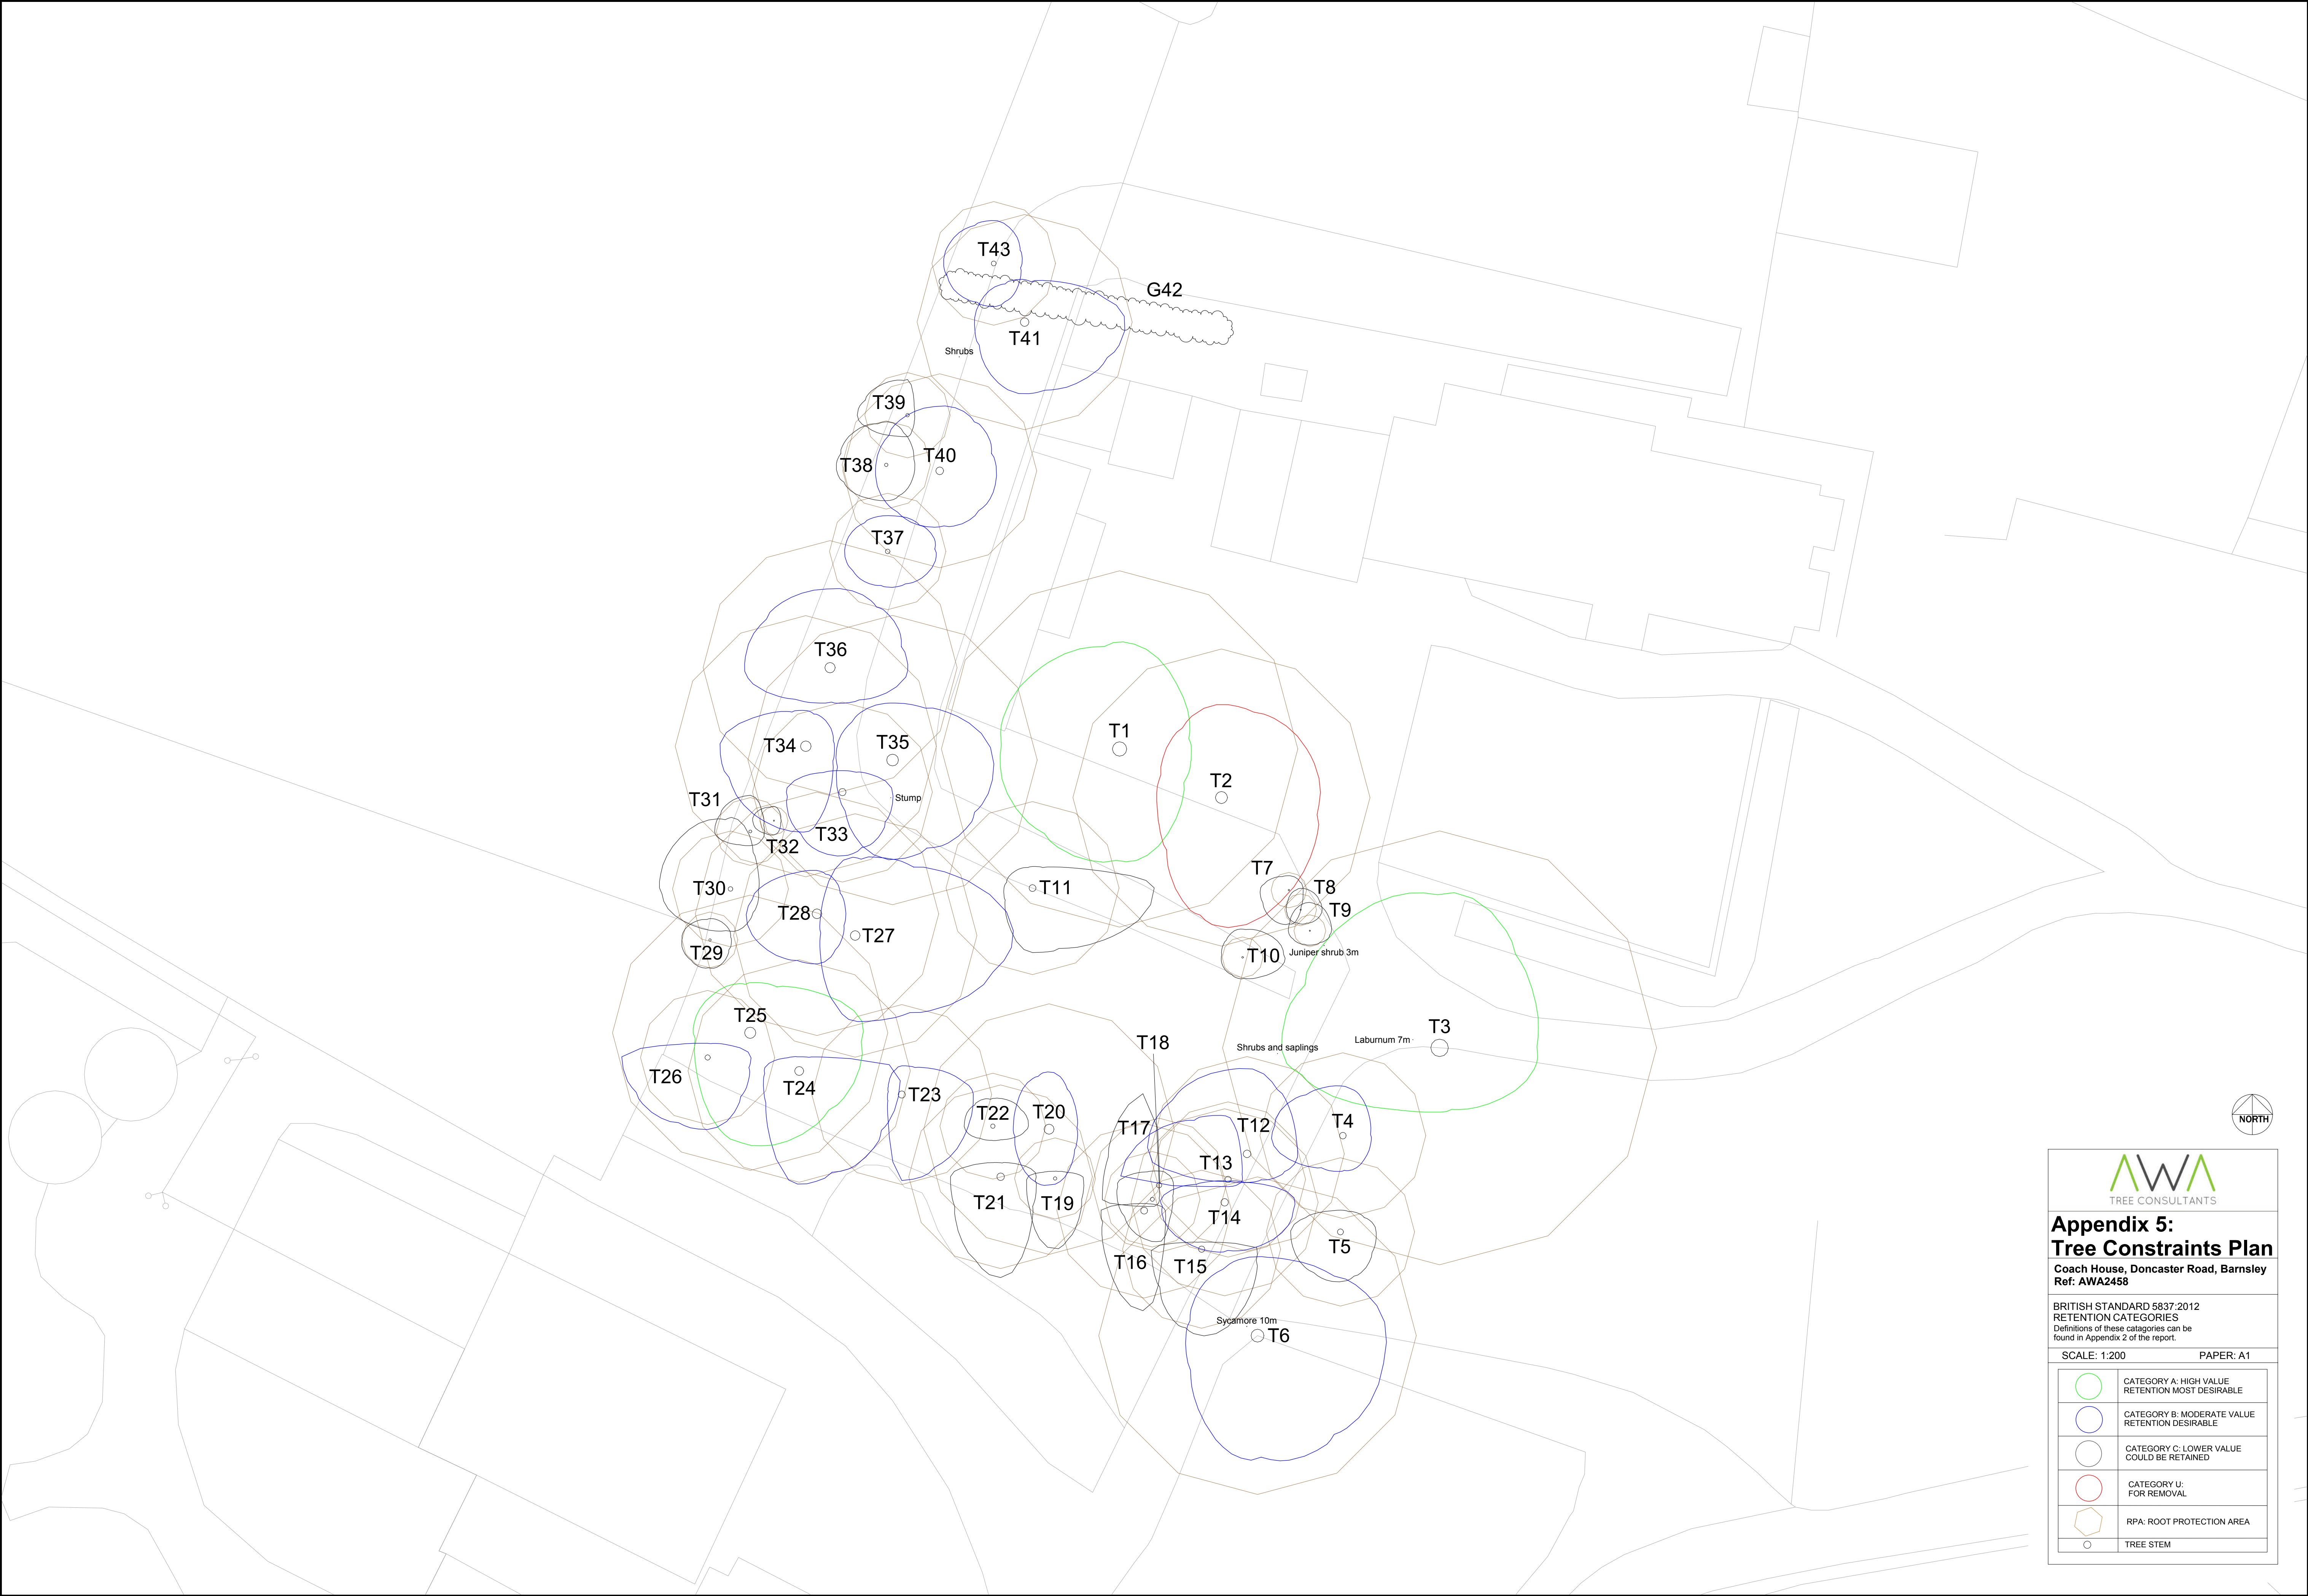
**Appendix 5:  
Tree Constraints Plan**  
Coach House, Doncaster Road, Barnsley  
Ref: AWA2458

- 3.2.11 The tree Root Protection Area (RPA) detailed on the Tree Constraints Plan at Appendix 5, has been used as a layout design tool, to inform on the area around a tree where the protection of the roots and soil structure is treated as a priority.

- 3.2.13 The RPA for each tree has been plotted as a polygon centred on the base of the stem. Due to the presence of roads, structures, topography (and past tree management) the RPA is likely to be a simplified representation of the tree roots actual morphology and disposition. However, detailed modifications to the shape of the RPA would largely be based on conjecture and so have been avoided.
