Project No: 22131

Project: Roughbirchworth Lodge
Roughbirchworth Lane
Oxspring
Barnsley
S36 8YZ

Subject: Road Condition Report

Date: 24th October 2023 (Issue 02)

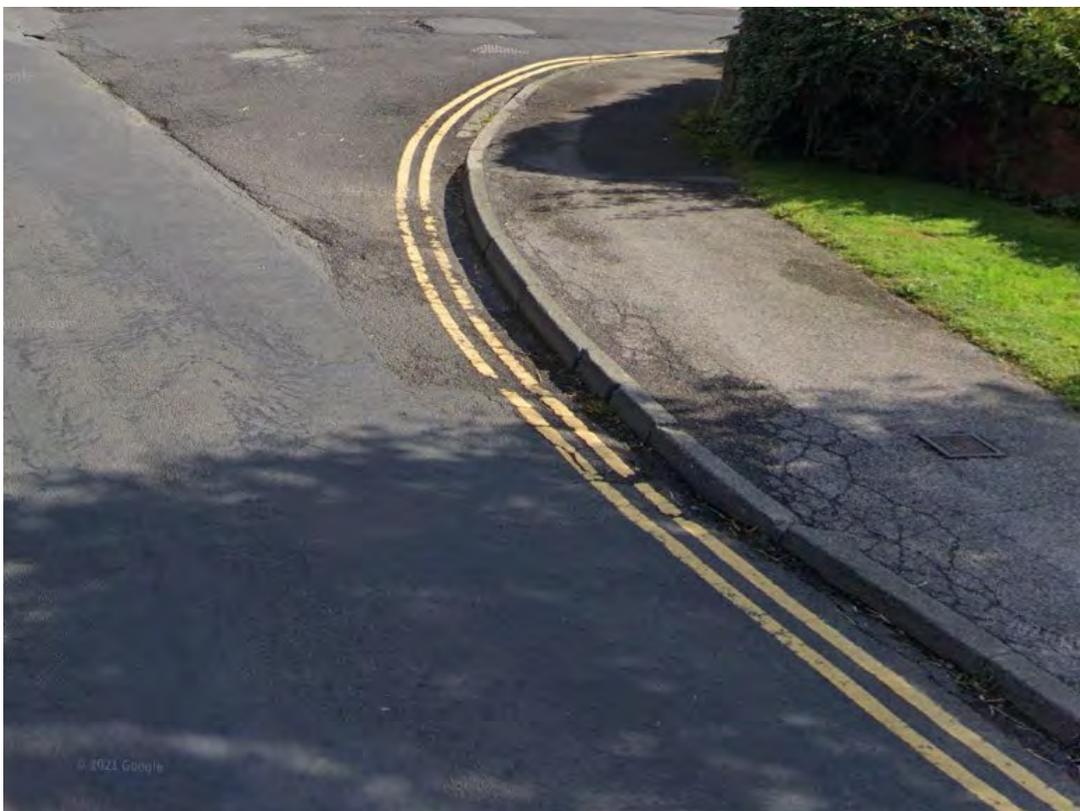
Image 01 – Chainage -50m

This location includes the junction between Roughbitchworth Lane and Tollbar Close. Image 01 shows crazing in the footpath surface layer and in addition, kerbs and road markings are in poor condition.

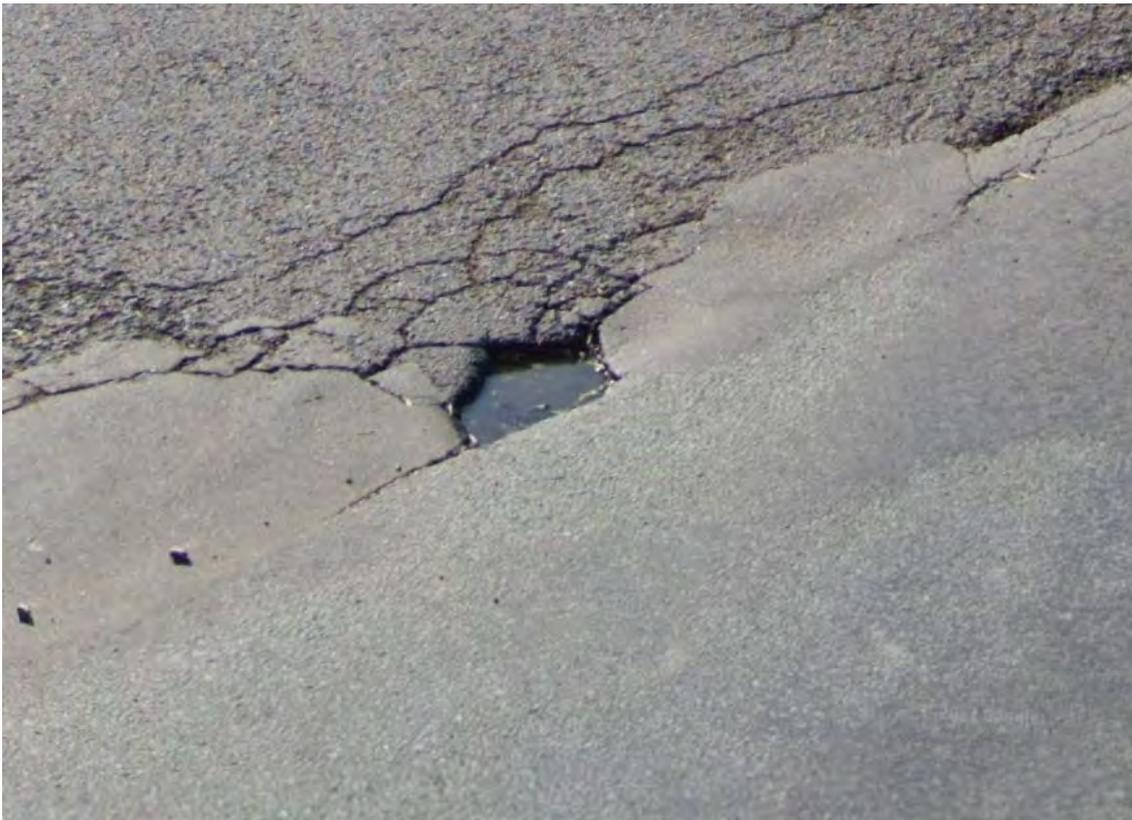
Image 03 – Chainage 40m

Image 03 also shows potholes forming along the junction tie-in construction joint and that pothole repair attempts have been carried out previously.

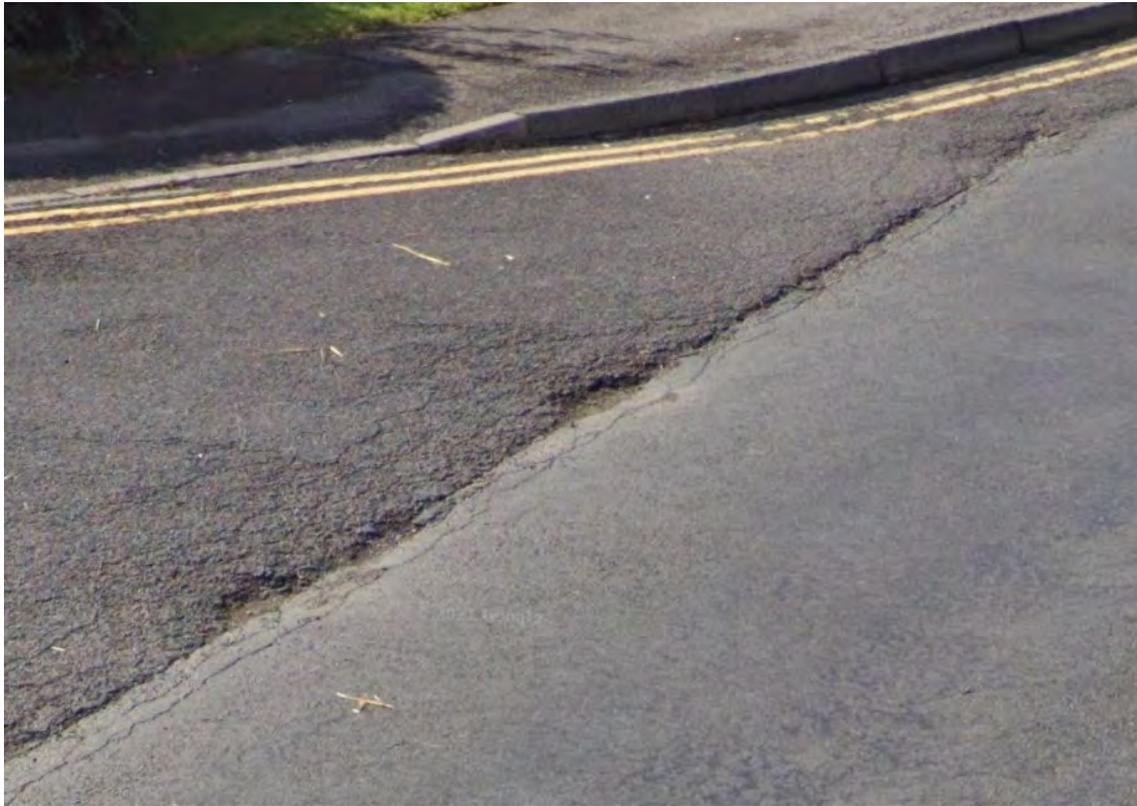
Image 04 – Chainage 47m

Image 04 shows several service trench infills with a variety of asphalt mixes and aggregate sizes.

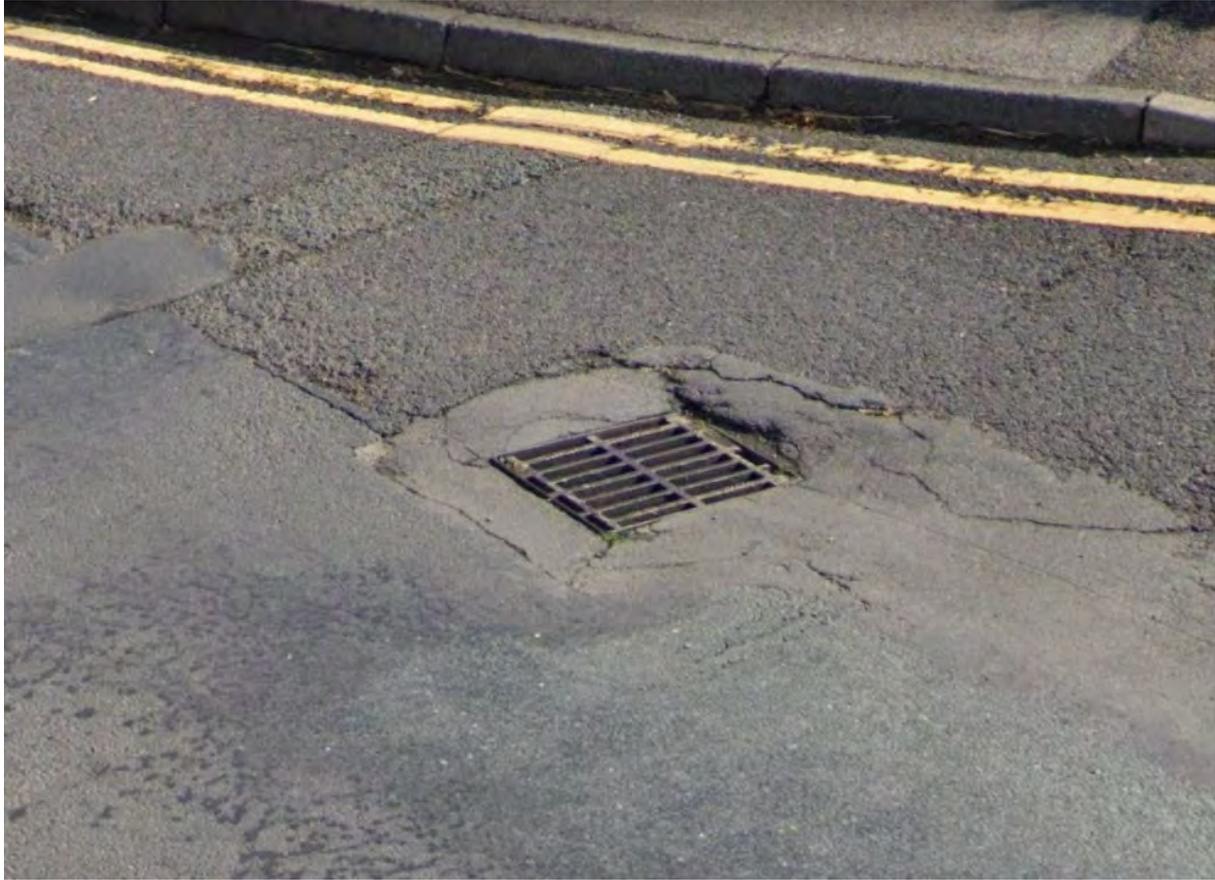
Image 05 – Chainage 36m

Image 05 shows concrete gully surround failure including fretting and crazing of the surface layer.

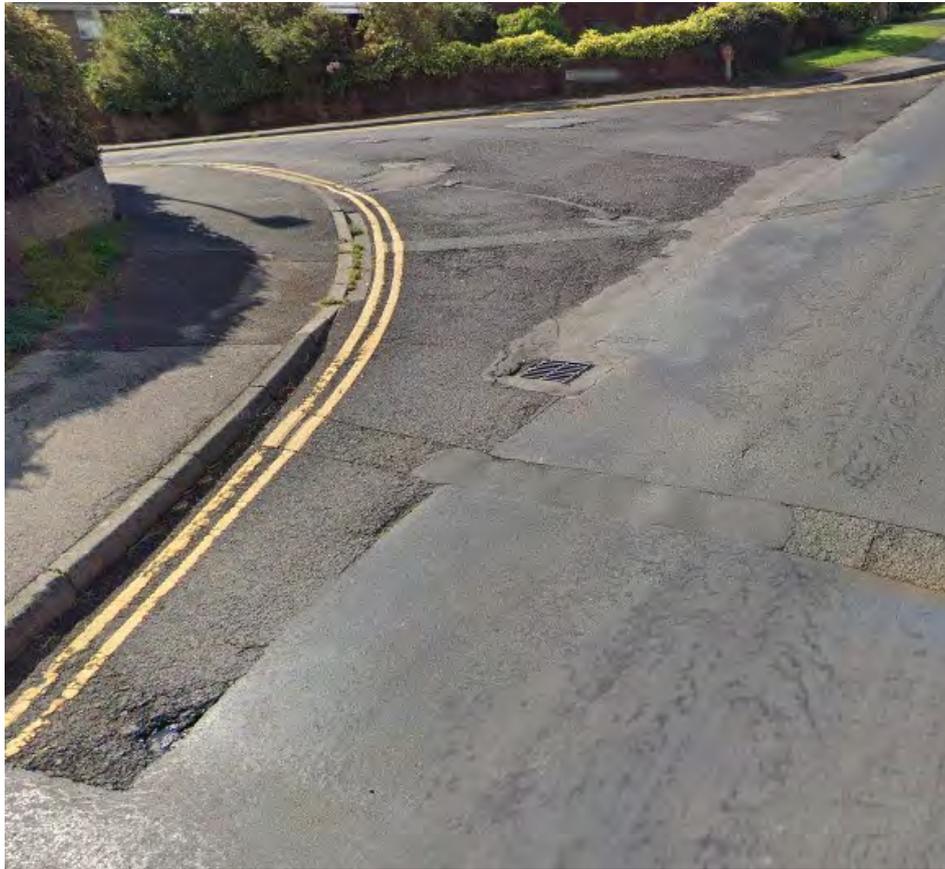
Image 06 – Chainage 35m

Images 06 and 07 appear to show polishing of the surface course, possibly caused by excessive amounts of binder in the asphalt mix.

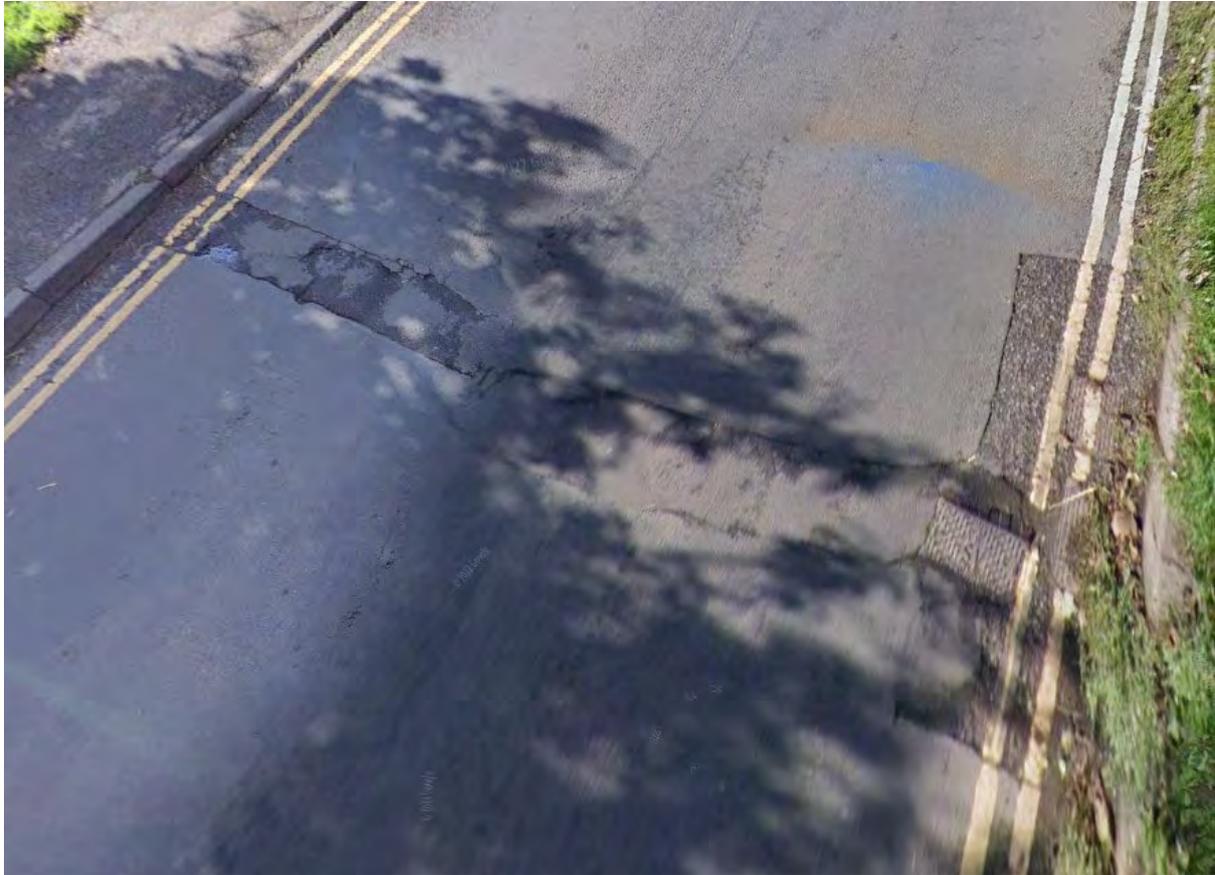
Image 08 – Chainage 23m

Image 08 reveals failing trench infill forming along the construction joint of the trench. The failure is likely due to non-application of sealant.

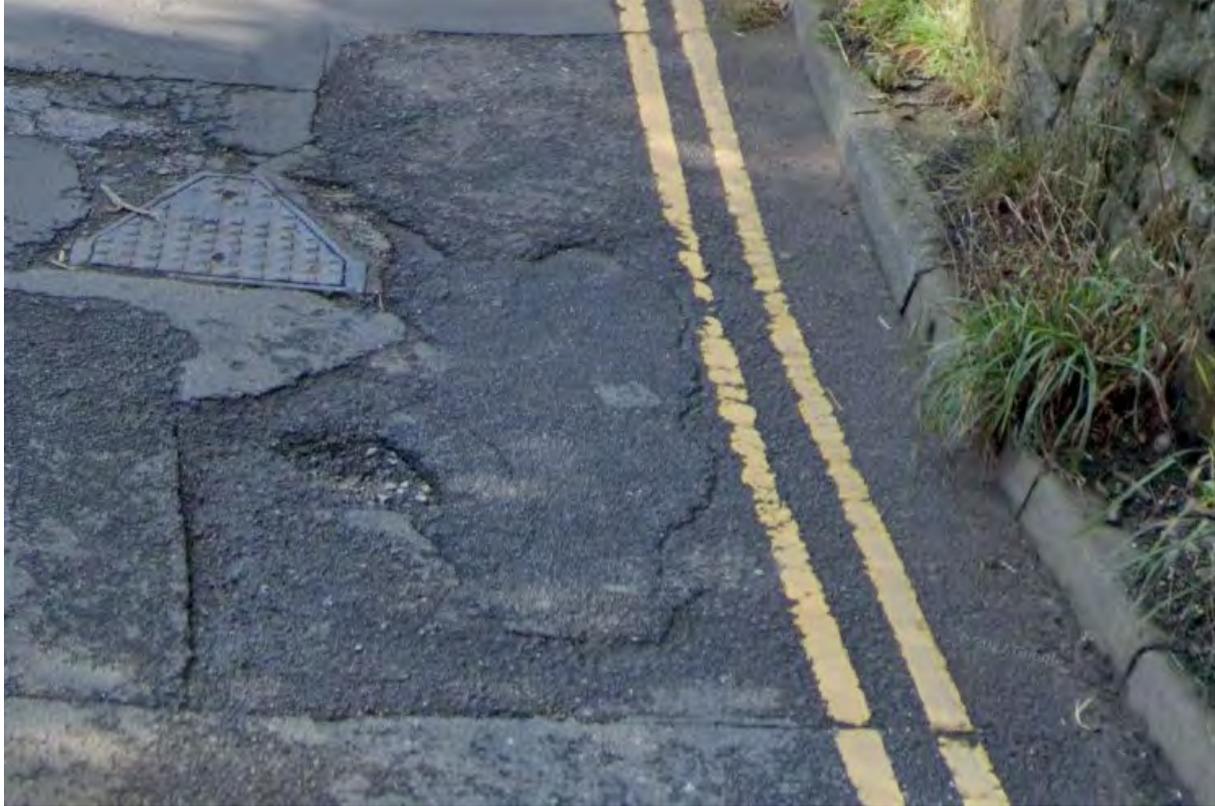
Image 09 – Chainage 38m

Image 09 reveals several patch repairs that are poorly constructed with potholes forming. The use of varying aggregates and no sealant has caused weakness in the surface layer. Road markings are in poor condition.

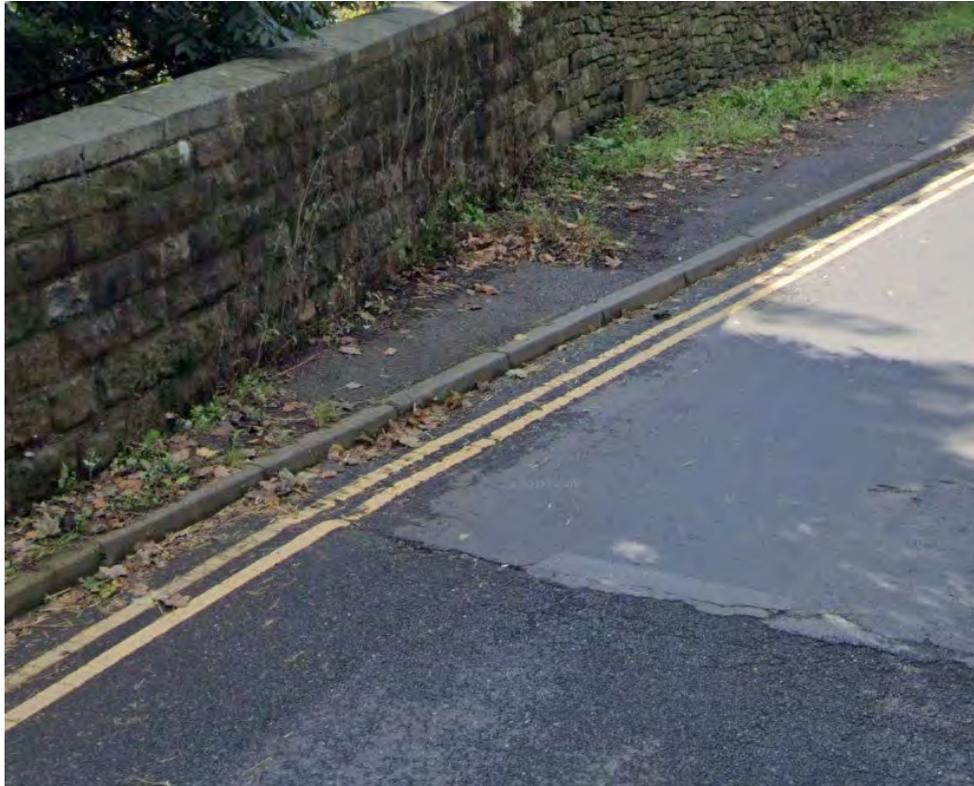
Image 10 – Chainage 38m

Image 10 reveals cracks forming in the joint tie-in and the use of different aggregates is causing weakness in the surface layer. Road marking are in reasonable condition.

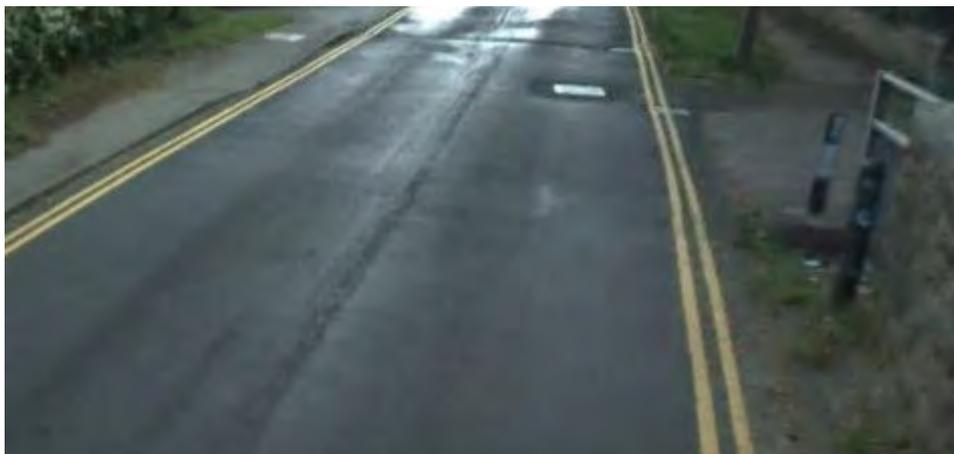
Image 11 – Chainage 40m

Image 11 reveals fretting (aggregate loss from the surface layer) along the crown line of the carriageway.

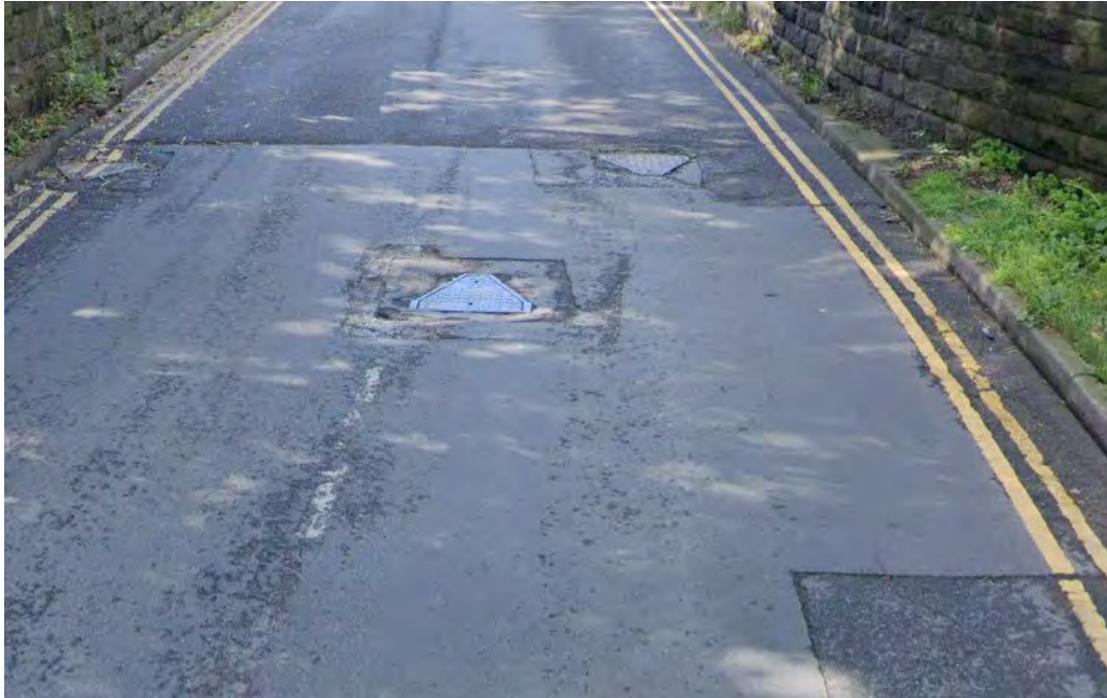
Image 12 – Chainage 50m

Image 12 reveals the failure of manhole surround, which is usually the symptom of partial or total failure of the road surface layer. In addition, road markings are in poor condition.

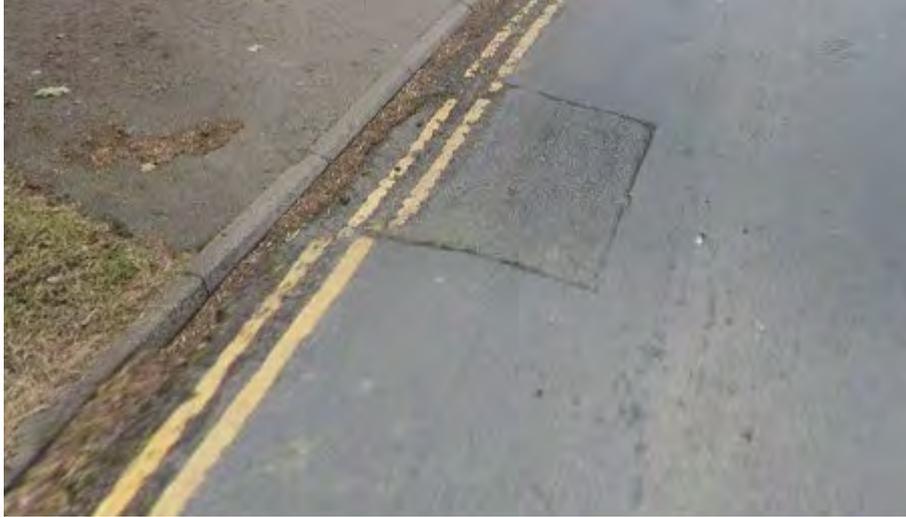
Image 13 – Chainage 62m

Image 13 reveals settlement of a patch repair. Generally road markings are in reasonable condition and kerbs are in poor condition.

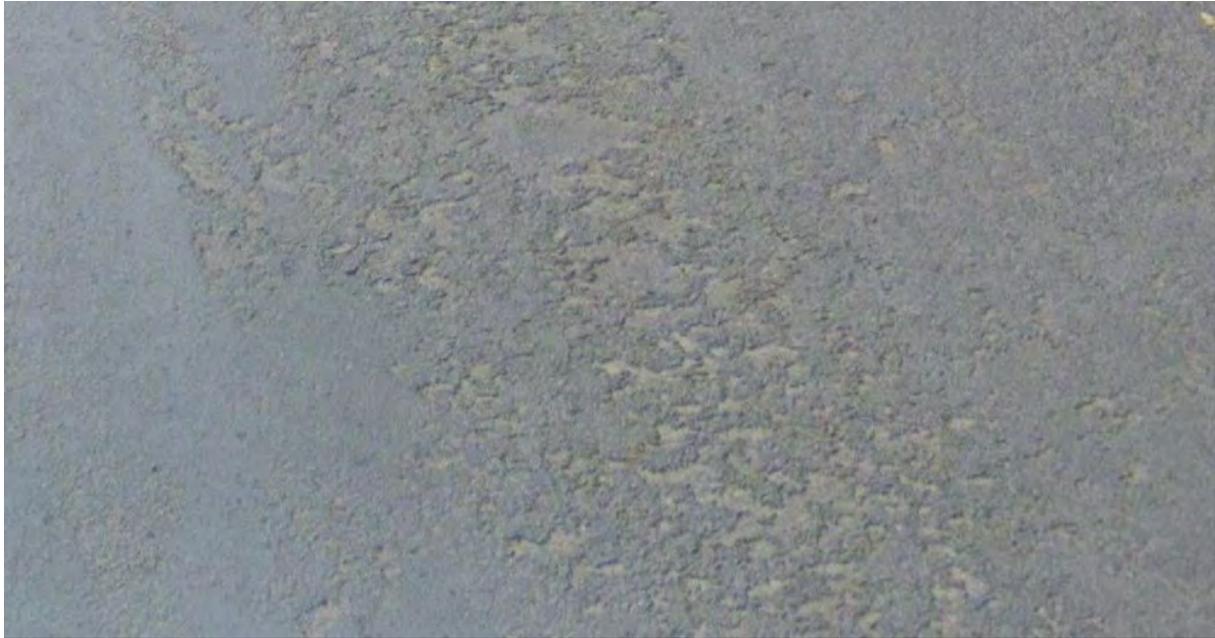
Image 14 – Chainage 82m

Image 14 reveals fretting of the surface course, which is usually caused by the loss of aggregate in the road surface. Due to water ingress this will eventually cause potholes.

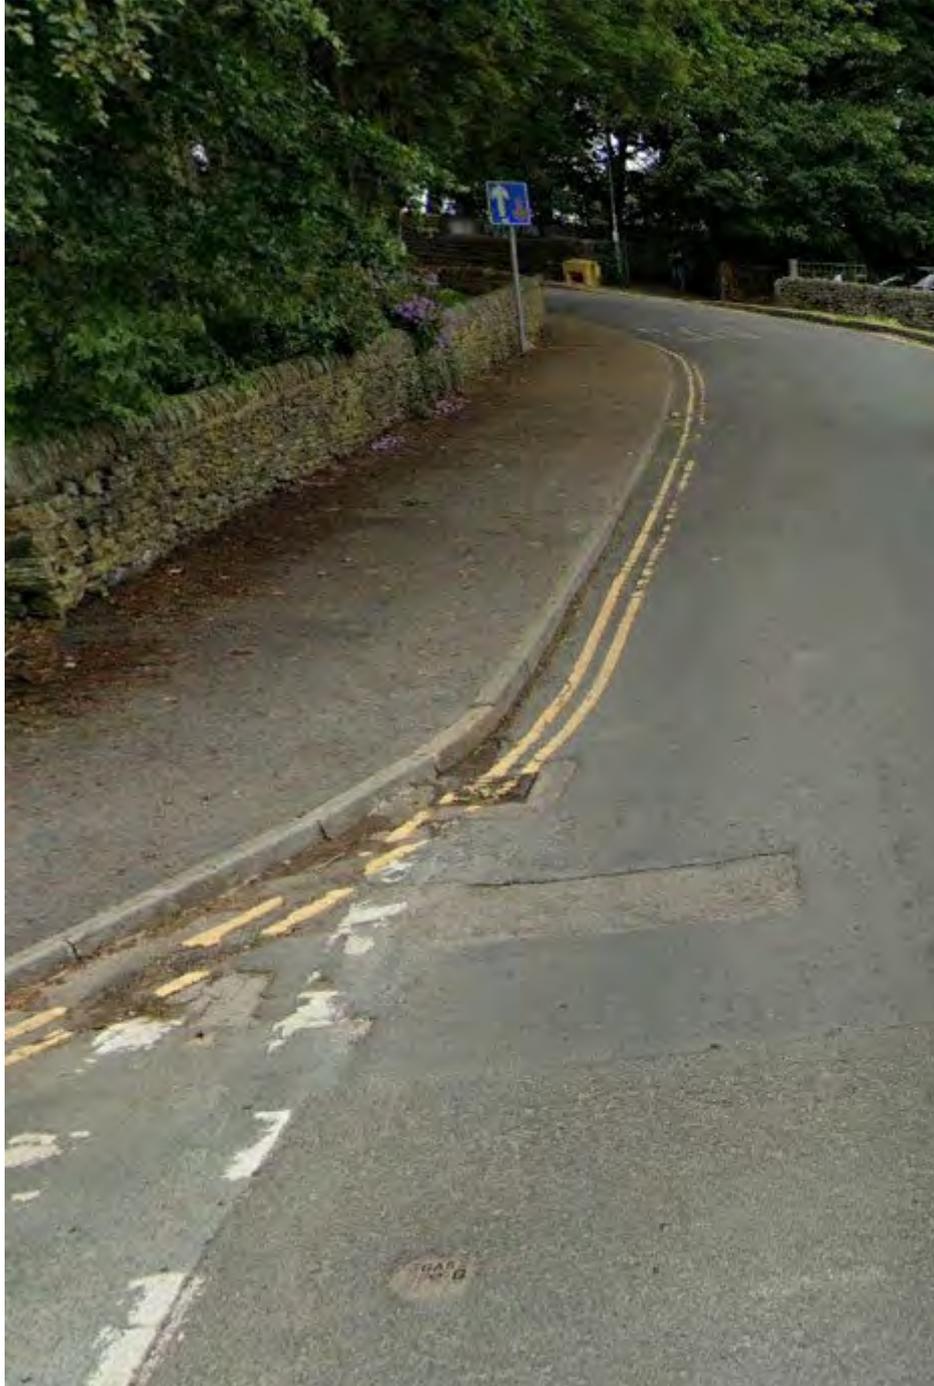
Image 15 – Chainage 104m

Image 15 reveals the failure of the gully surround and patch repair. This failure does not require immediate repair, however, it may be likely that these two patch repairs will form potholes. In addition, road markings are in poor condition.

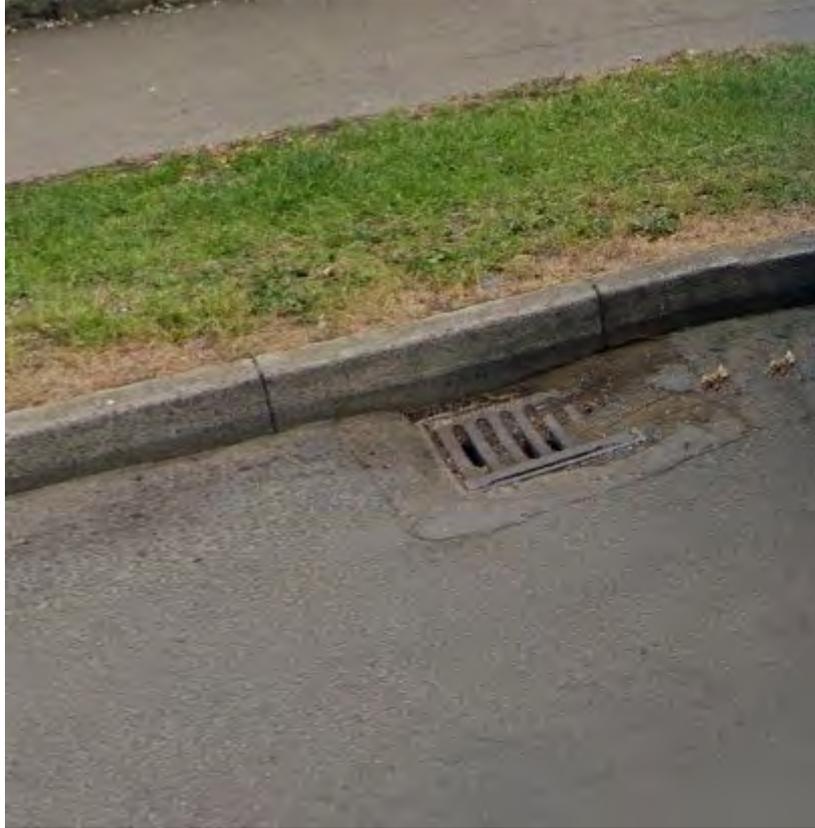
Image 16 – Chainage 107m

Image 16 reveals the failure of the gully surround and patch repair. This failure does not require immediate repair, however, it is considered that these two patch repairs will form potholes.

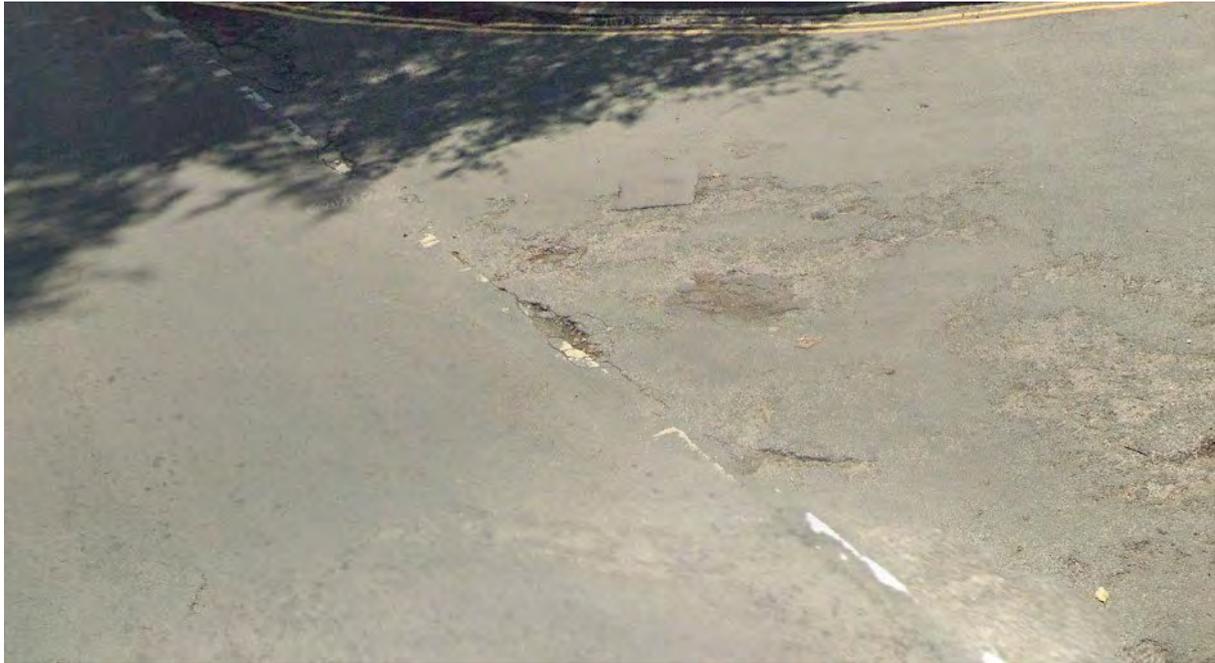
Image 17 – Chainage 125m

Image 17 reveals crazing of the surface course, which is usually the symptom of partial or total failure of the road surface layer.

In addition, potholes are forming along the joint. Not all potholes that form on roads require immediate repair and most reported to us generally receive a lower category of priority for repair depending on their depth, position in the road and the volume of traffic using the route. In addition, road markings are in poor condition.

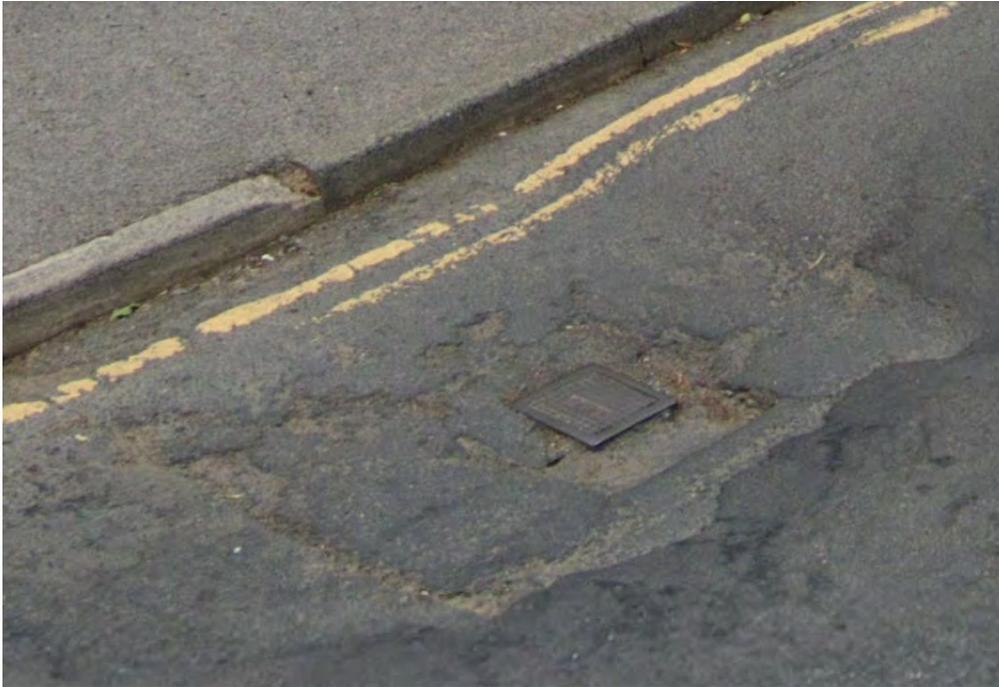
Image 18 – Chainage 172m

Image 18 reveals a pothole, cracking and crazing forming around the ironwork. Road markings and kerbs generally in poor condition.

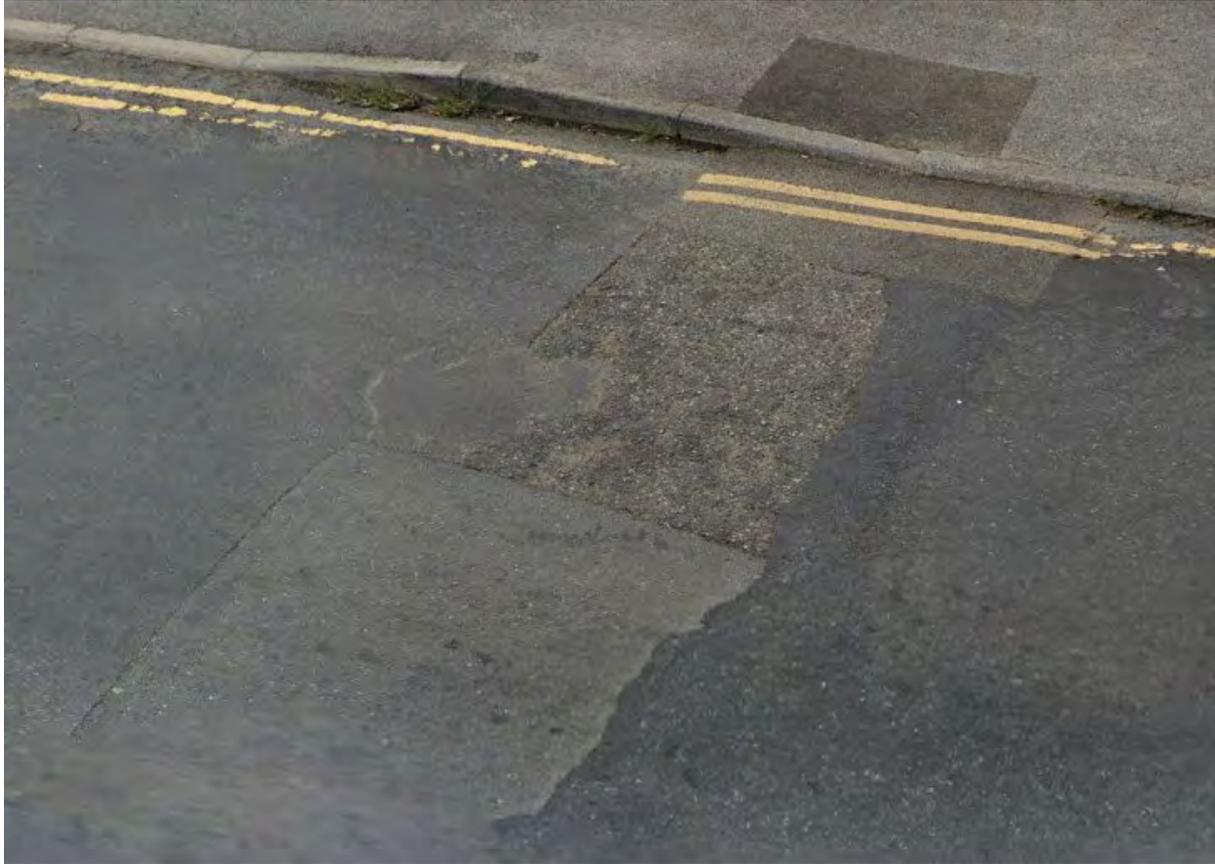
Image 19 – Chainage 176m

Image 19 reveals the failure of several patch repairs. This failure does not require immediate repair, however, it is considered that these patch repairs are likely to form potholes. In addition, road markings are in poor condition.

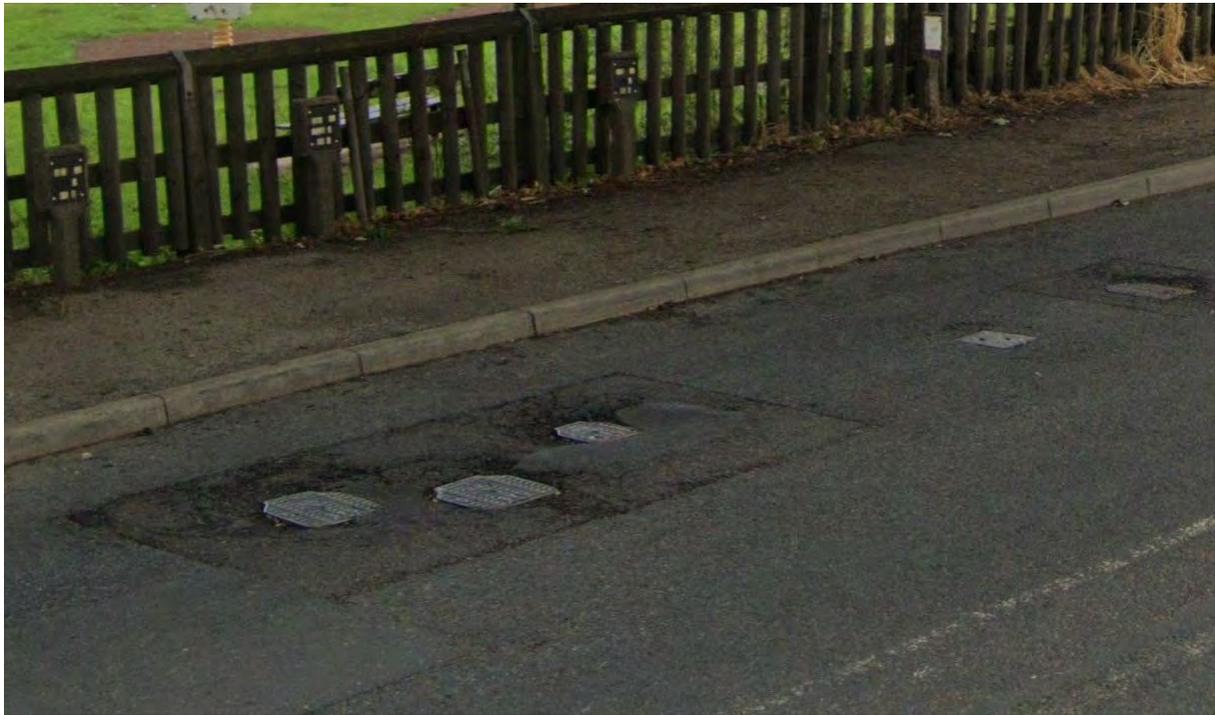
Image 20 – Chainage 192m

Image 20 reveals reveals the failure of several patch repairs surrounding ironwork. This failure does not require immediate repair, however, it is considered that these patch repairs are likely to form potholes. In addition, road markings are in poor condition.

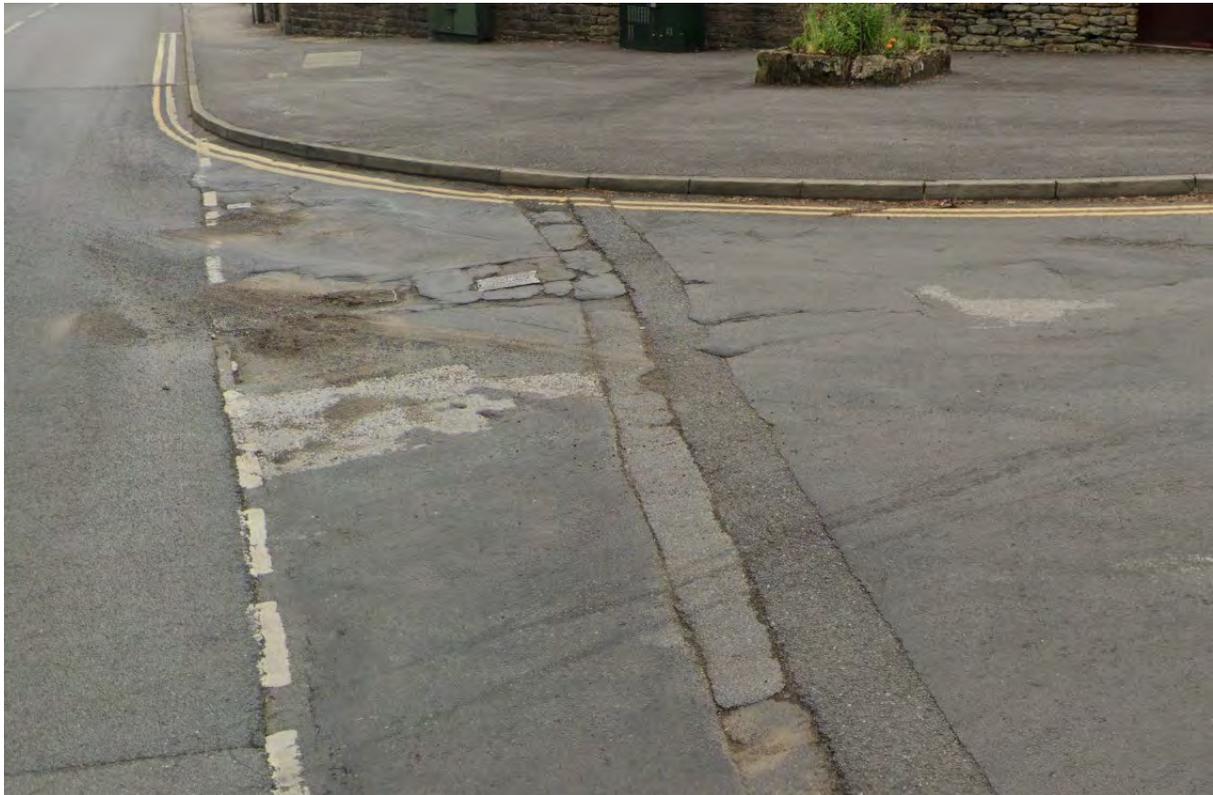
Image 21 – Chainage 192m

Image 21 reveals the failure of several patch repairs forming cracking, crazing and potholes. This failure does not require an immediate repair, however, it is considered that these road surface failures will be exacerbated by water ingress and freeze thaw effects. In addition, road markings are in poor condition.

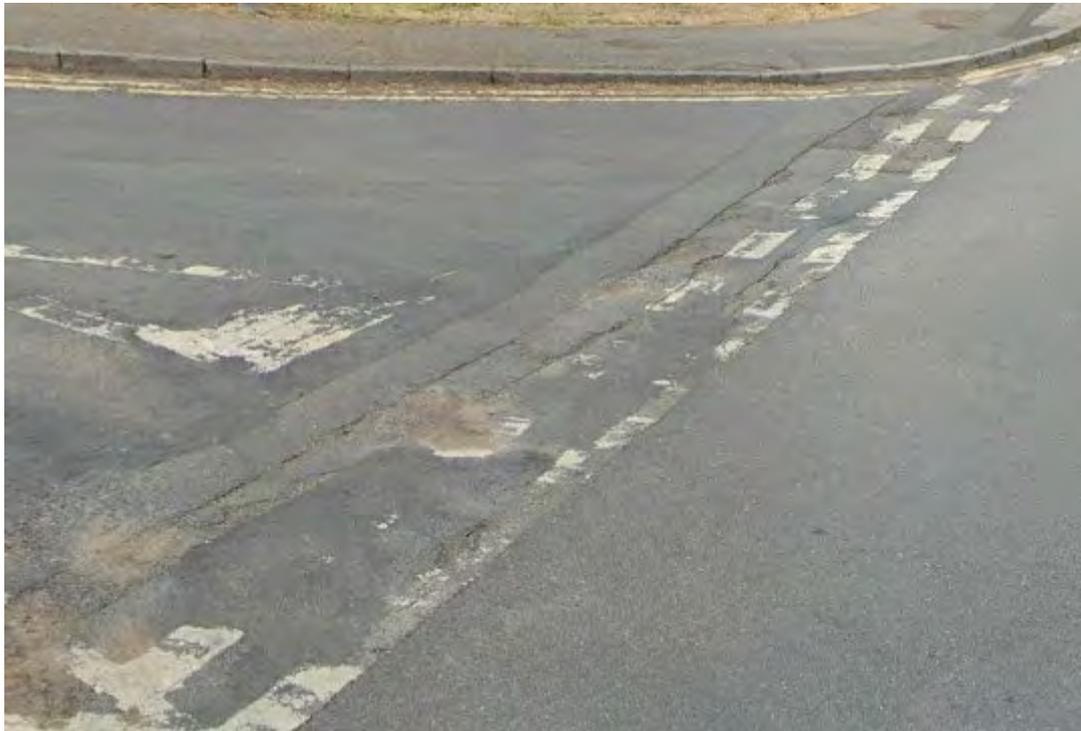
Image 22 – Chainage 192m

Image 22 reveals the failure of several patch repairs forming cracking and crazing. This failure does not require immediate repair, however, it is considered that these road surface failures will be exacerbated by water ingress and freeze thaw effects. In addition, road markings are in poor condition.

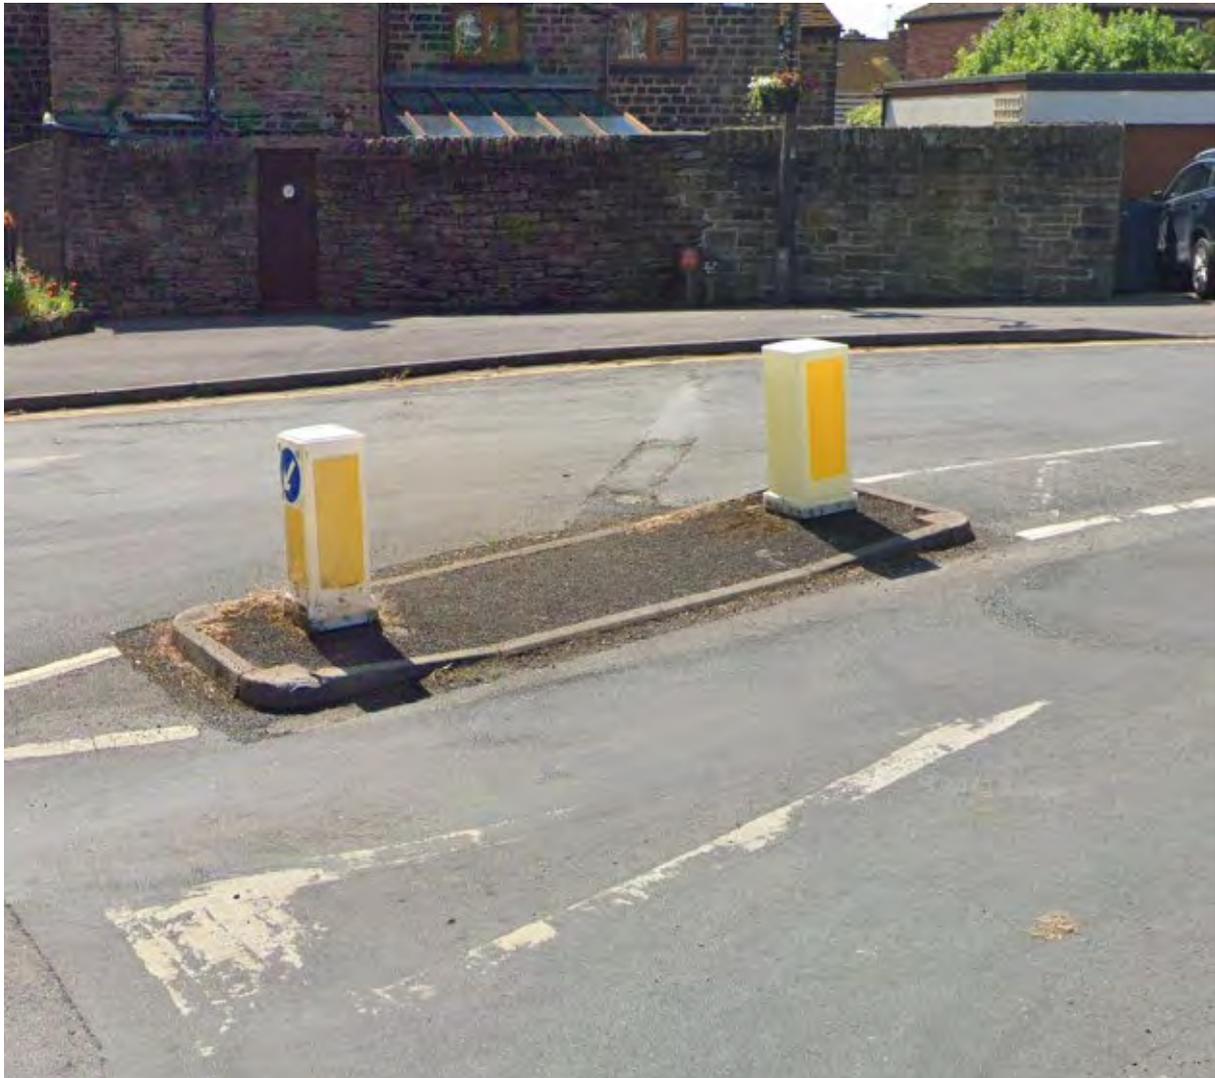
Image 23 – Chainage 192m

Image 23 reveals the current condition of traffic bollards that are in reasonable condition. However road markings are in poor condition and kerbs are in reasonable condition.

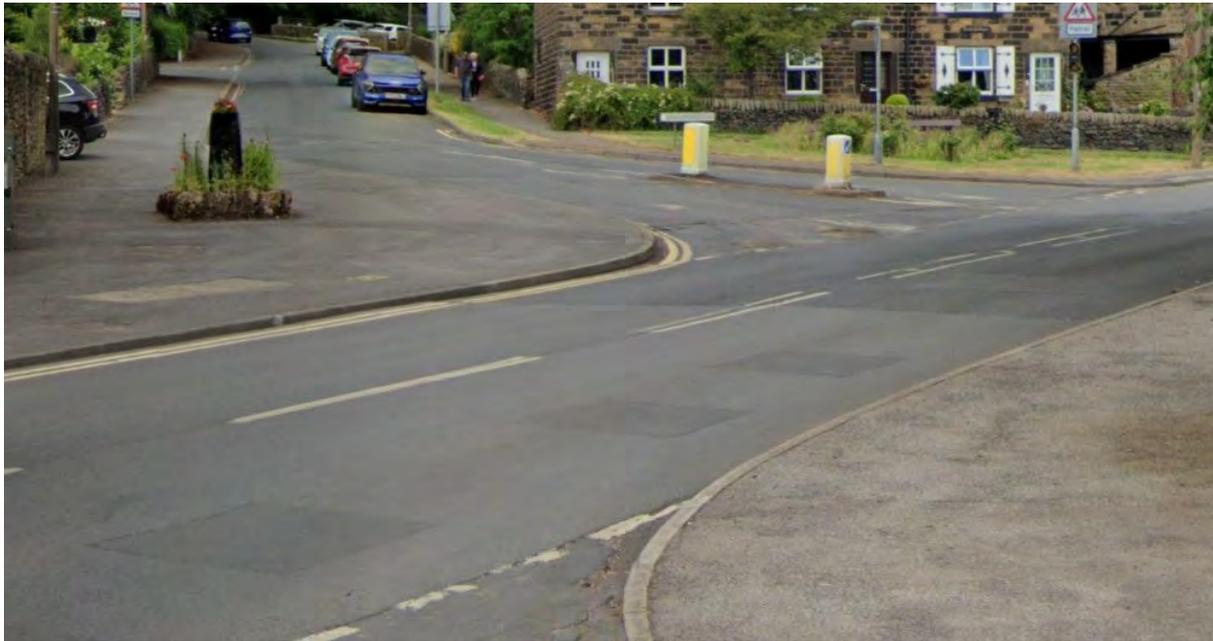
Image 24 – Chainage 192m

Image 24 reveals the failure of several patch repair forming cracking, crazing and potholes. This failure does not require immediate repair, however, it is considered that these road surface failures will be exacerbated by water ingress and freeze thaw effects. In addition, road markings are in poor condition.

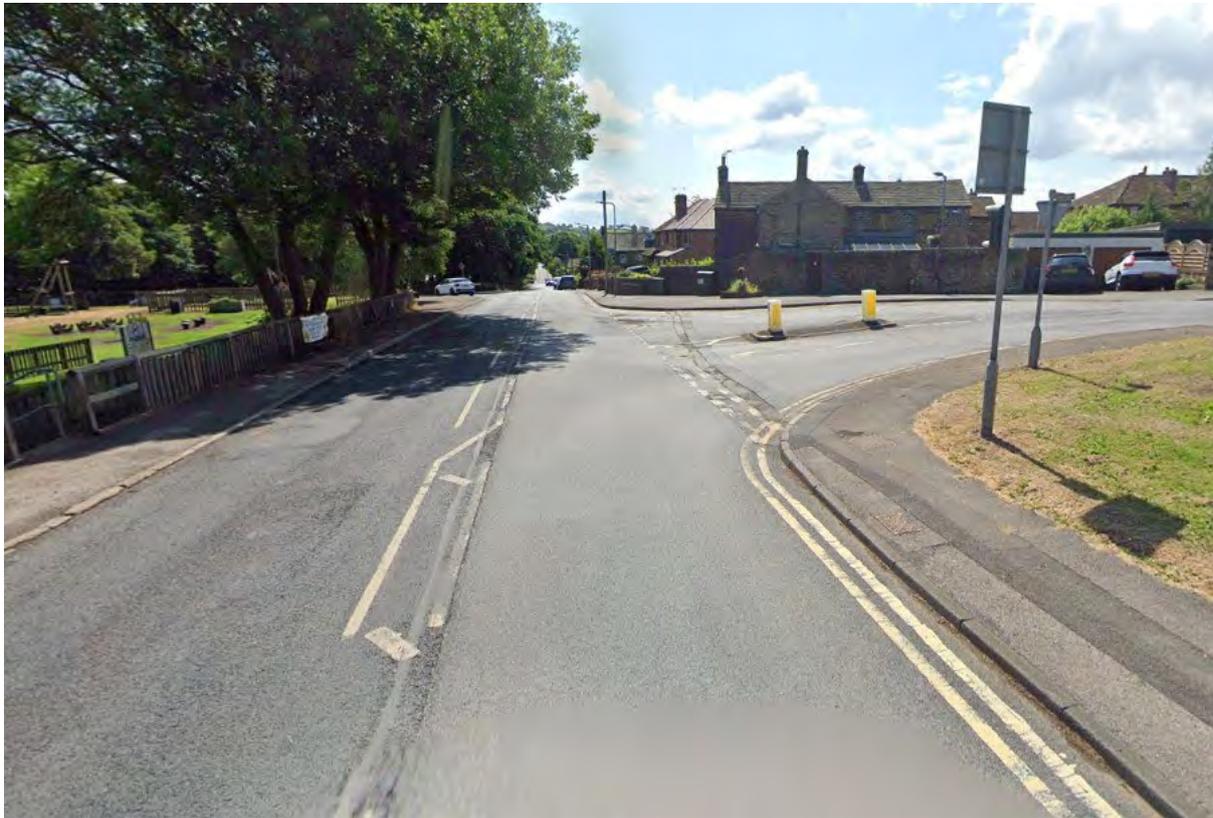
Image 25 – Chainage 192m

Image 25 reveals the failure of several patch repair forming cracking, crazing and potholes. This failure does not require immediate repair, however, it is considered that these road surface failures will be exacerbated by water ingress and freeze thaw effects. In addition, road markings are in poor condition.
