STRUCTURAL REPORT - EXISTING BARN BUILDING

RESIDENTIAL CONVERSION

Middle Barn, Anchor Farm, Elmhirst Lane, Dodworth, S75 4LD

Report Ref: TH/Anchor/Struct/01/Feb2020/v.01

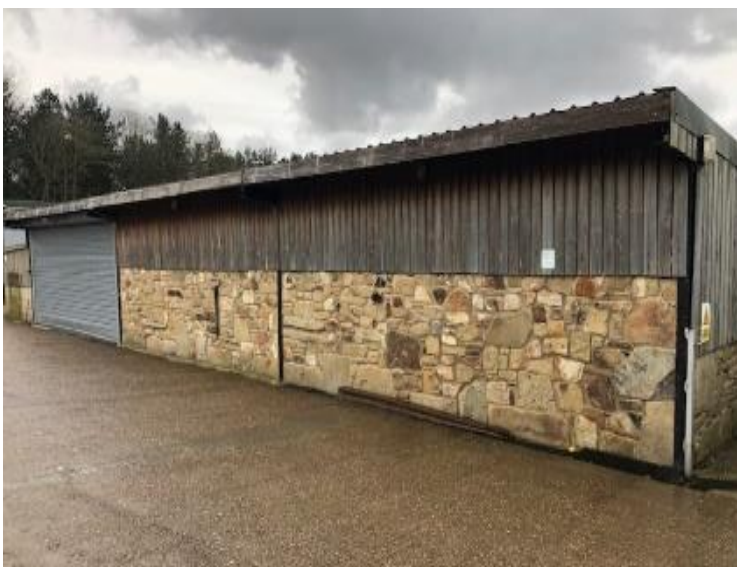
2.1 SOUTH WEST ELEVATION

On the south west elevation at the (main) front of the building facing the courtyard area the general structure of the building is plumb and exhibits no signs of substantial (or any) movement and/or significant damage.

The structural fabric requires some nominal repairs and alterations but is capable of full retention with no major (or any) areas of deflection and no requirement to remove and/or replace large sections (although there may be a requirement to consider appropriate fire protection etc.).

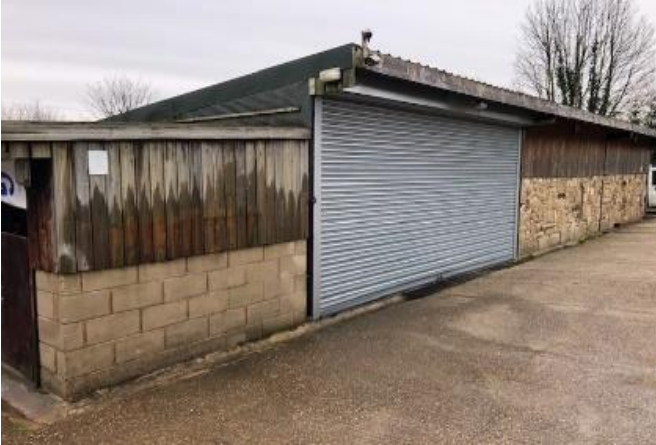
The adjoining leant-too side at the north west elevation is also in good general structural order, with the main elements all reasonably plumb and exhibiting no serious signs of movement, deflection and/or significant damage.

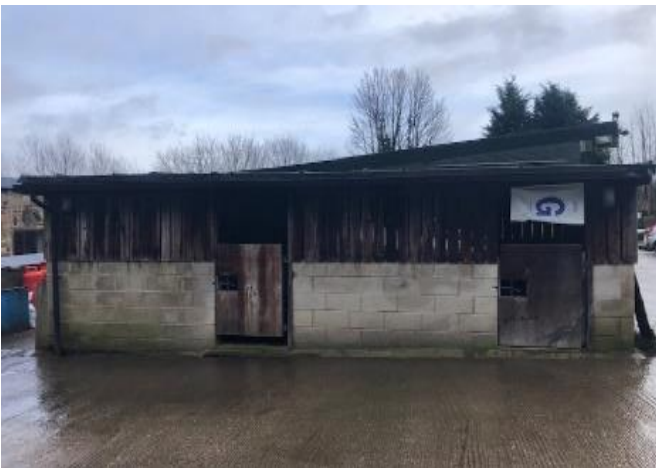
2.2 NORTH WEST ELEVATION

The roof structure is intact and stable, and whilst there may be some fabric repairs and infilling etc., it should be capable of retention with no requirement to remove and/or replace large structural sections (although there may be a requirement to consider appropriate fire protection etc.).

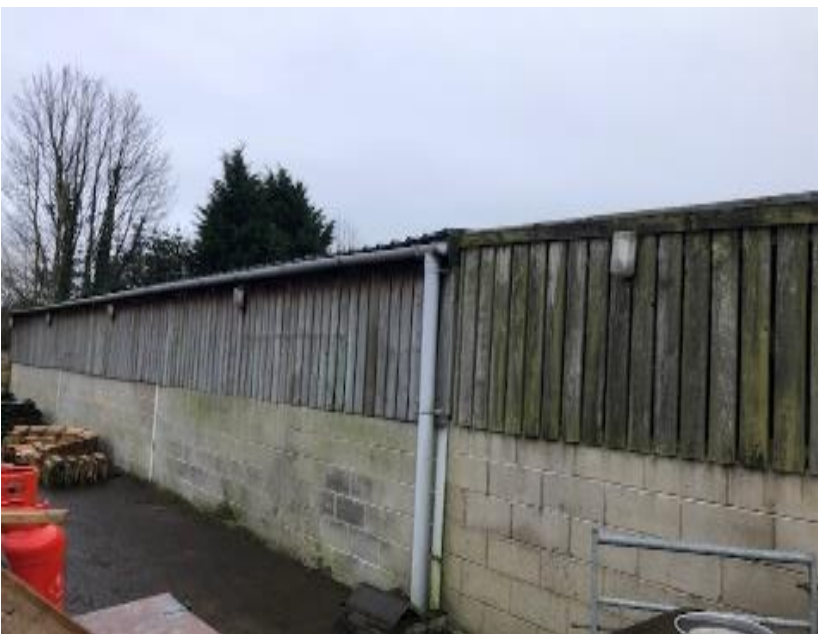
2.3 NORTH EAST ELEVATION

On the north east elevation at the rear of the building the general structure of the frame is plumb and exhibits no major signs of structural movement and/or damage.

The fabric requires some nominal repairs but in the main it should be capable of retention.

The roof shows no signs of deflection and there is no immediate requirement to remove and/or replace large sections.

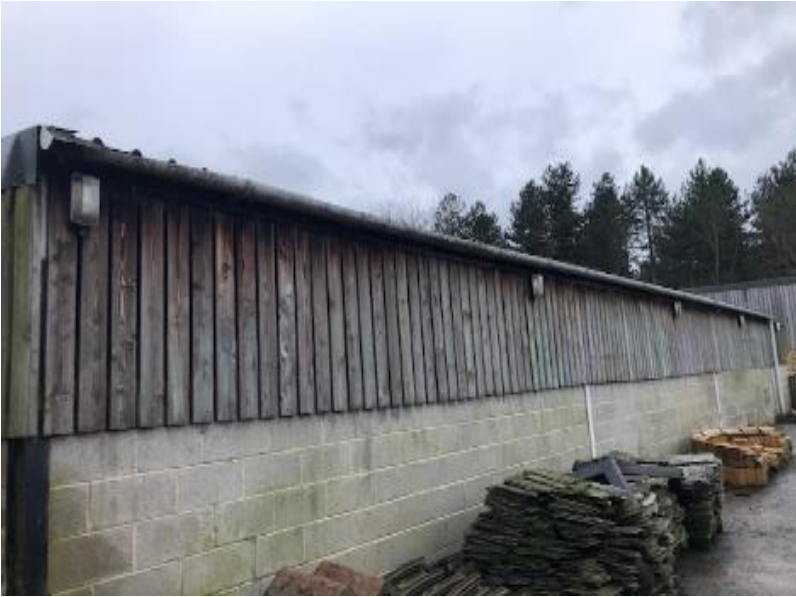
2.4 EAST ELEVATION

The east gable to side is plumb and in very good general order. It exhibits no signs of structural deflection and/or damage. The gable elevation is fully capable of retention with no areas of bulging / deflection and no requirement for extensive replacement / repairs.

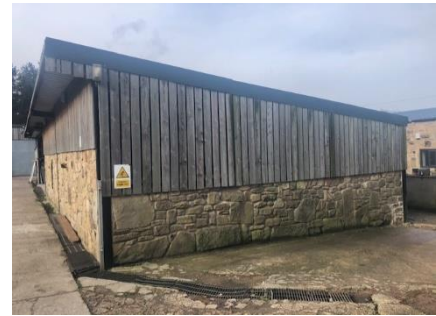
The north east elevation (viewed from the opposite side) is plumb and exhibits no signs of structural deflection and/or significant damage.

Some alterations will be required but in general the fabric is fully capable of retention with no areas of bulging/deflection and no requirement to repair by any means of disruptive dismantling or rebuilding.
