18th December 2017

Ref C237/02/GS

Ref: Shallow Mining Investigation on land off Ledbury Road, Athersley South, Barnsley, S71 1EX.

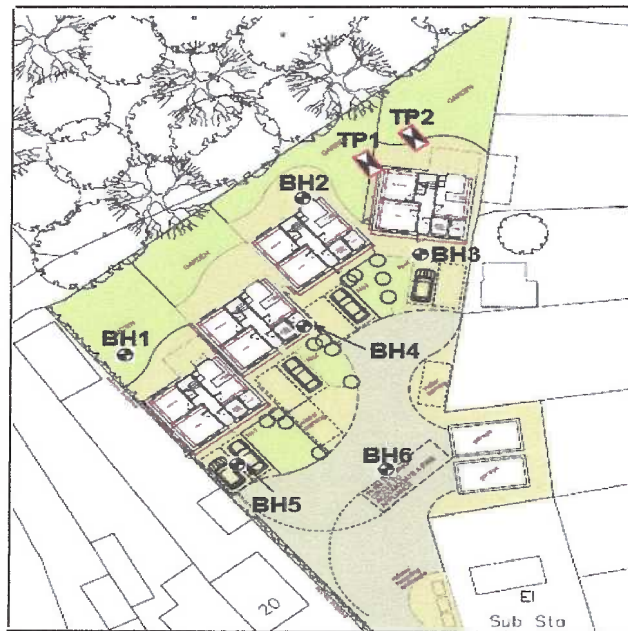
The locations of the exploratory holes are shown below.
