Wakefield Road, Smithies, Barnsley

Visual Condition Survey

GLEESON DEVELOPMENTS LIMITED

Ref: 22-137-003.01

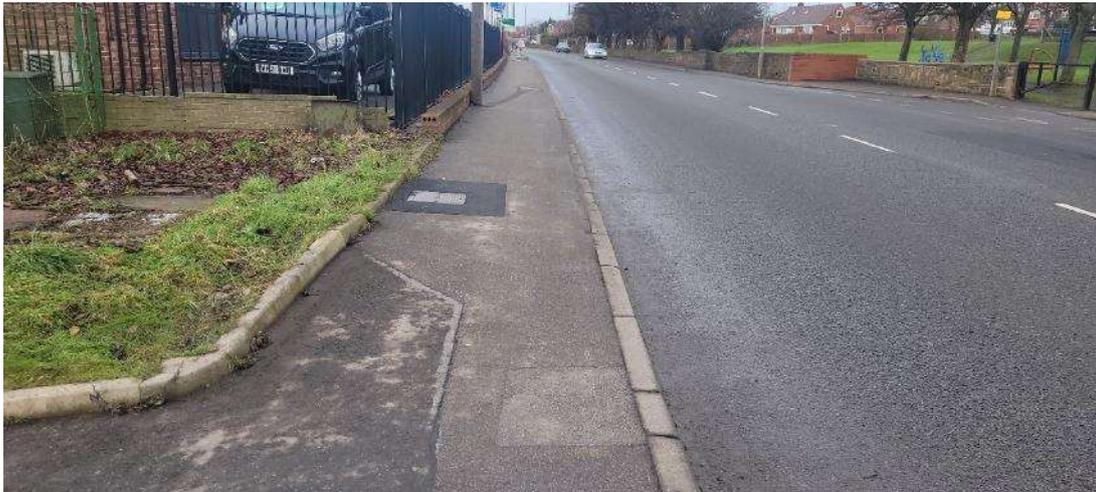
Photo 1

Wakefield Road looking North from site extents.

Scars present around utilities in footway

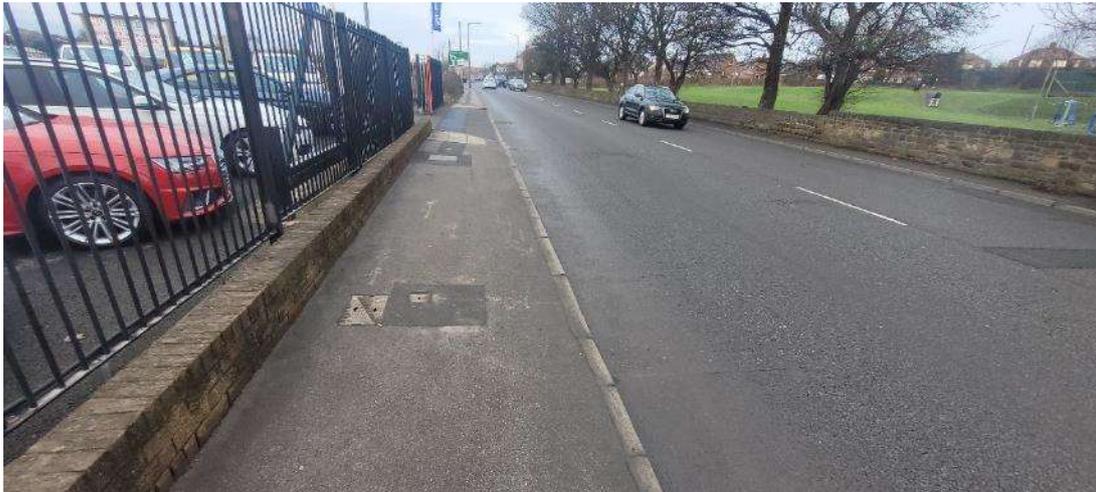
Photo 3

Wakefield Road looking North

Visible scarring in footway around utilities

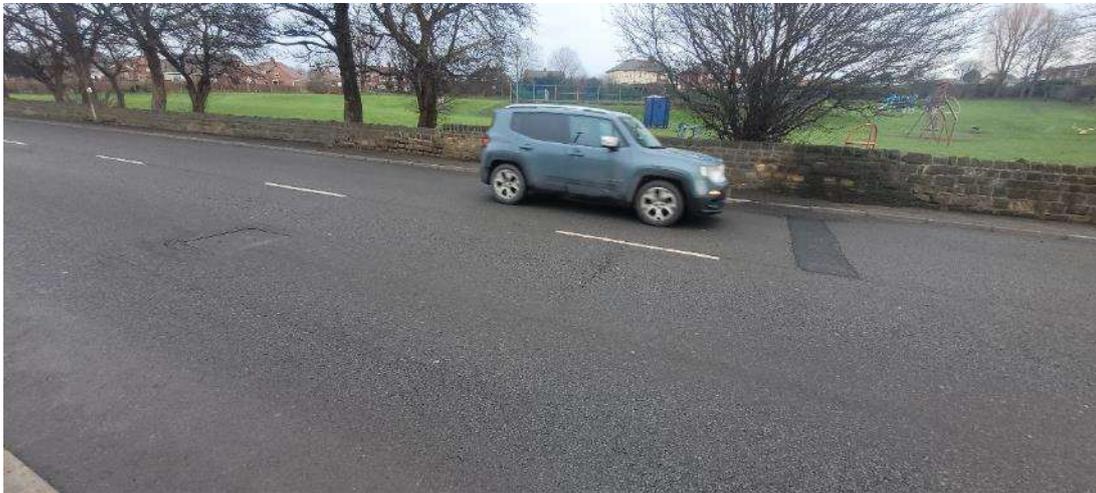
Photo 4

Wakefield Road looking North

Surface damage around manhole, plucked road surface and scarring in carriageway due to utilities

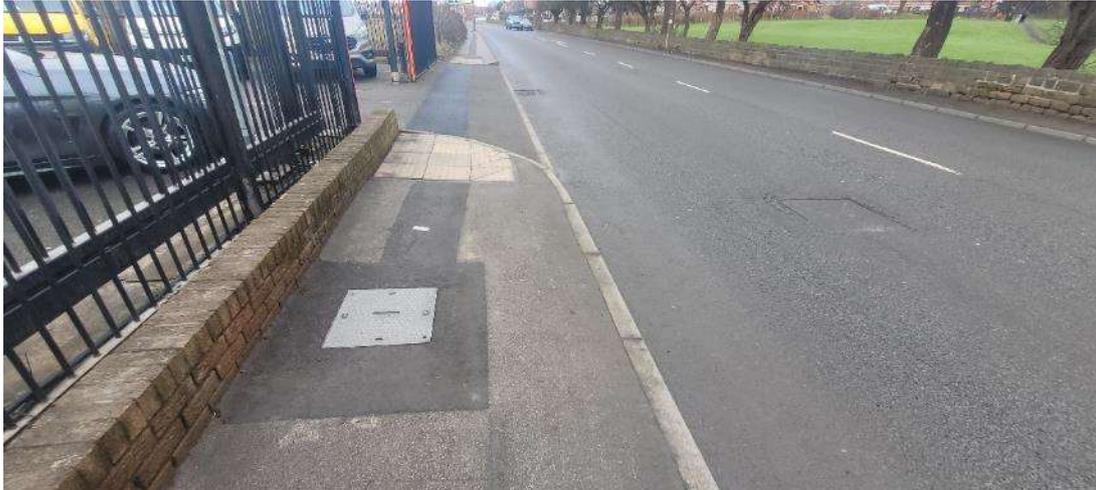
Photo 5

Wakefield Road looking North

Visible scarring in footway around utility inspection cover and across car sales access point, uneven and damaged tactile paving due to vehicles overrunning. Damaged surface around manhole previously indicated in Photo 4.

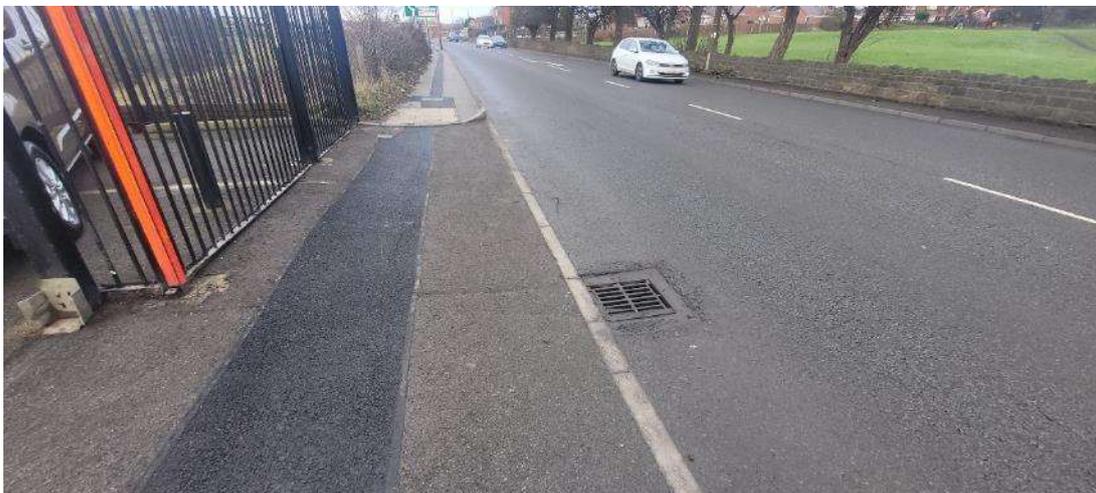
Photo 6

Wakefield Road looking North

Fresh recent scarring on vehicular crossing and on footway due to utility been laid. Road gully silted and the road surface around gully is plucked.

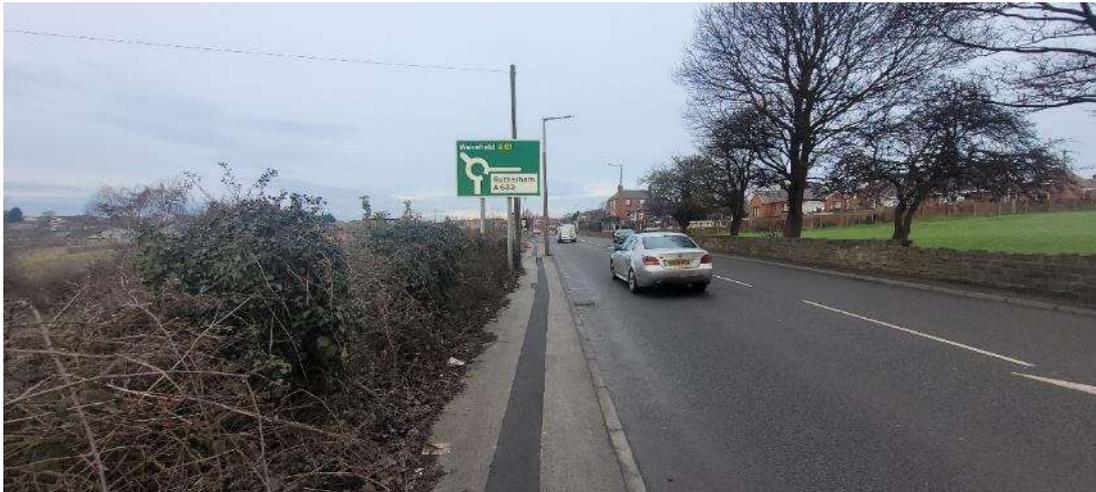
Photo 7

Wakefield Road looking North

Visible scaring in footway, Road gully silted

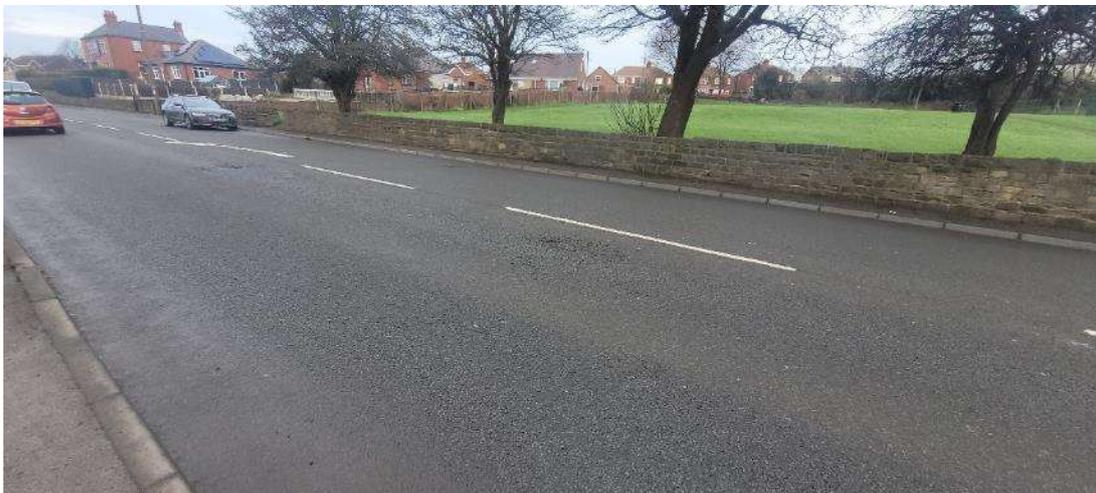
Photo 8

Wakefield Road looking North

Plucked road surface with water ingress.

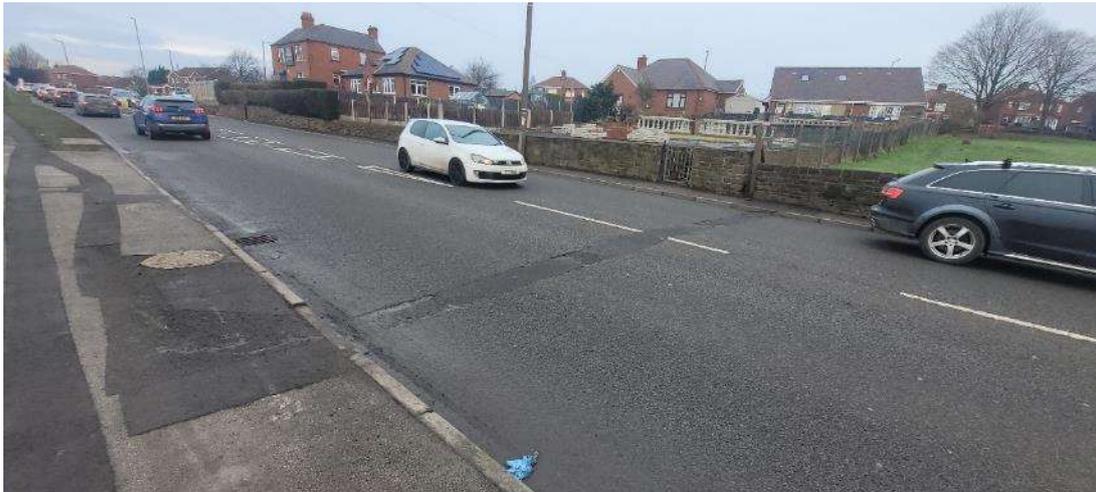
Photo 9

Wakefield Road looking North

Utility scars visible in Footway, poor reinstatement of utility duct crossing in carriageway.

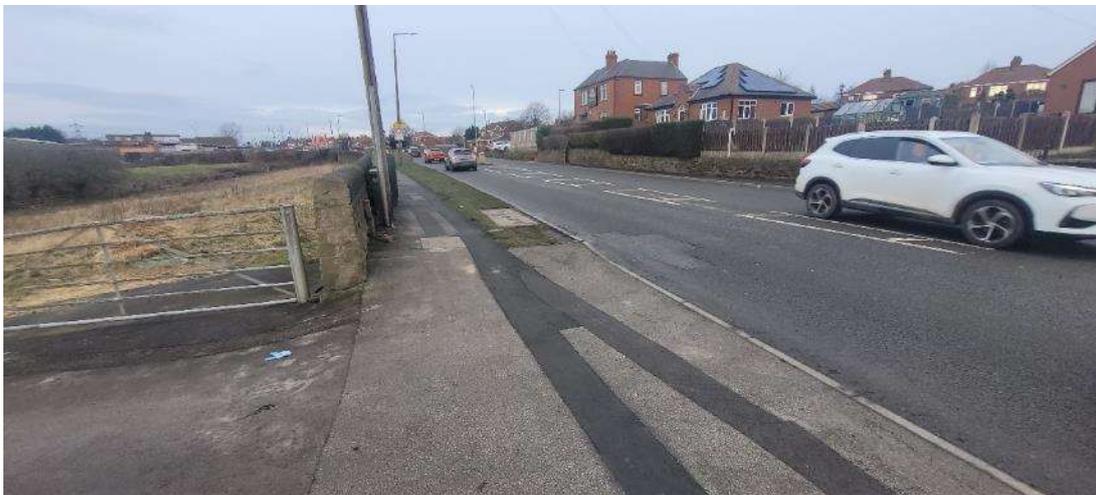
Photo 10

Wakefield Road looking North

Utility scars visible in Footway. Visible scar in carriageway adjacent to transition kerb.

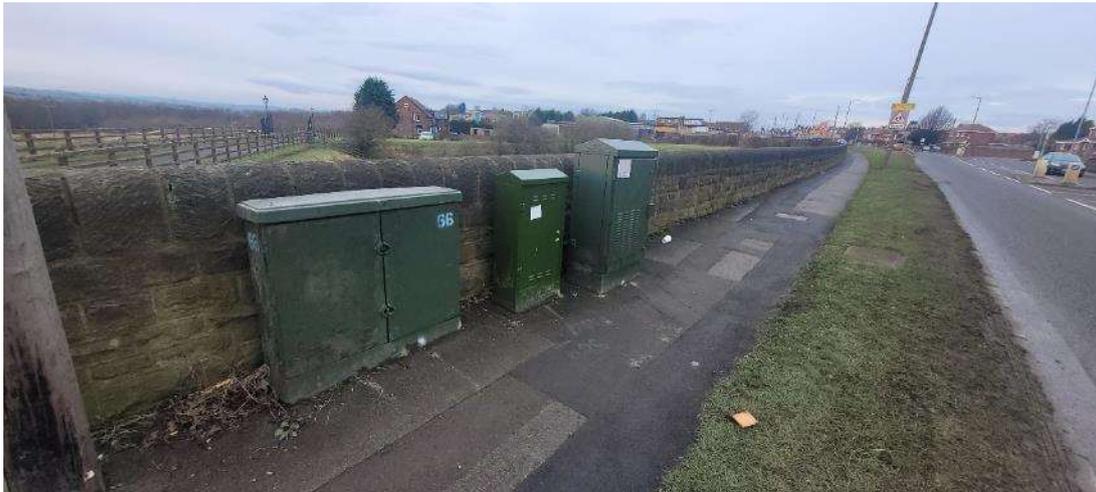
Photo 11

Wakefield Road looking North

Numerous scars in footway and utilities cabinets against boundary wall.

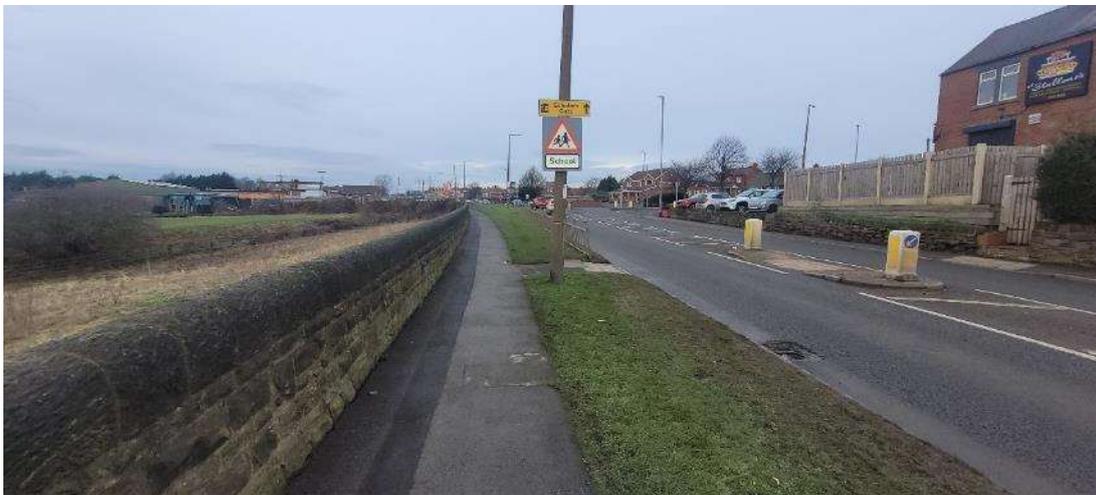
Photo 12

Wakefield Road looking North

Visible scars in footway, plucked surface around gully.

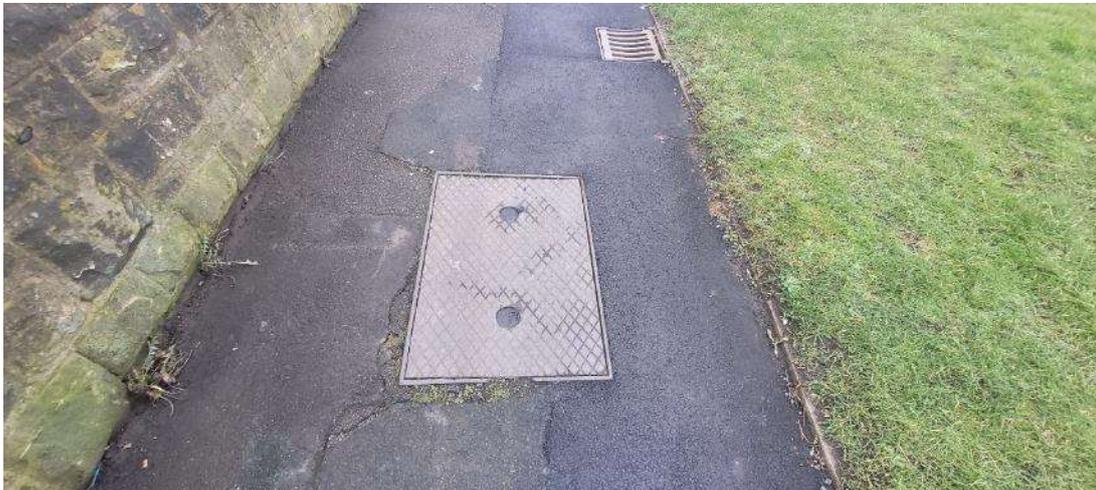
Photo 14

Wakefield Road looking North

Close up of Photo 13, broken inspection chamber frame, plucked surfacing around inspection chamber and gully silted.

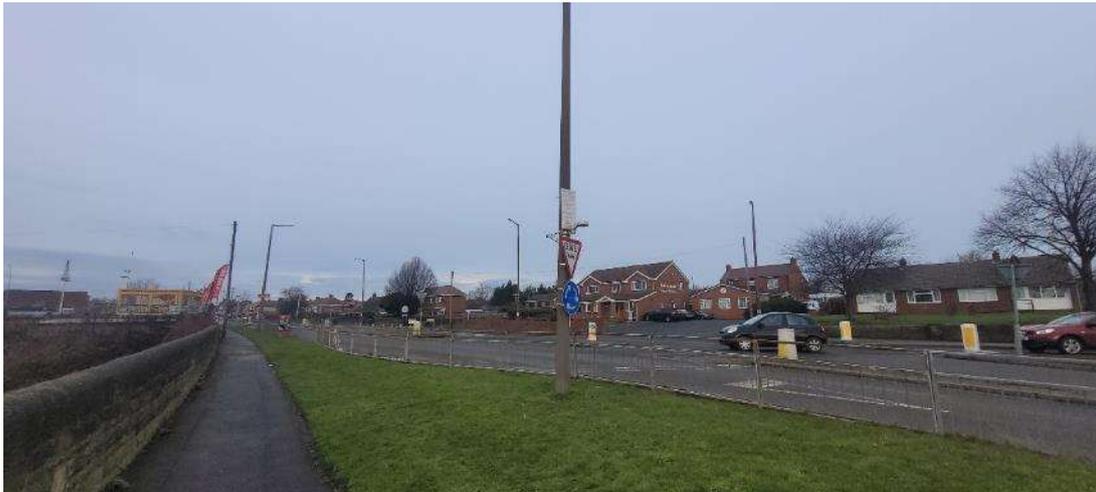
Photo 15

Wakefield Road looking North

Visible scars in footway.

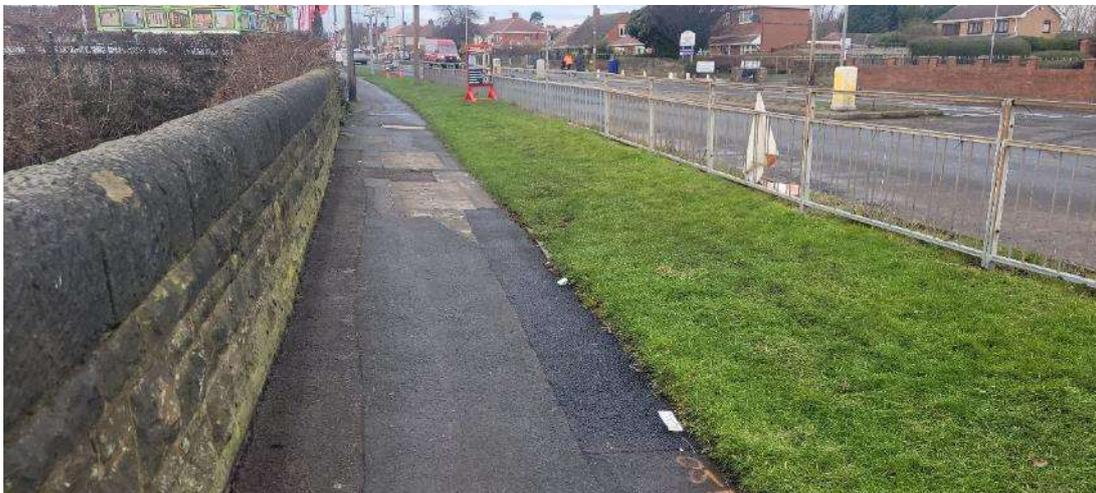
Photo 16

Wakefield Road looking North

Visible scars in footway, uneven surface around inspection chambers.

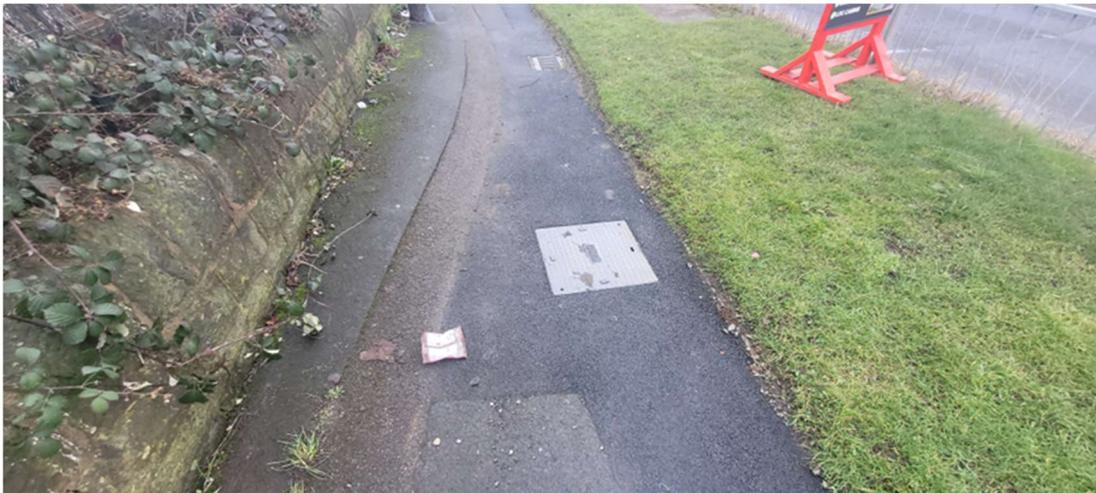
Photo 18

Wakefield Road looking North

Visible scars in footway, Existing Non-metal gully cover located in footway.

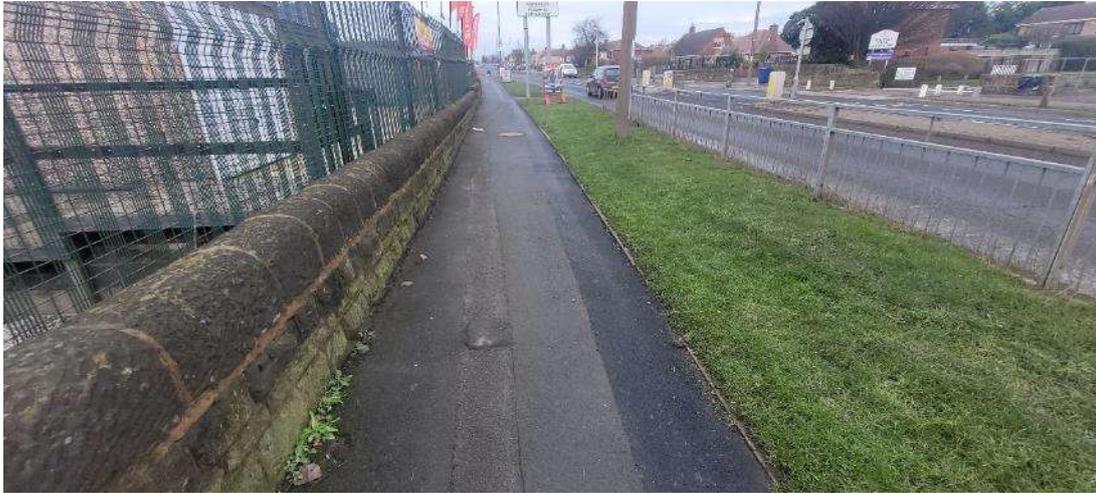
Photo 19

Wakefield Road looking North

Visible scars in footway, poor reinstatement with plucked surface within footway.

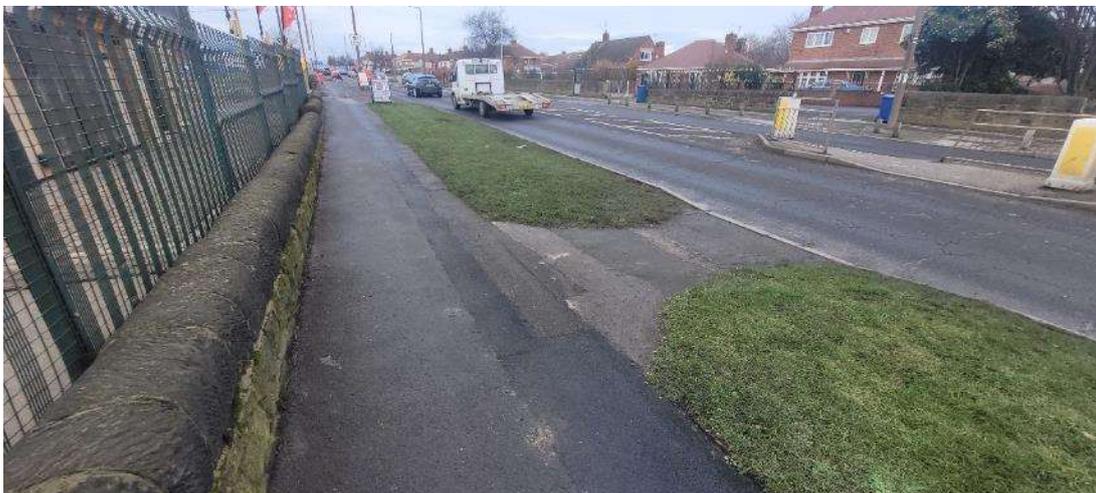
Photo 20

Wakefield Road looking North

Visible scars in footway surface. Visible loose stone from footway reinstatement. Visible cracks within carriageway.

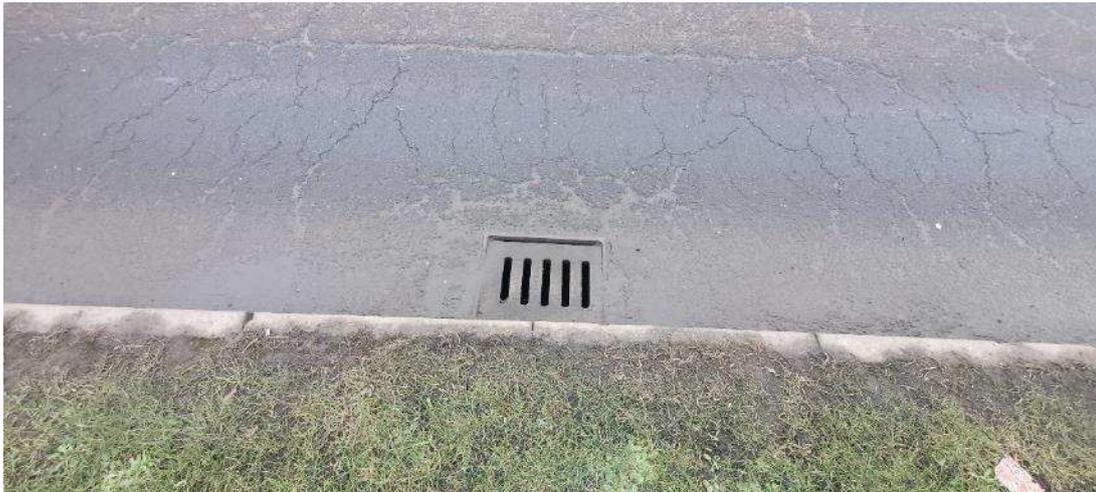
Photo 21

Wakefield Road looking North

Visible cracks in carriageway surface and Non-metal gully cover in carriageway.

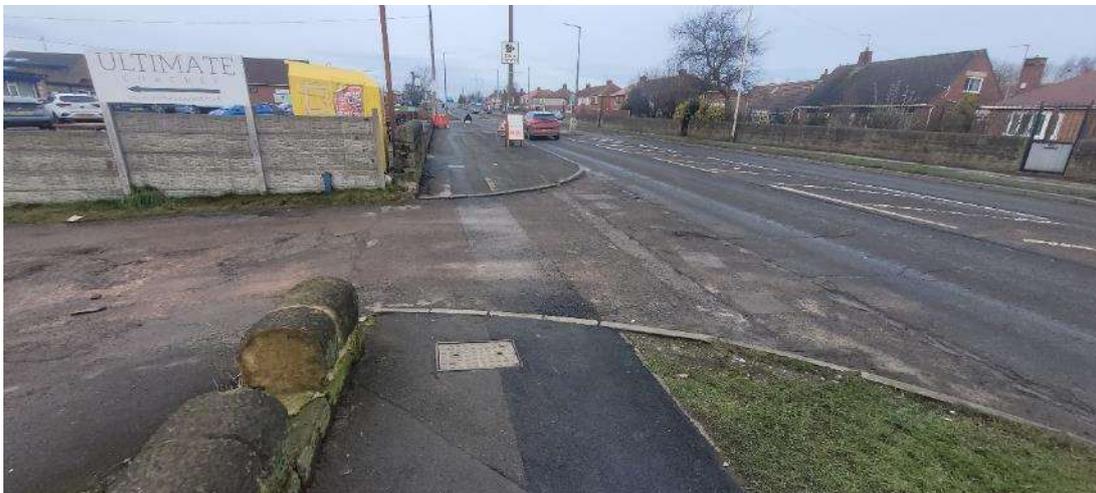
Photo 22

Wakefield Road looking North

Visible scars in footway surface. Access road into bus garage is in a poor state of repair with a number of utility scars in carriageway and small areas of patch repairs. Carriageway Joint with Wakefield Road has water egress with plucked surface along tie in joint. Main carriageway has a significant number of cracks with water egress.

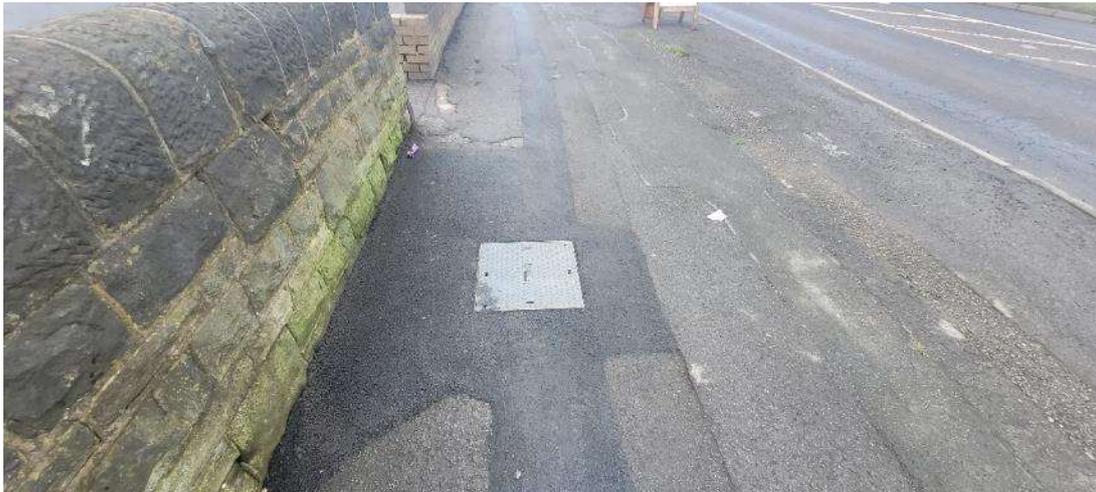
Photo 23

Wakefield Road looking North

Numerous utility scars in footway surface. Traffic Signal inspection cover recently installed. Carriageway surface has a number of cracks in the surface.

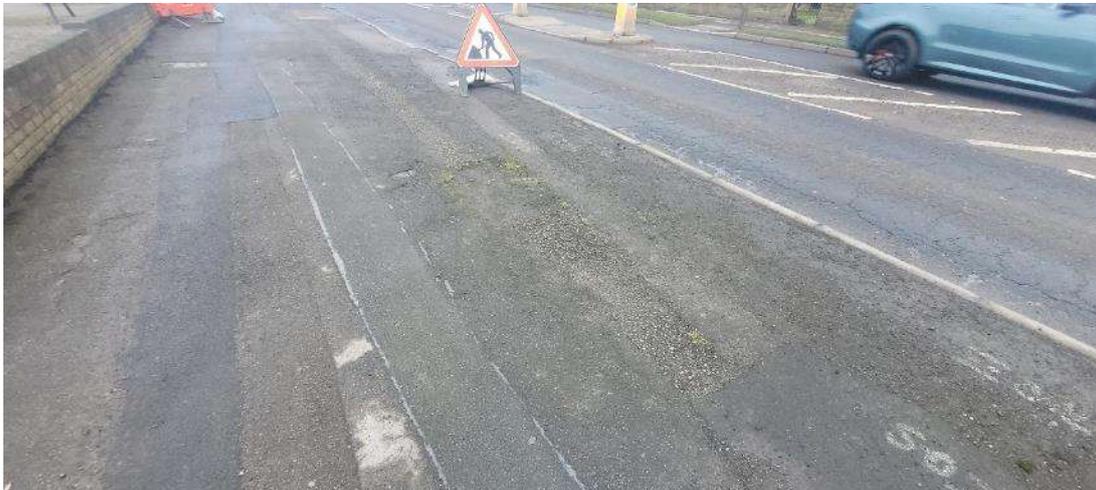
Photo 24

Wakefield Road looking North

Numerous utility scars in footway surface. Carriageway surface has a number of cracks in the surface.

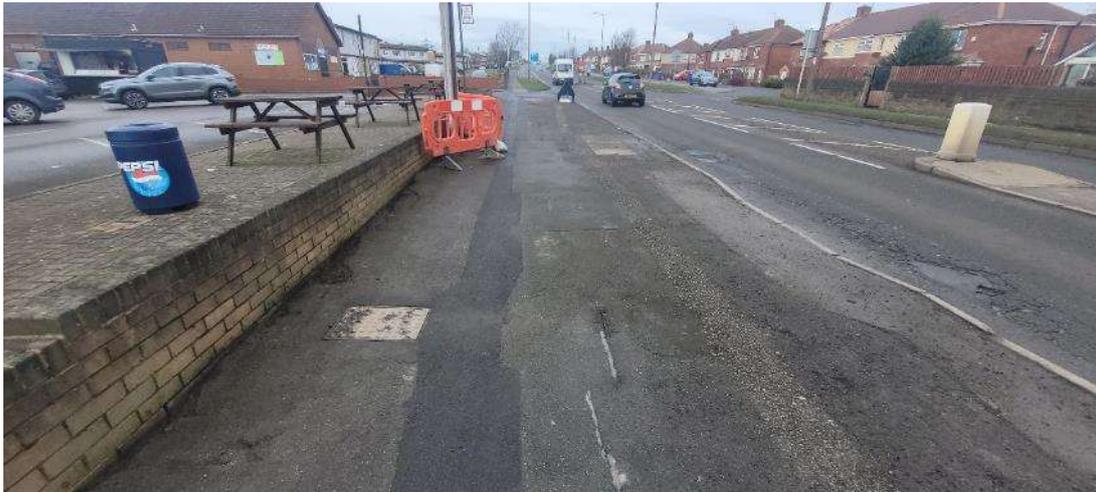
Photo 25

Wakefield Road looking North

Numerous utility scars in footway surface. Traffic Signal inspection cover recently installed. Carriageway surface has a number of cracks in the surface.

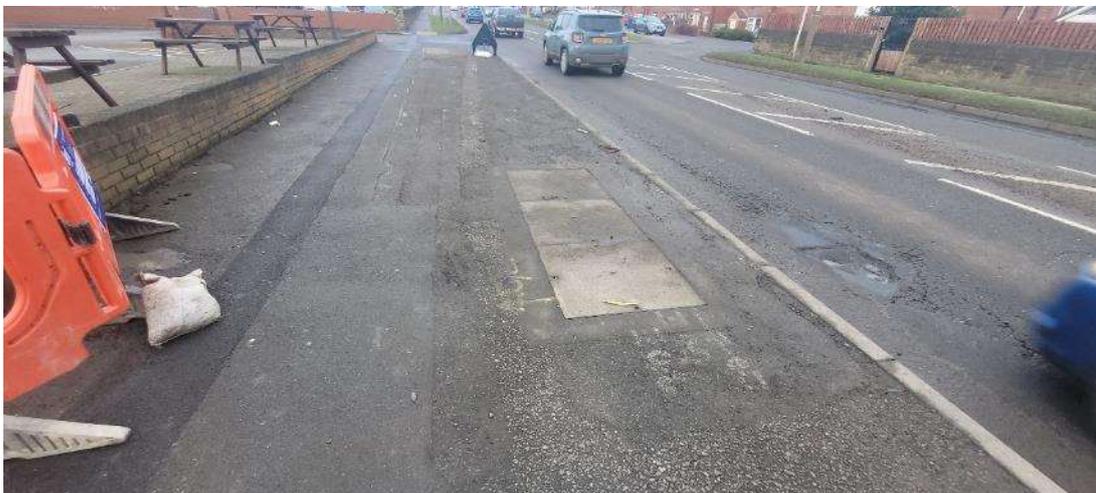
Photo 26

Wakefield Road looking North

Visible cracking of carriageway surface with water egress and appears to be a failed pot hole repair in the carriageway with loose stone material on carriageway. Numerous scars from utilities in footway.

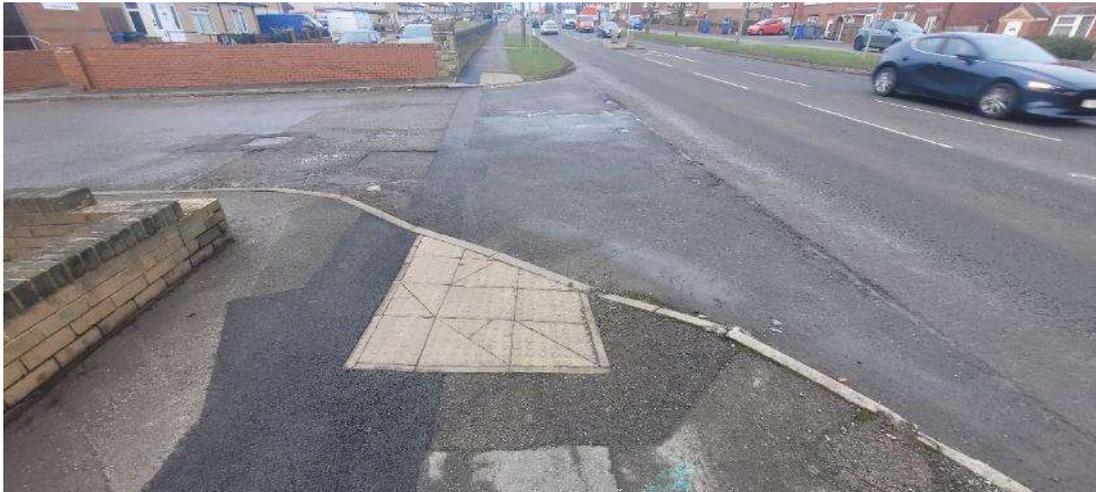
Photo 27

Wakefield Road looking North at Social Club access.

Broken tactile paving units. Visible cracking of carriageway surface.

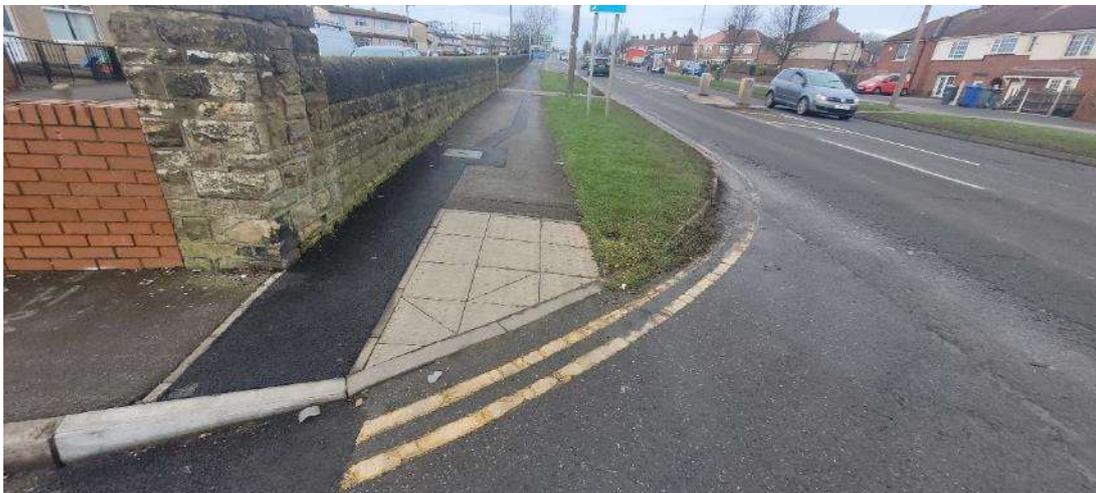
Photo 28

Wakefield Road looking North at Social Club access.

Visible utility scars in footway. Visible cracking of carriageway surface.

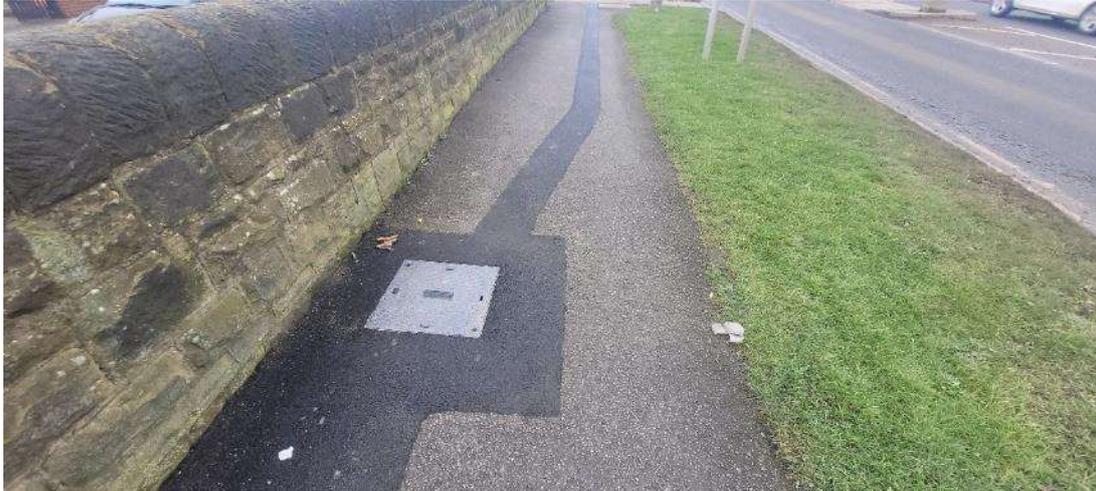
Photo 29

Wakefield Road looking North

Visible utility scars in footway. New Utility inspection cover in footway

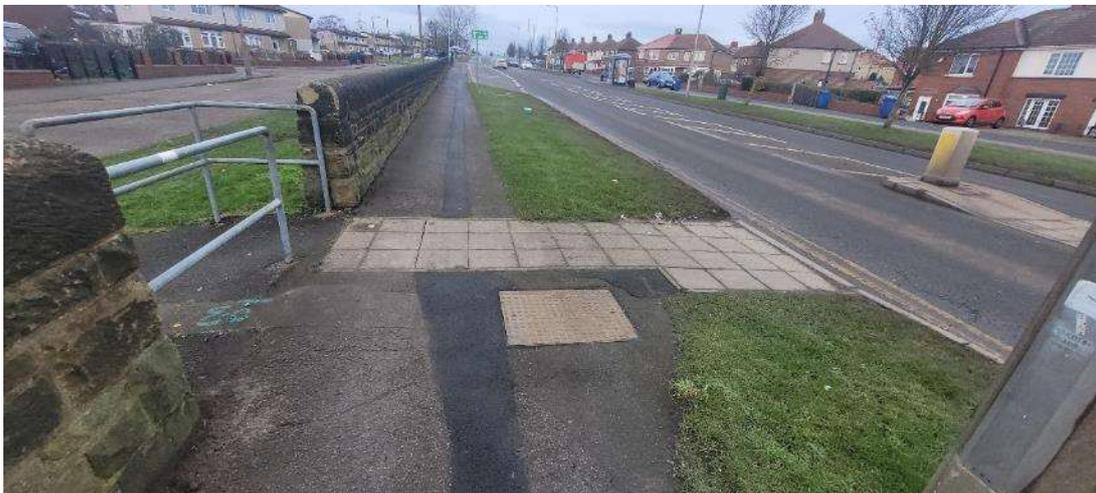
Photo 30

Wakefield Road looking North

Visible utility scars in footway. Visible cracking of carriageway surface. Non-standard tactile paving arrangement with badly worn blister tactile paving units.

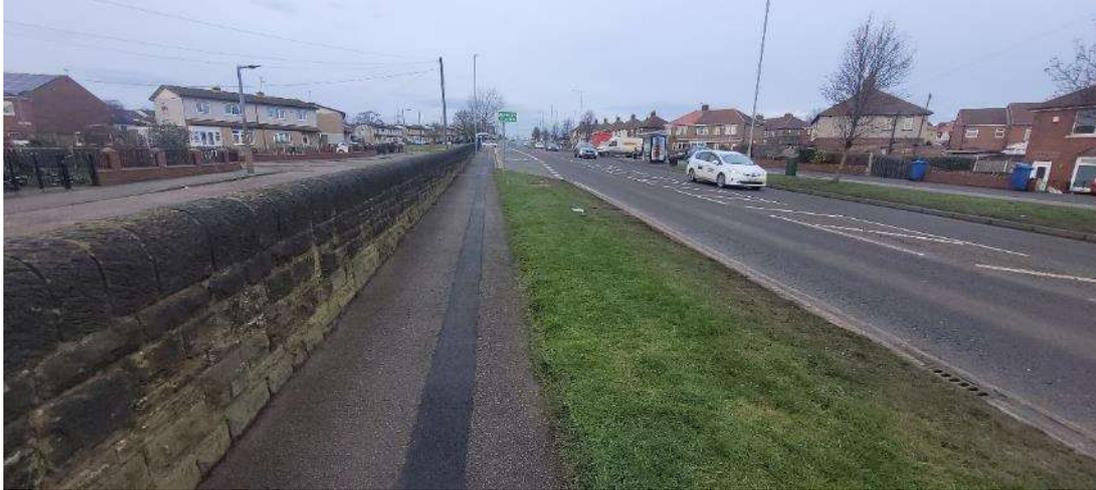
Photo 31

Wakefield Road looking North

Visible utility scars in footway. Visible cracking of carriageway surface.

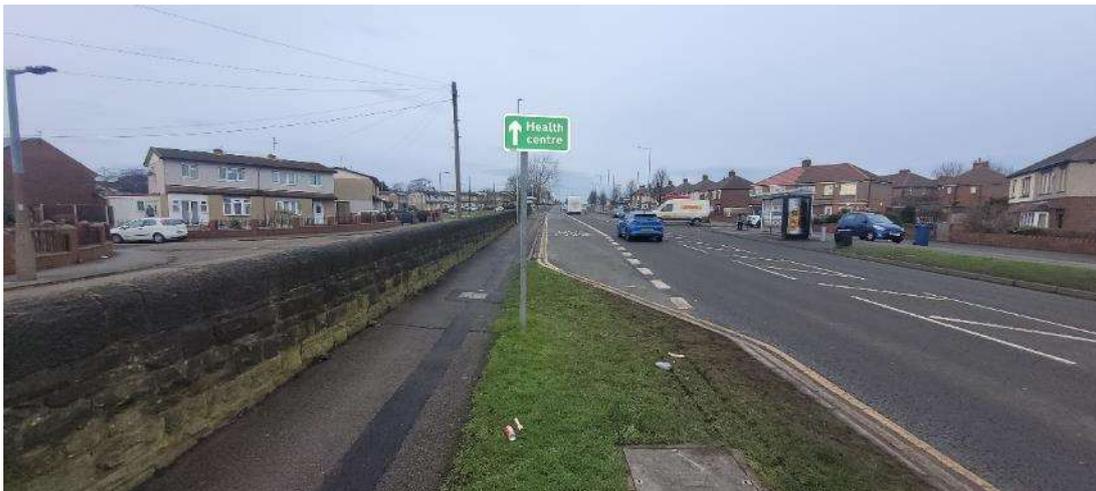
Photo 32

Wakefield Road looking North

Visible utility scars in footway. Visible cracking of carriageway surface.

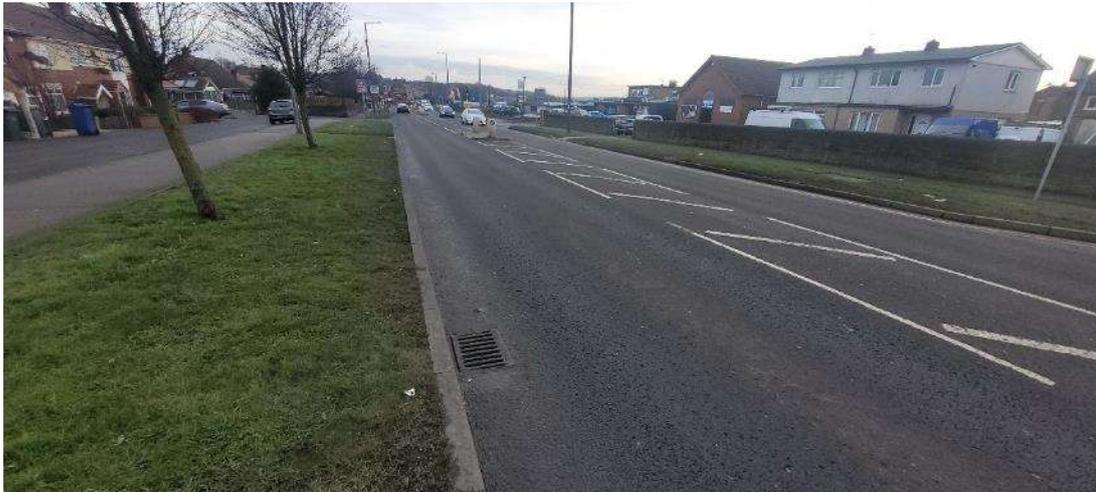
Photo 33

Wakefield Road looking South

Visible cracking of carriageway surface. Gully needs to be cleaned of detritus.

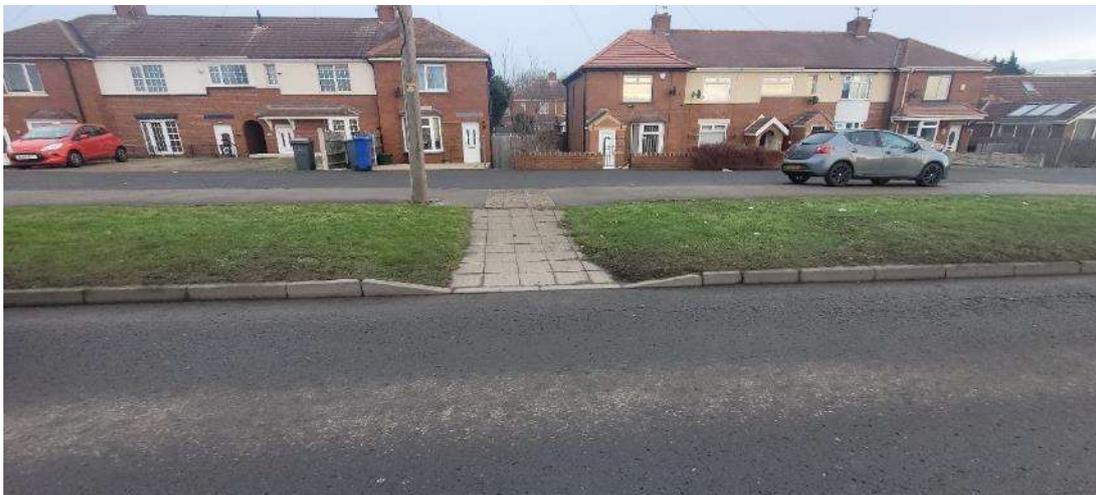
Photo 34

Wakefield Road looking South

Visible cracking of carriageway surface. Tactile paving overgrown, damaged tactile unit.

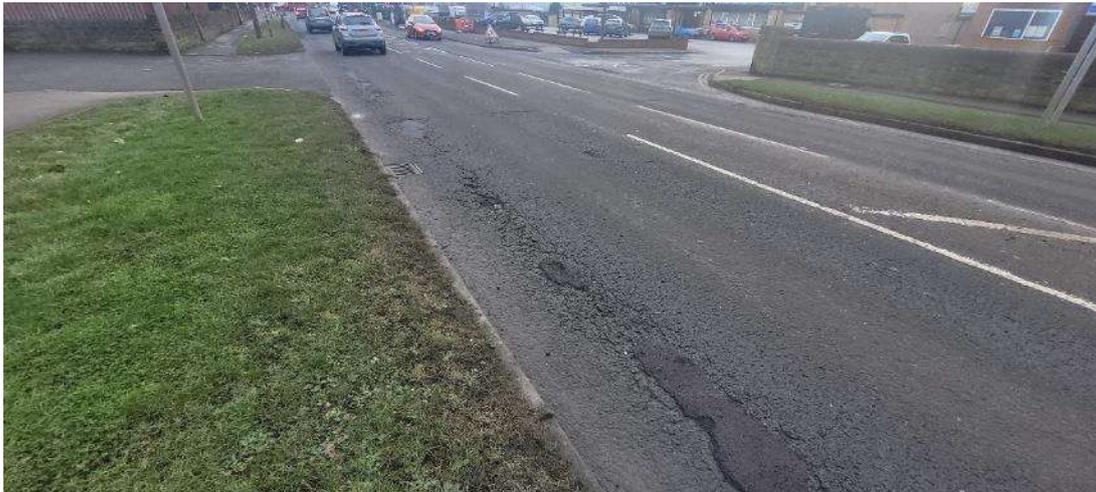
Photo 35

Wakefield Road looking South

Visible cracking of carriageway surface with temporary reinstatement.

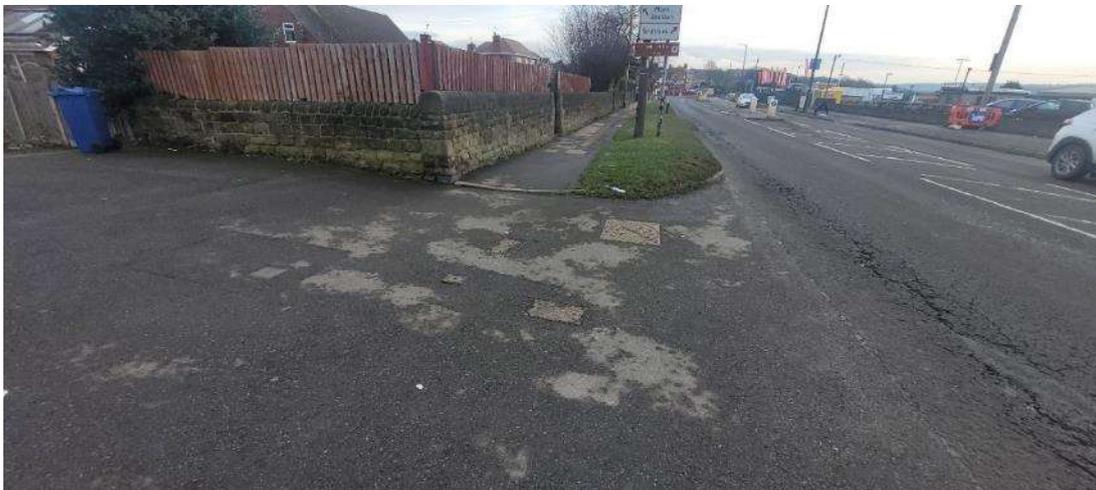
Photo 36

Wakefield Road looking South

Visible cracking of carriageway surface.

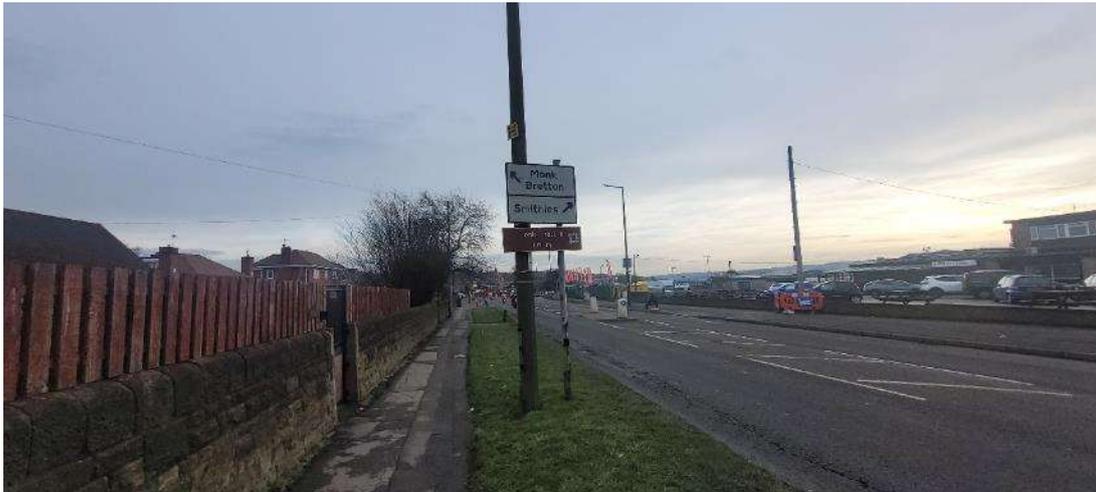
Photo 37

- 2.4 In addition, there is some damage to street furniture items, including a badly rusted sign post and a length of guardrail on the refuge island close to the school access which appears to have been struck by a vehicle. It should be noted that the road markings were found to be badly worn around the roundabout itself and a number of gullies are silted. Whilst on site, it was also noted that there are some non-metal gully frames installed on the footway and in the channel of the carriageway, which it is understood are not to current Barnsley M.B.C design guidance.

Wakefield Road looking South

Visible cracking of carriageway surface, Signs need replacing, post badly rusted and needs replacing.

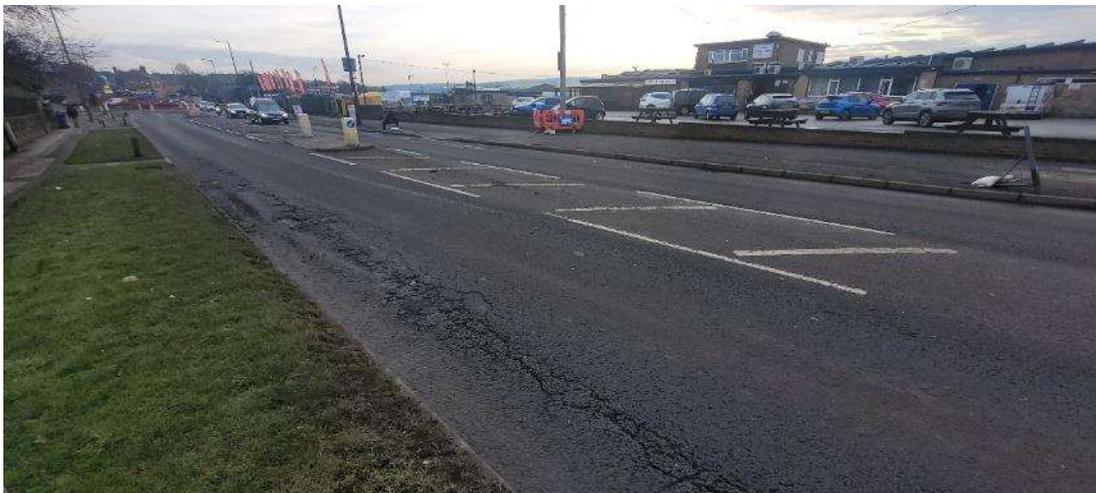
Photo 38

Wakefield Road looking South

Visible cracking of carriageway surface with water egress.

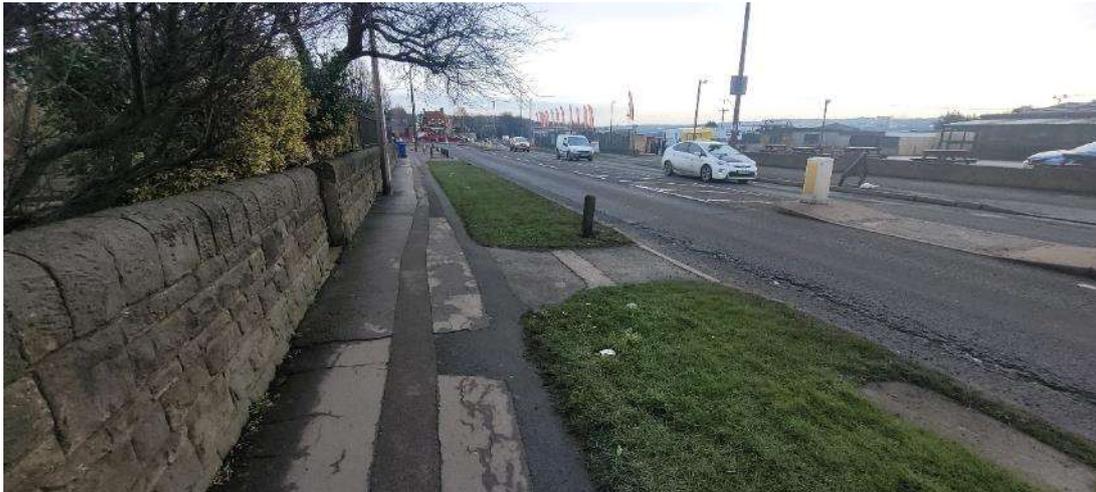
Photo 39

Wakefield Road looking South

Damaged post in verge, Visible cracking of carriageway surface and visible scars in footway.

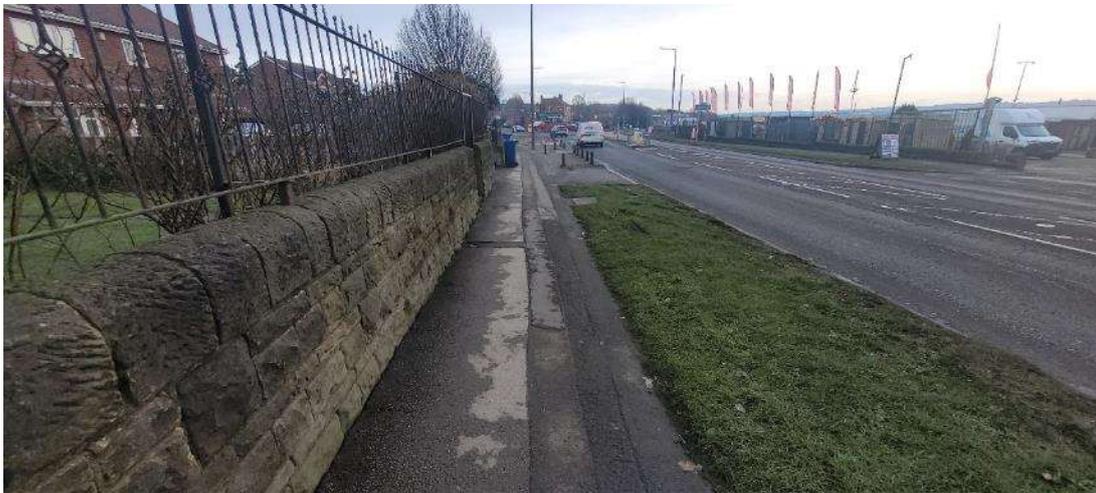
Photo 40

Wakefield Road looking South

Visible cracking of carriageway surface and visible scars in footway.

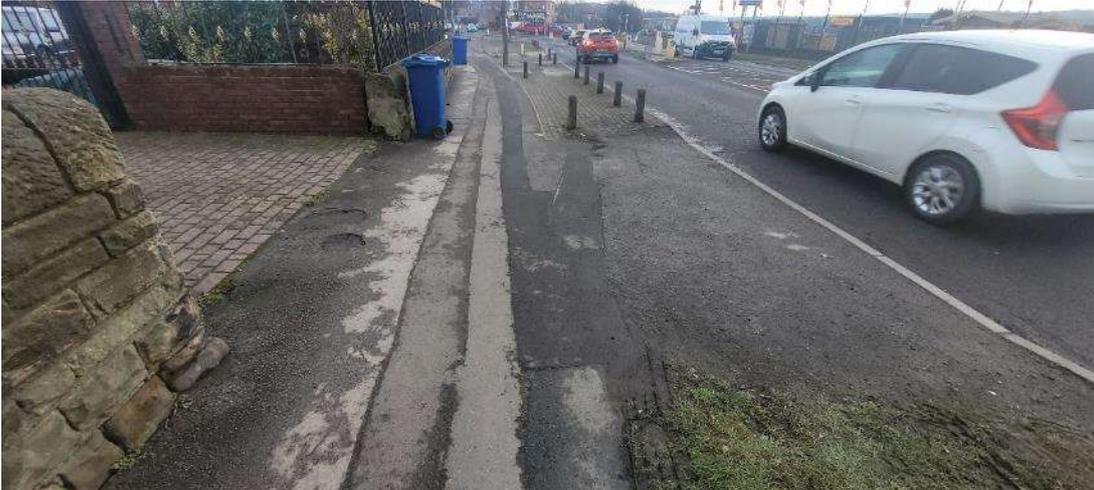
Photo 41

Wakefield Road looking South

Visible cracking of carriageway surface, plucked footway surface and visible scars in footway.

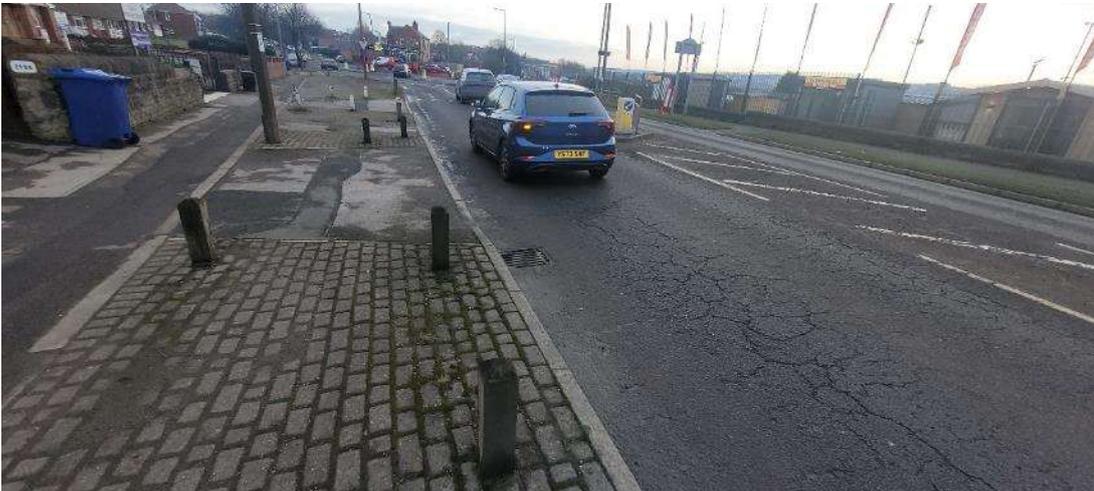
Photo 42

Wakefield Road looking South

Visible cracking of carriageway surface.

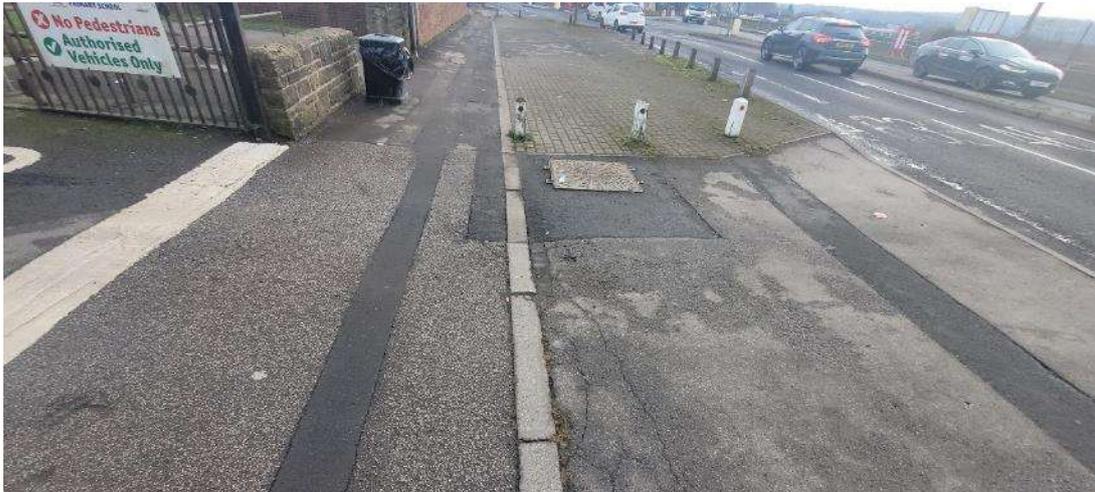
Photo 43

Wakefield Road looking South

Visible cracking of carriageway surface, chipped channel blocks and cracking of footway surface and visible scars in footway.
