Wakefield Road, Smithies, Barnsley

Visual Condition Survey

GLEESON DEVELOPMENTS LIMITED

Ref: 22-137-003.01

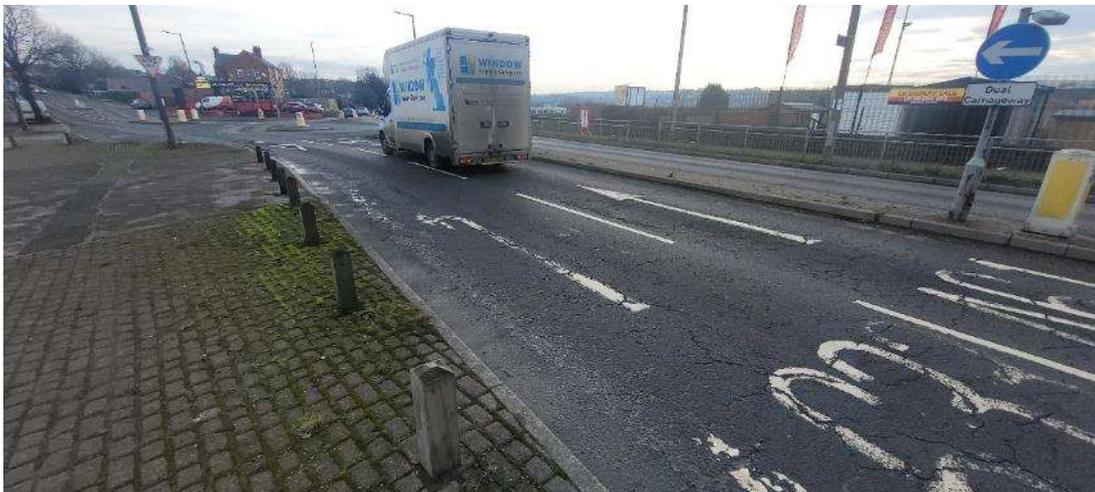
Photo 44

Wakefield Road looking South

Visible cracking of carriageway surface, road markings badly faded and visible scars in footway.

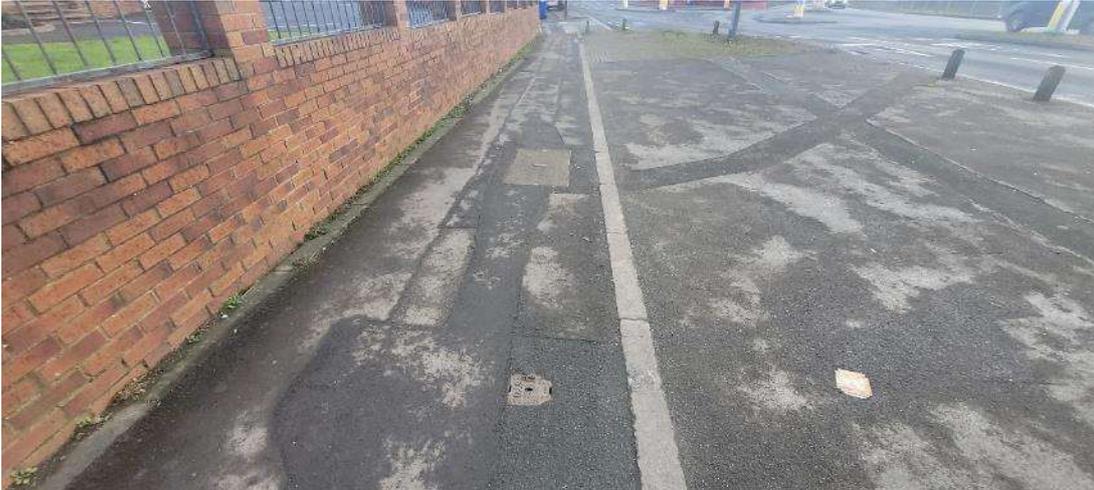
Photo 45

Wakefield Road looking South

Visible cracking of carriageway surface, chipped channel blocks and cracking of footway surface and visible scars in footway.

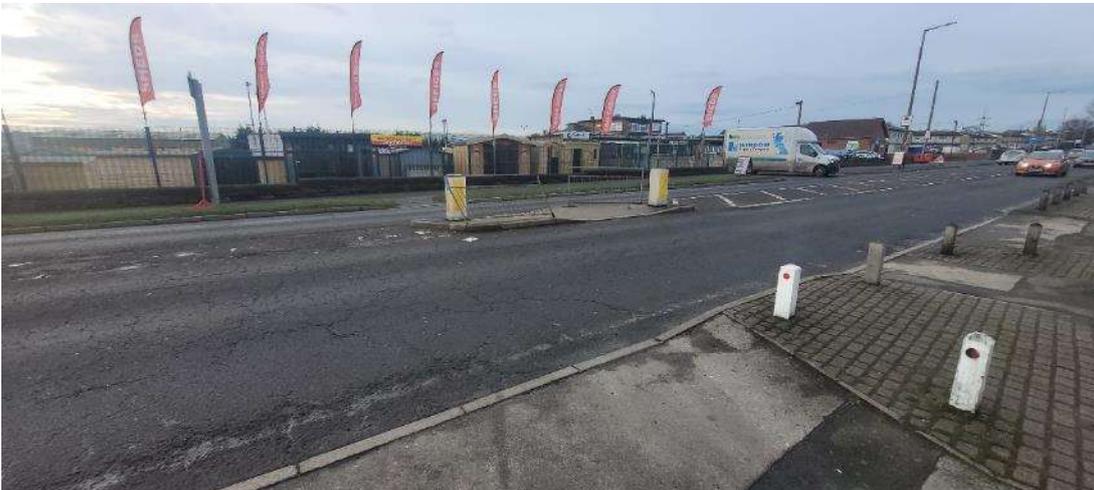
Photo 46

Wakefield Road looking South

Visible cracking of carriageway surface, Guardrail appears to be in a poor state of repair.

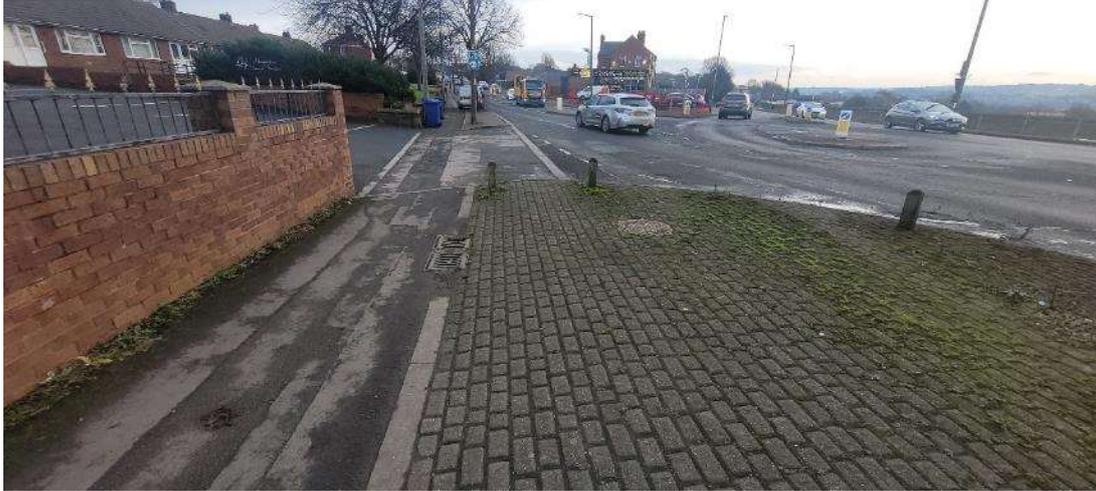
Photo 47

Wakefield Road looking South at roundabout with Rotherham Road and access to funeral directors.

Visible cracking of carriageway and footway. Visible utility scars in footway and overgrown vegetation in channel. Gullies require clearing of debris.

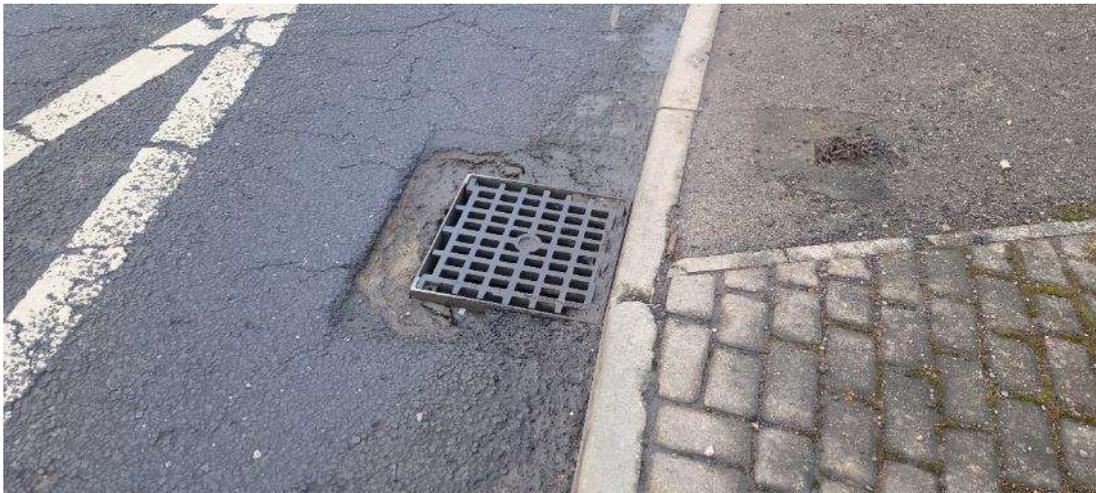
Photo 48

Rotherham Road looking South

Road gully with incorrect pedestrian friendly grate, silted, carriageway plucked due to water egress, damaged round gully frame, needs addressing.

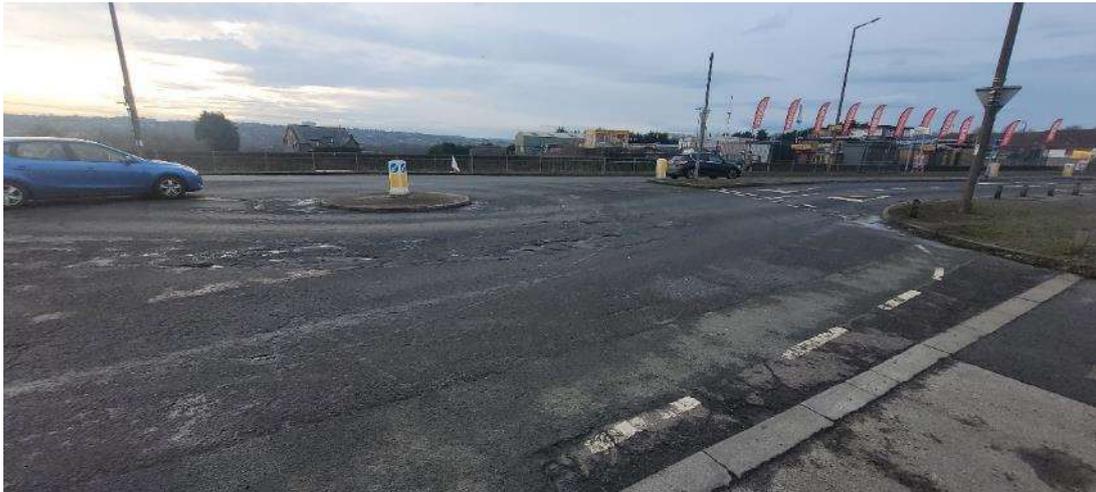
Photo 49

Wakefield Road looking North

Carriageway surface damaged with numerous reinstatements, plucked surface due to water egress and road markings badly worn.

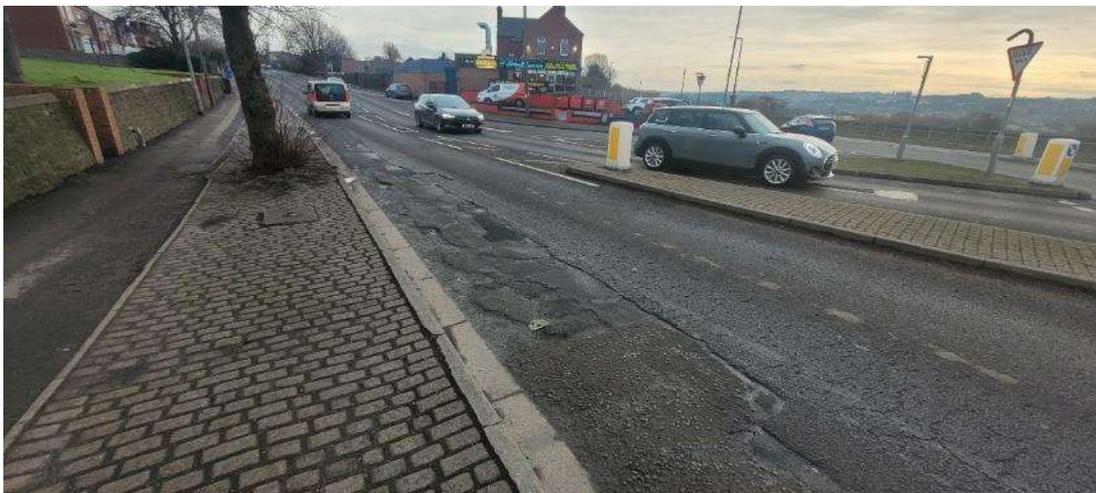
Photo 50

Rotherham Road looking South

Visible damage to carriageway surface . Visible scars in footway due to utilities.

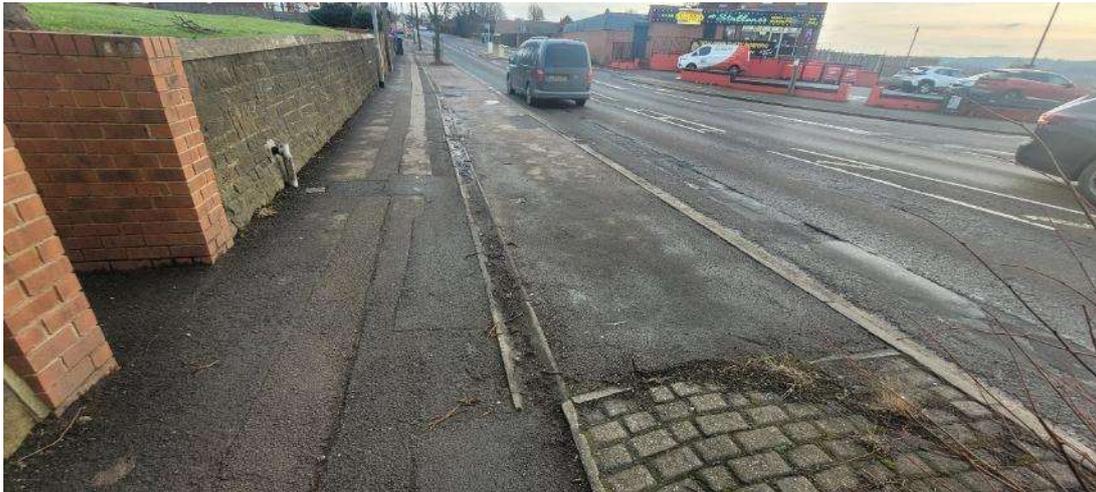
Photo 51

Rotherham Road looking South

Visible scar in carriageway has failed, cracking of carriageway surface. Visible scars in footway due to utilities and drainage channel silted.

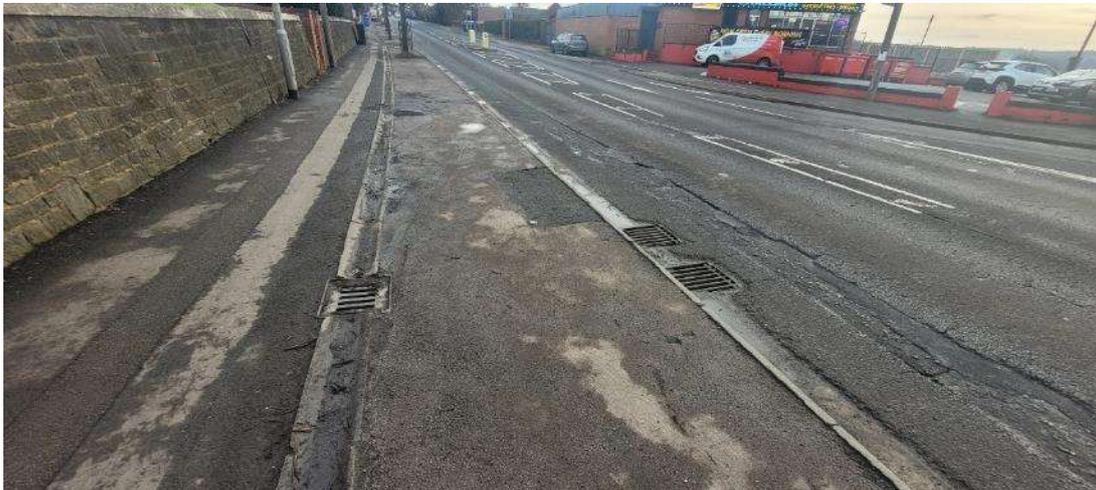
Photo 52

Rotherham Road looking South

Three No. gullies needs jetting to remove detritus. Gully in footway has a non-metal frame. Visible scar in carriageway has failed, cracking of carriageway surface. Visible scars in footway due to utilities and drainage channel silted.

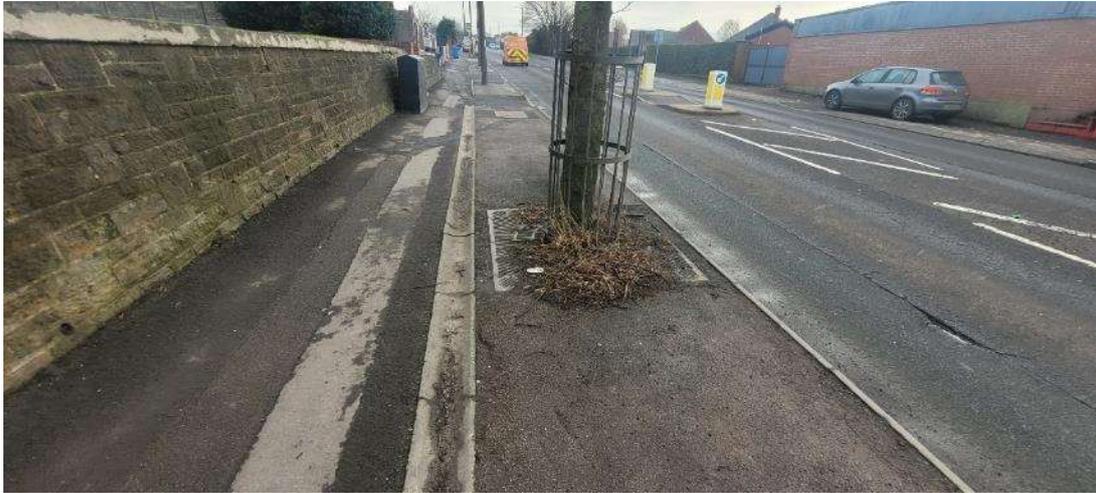
Photo 53

Rotherham Road looking South

Visible plucking of carriageway surface. Visible scars in footway and loose debris in drainage channel.

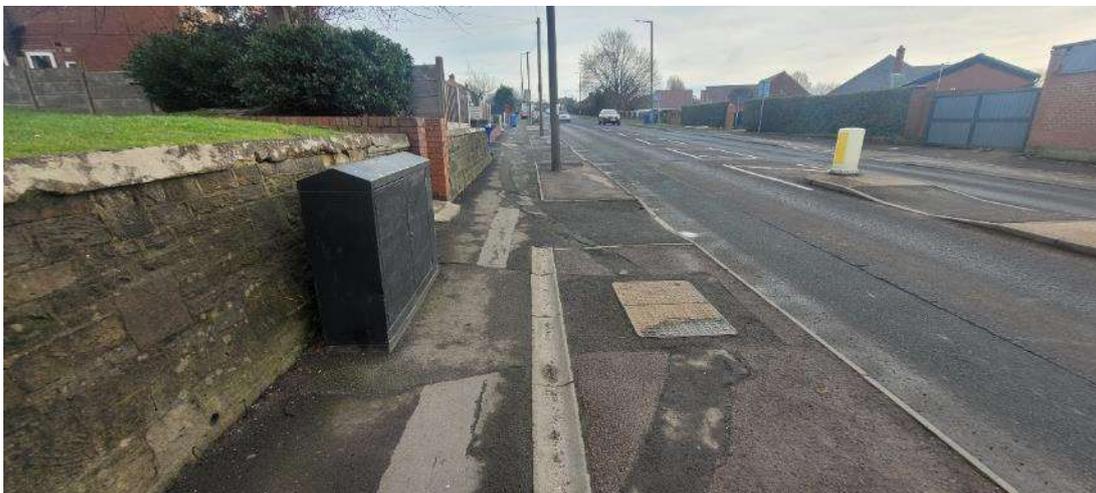
Photo 54

Rotherham Road looking South – Extents of works

Visible plucking of carriageway surface. Visible scars in footway and loose debris in drainage channel. Uncontrolled crossing with no visible tactile paving.

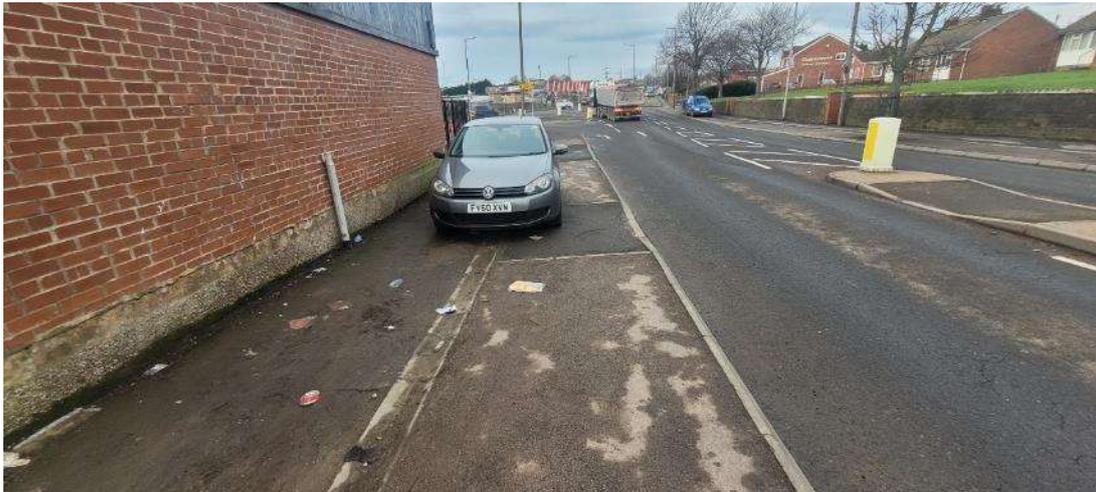
Photo 55

Rotherham Road looking South – Extents of works

Small cracks visible in carriageway surface. Visible scars in footway and loose debris in drainage channel. Uncontrolled crossing with no visible tactile paving.

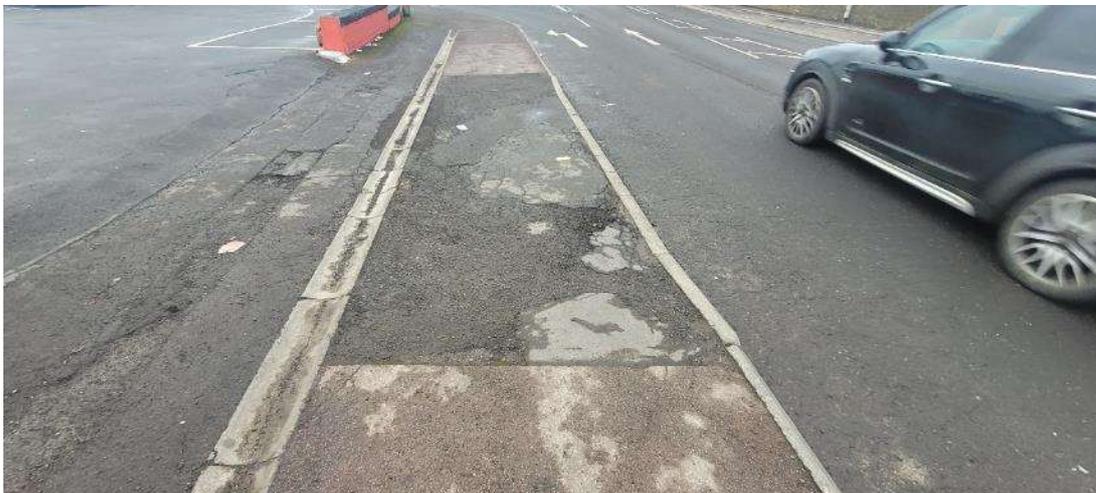
Photo 56

Rotherham Road looking north

Small cracks visible in carriageway. Footway is badly damaged due to vehicles overrunning footway to access car park. Visible scars in footway due to utilities.

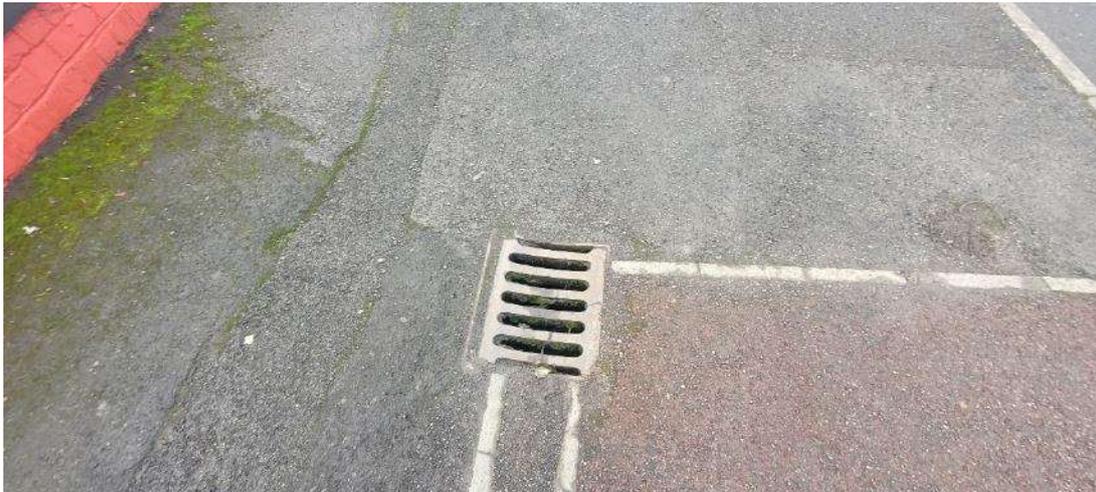
Photo 57

Rotherham Road looking north

Footway gully at low point of drainage channel needs clearing of debris. Drainage channel full of debris and need clearing. Visible scars in footway due to utilities.

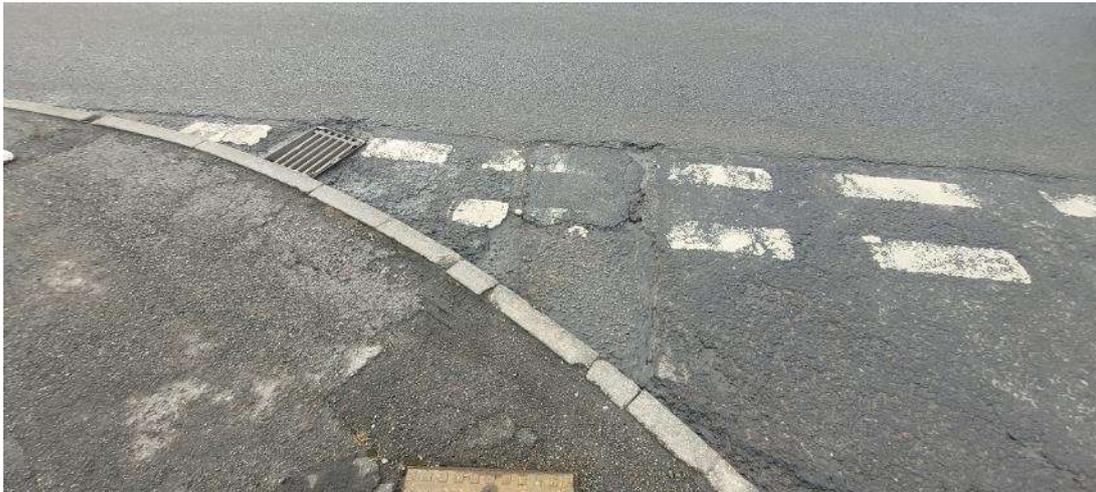
Photo 59

Rotherham Road give way line looking toward Wakefield Road south

Visible cracking of carriageway. Visible scars in footway due to utilities. Gully sat proud of surface, Gully needs clearing of detritus.

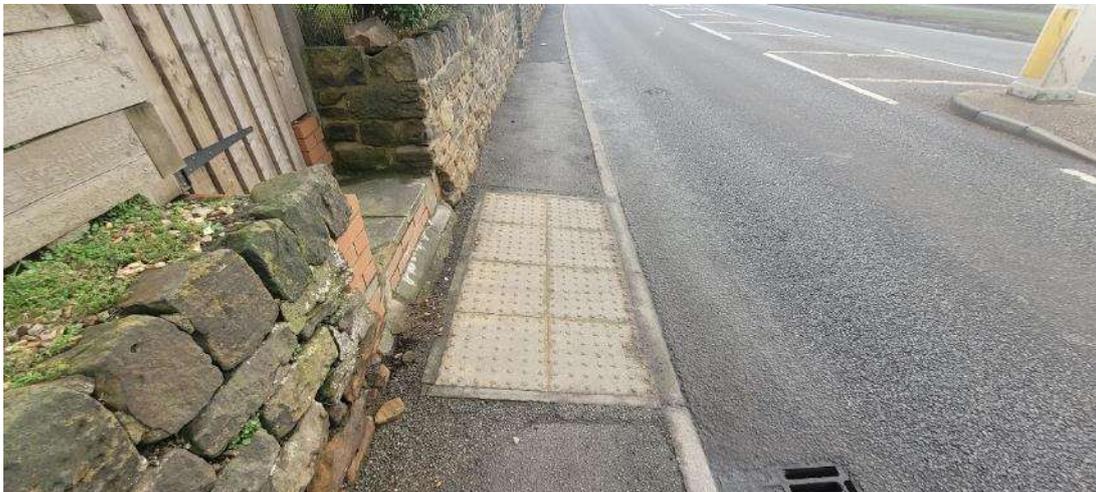
Photo 60

Wakefield Road looking South

Carriageway plucked with water egress. Gully pot is badly silted and needs clearing of detritus.

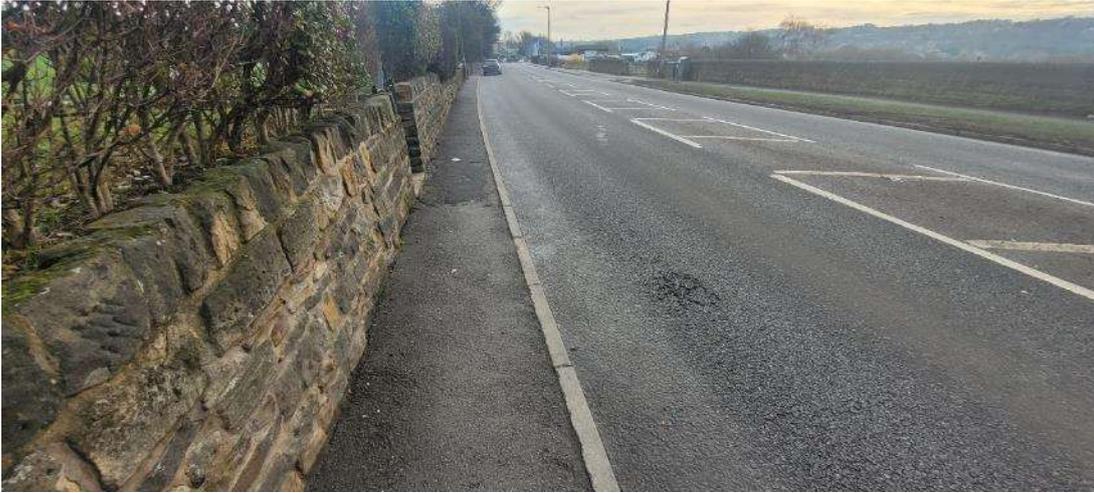
Photo 61

Wakefield Road looking South

Carriageway plucked with water egress.

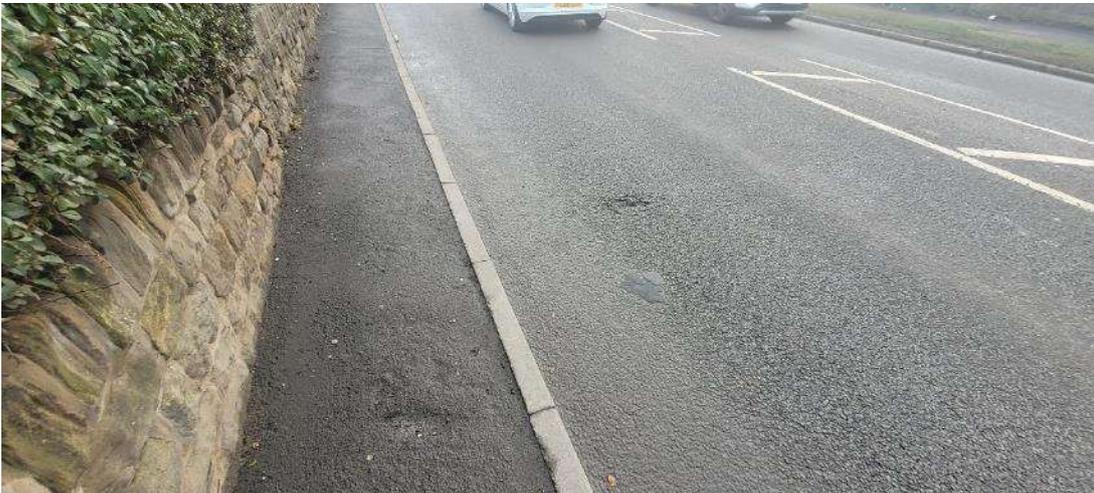
Photo 62

Wakefield Road looking South

Carriageway plucked with water egress.

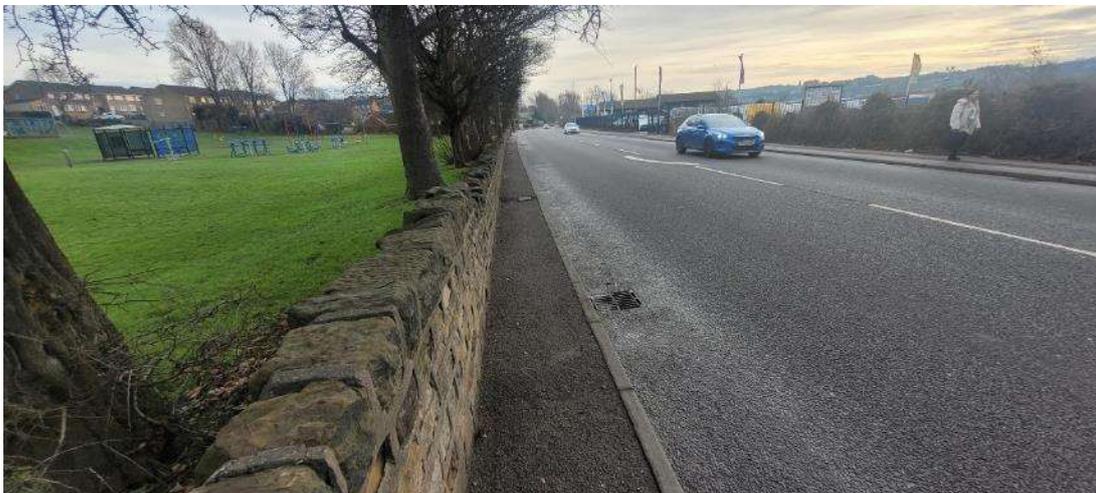
Photo 66

Wakefield Road looking South

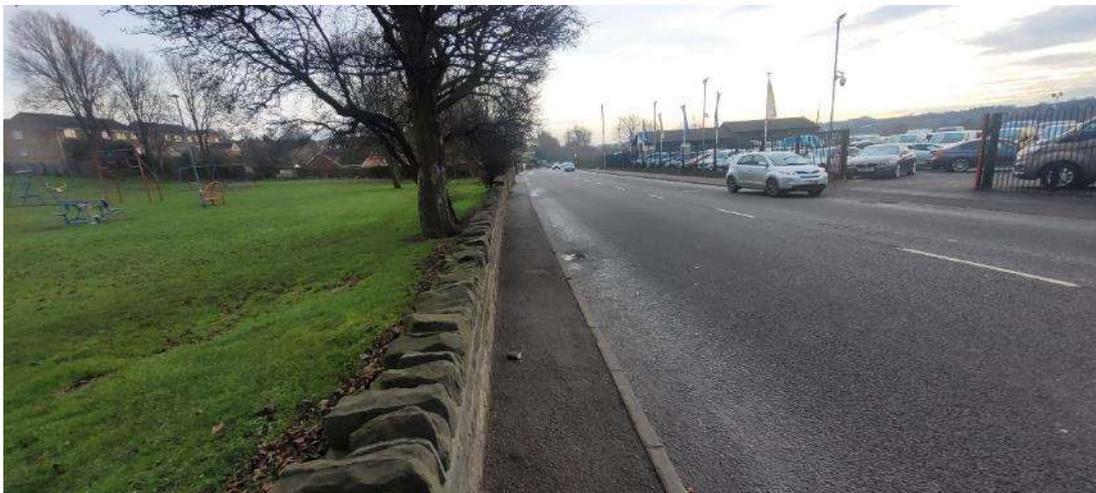
Photo 68

Wakefield Road looking South

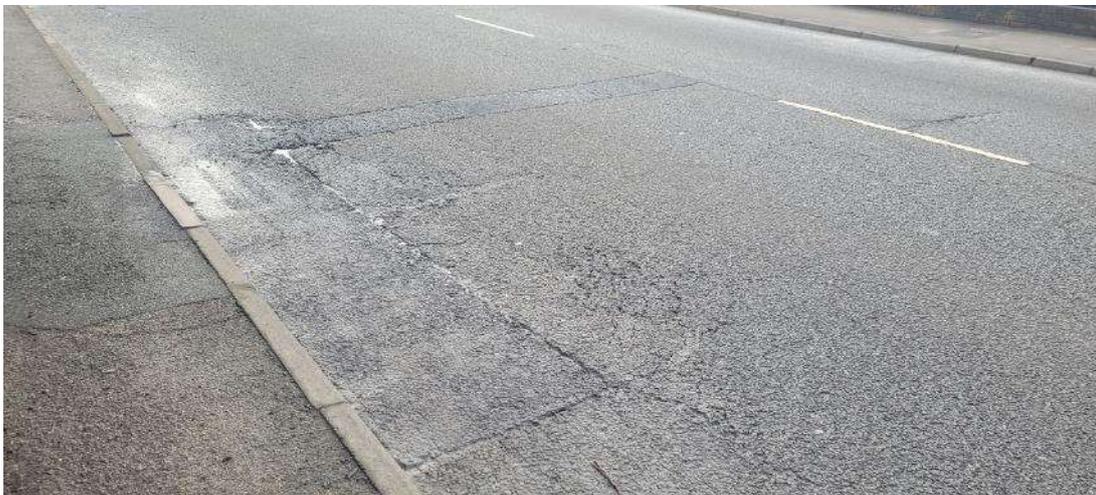
Photo 70

Wakefield Road looking South

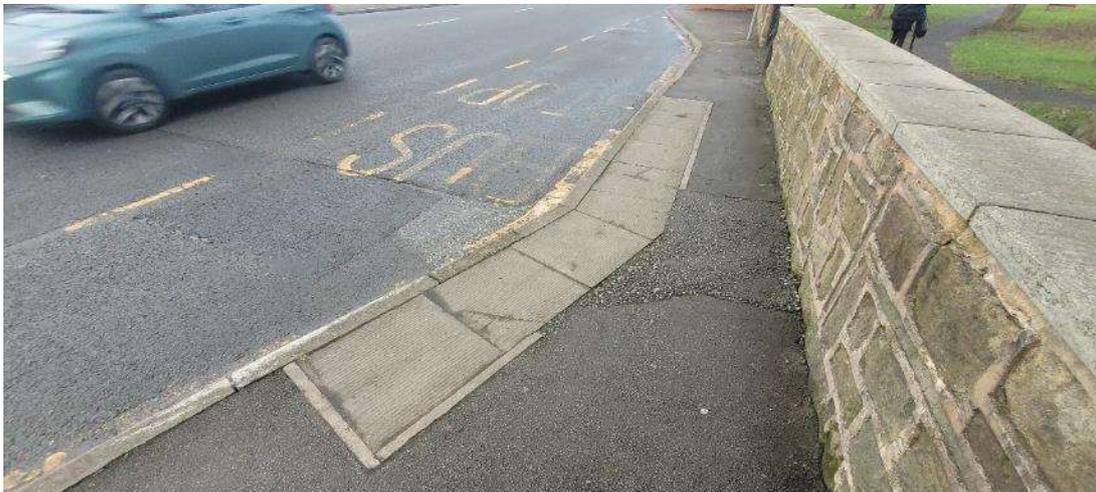
Photo 72

Wakefield Road looking from bus stop north

Damaged bus stop hazard paving units. Scar in footway. Bus stop marking badly worn.

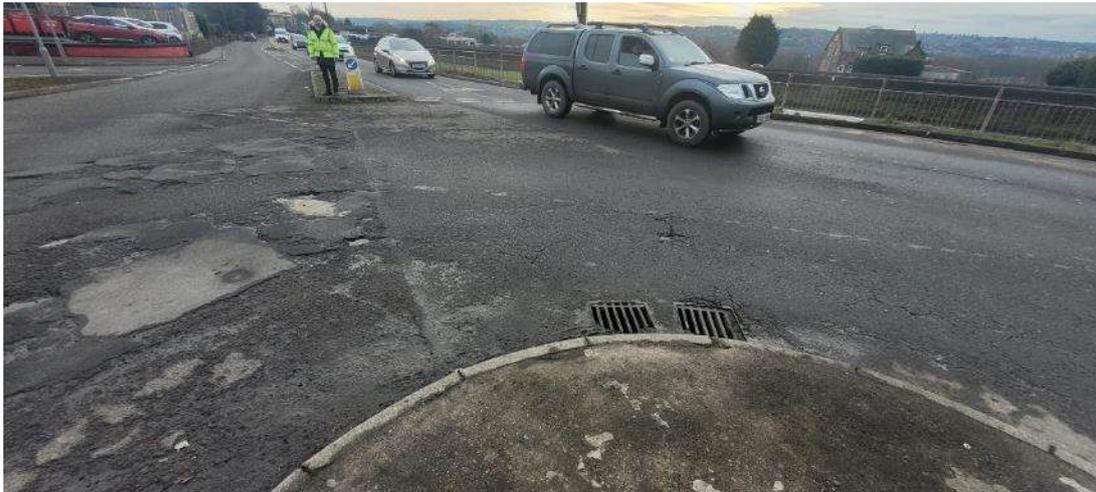
Photo 73

Wakefield Road Roundabout with Rotherham Road looking south towards Wakefield Road

Significant visible damage to carriageway surface. Multiple temporary reinstatements undertaken visible. Roundabout island surface is in poor state of repair. Gullies with visible debris, need jetting to clear detritus.

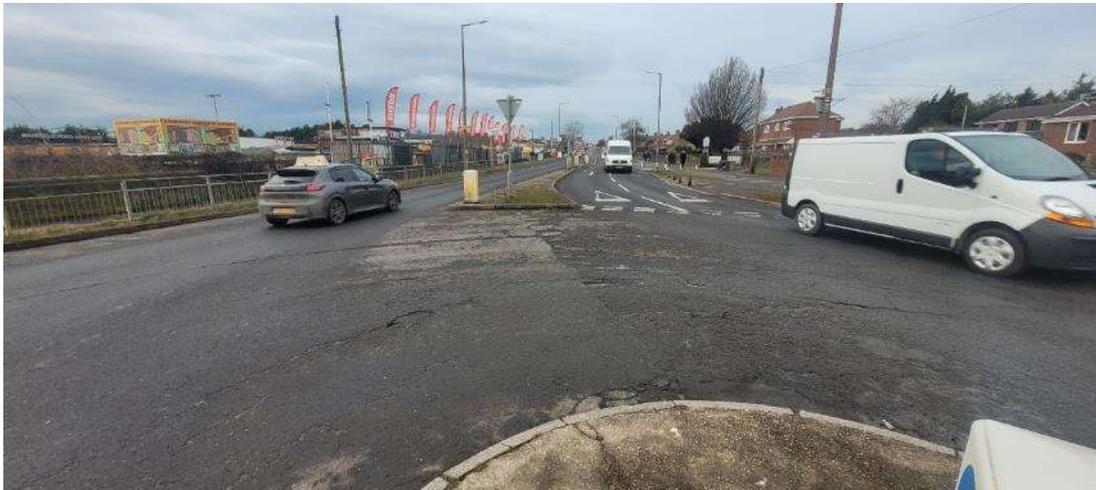
Photo 74

Wakefield Road Roundabout with Rotherham Road looking north towards Wakefield Road

Significant visible cracking of carriageway. Water egress on joint line. Kerb damaged on roundabout island.

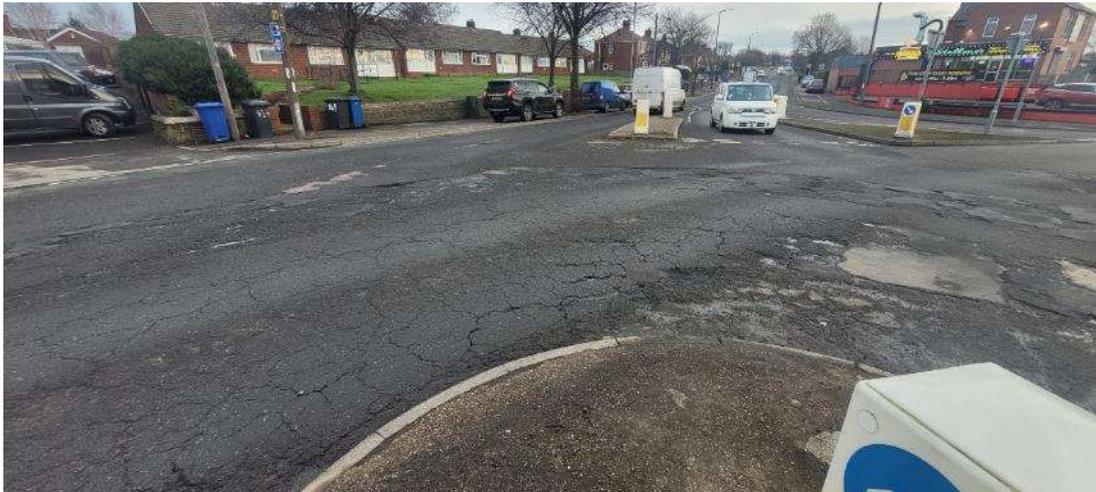
Photo 75

Wakefield Road Roundabout with Rotherham Road looking south towards Rotherham Road

Significant visible damage to carriageway surface. Multiple temporary reinstatements undertaken visible. Roundabout island surface is in poor state of repair.

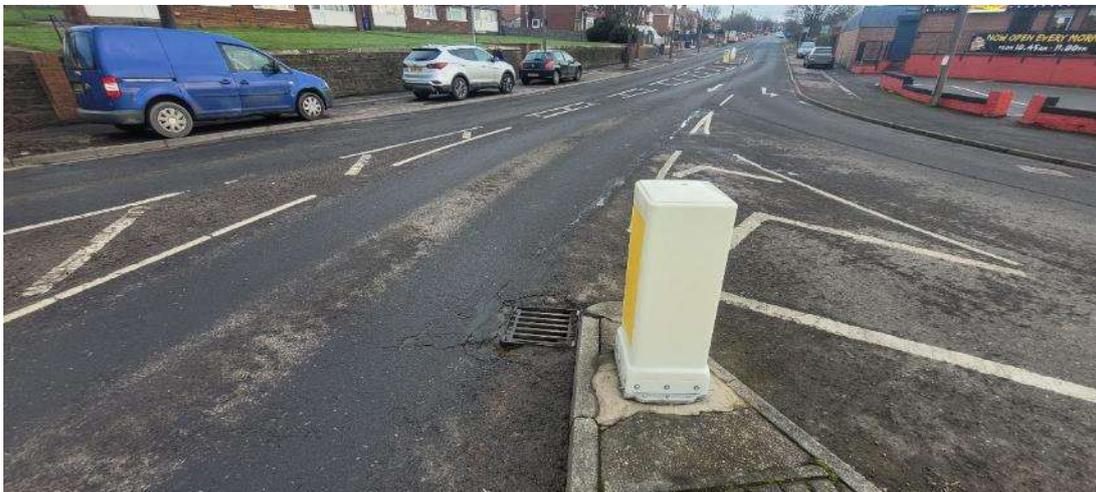
Photo 76

Rotherham Road looking south from Give Way line on roundabout

Visible cracking of carriageway surface around gully frame. Gully silted and needs clearing of detritus.
