# **ARBORICULTURAL REPORT**

## **& Impact Assessment**

***Burntwood Hall Farm,  
Moor Lane,  
Barnsley,  
S72 9HB***

Reference: *AWA5431*

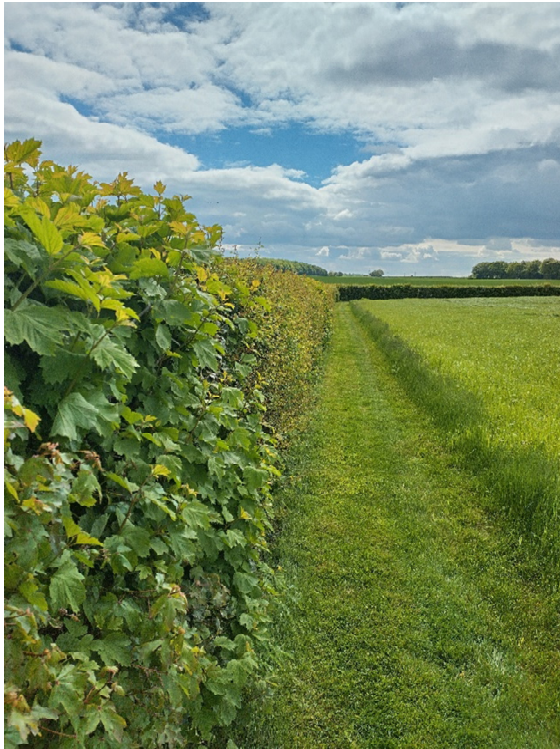
Photo 1: G1 from north.

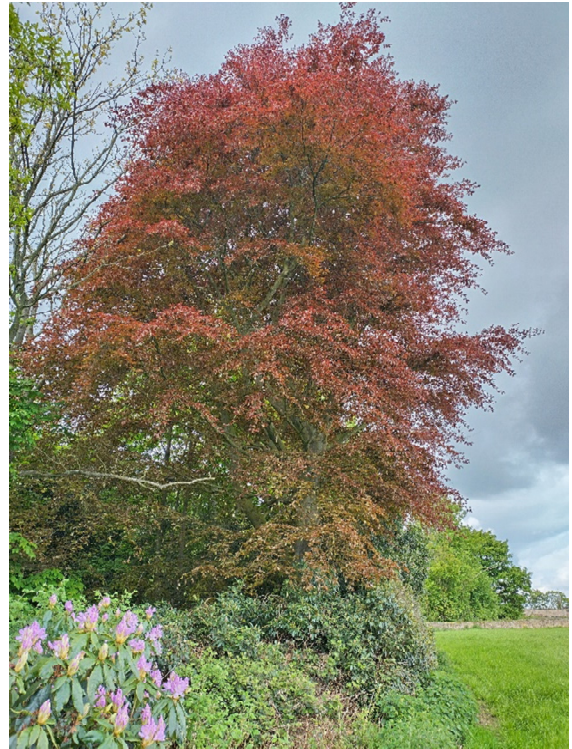
- 3.2.9 Beeches T6, T9, T17 and Sycamore T7 are also valuable trees within the site. All four are large, mature trees which provide moderate levels of amenity within the landscape. All four were inaccessible due to ivy, adjacent property, or other vegetation but appeared are in good condition with good long term prospects.

Photo 2: T6 from south east.

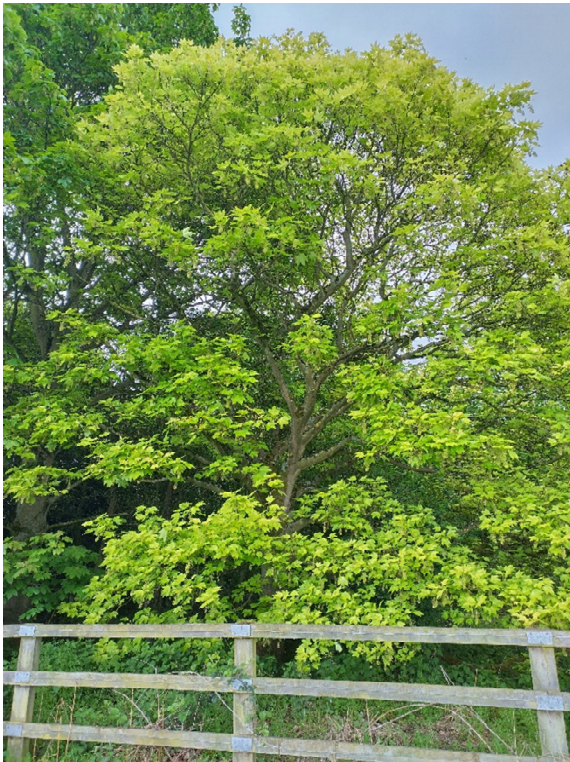
Photo 3: T8 from east.

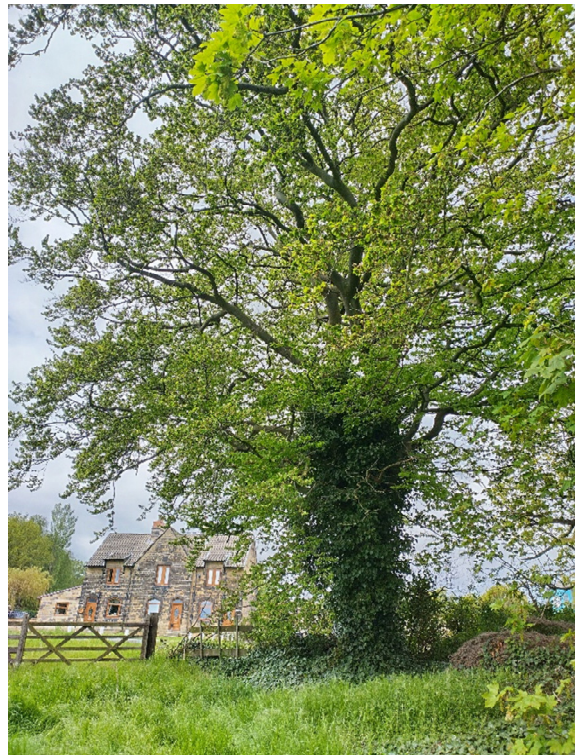
Photo 4: T9 from south east.

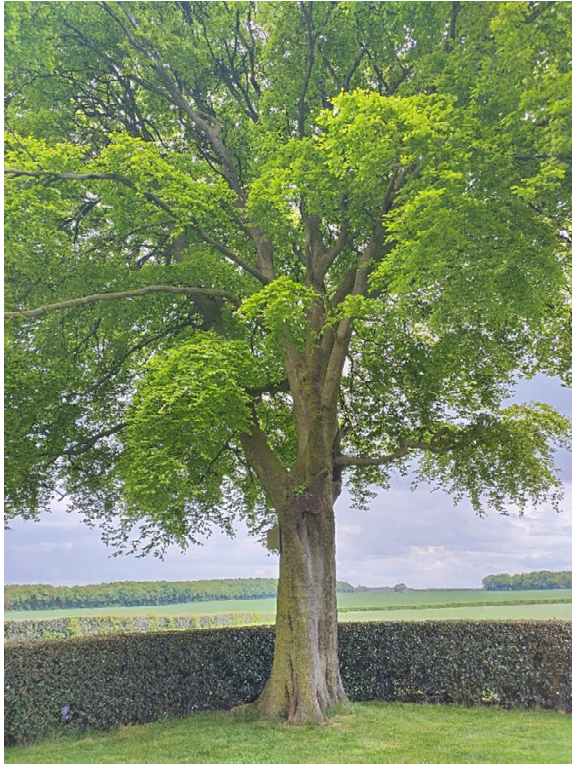
- 3.2.7 Most of the trees are semi-mature with only occasional early mature to mature trees.
- 3.2.8 The sites most significant tree is Beech T22. The tree is a large mature tree in good condition, providing moderate amenity to the property and surrounding landscape. The tree has some visual defects, including exposed roots and soil compaction, but nothing that limits its long term prospects or value. It is retention category 'A'.

Photo 5: T22 from north.

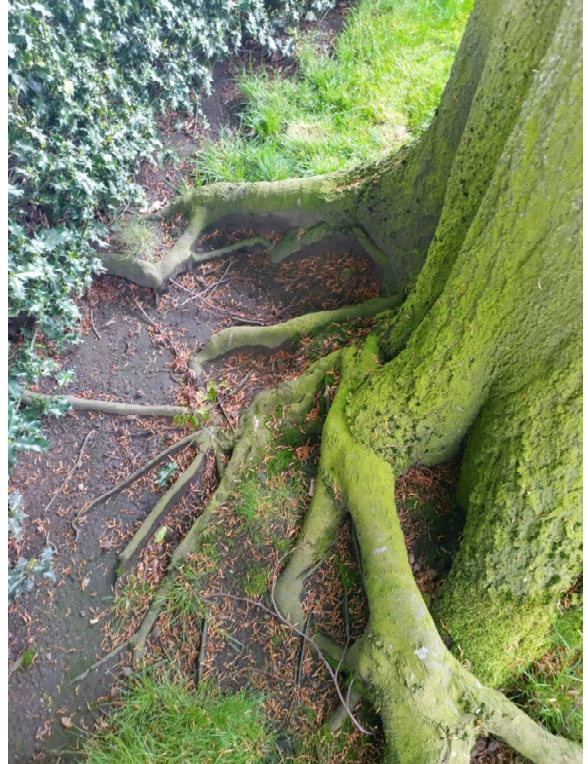
Photo 6: Exposed roots of T22.

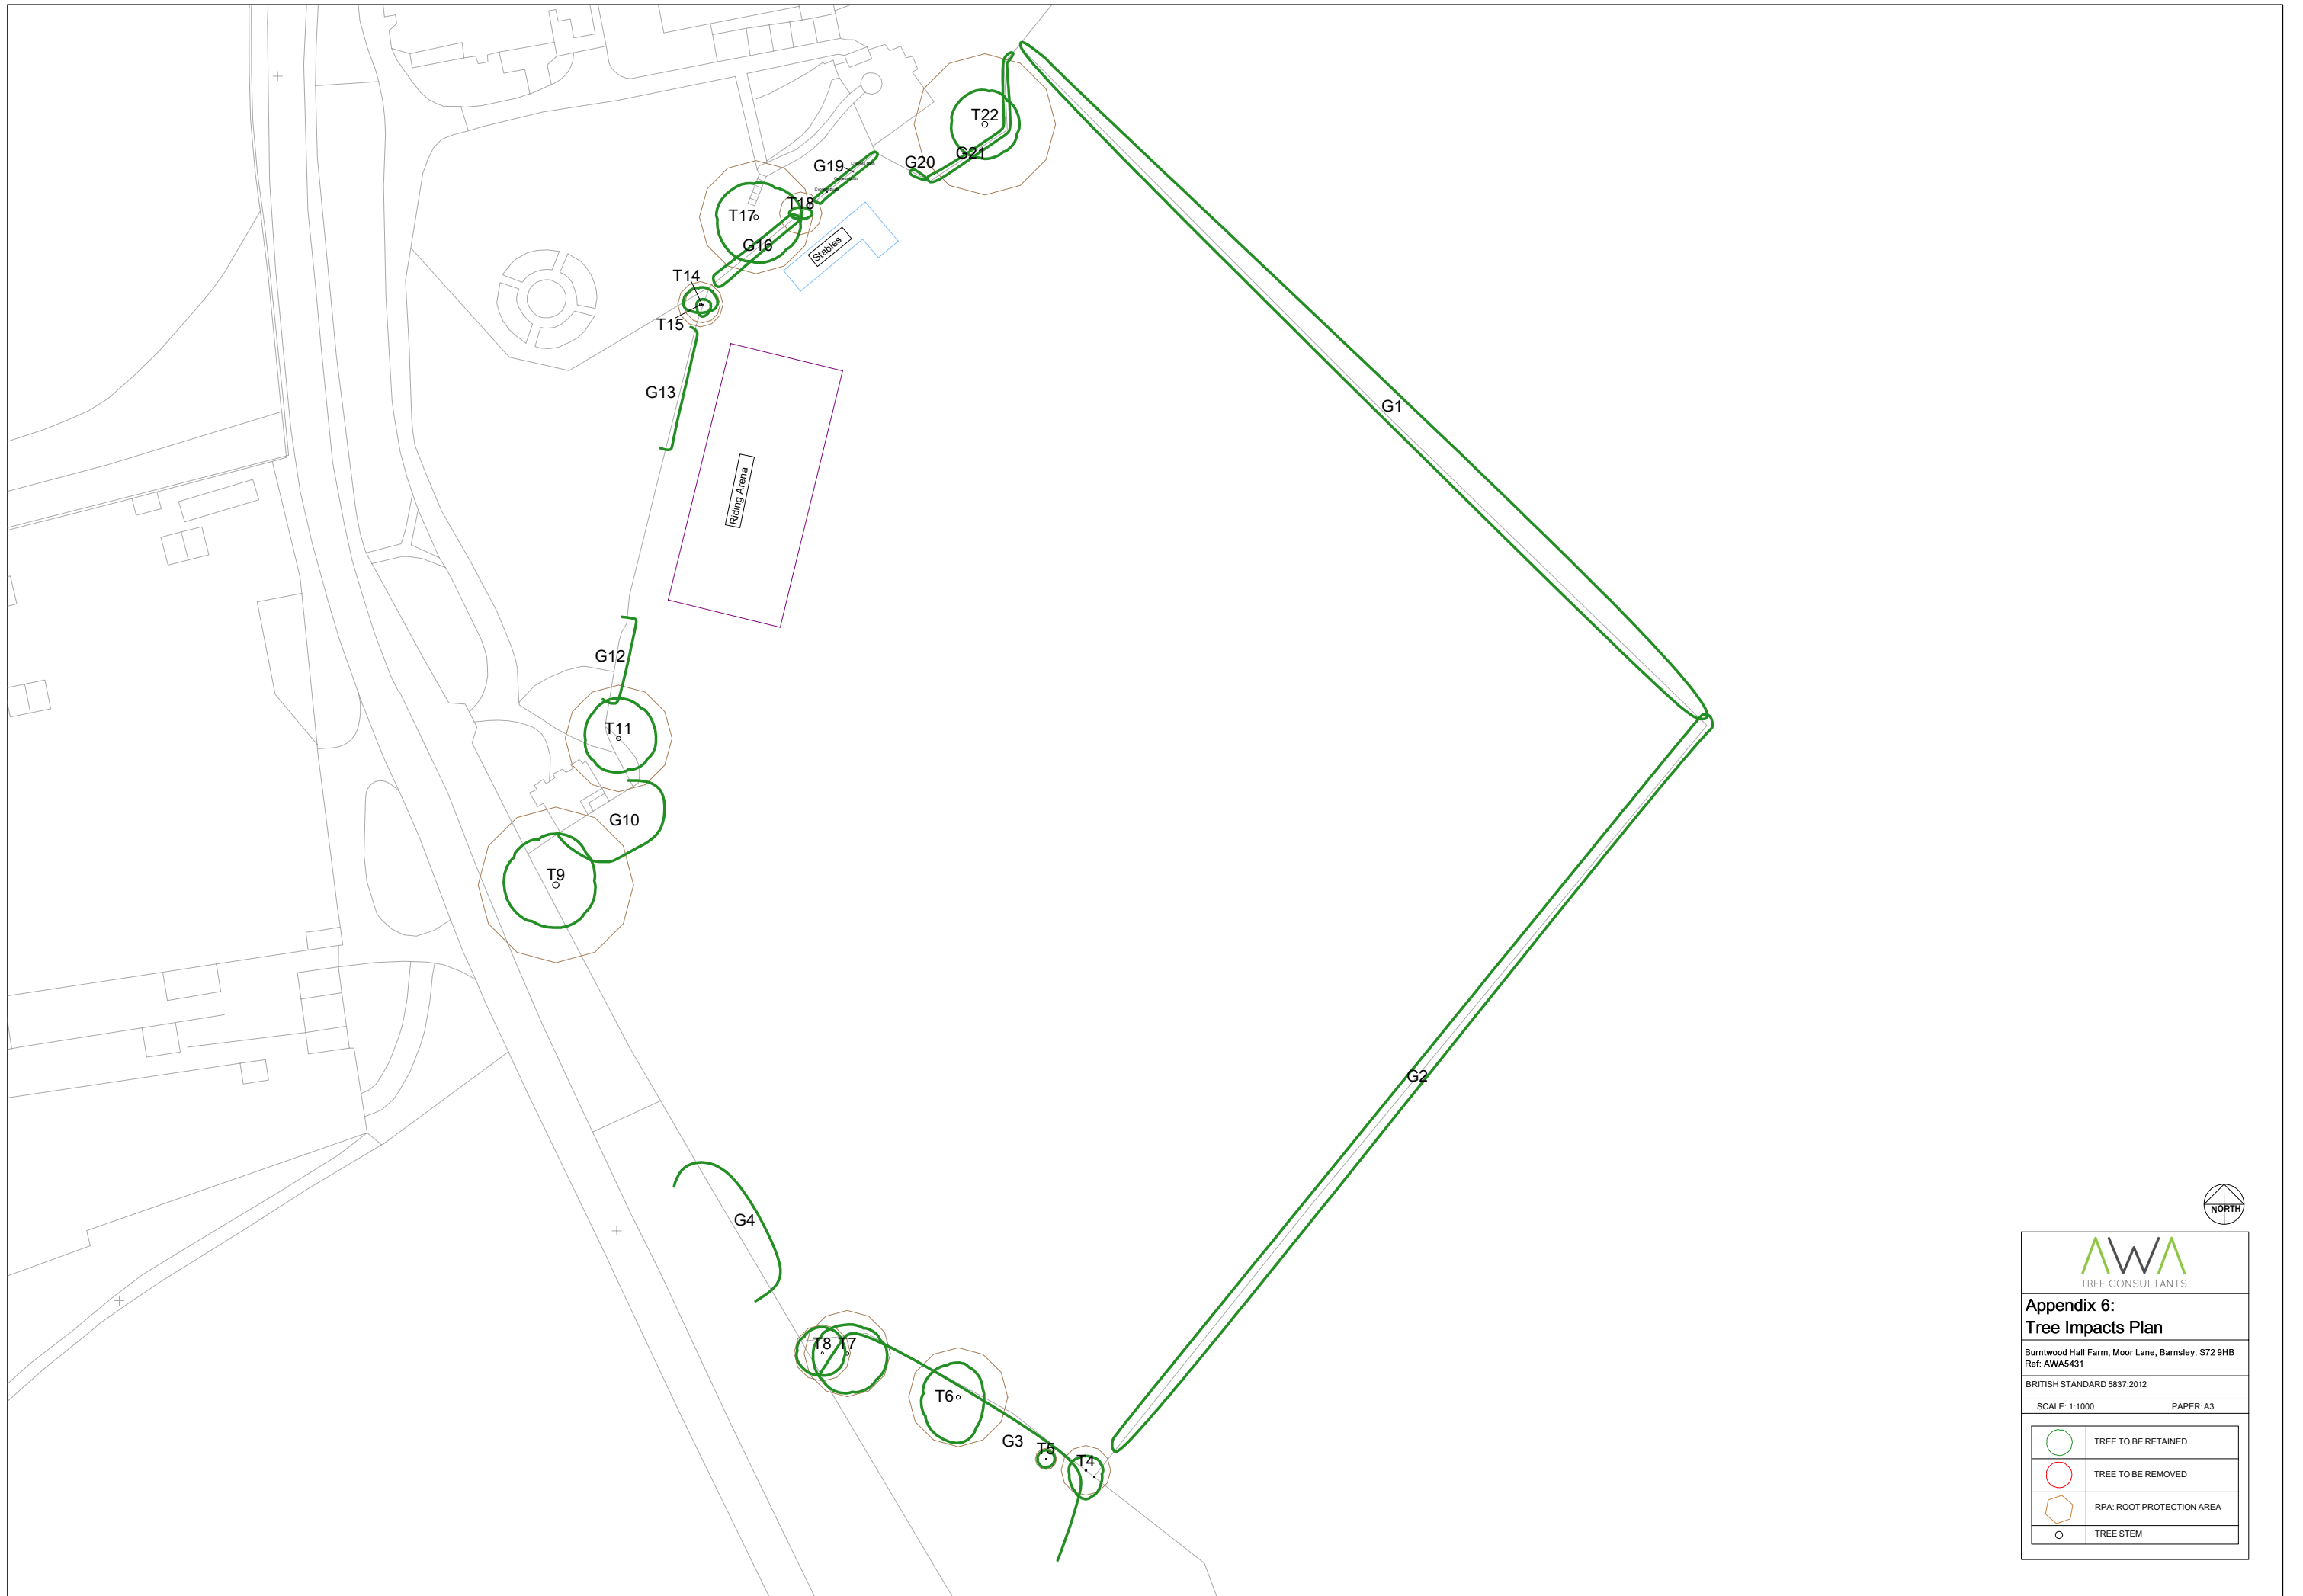
**Appendix 6:**  
**Tree Impacts Plan**

4.3.3 The new development encroaches close to the edge of the RPA of retained tree T17, however, the encroachment is minor and the detailed RPA is likely to be a slightly exaggerated representation of the tree's actual rooting area. As such, it is unlikely that significant roots will be within these areas and the retained tree should remain largely unaffected by the works, provided care is taken during construction.

4.4.1 The retained trees may require protection by fencing in accordance with BS 5837: 2012, during the development phase.
