# **ARBORICULTURAL REPORT & Impact Assessment to BS5837:2012 at:**

***South Street,  
Darfield,  
Barnsley,  
South Yorkshire  
S73 9NH***

Date: September 2018

Reference: AWA2193/A

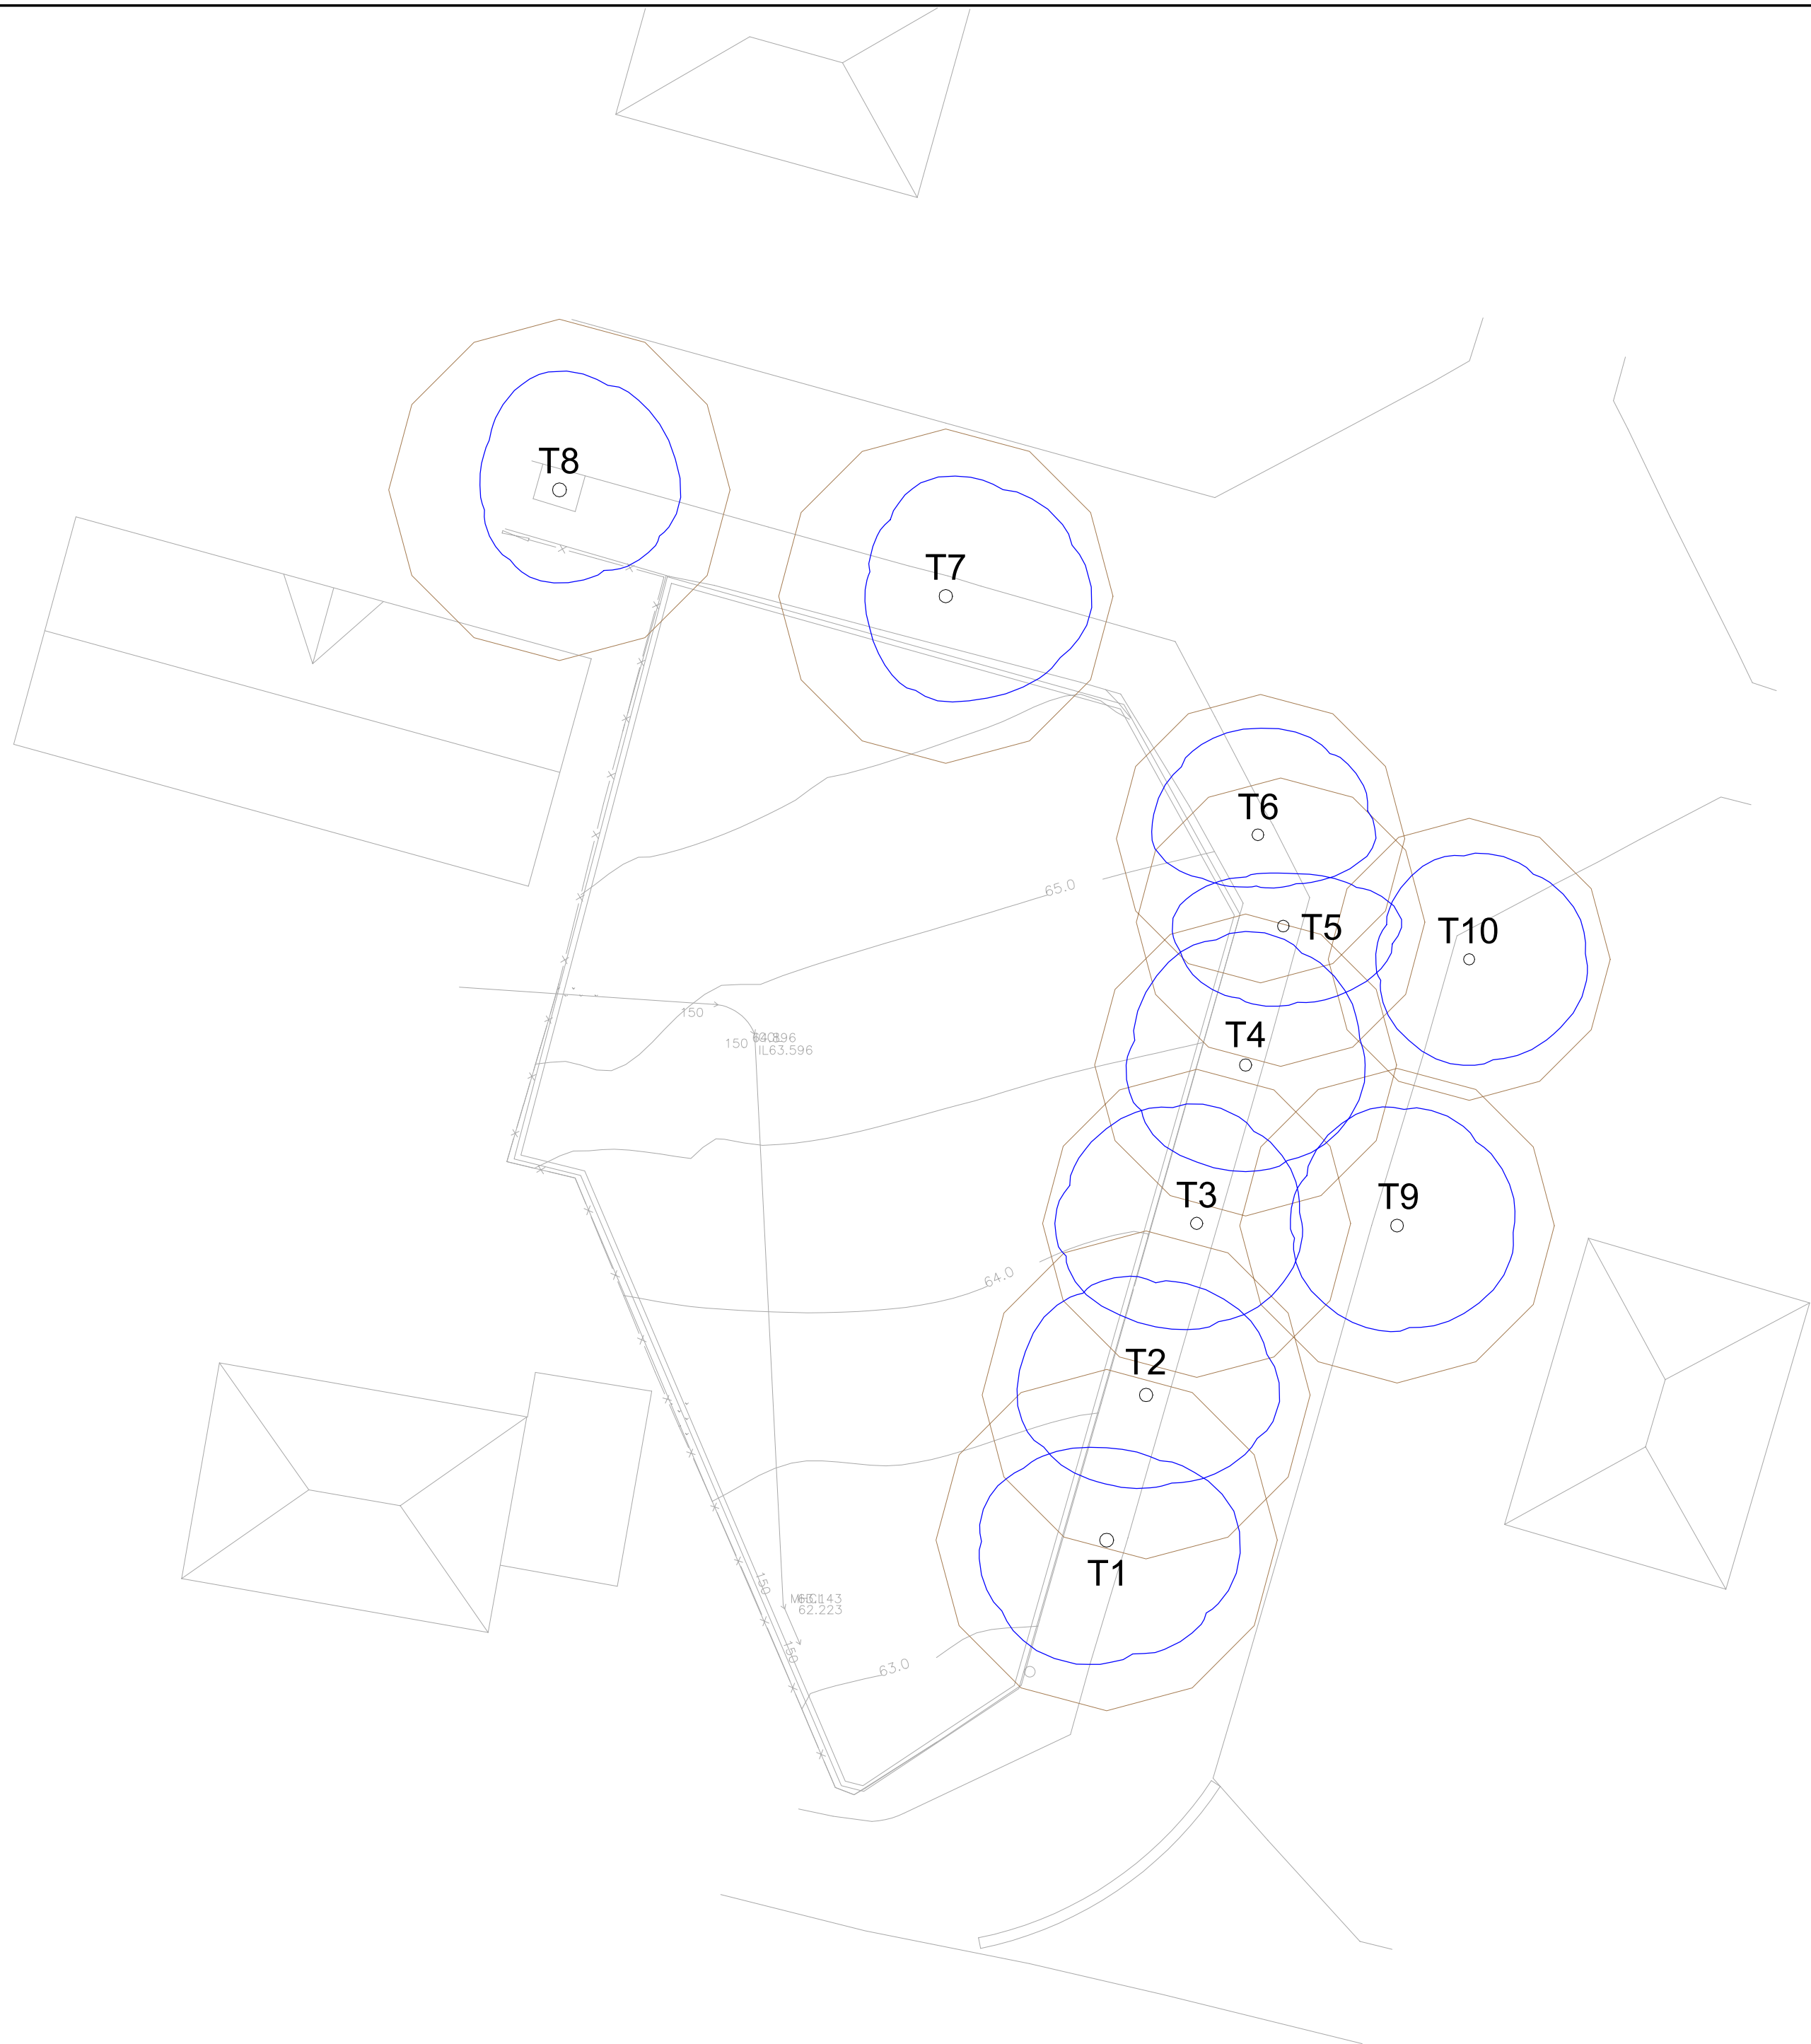
**Appendix 5:**  
**Tree Constraints Plan**  
South Street, Darfield, Barnsley  
Ref: AWA2193/A

- 4.3.1 The tree Root Protection Area (RPA) is detailed on the Tree Constraints Plan at Appendix 5. The RPA for each tree has been plotted as a polygon centred on the base of the stem. Due to the presence of roads, structures, topography and past tree pollard management, the RPA is likely to be a simplified representation of the tree roots actual morphology and disposition.
- 4.3.2 Potentially damaging activities are proposed near retained trees. New hard surfaces are proposed that encroach into the RPA of retained trees T1, T2, T6, T7 and T8. The construction of hard surfaces within the RPA can have negative impacts on tree roots. However, the potential negative impacts can often be overcome or minimised by employing a 'no-dig' type construction methods with a porous final surface.

- 4.4.1 The retained trees will require protection by fencing in accordance with BS 5837: 2012, during the development phase.
- 4.4.2 An associated Arboricultural Method Statement, detailing protective fencing specifications and 'no-dig' construction methods close to the retained trees can be provided.
