# Condition Report

PARKWAY CINEMA, 62-68 ELDON STREET, BARNSELY, SOUTH  
YORKSHIRE S70 2JL

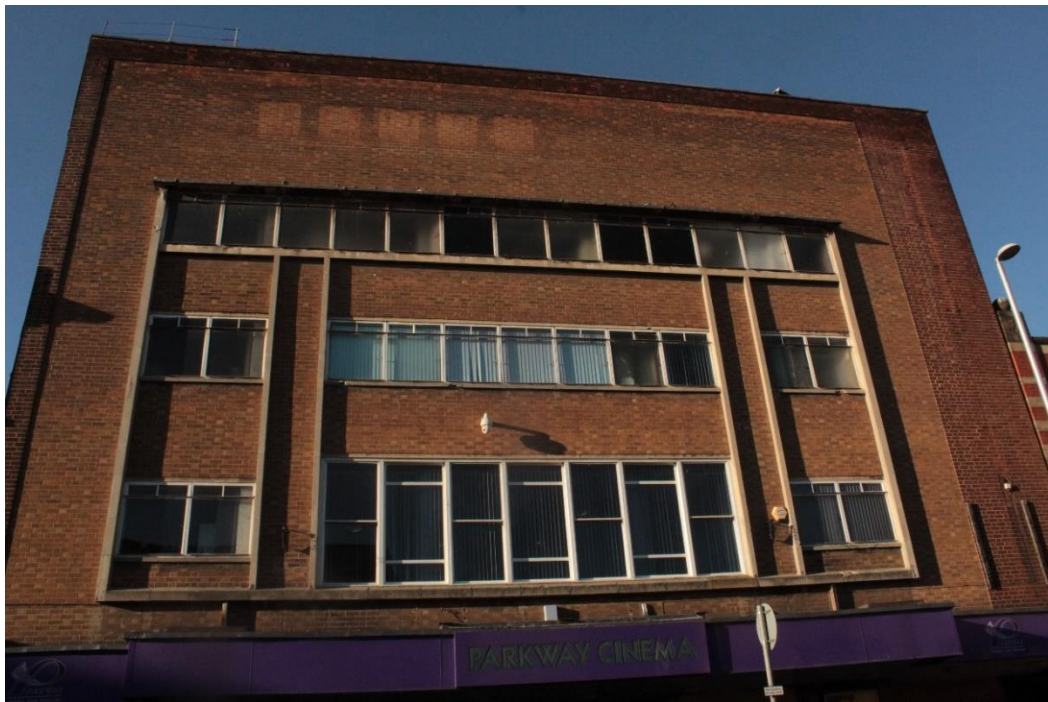
**Fig 02.** The brick and concrete inset panel on the Eldon Street elevation.

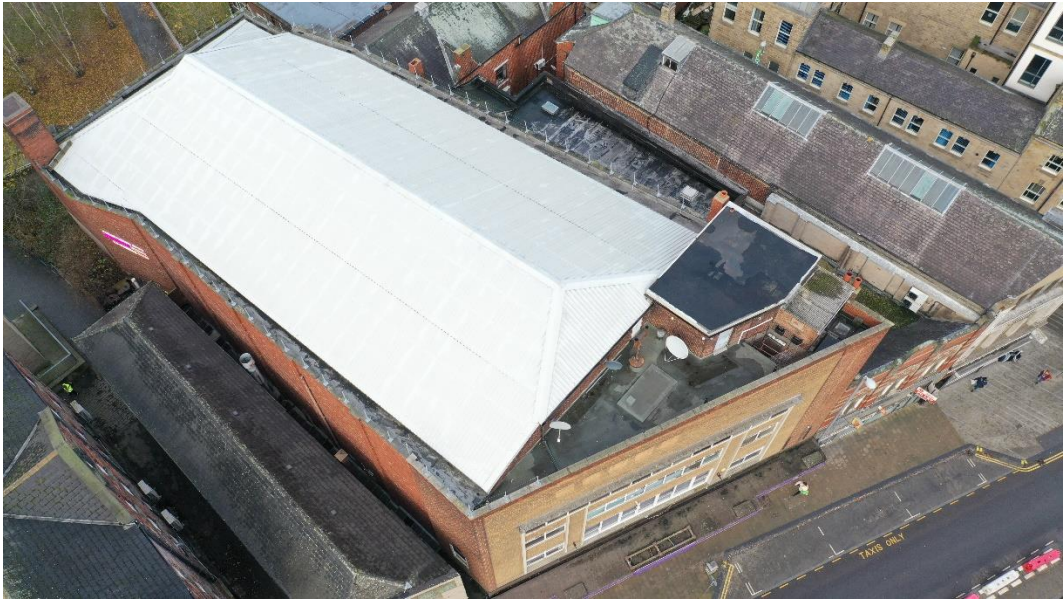
**Fig 03.** The roof of the cinema (taken by drone from the south-east).

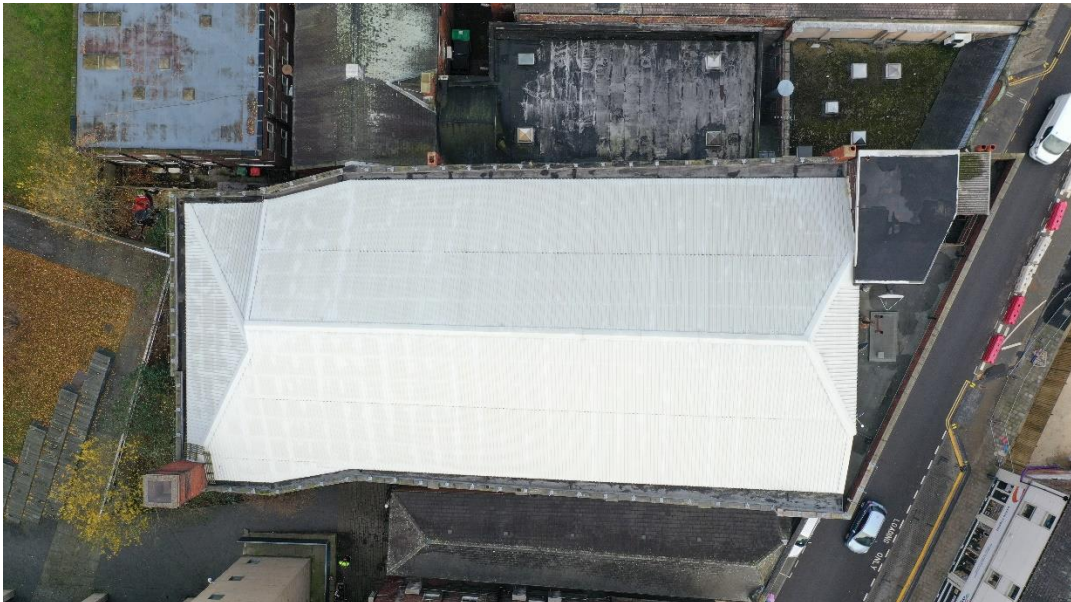
**Fig 04.** The roof of the cinema (taken by drone from above).

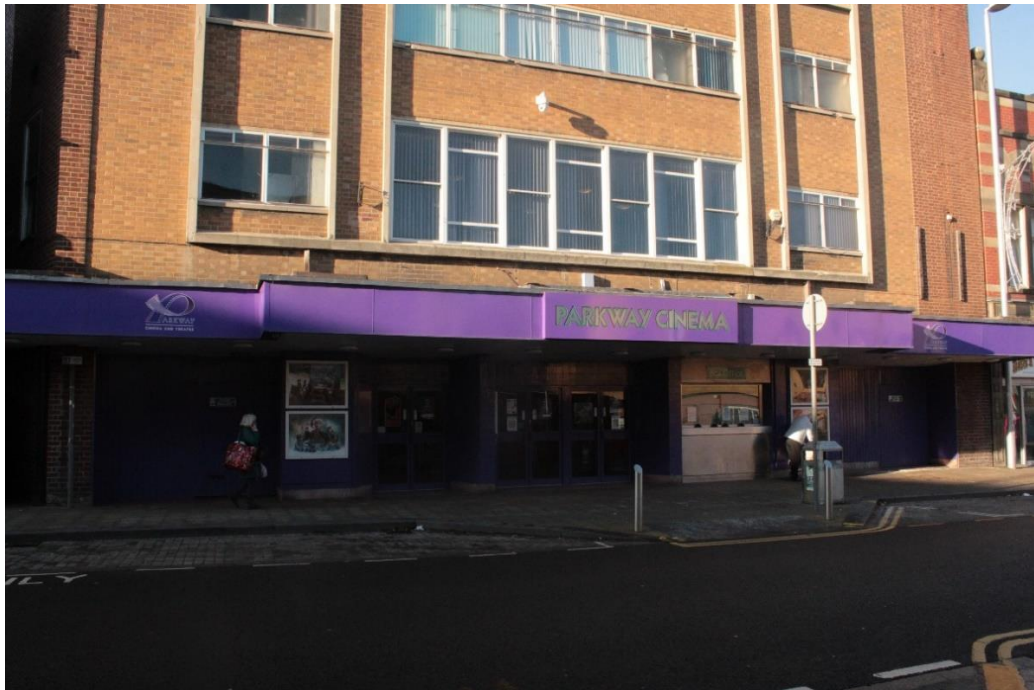
**Fig 05.** The main entrance on Eldon Street (taken from the eastern side of Eldon Street).

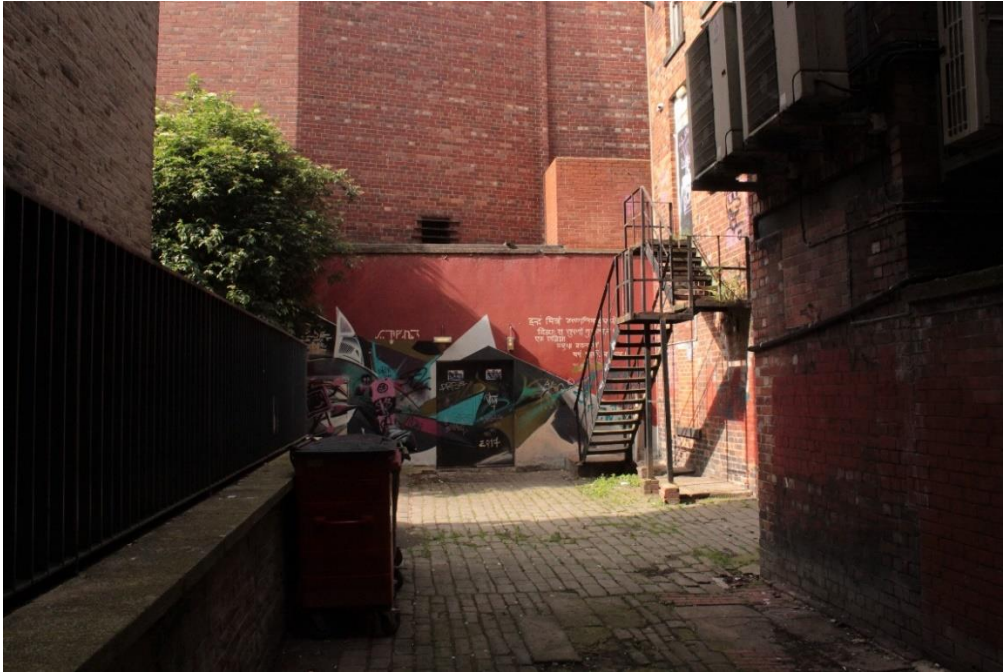
*Fig 07. The double fire escape door opening onto the yard behind Globe Travel and Leslie Francis Hairdressing.*

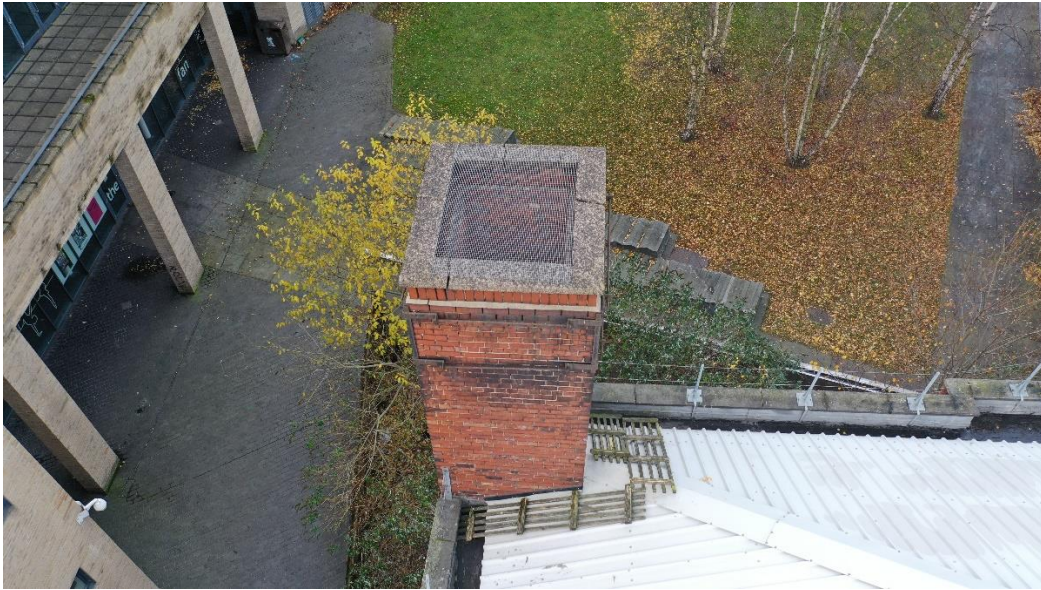
**Fig 08.** The brick chimney at the south-western corner of the cinema which terminates the southern and western parapet gutters.

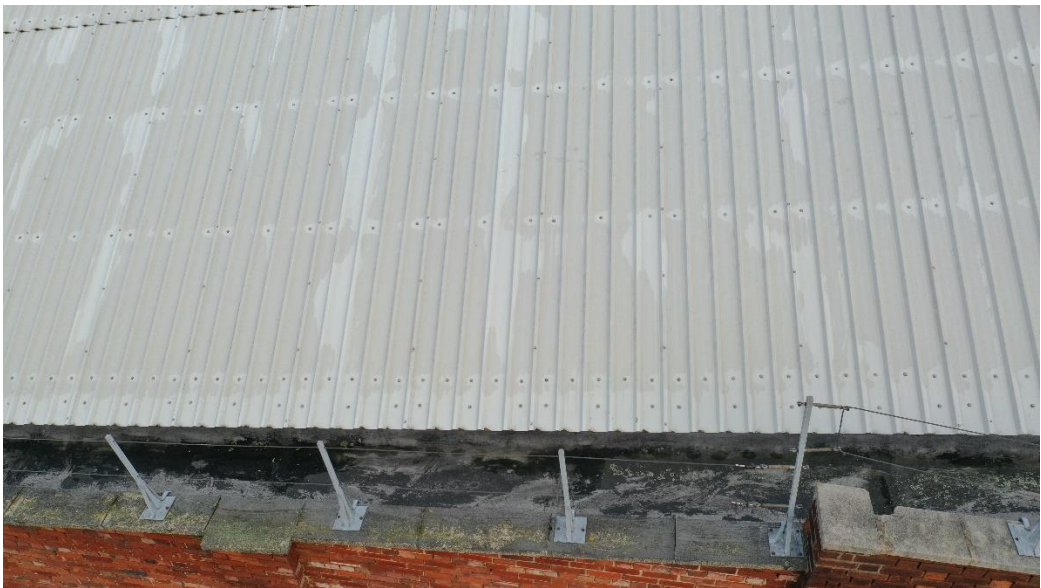
**Fig 09.** There is creep and splitting visible (in the dark area immediately above the projecting coping far left) in the bitumen felt lining the parapet gutter, throughout the gutter length.

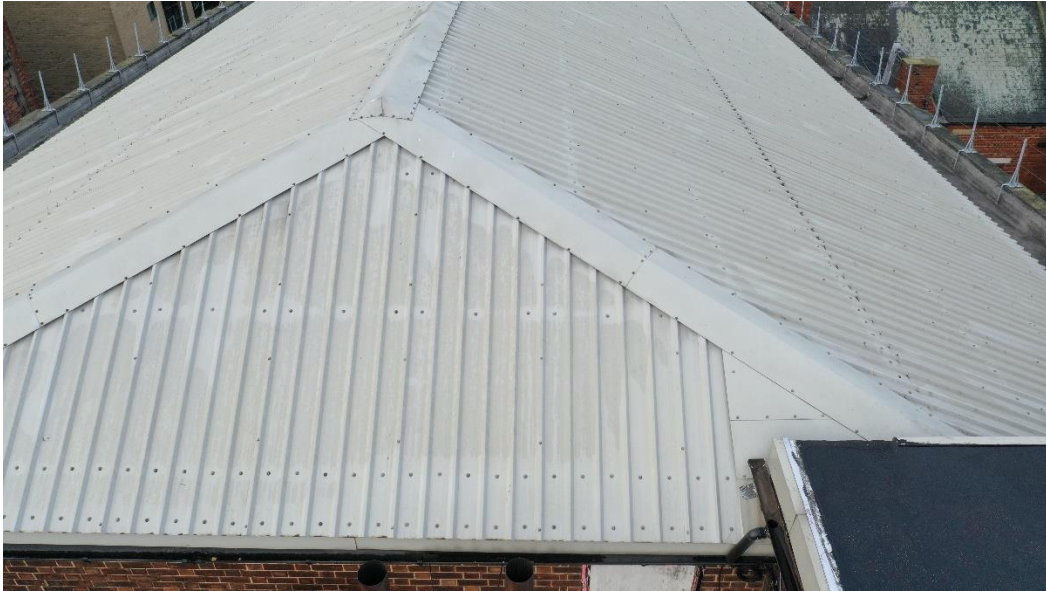
**Fig 10.** The east facing pitch empties into a black plastic gutter and thereby via a black plastic downpipe onto the flat roof above the Eldon Street entrance.

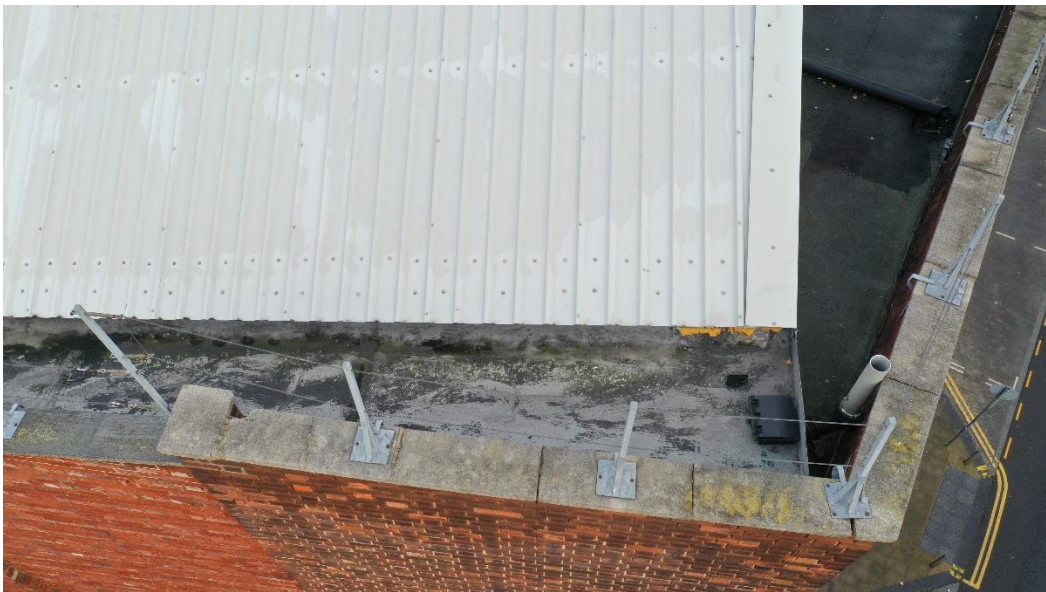
**Fig 11.** The parapet is capped with concrete copings, some of which are cracked/broken and some dislodged.

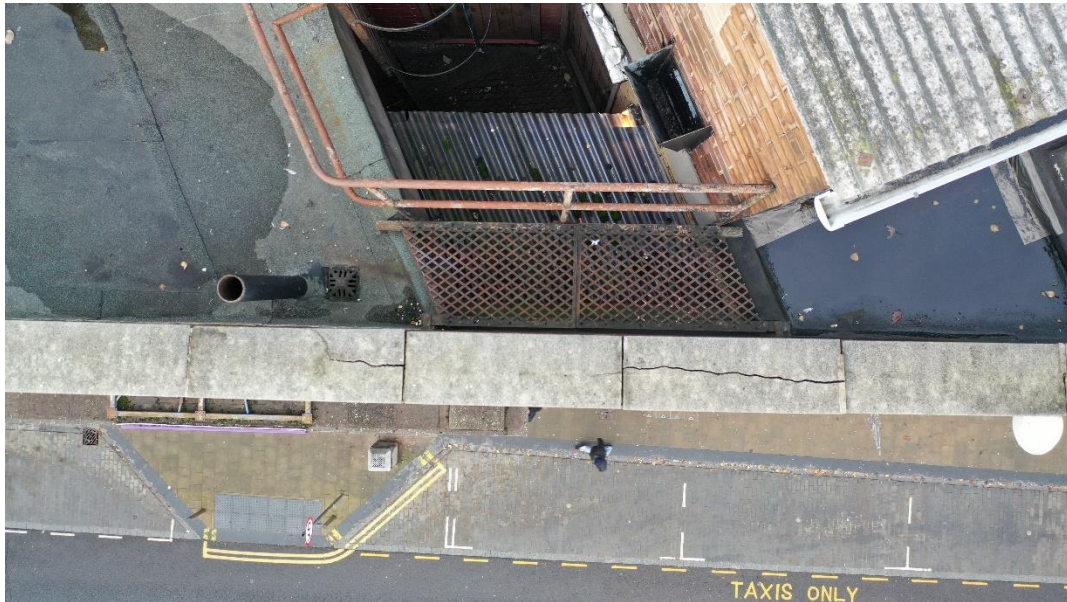
**Fig 12.** Cracked concrete copings along the Eldon Street frontage.

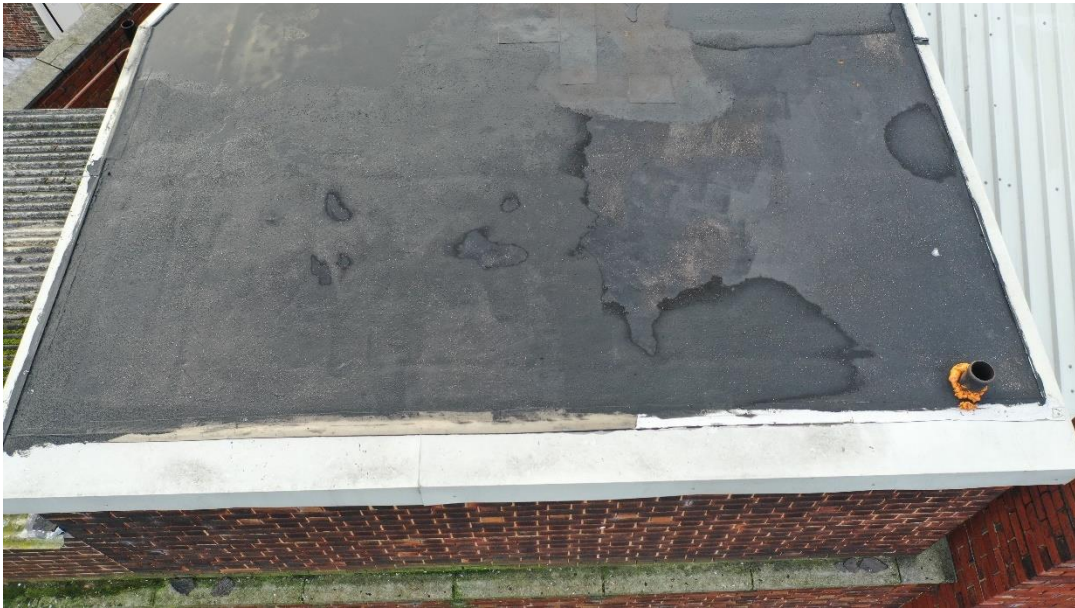
**Fig 13.** The flat roof over the stair enclosure is finished with black bitumen-based roofing felt which has been patch repaired and finished with bitumen paint.

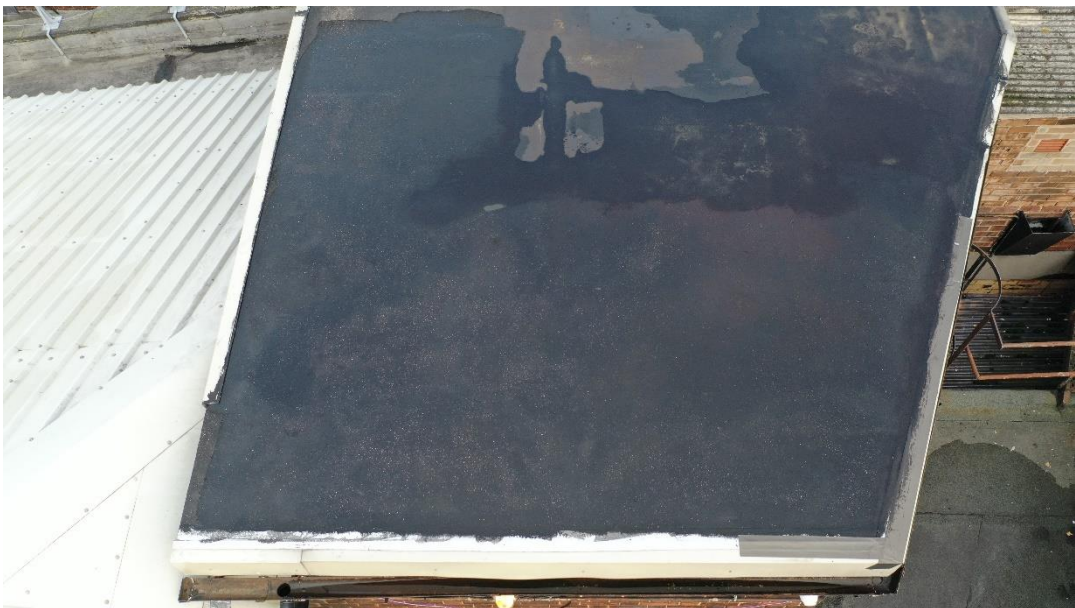
**Fig 14.** Rainwater ponding in the southern gutter of the stair enclosure (bottom of photo).

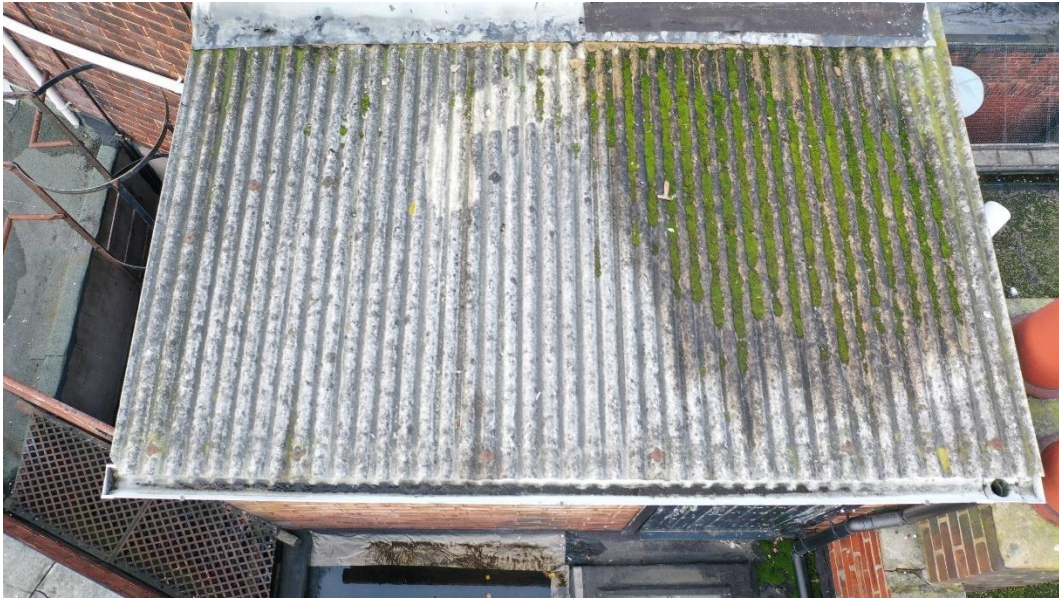
**Fig 15.** The small lean-to structure abutting the eastern (front) elevation of the stair enclosure which is finished with profiled asbestos cement sheeting.

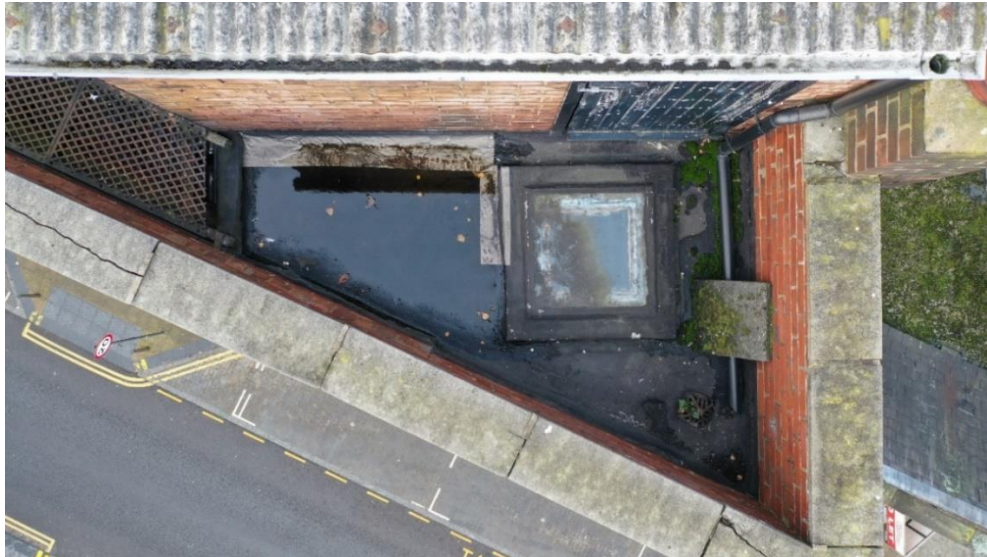
**Fig 16.** The small triangular flat roof in front of the door into the lean-to structure at the north-eastern corner of the roof.

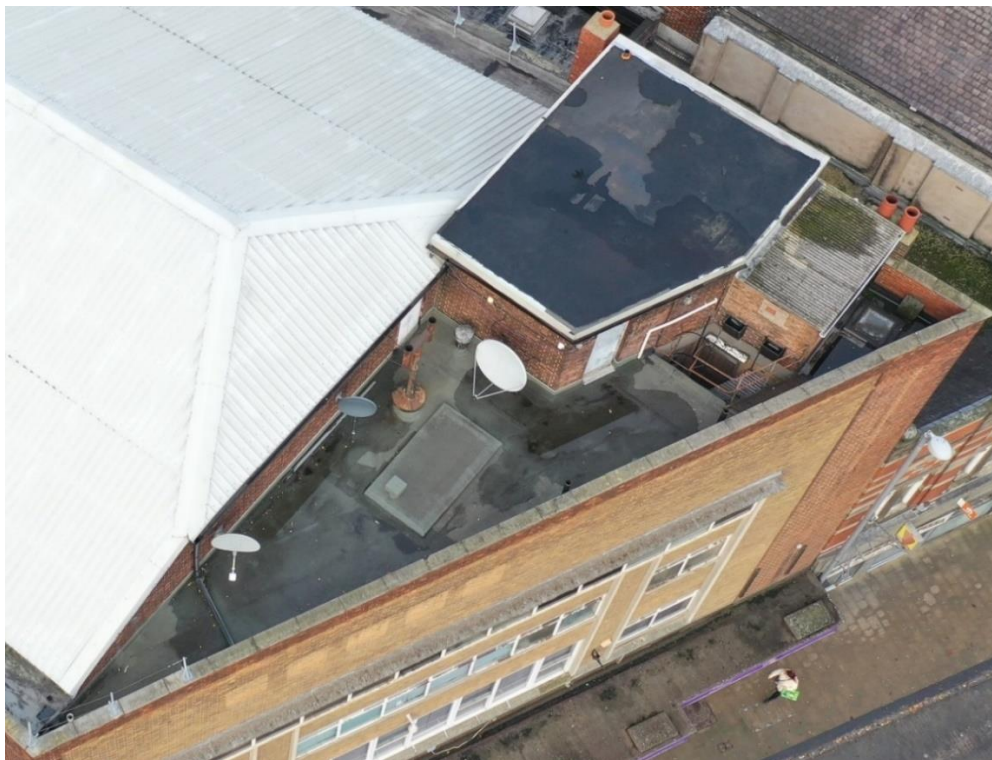
**Fig 17.** The triangular area of flat roof finished with green bitumen-based roofing felt

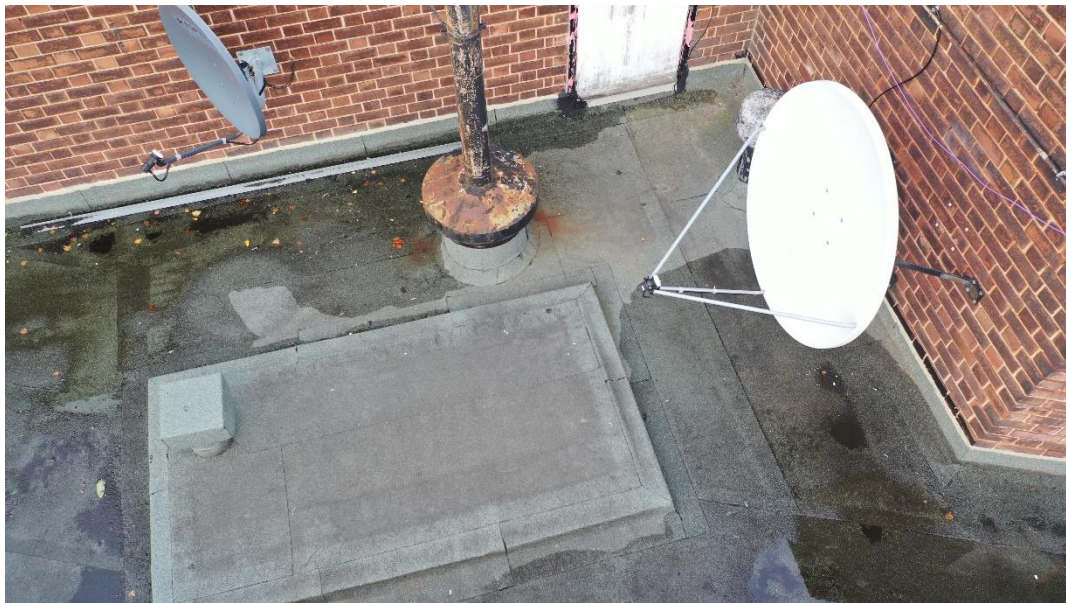
**Fig 18.** The felt has been laid in narrow and short sections increasing the potential of failure and rainwater ingress. The upstand at the abutments is not cover flashed.

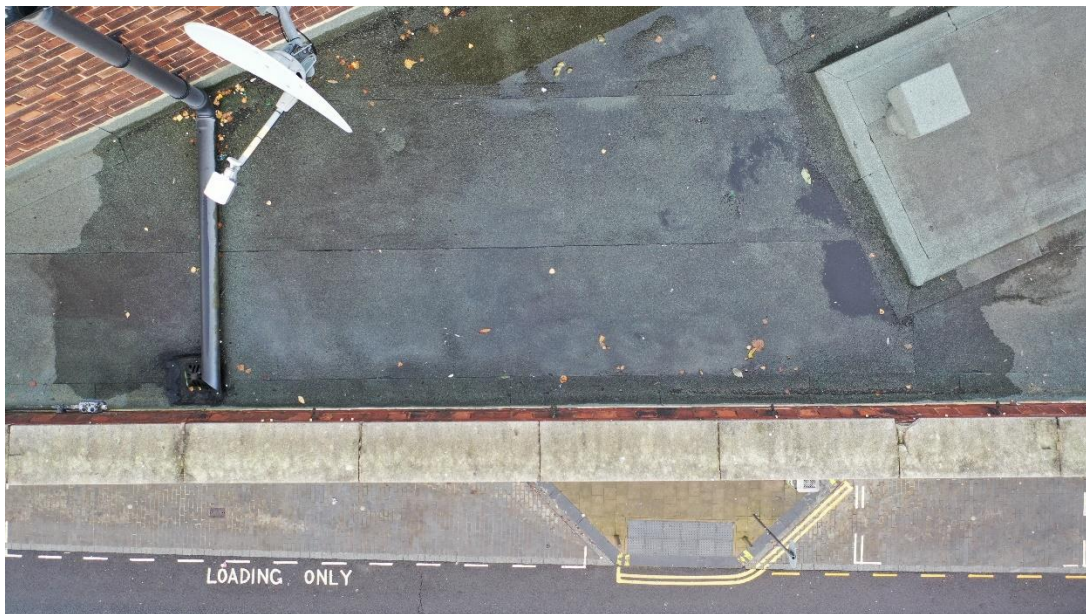
**Fig 19.** The felt has been laid in narrow and short sections increasing the potential of failure and rainwater ingress. The upstand at the abutments is not cover flashed.

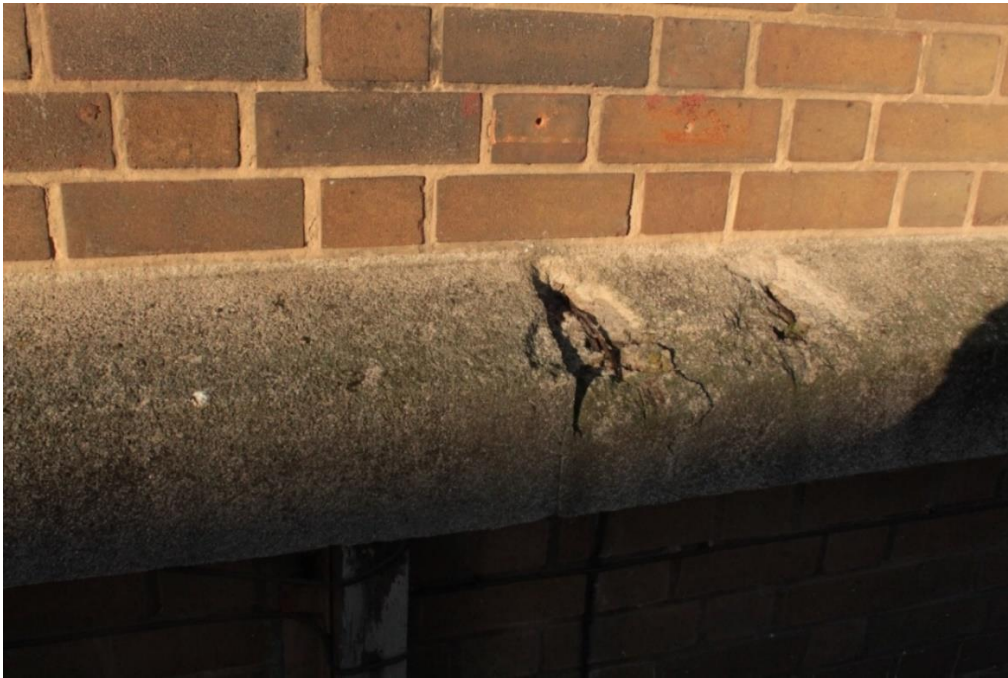
**Fig 20.** Concrete spalling which has exposed the shallow steel reinforcing bars in a number of places along the cill of the concrete 'frame'.

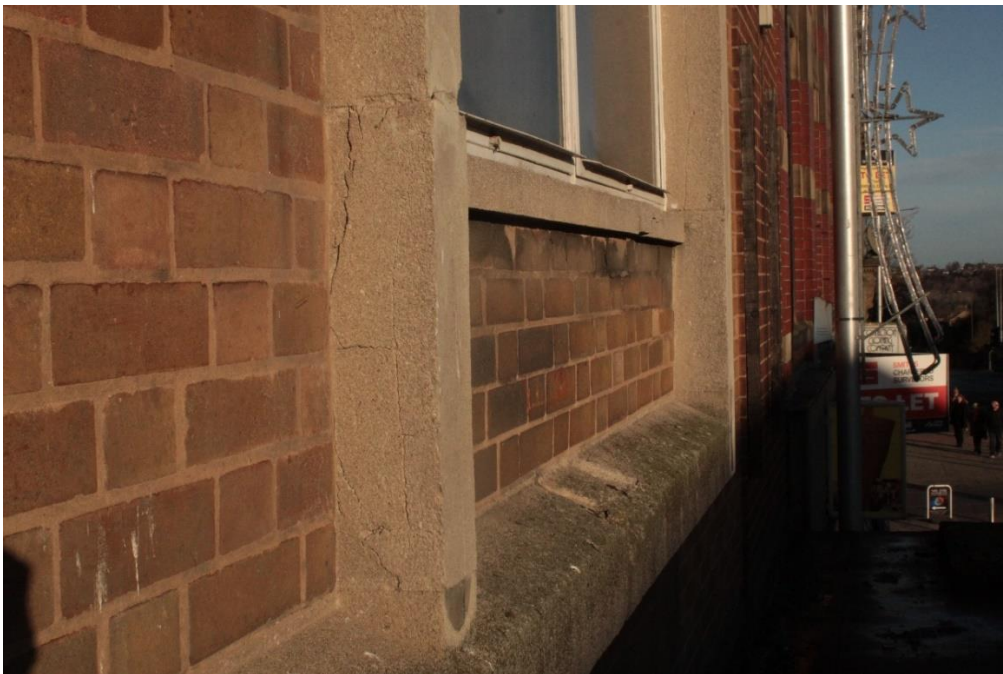
**Fig 21.** Cracks to the first-floor window cill indicating corroded embedded steel reinforcing. Spalling at (and repair of) the joint in the concrete lintel and corresponding hairline cracks up the side of the concrete mullion. Note also, the hairline crack visible in the adjoining vertical section of the concrete 'frame' beyond the window, above cill level.

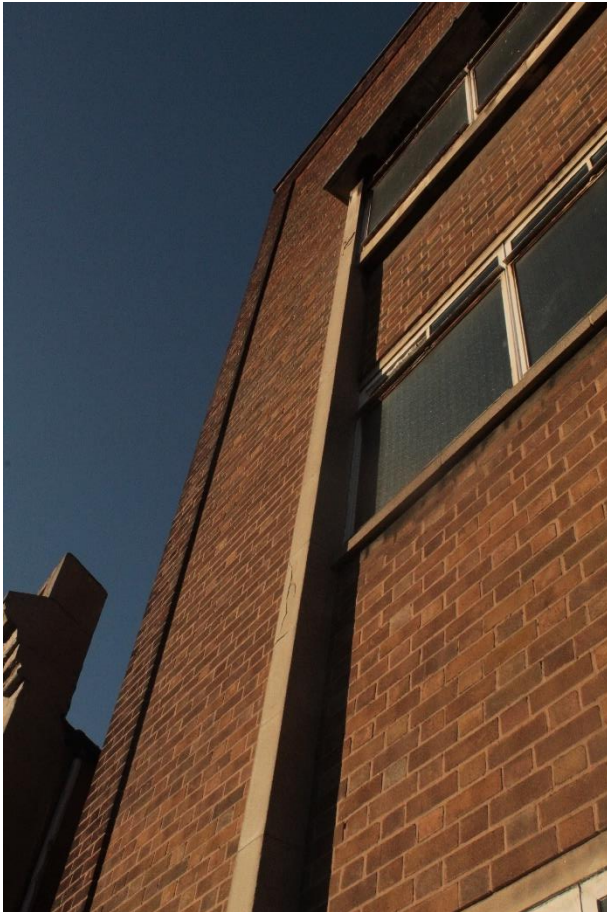
**Fig 22.** Cracks in two locations on the face of the vertical section of the concrete 'frame'. The cracking continues up both sides of the frame in both locations.

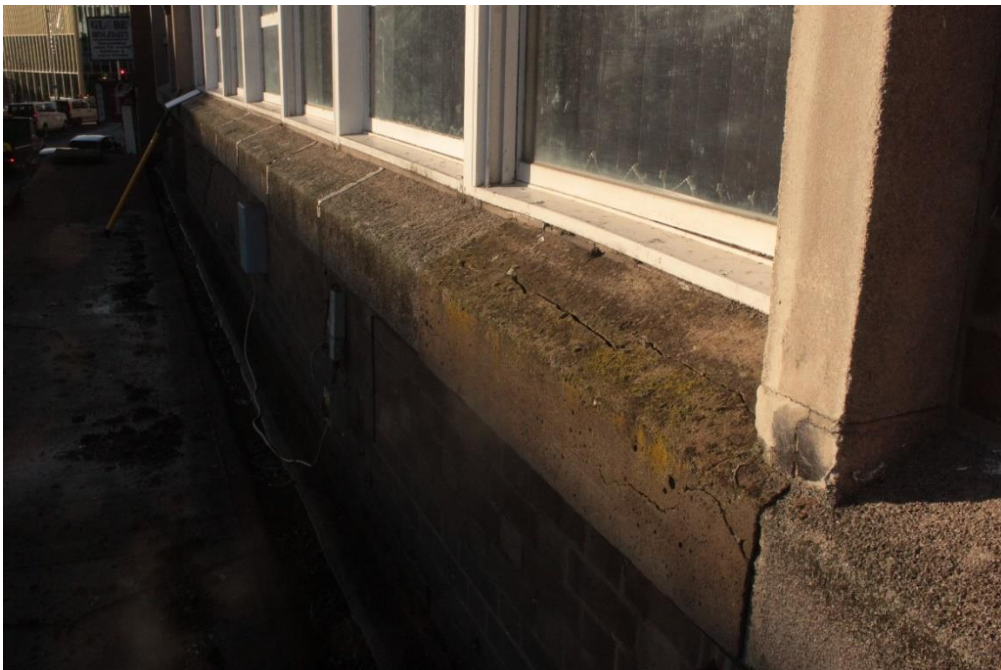
**Fig 23.** Repair of a cill section (poorly executed and now cracking) and spalling at the cill joints which has been temporarily covered with flashband.

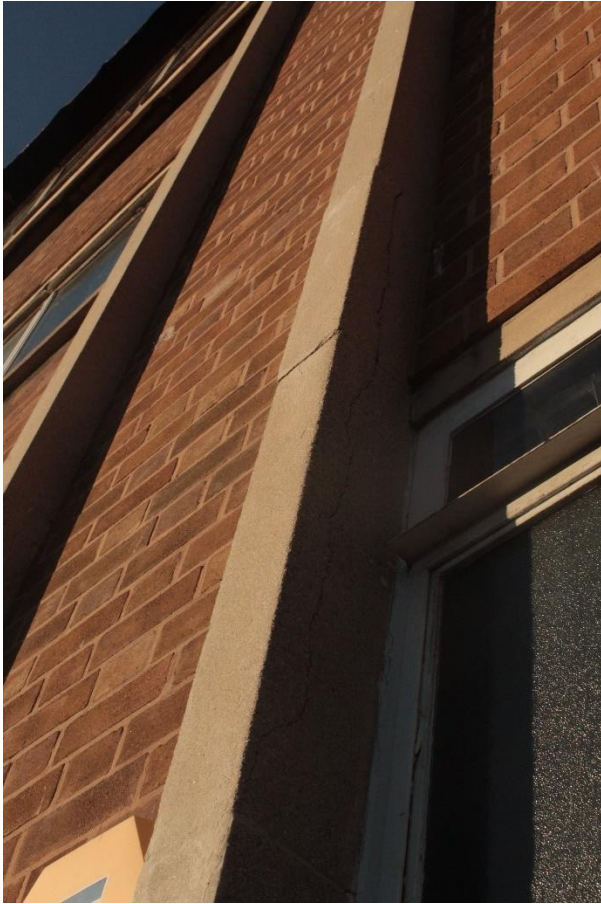
**Fig 24.** Cracks extending up the side of two units forming one of the concrete mullions.

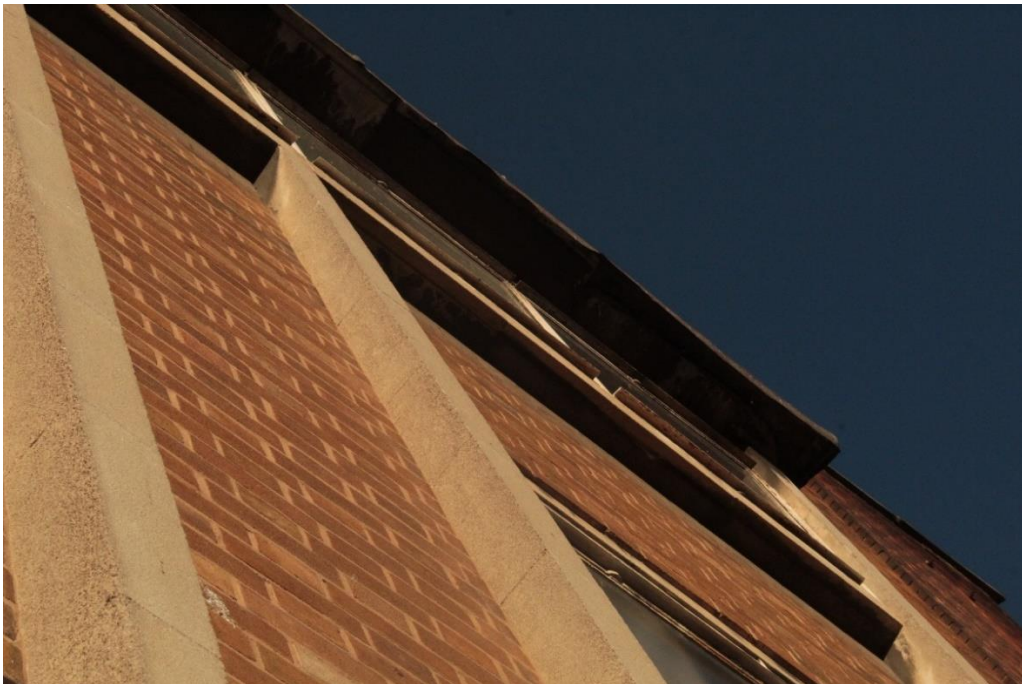
**Fig 25.** Unclear due to the strong sunshine and the deep shadow, but just visible a missing section at the northern end of the projecting concrete 'frame' lintel.

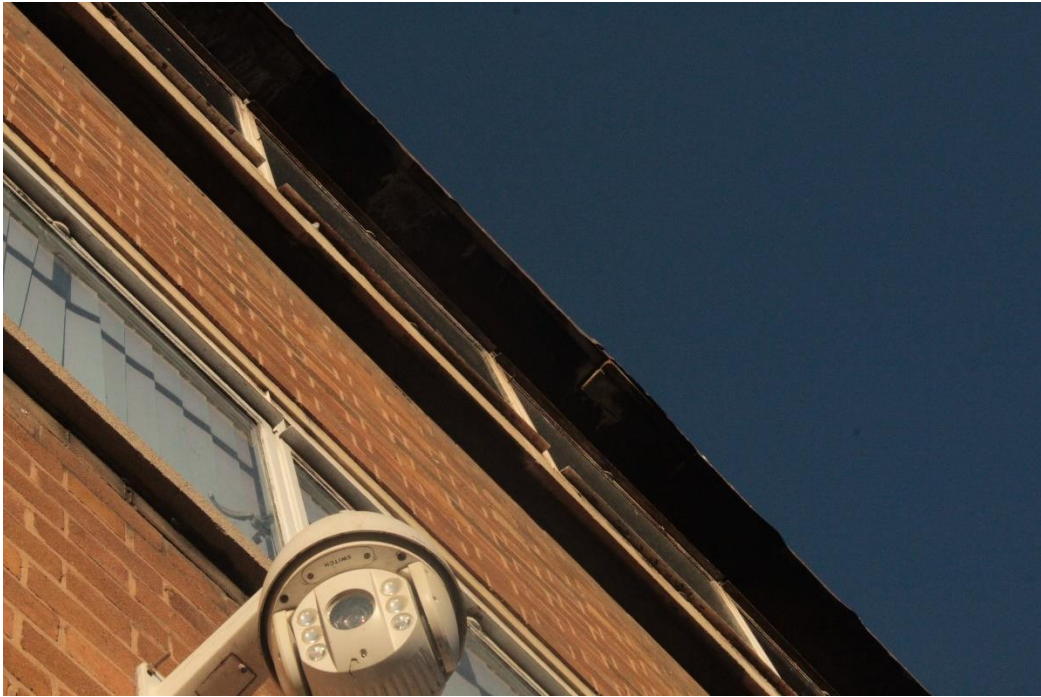
**Fig 26.** Unclear due to the strong sunshine and the deep shadow, but just visible a substantial crack and partially dislodged part of one of the units forming the projecting lintel of the concrete 'frame'.

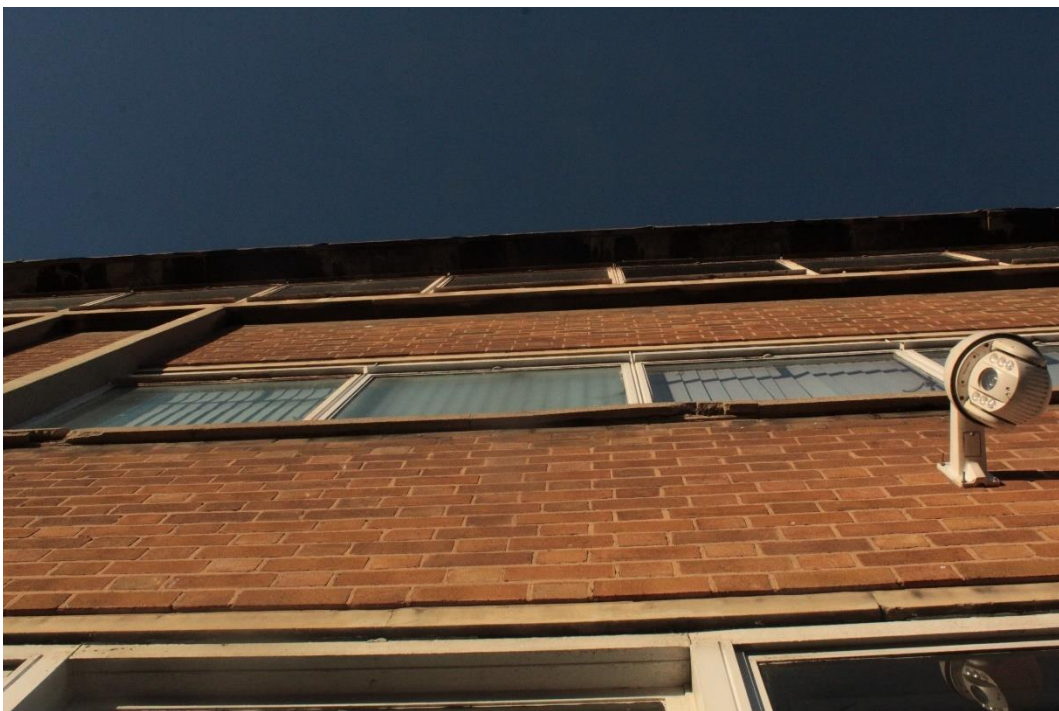
**Fig 27.** Cracking and damage extending almost the full length of one of the second floor window cill units. Far left similar cracking and damage along the same cill.

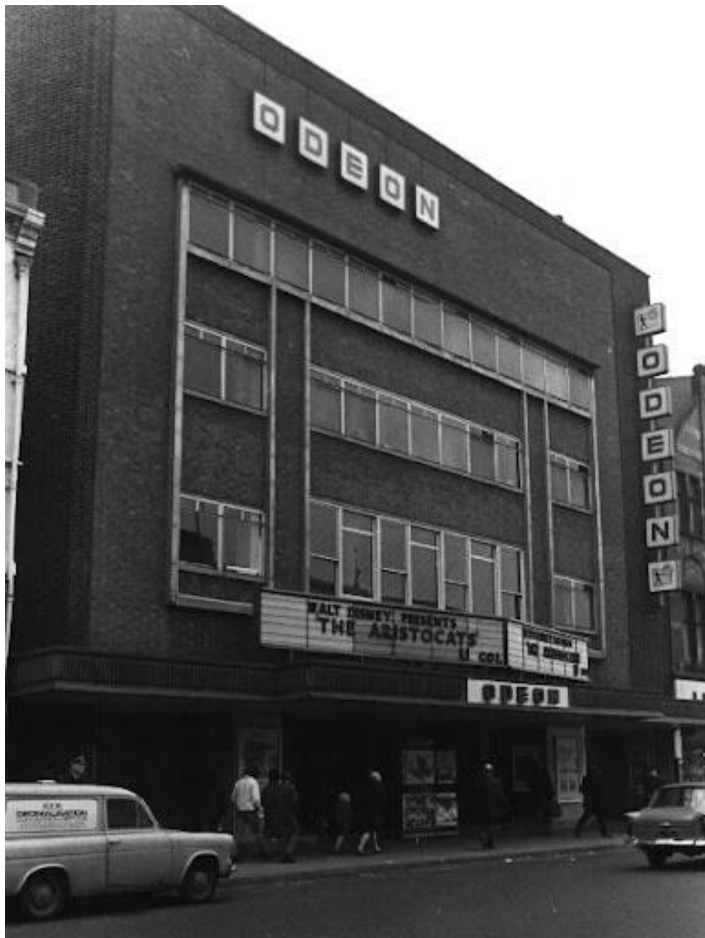
**Fig 28.** The Eldon Street frontage post-1962 when the cinema was renamed ODEON showing the Readograph, the re-used GAUMONT projecting sign and the high level light box signage.
