**Arboricultural Impact Assessment  
Mount Vernon Hospital, Barnsley**

Report reference: AR-3716-01.02  
September 2019  
Revised December 2019

Tree Protection Plan

Dwg. No. DR-3716-01-01

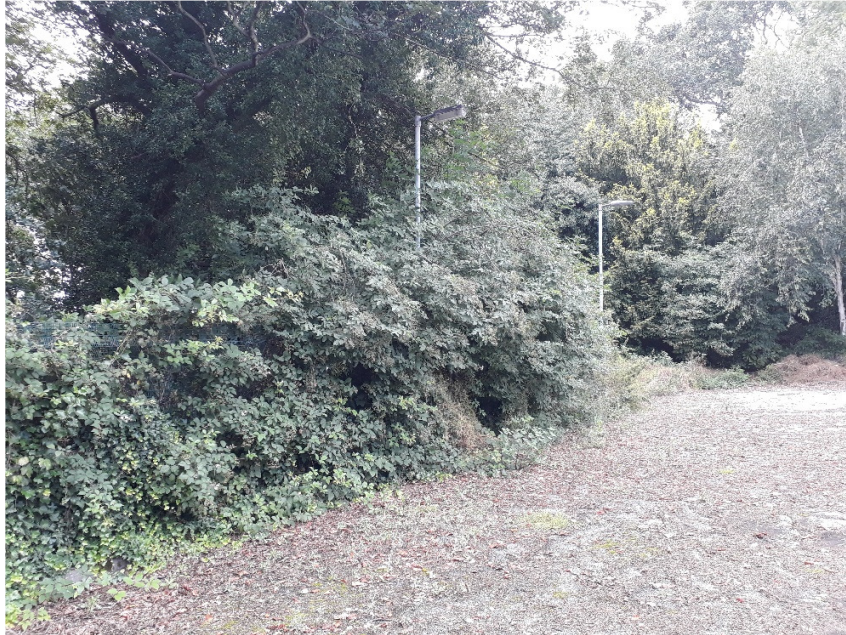
Photograph 1

The lower, south-east corner of the Site where a section of palisade fencing stands between the woodland belt and the car parking area (discernible on the left side of image above the bramble). This fencing could be utilised as a tree barrier protecting the woodland, subject to the location of proposed garden fencing.

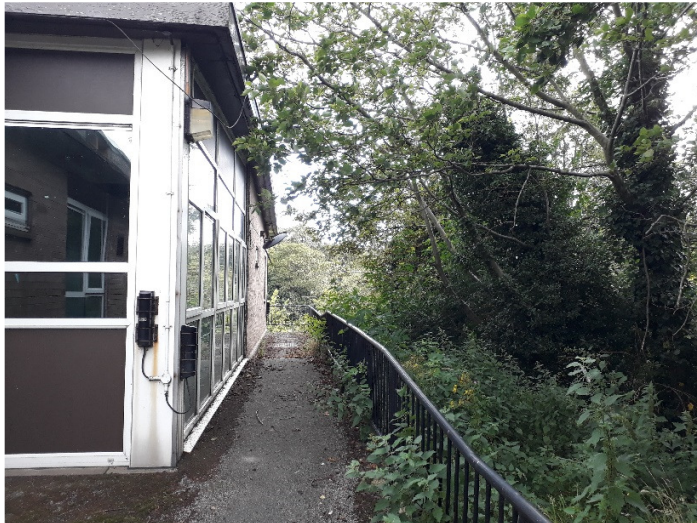
Photograph 2

Looking south-east along the edge of one of the disused hospital buildings on the left and the top of the steep slope with the woodland belt to the right. The tree protection barrier is recommended at the top of this slope, approximately where the railings are now in the centre of the image.

5. The top of the steep slope along the woodland belt is recommended as a location for extending the tree protection fencing along the belt.
6. All-weather notices should be attached to the barrier with words such as: "Construction exclusion zone – no access".

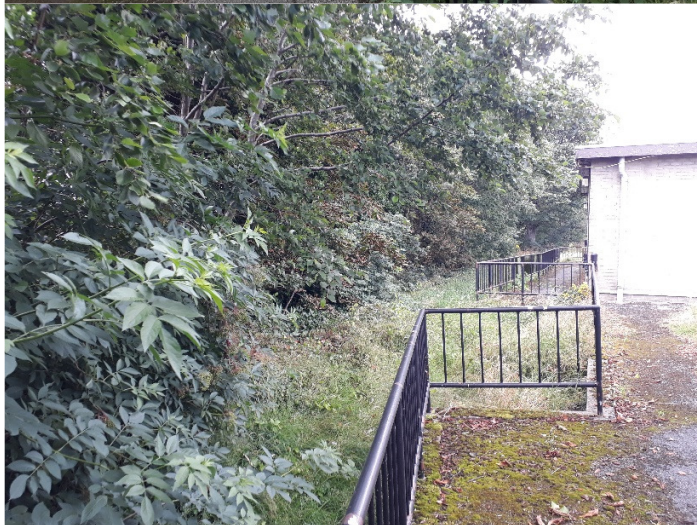
Photograph 3

Looking north-west along the edge of one of the disused hospital buildings on the right and the top of the steep slope with the woodland belt to the left. The tree protection barrier is recommended at the top of this slope, approximately where the railings are now in the centre of the image.

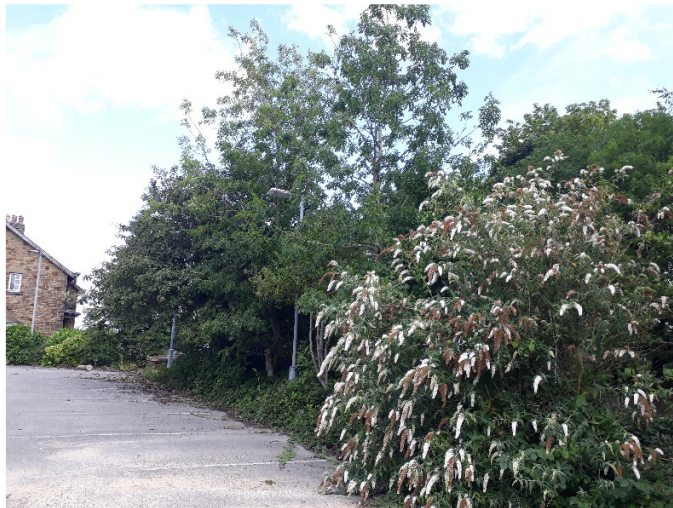
Photograph 4

Looking north-east along the Mount Vernon Road side of the Site to tree 1924 Swedish whitebeam (left hand side) and group G6 are expected to be retained within the development.

11. It is recommended that tree protection fencing is erected to protect these trees from damage during the demolition works.
12. Where existing road paving is uplifted for the plots affecting tree 1924, Group 6 and the woodland, it is recommended that the paving remains in situ during the construction works to provide some ground protection for the root protection areas, then removed with the use hand tools only.

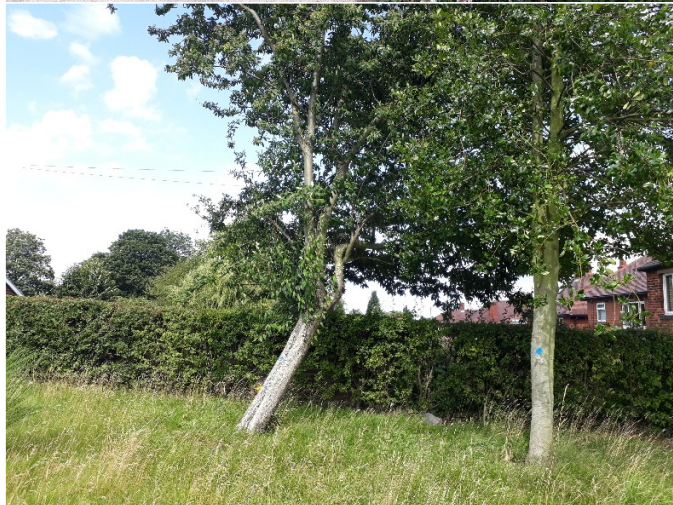
Photograph 5

Looking north to small trees Cotoneaster 1961 and holly 1990 which have been removed for the development after the bird nesting season 2019.
