# ARBORICULTURAL REPORT

To BS 5837:2012 at:

***Stonewell House  
Sheffield Road  
Birdwell  
Barnsley  
S70 5RB***

Reference: AWA2597

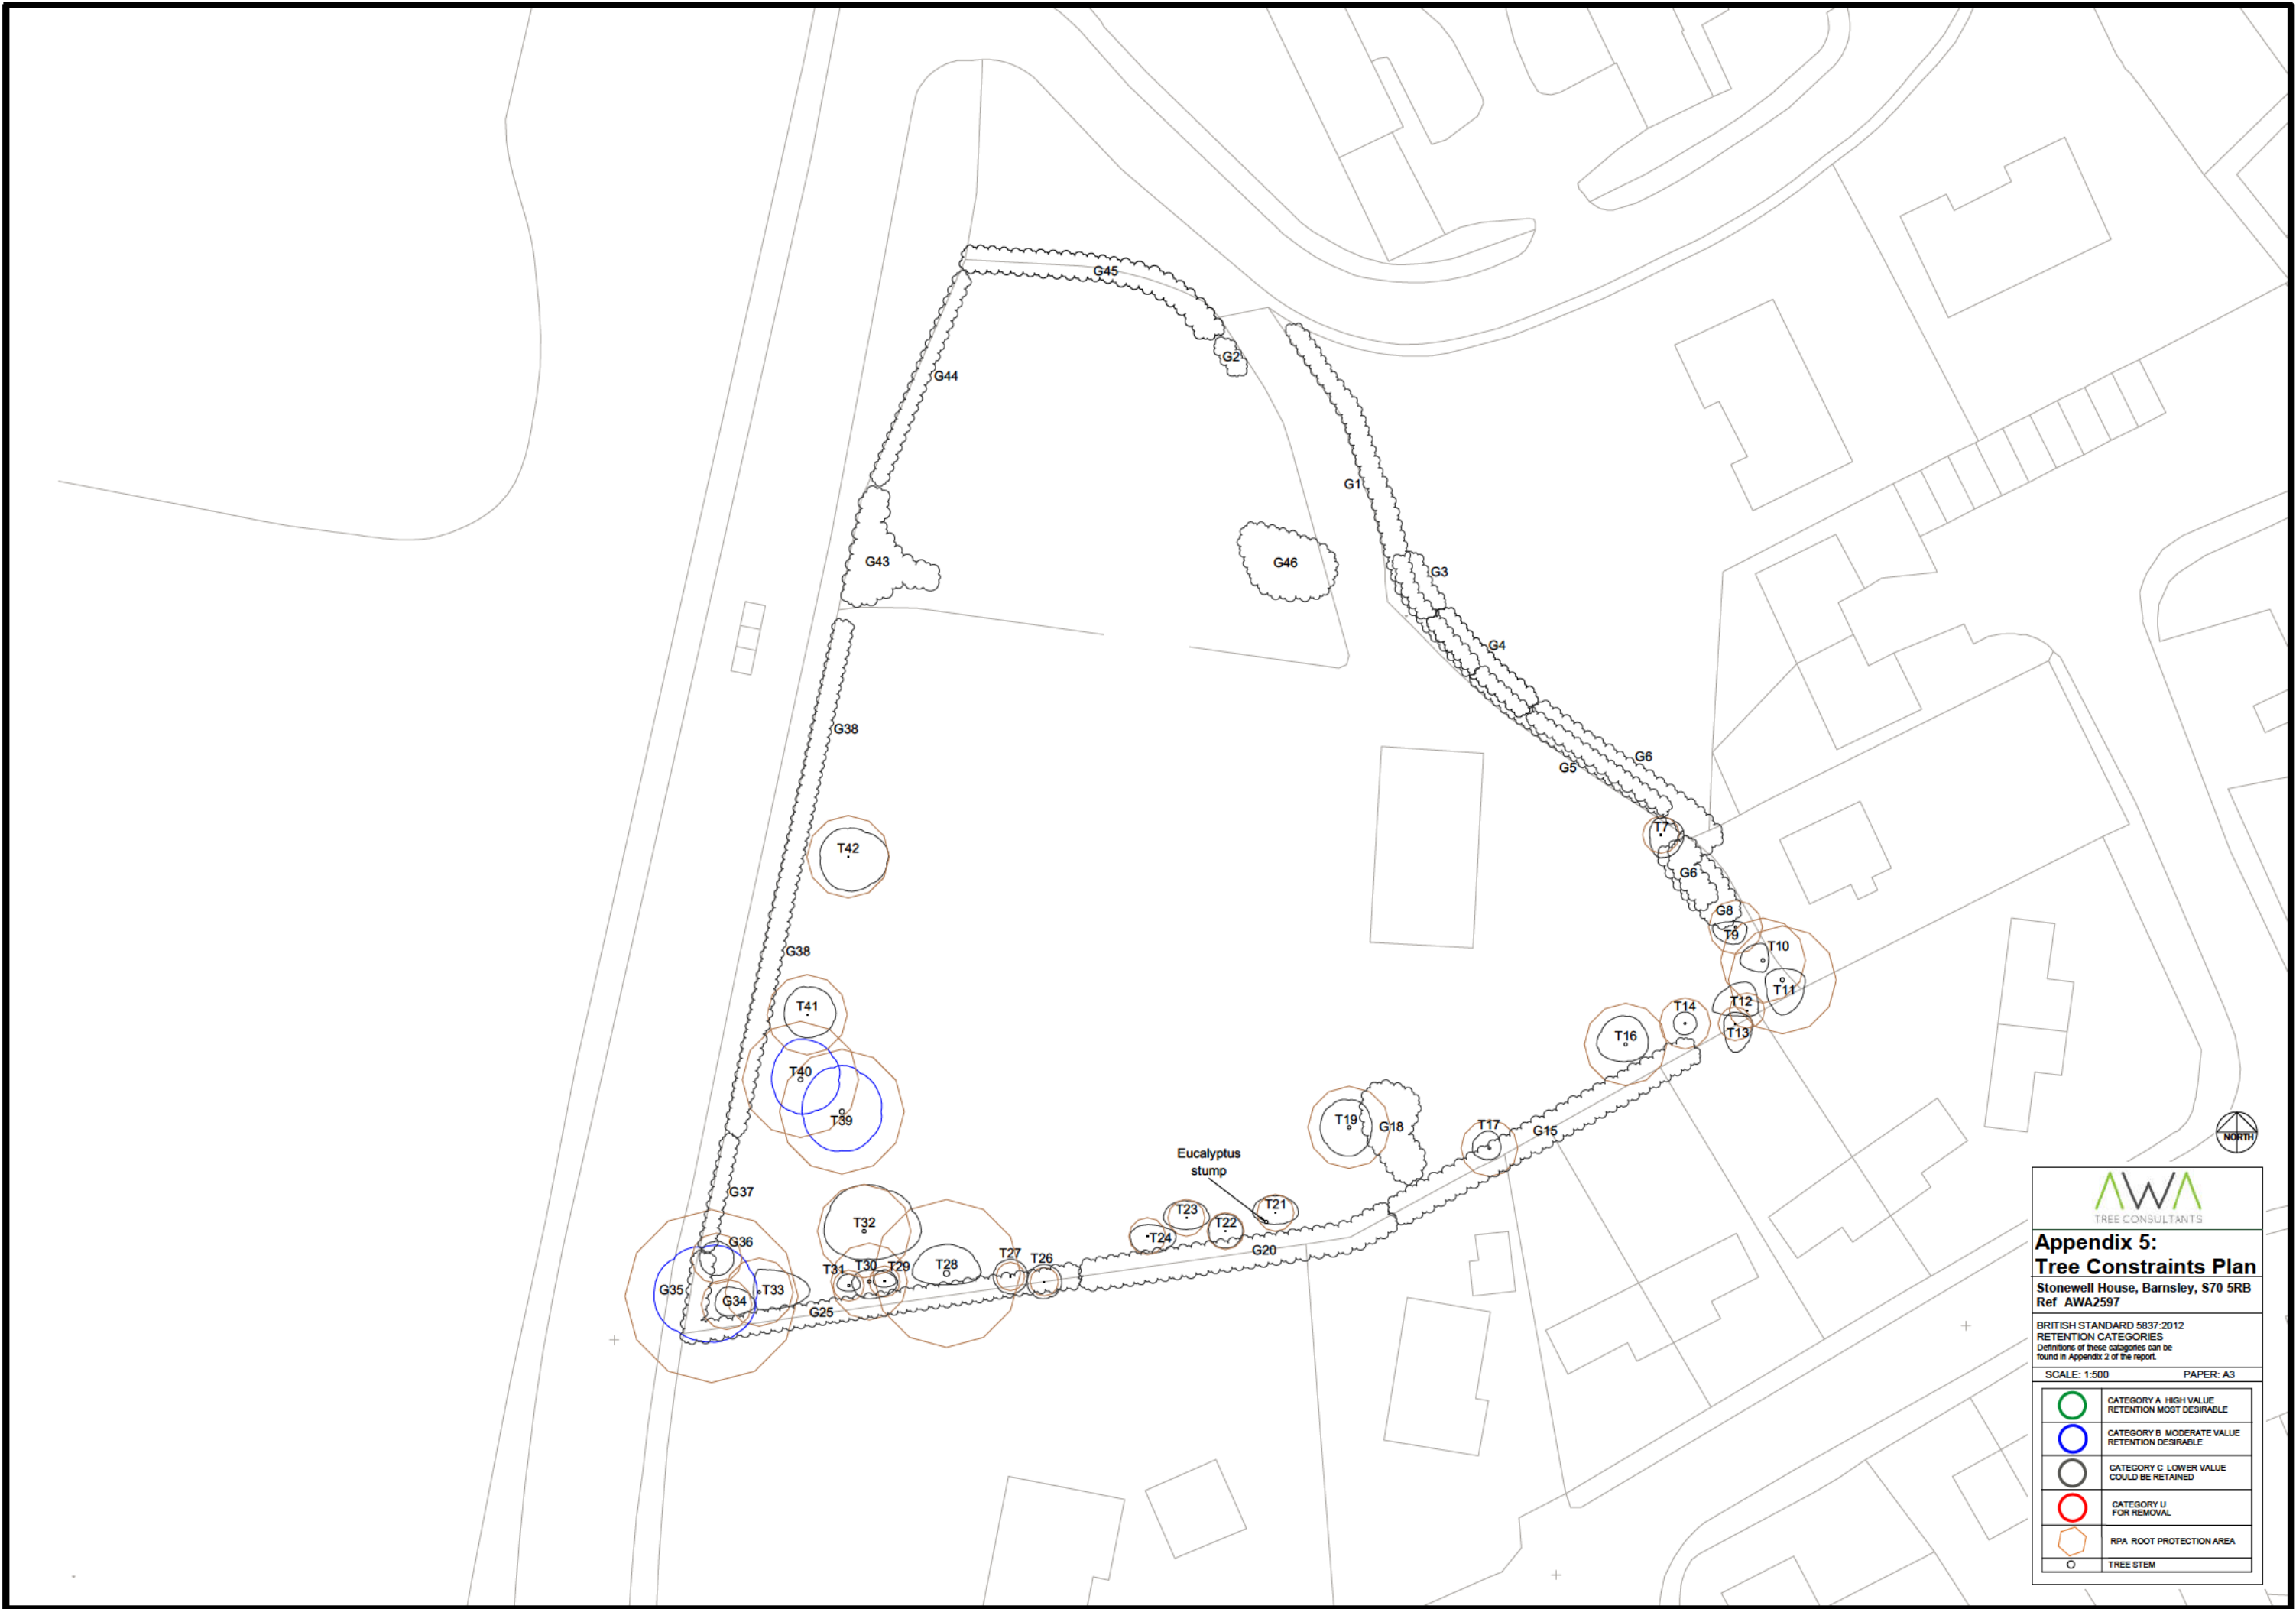
| <b>Appendix 5: Tree Constraints Plan .....</b> | <b>14</b> |

- 3.2.6 The sites most significant trees are the Ash within G35 at the south west corner of the site. These trees are prominent throughout most of the site and surrounding area, providing a good level of collective amenity value.

- 3.2.7 The two Poplar trees, T39 and T40, are located close to the south west of the site. Both trees provide some moderate amenity value and are situated in a prominent position close to the roadside. Poplar trees are a relatively fast-growing and short-lived species, and so these trees may be unsuitable for retention in the longer term.

- 3.2.8 The site is surrounded by many boundary hedges of various species (G1, G3, G4, G5, G6, G15, G20, G25, G37, G38, G44, G45). These groups are of relatively low value; however, they provide comprehensive screening between the site and surrounding areas.
