**Tree Survey: Former Pheasant Inn site, 88-90 High Street,  
Dodworth, Barnsley.**

**Client: Eldwick Estates Limited.**

**Date of Survey: May 12<sup>th</sup> 2015.**

**File reference: Pheasant Inn 01**

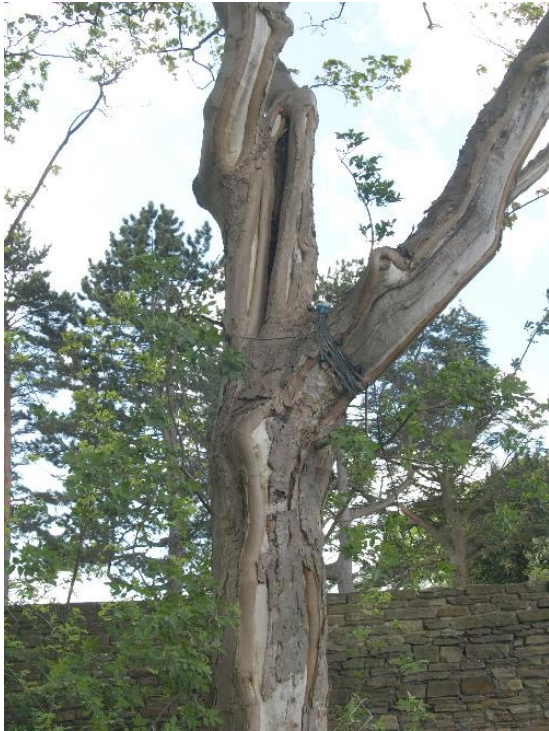
Photograph 1.

| Tree No. | Species. | Ht | TD | Age class | Category | Comments. | RPA |
|---|---|---|---|---|---|---|---|
| 8. | Sycamore | 14 | 610 | M | U | Severely damaged and dying back, has clearly been abused over many years. | 0 |

Photograph 1 shows tree 8, it has clearly been in poor condition for some time. While the TPO might be a very old one if it was a recent imposition it should have excluded this tree. Photograph 2 shows a wire for a floodlight fastened around the branch.

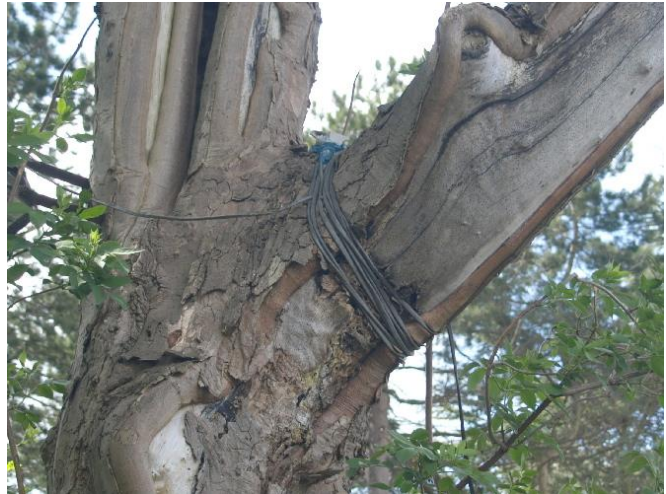
Photograph 2

This may sound somewhat far-fetched but the damage here is almost certainly caused by a bonfire. Bark lost in this way is a common sight where a fire has scorched a tree.

Once the bark has been killed it eventually drops off leaving the heartwood exposed, which leaves an increased risk of infection. In photographs 1 & 2 there are examples of the heartwood having been decayed away presumably it was infected with a decay-organism, while elsewhere the heartwood still seems solid. Exposed heartwood clearly does not always become infected with anything, but the bark that would ordinarily protect the heartwood is missing so the tree is at risk.

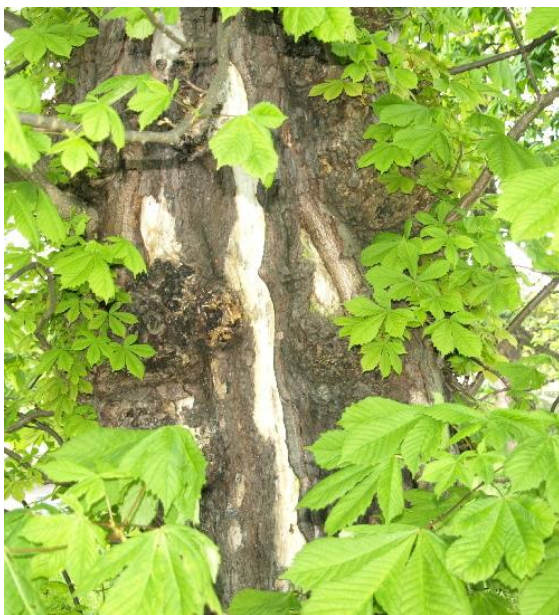
Photograph 3.

The same fire also scorched the nearby Horse Chestnut, tree 9, although that tree does not seem to have suffered quite as badly as the Sycamore. Photograph 3 shows the damage albeit partially hidden by foliage.

Tree 9 has also had a floodlight fastened to it.

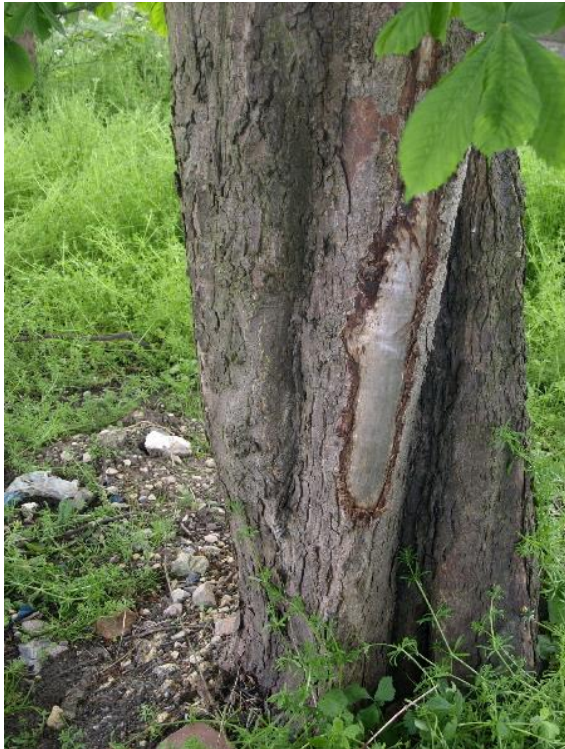
Photograph 4.

Photograph 4 shows the base of Horse Chestnut tree 11. This has suffered bark damage more recently; I imagine that the machinery that demolished the building caused it, probably while levelling the ground around the tree.

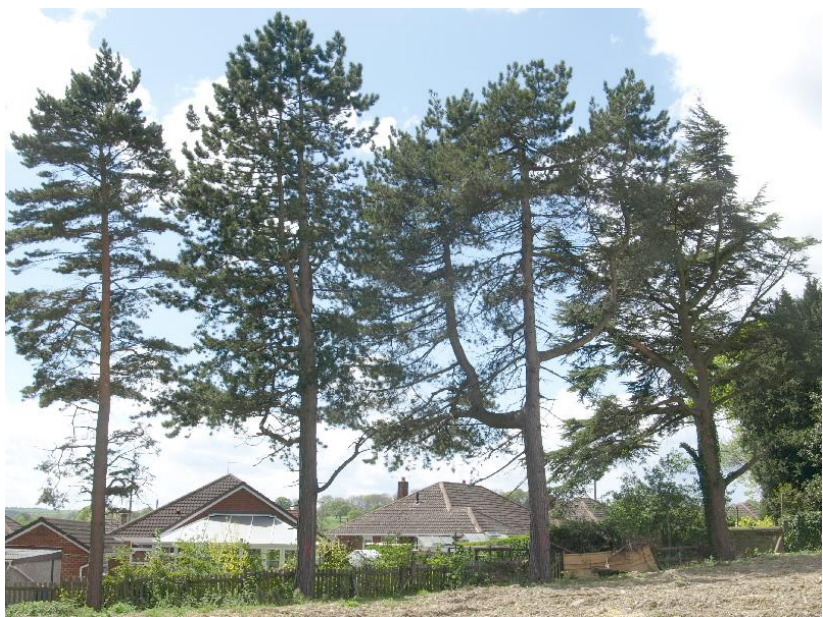
Photograph 5.

Photograph 5 is a view of trees 3 to 6. Tree 3 is at the right. Note also the way these trees tower over the houses to the rear fortunately they are to the north of the houses, so shade (there) is not a major consideration. They will be to the south of the proposed buildings so shade may well be more of a problem there. That said none of the trees are particularly densely foliated.

It is obvious that the ground has been disturbed at the base of these trees. While trees 3 to 6 appear reasonable specimens I noted that tree 3, the Deodar (a species of Cedar) has suffered some damage in the upper crown. Unfortunately Deodars of this age are somewhat prone to damage caused by snow; being evergreen they manage to catch more snow than might be anticipated and as a result branches are ripped off by the weight.

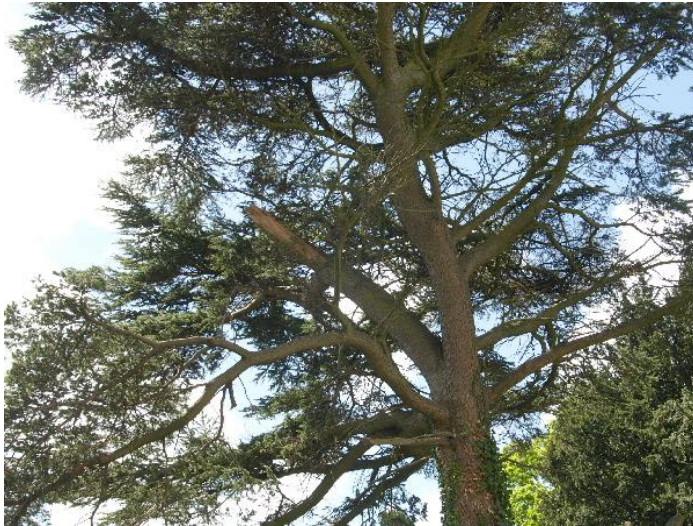
Photograph 6.

Photograph 6 is a view of the crown of tree 3 showing a large broken branch. This is almost certainly damage caused by snow, which is very common in Cedars.

Ideally this tree would be climbed and the damage pruned out in an attempt to leave a tidier, more aesthetically pleasing tree.

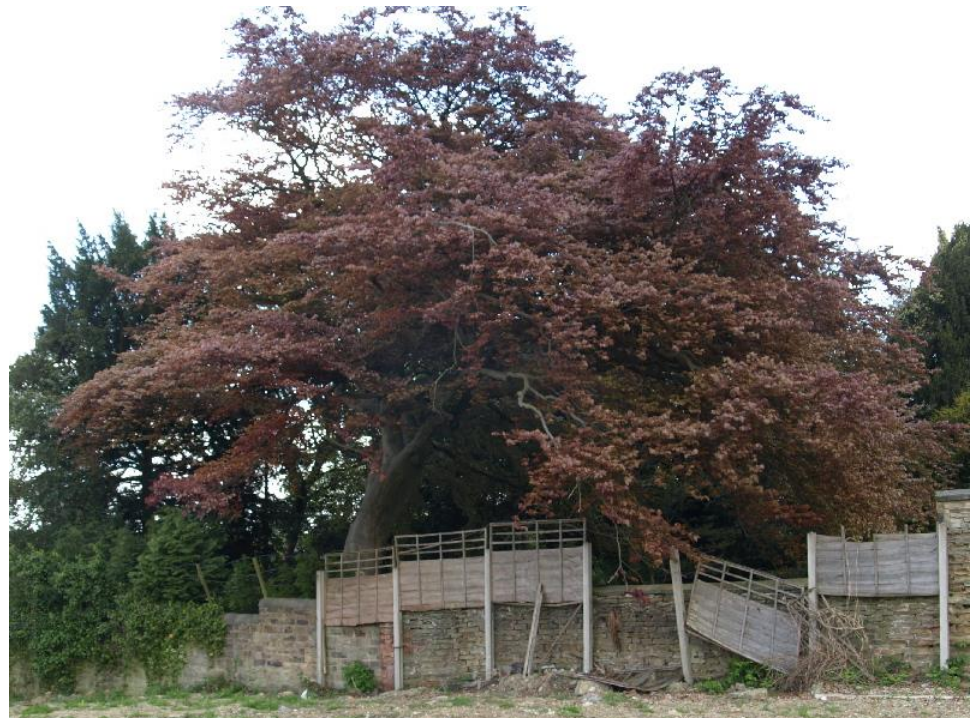
Photograph 7.

Photograph 7 is a view of the Purple Beech tree 2. While it is close to the site it does not reach very far into the site.

I note that this tree was mentioned in the Planning Officer's e-mail, concern was expressed about its bearing on the proposed development.

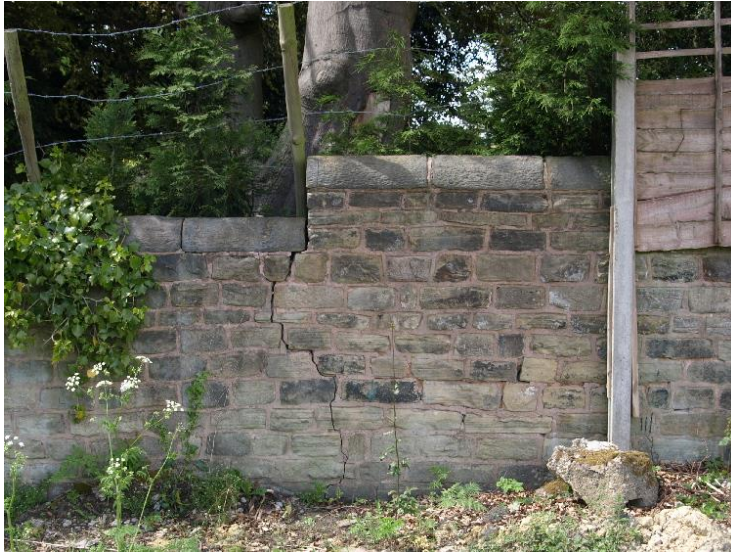
Photograph 8.

While I appreciate the Officer's concerns about the proposal's effect on the tree, it is fair to point out that the tree is already likely to be accused of nuisance. Photograph 8 is a view of the wall at the base of the tree.

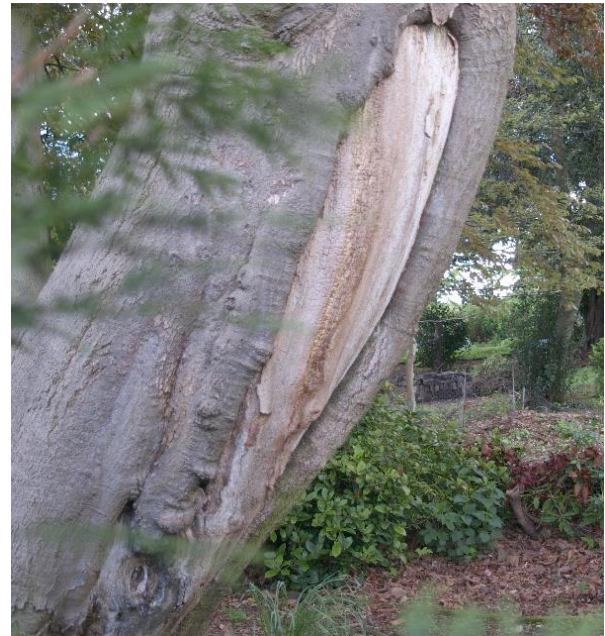
Photograph 9.

It would also be reasonable to note the condition of the tree; photograph 9 shows the base of tree 2. It appears that this tree has suffered damage in much the same as trees 8 & 9. While this damage is probably not structurally significant (being off-site I have not inspected it closely), it would be perverse to oblige a neighbour to pay a tree more heed than the owners do.

The Officer also refers to the canopy of the "large Copper Beech (TPO'd) that substantially overhangs the site at plot 5." In my opinion the tree does not overhang too badly although being to the west of the proposed building, evening sunshine will be interrupted. The overhang can be reduced by pruning which would not be detrimental to the tree's appearance, but my main concern with regard to this tree would be potential root damage should the boundary wall require rebuilding. I realise I've not closely inspected the tree beyond noting the large wound (photo 9), but I think this matter is a minor issue.

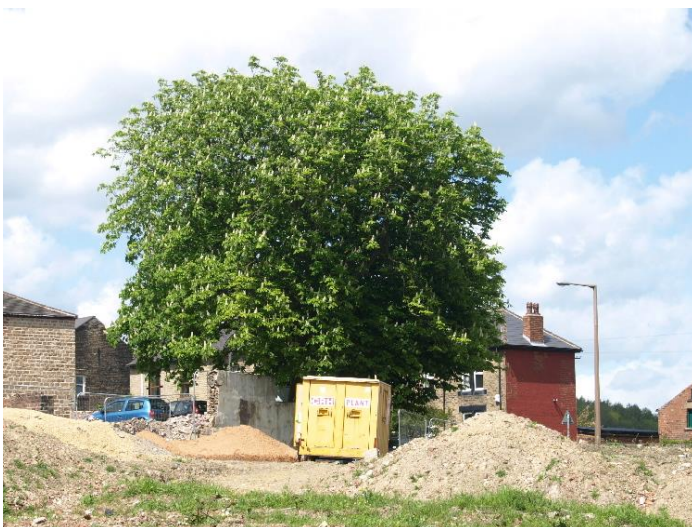
Photograph 10.

Photograph 10 shows tree group 1, three Horse Chestnuts. These are also off-site and even closer to a wall than tree 2.

This wall is in poor condition, although being rendered the condition is not immediately obvious. The main consideration here is whether such a wall could be rebuilt without damaging the trees' roots.

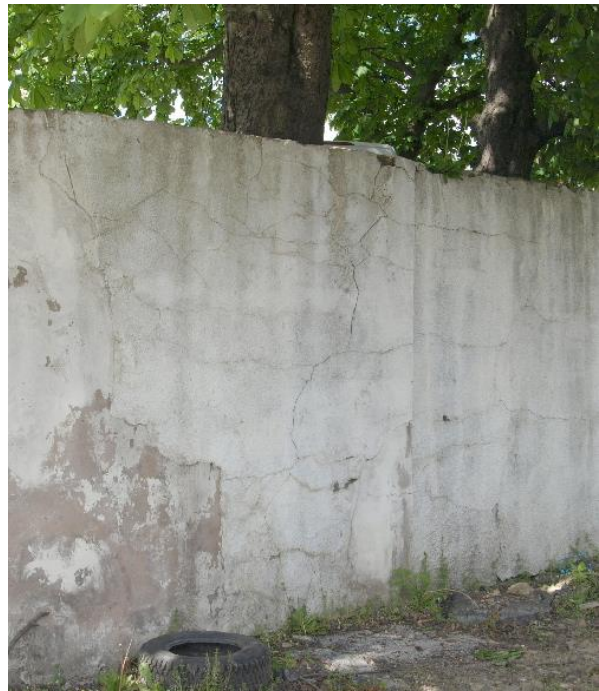
Photograph 11.

Photograph 11 shows the wall at the base of group 1. The render has hidden the wall's structure but elsewhere it is obvious that not only does it retain a difference in soil levels but it is of a construction that is not really suitable for retaining a difference in soil levels. (Please bear in mind that I'm not a builder or structural engineer and my comments about a wall's solidity (or otherwise) should be confirmed by someone with appropriate expertise.)

While these things are difficult to predict, rebuilding walls close to trees like this is almost certain to cause root damage. Although this might not immediately destabilise a tree, the main concern is whether the wounds caused to the roots, which are inevitable, become infected with some sort of decay organism that spreads to weaken the roots and reduce a tree's vigour.

I mention this because if it is decided to rebuild the wall in photograph 11 then I consider it would be pragmatic to remove the 3 Horse Chestnuts. It would be wisest to simply remove them and replant new trees.
