REFURBISHMENT/DEMOLITION ASBESTOS SURVEY

LOWER EASTFIELD FARM, EASTFIELD LANE, THURGOLAND, SHEFFIELD, S35 7AY

DATE SURVEYED: 27 MARCH 2019

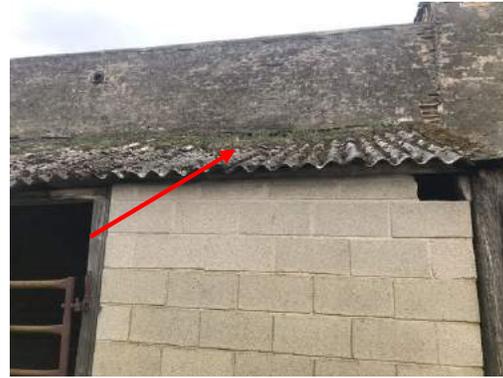
Job No.	R-12773
Sample No.	R-12773/001
Risk Ass't No.	158740
Sampled By	Eddie Starr & Paul Gallagher
Date Sampled	27/03/2019

ACM		
Asbestos Type by Analysis	Chrysotile	Comments:
Material Type	Roof system - Asbestos cement (AC)	
Approx. Quantity	45 m ²	
Location	External/ Shed

MATERIAL ASSESSMENT				
	Product Type	Damage/Deterioration	Surface Treatment	Asbestos Type
Risk Points	1	1	1	1
Points Scale	1-3	0-3	0-3	1-3
MATERIAL RISK SCORE =	4

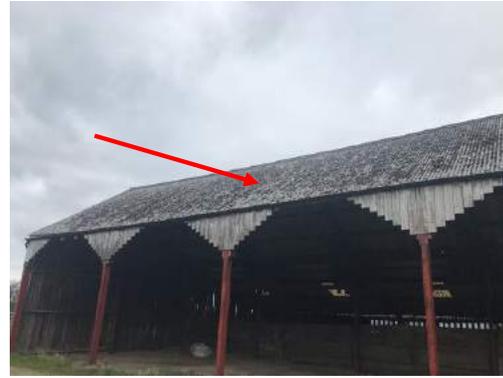
Job No.	R-12773
Sample No.	R-12773/002
Risk Ass't No.	158739
Sampled By	Eddie Starr & Paul Gallagher
Date Sampled	27/03/2019

ACM		
Asbestos Type by Analysis	Chrysotile	Comments:
Material Type	Roof system - Asbestos cement (AC)	
Approx. Quantity	275 m ²	
Location	External/ Open plan cattle shed

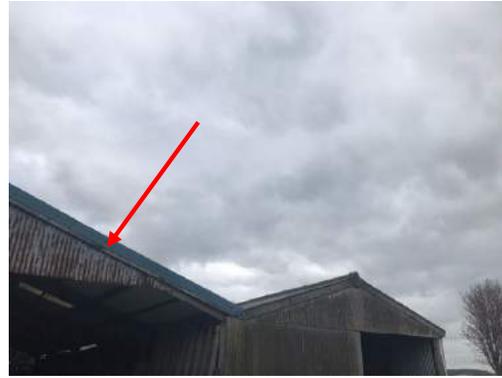
Job No.	R-12773
Sample No.	R-12773/003
Risk Ass't No.	158787
Sampled By	Eddie Starr & Paul Gallagher
Date Sampled	27/03/2019

ACM		
Asbestos Type by Analysis	Chrysotile	Comments:
Material Type	Roof system - Asbestos cement (AC)	
Approx. Quantity	250 m ²	
Location	External / Cattle shed

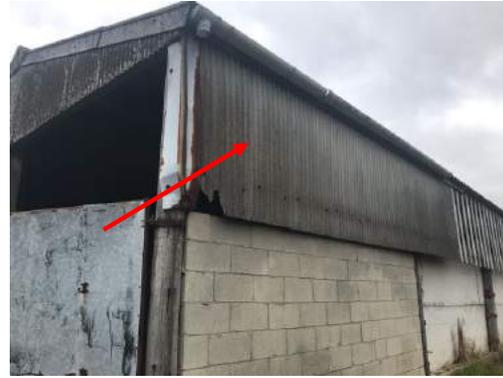
Job No.	R-12773
Sample No.	R-12773/004
Risk Ass't No.	158857
Sampled By	Eddie Starr & Paul Gallagher
Date Sampled	27/03/2019

ACM		
Asbestos Type by Analysis	Chrysotile	Comments:
Material Type	Wall panels - Asbestos cement (AC)	
Approx. Quantity	30 m ²	
Location	External/ Cattle shed

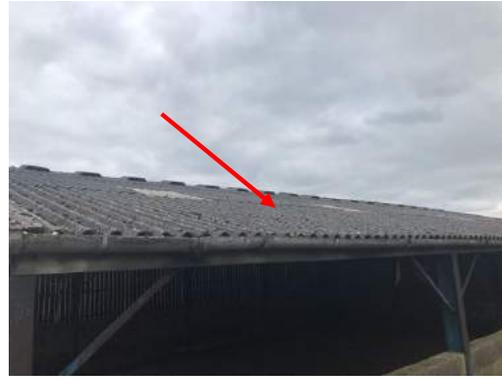
Job No.	R-12773
Sample No.	R-12773/005
Risk Ass't No.	158794
Sampled By	Eddie Starr & Paul Gallagher
Date Sampled	27/03/2019

ACM		
Asbestos Type by Analysis	Chrysotile	Comments:
Material Type	Roof system - Asbestos cement (AC)	
Approx. Quantity	250 m ²	
Location	External/ Open plan sheep shed

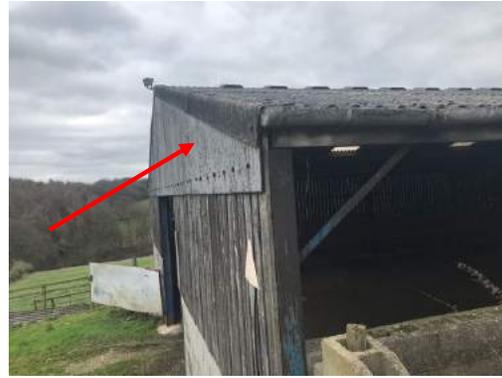
Job No.	R-12773
Sample No.	R-12773/006
Risk Ass't No.	158752
Sampled By	Eddie Starr & Paul Gallagher
Date Sampled	27/03/2019

ACM		
Asbestos Type by Analysis	Chrysotile	Comments:
Material Type	Wall panels - Asbestos cement (AC)	
Approx. Quantity	60 m ²	
Location	External/ Open plan sheep shed

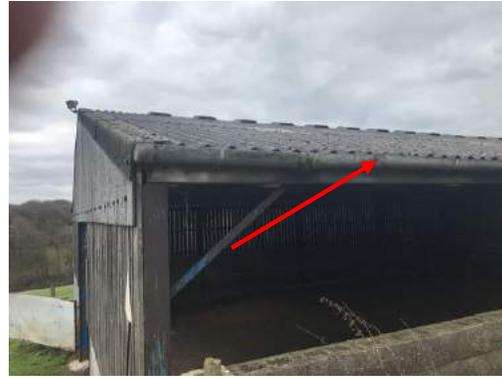
Job No.	R-12773
Sample No.	R-12773/007
Risk Ass't No.	158864
Sampled By	Eddie Starr & Paul Gallagher
Date Sampled	27/03/2019

ACM		
Asbestos Type by Analysis	Chrysotile	Comments:
Material Type	Rainwater goods - Asbestos cement (AC)	
Approx. Quantity	100 l/m	
Location	External/ Open plan sheep shed

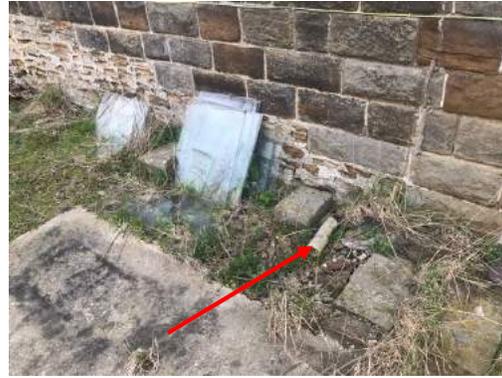
Job No.	R-12773
Sample No.	R-12773/009
Risk Ass't No.	158753
Sampled By	Eddie Starr & Paul Gallagher
Date Sampled	27/03/2019

ACM		
Asbestos Type by Analysis	Chrysotile	Comments:
Material Type	Loose pipe - Asbestos cement (AC)	
Approx. Quantity	1 no	
Location	External/ Rear of main building

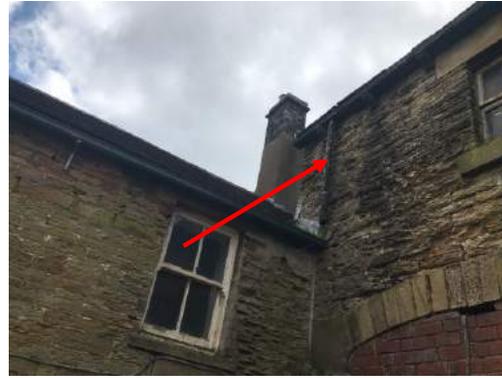
Job No.	R-12773
Sample No.	R-12773/As009
Risk Ass't No.	158779
Sampled By	Eddie Starr & Paul Gallagher
Date Sampled	27/03/2019

ACM		
Asbestos Type by Analysis	SP Chrysotile	Comments:
Material Type	Downpipe - Asbestos cement (AC)	
Approx. Quantity	2 l/m	
Location	External / Front of main building

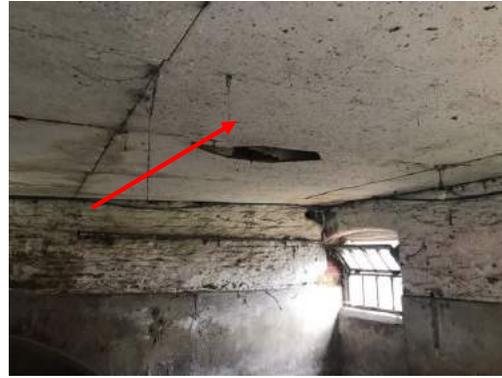
Job No.	R-12773
Sample No.	R-12773/012
Risk Ass't No.	158930
Sampled By	Eddie Starr & Paul Gallagher
Date Sampled	27/03/2019

ACM		
Asbestos Type by Analysis	Chrysotile	Comments:
Material Type	Ceiling panels - Asbestos cement (AC)	
Approx. Quantity	75 m ²	
Location	Ground Floor, R09 / Milking shed

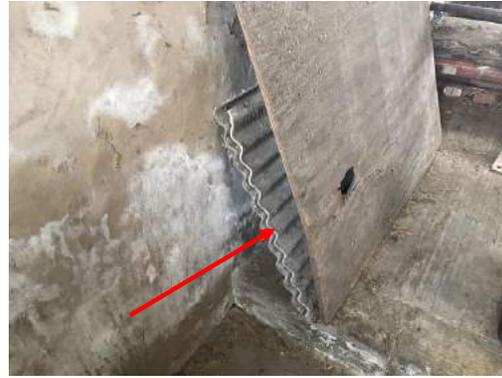
Job No.	R-12773
Sample No.	R-12773/013
Risk Ass't No.	158792
Sampled By	Eddie Starr & Paul Gallagher
Date Sampled	27/03/2019

ACM		
Asbestos Type by Analysis	Chrysotile	Comments:
Material Type	Loose panels - Asbestos cement (AC)	
Approx. Quantity	2 no	
Location	Ground Floor, R09 / Milking shed

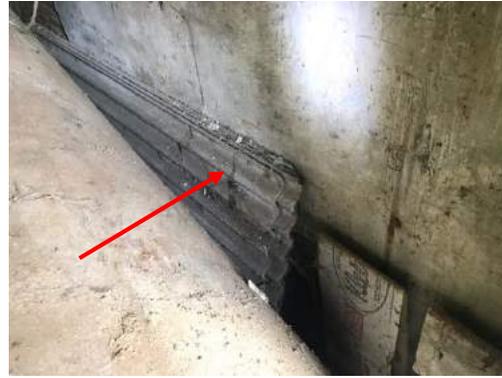
Job No.	R-12773
Sample No.	R-12773/015
Risk Ass't No.	158902
Sampled By	Eddie Starr & Paul Gallagher
Date Sampled	27/03/2019

ACM		
Asbestos Type by Analysis	Chrysotile	Comments:
Material Type	Loose panels - Asbestos cement (AC)	
Approx. Quantity	5 no	
Location	Ground Floor, R15 / Shed

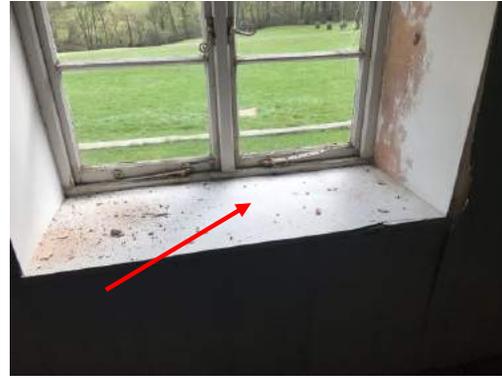
Job No.	R-12773
Sample No.	R-12773/018
Risk Ass't No.	158916
Sampled By	Eddie Starr & Paul Gallagher
Date Sampled	27/03/2019

ACM		
Asbestos Type by Analysis	Amosite, Chrysotile	Comments:
Material Type	Window sill - Asbestos cement (AC)	
Approx. Quantity	1 no	
Location	1st Floor, R19 / Bedroom

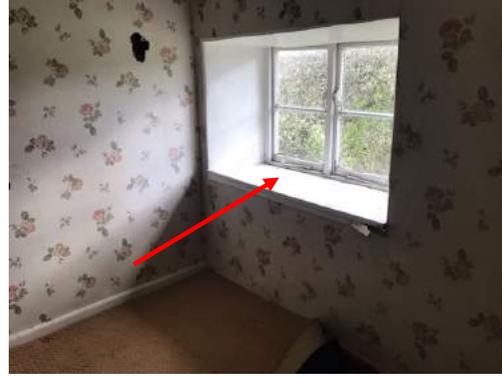
Job No.	R-12773
Sample No.	R-12773/As018
Risk Ass't No.	158738
Sampled By	Eddie Starr & Paul Gallagher
Date Sampled	27/03/2019

ACM		
Asbestos Type by Analysis	SP Amosite, Chrysotile	Comments:
Material Type	Window sill - Asbestos cement (AC)	
Approx. Quantity	1 no	
Location	1st Floor, R21 / Bedroom

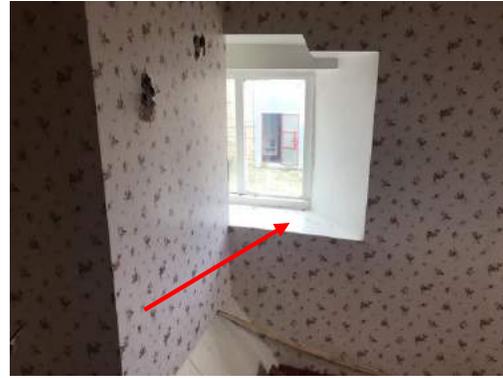
Job No.	R-12773
Sample No.	R-12773/As018
Risk Ass't No.	158789
Sampled By	Eddie Starr & Paul Gallagher
Date Sampled	27/03/2019

ACM		
Asbestos Type by Analysis	SP Amosite, Chrysotile	Comments:
Material Type	Window sill - Asbestos cement (AC)	
Approx. Quantity	1 no	
Location	1st Floor, R23 / Bedroom

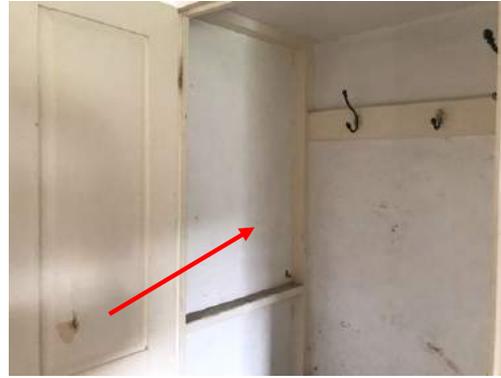
Job No.	R-12773
Sample No.	R-12773/020
Risk Ass't No.	158928
Sampled By	Eddie Starr & Paul Gallagher
Date Sampled	27/03/2019

ACM		
Asbestos Type by Analysis	Chrysotile	Comments:
Material Type	Wall panel - Asbestos cement (AC)	
Approx. Quantity	3 m ²	
Location	Ground Floor, R24 / Kitchen

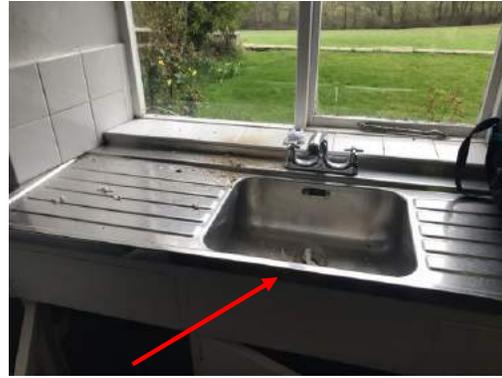
Job No.	R-12773
Sample No.	R-12773/021
Risk Ass't No.	158790
Sampled By	Eddie Starr & Paul Gallagher
Date Sampled	27/03/2019

ACM		
Asbestos Type by Analysis	Chrysotile	Comments:
Material Type	Sink pad - Bituminous product	
Approx. Quantity	1 no	
Location	Ground Floor, R24 / Kitchen

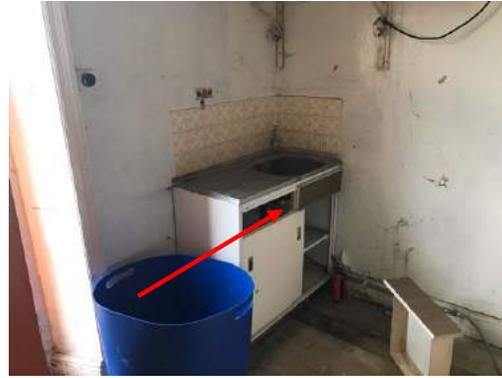
Job No.	R-12773
Sample No.	R-12773/022
Risk Ass't No.	158929
Sampled By	Eddie Starr & Paul Gallagher
Date Sampled	27/03/2019

ACM		
Asbestos Type by Analysis	Chrysotile	Comments:
Material Type	Sink pad - Bituminous product	
Approx. Quantity	1 no	
Location	Ground Floor, R27 / Utility room
