## CCTV DRAINAGE SURVEY REPORT

| <b>CLIENT:</b> Simpson (York) Limited | <b>Date:</b> 18 <sup>th</sup> August 2021 | <b>Page:</b> 1 of 4 |
| <b>SITE:</b> Portwest Clothing Limited, Fields End Business Park, Thurnscoe, S36 0JF | | |

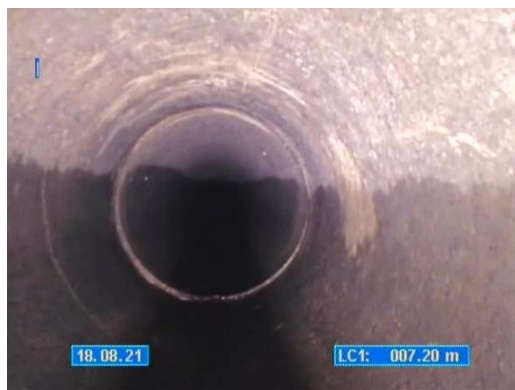
Screen Capture Photograph (1)

| 7.2 | Circumferential crack at joint | 6 o'clock to 10 o'clock (Screen Capture Photograph (1)) | |

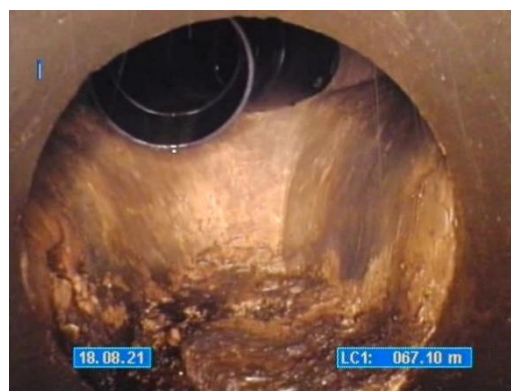
Screen Capture Photograph (2)

| 67.1 | Enter Manhole S7/Debris 20%<br>End of survey | Cement on invert (Screen Capture Photograph (2)) | |

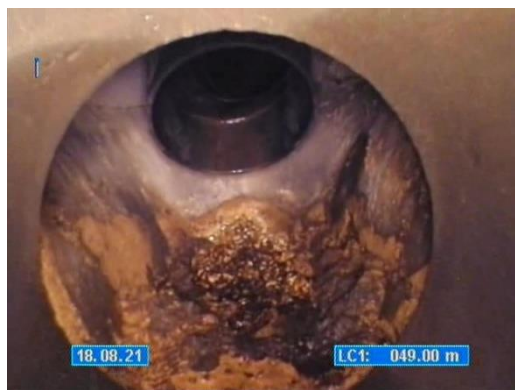
| 49.0 | | Screen Capture Photograph (3) | |
| 49.7 | Enter Manhole S9/Debris 20%<br>End of survey | Cement on benching | |

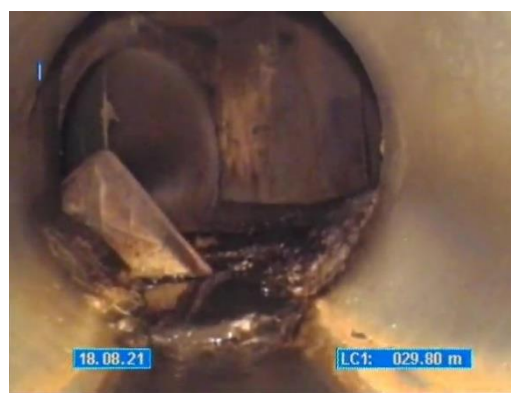
| 29.8 | | Screen Capture Photograph (4) | |

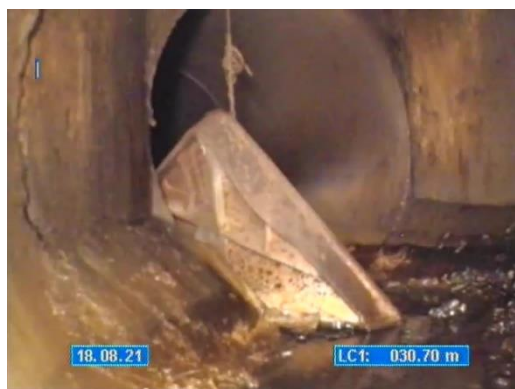
Screen Capture Photograph (5)

| 30.7 | Enter Manhole SX2/Debris 20%<br>End of survey | Manhole Cover removed (Screen Capture Photograph (5)) | |

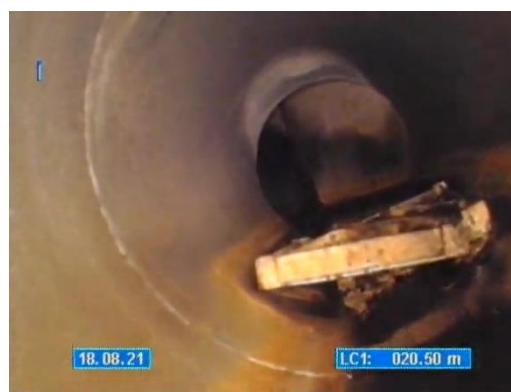
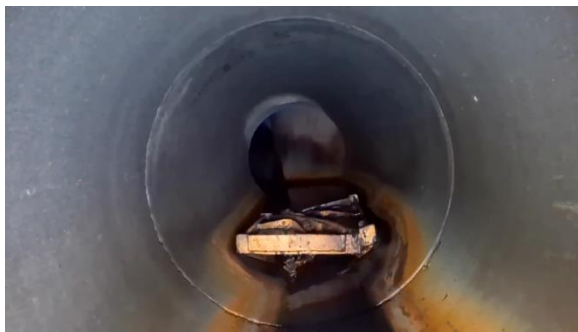
| 20.5 | | Screen Capture Photographs (6) & (7) | |
| 20.9 | Debris 20%/Survey abandoned | On Manhole Cover (approximately 2 metres from Manhole) | |

Structurally, the concrete pipes inspected were in an excellent condition with no defects of note. Hydraulically, they were also in an excellent condition, except for the loose Manhole Cover and Frame 20.9 metres upstream of SX2.

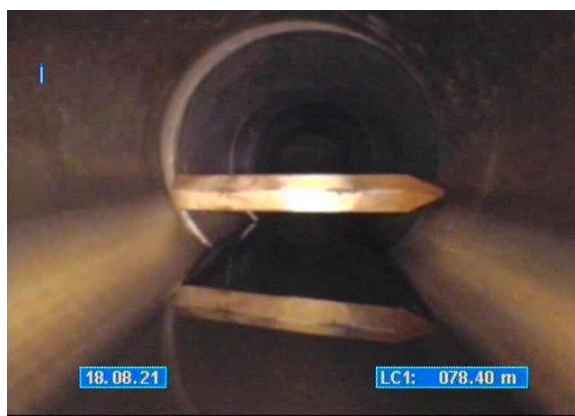
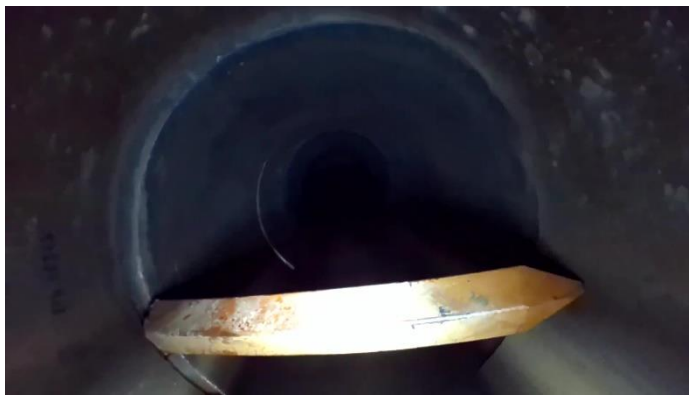
| 78.4 | | Screen Capture Photograph (8) & (9) | |
| 80.0 | Joint displaced - slight<br>Water level 20%<br>Survey abandoned | On Metal Stake across pipe | |
