SF3387 CMS Rockingham

ARBORICULTURAL SURVEY REPORT | BS 5837:2012

Revision C - February 2023

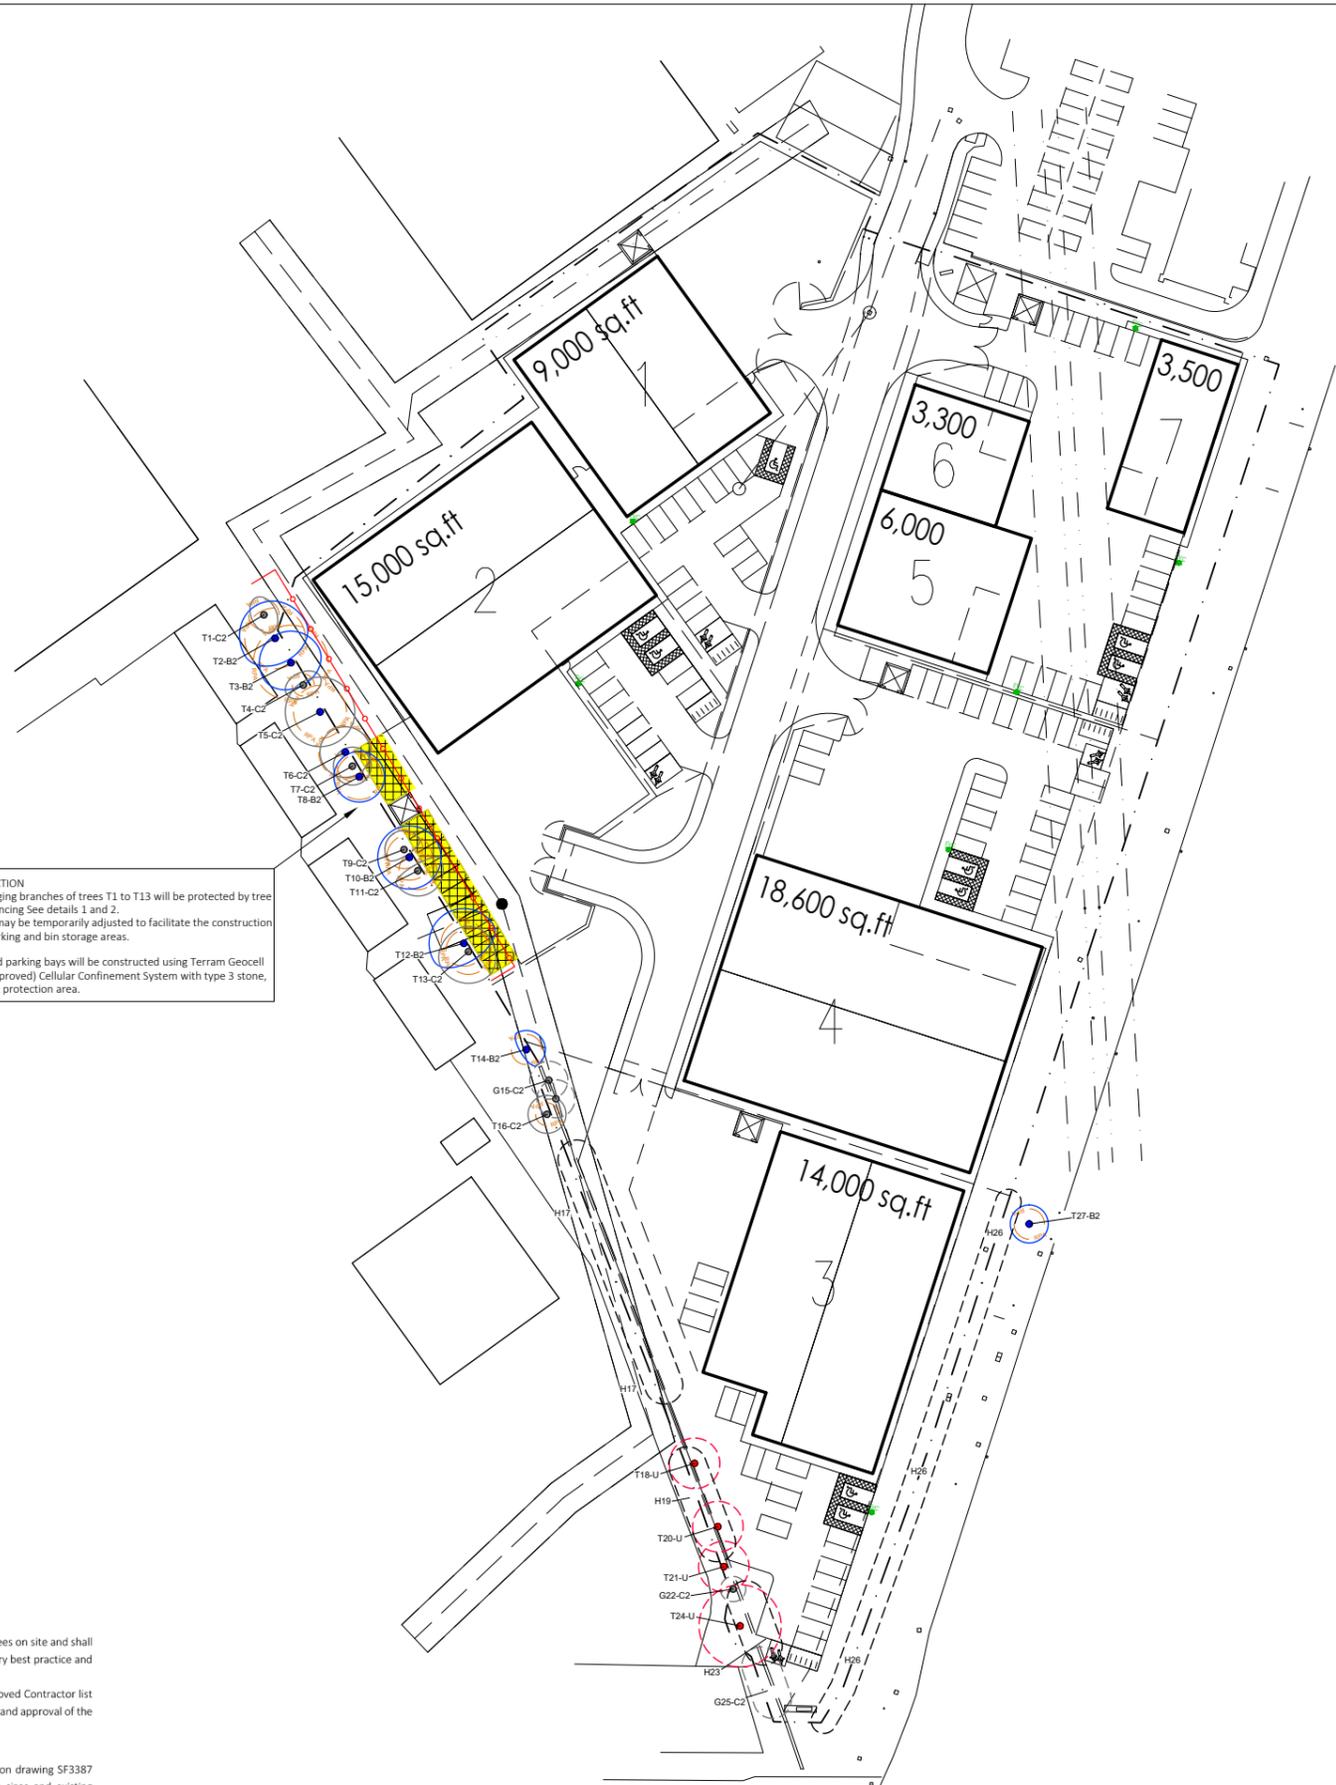
SF3387 AIA01 Arboricultural Impact Assessment Plan

Tree No.	Species	Proposed Works	Category
T18	Elm	Remove dead tree	U
T20	Elm	Remove dead tree	U
T21	Elm	Remove dead tree	U
T24	Ash	Remove - poor condition	U

**TREE PROTECTION**  
The overhanging branches of trees T1 to T13 will be protected by tree protection fencing. See details 1 and 2.  
The fencing may be temporarily adjusted to facilitate the construction of the car parking and bin storage areas.  
The proposed parking bays will be constructed using Terram Geocell (or similar approved) Cellular Confinement System with type 3 stone, in no dig root protection area.

Tree No.	Species	Proposed Works	Category
G15	Hawthorn	Removal	C2
H17	Hawthorn	Removal	-
H19	Hawthorn	Removal	-
G22	Ash	Removal	C2
H23	Hawthorn	Removal	-
G25	Ash	Removal	C2
H26	Mixed	Removal	-
