Our ref 09272GLOB

Monitoring visit 4 of 6

## Monitoring Plus Report

| Address | 16 Green Spring Avenue<br>Birdwell<br>Barnsley<br>S70 5RW | Principal area of damage | to be advised | Installed | 22/05/2023 |

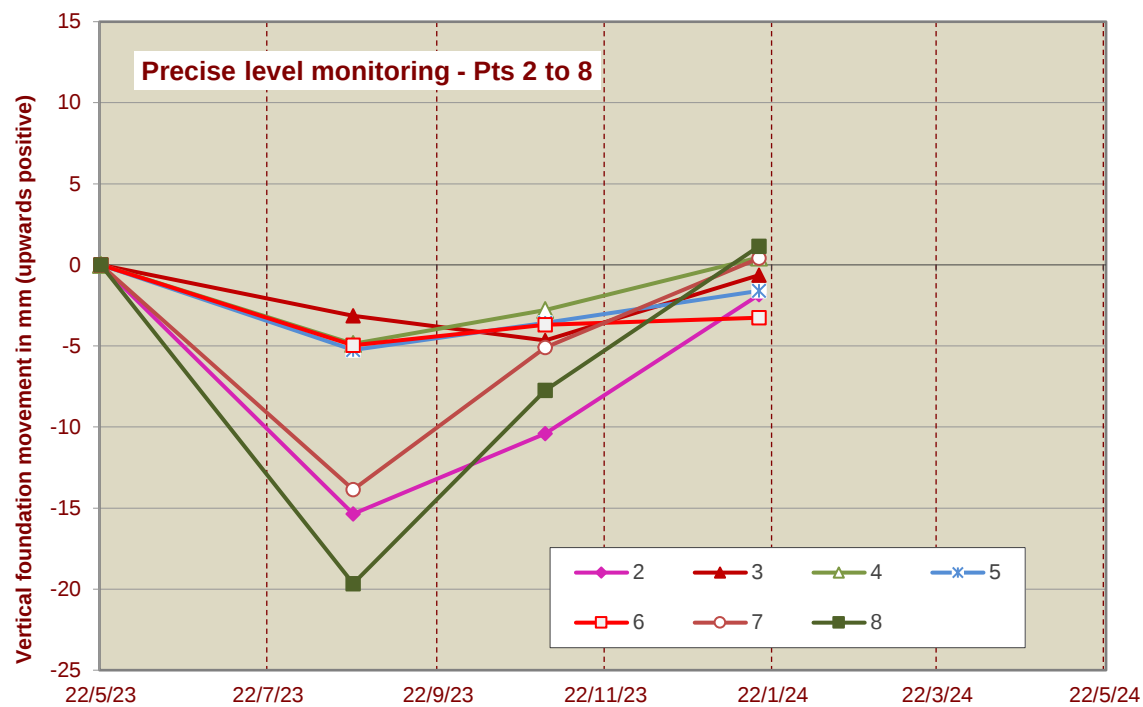
Precise level monitoring related to Point 1

| Max movement | 20.8 mm | Feedback from last visit | no feedback for this visit | | |
| Focal area | Pts 2, 7, 8, | | | | |

| 2 | 964.10 | 0.0 | 948.74 | -15.4 | 953.70 | -10.4 | 962.26 | -1.8 | | #N/A |
| 7 | 914.77 | 0.0 | 900.91 | -13.9 | 909.68 | -5.1 | 915.18 | 0.4 | | #N/A |
| 8 | 1000.89 | 0.0 | 981.23 | -19.7 | 993.15 | -7.7 | 1002.04 | 1.1 | | #N/A |

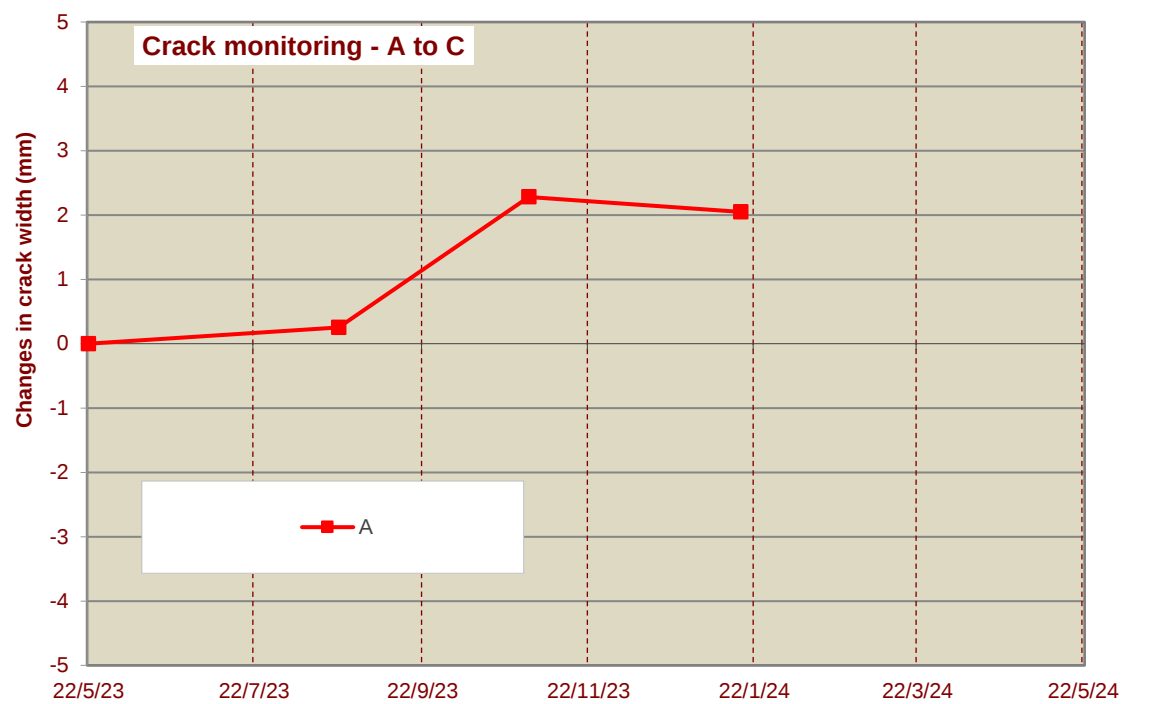
Crack monitoring

| A | 9.80 | 62.01 | 0.0 | 62.26 | 0.3 | 64.29 | 2.3 | 64.06 | 2.1 | | #N/A |

| A | Garage slab, rhs, on slab, ground level |
