# Arboricultural Consultancy for Aviva

| Insured | Mr & Mrs Steven Greagsby | Address | 55 Darton Road, Barnsley, S75 4HY | | |

**Scope of Report:** To survey the property and determine significant vegetation contributing to subsidence damage, make recommendation for remedial action and assess initial mitigation and recovery prospects. The survey does not make an assessment for decay or hazard evaluation. This is a revised report in receipt of root analysis results.

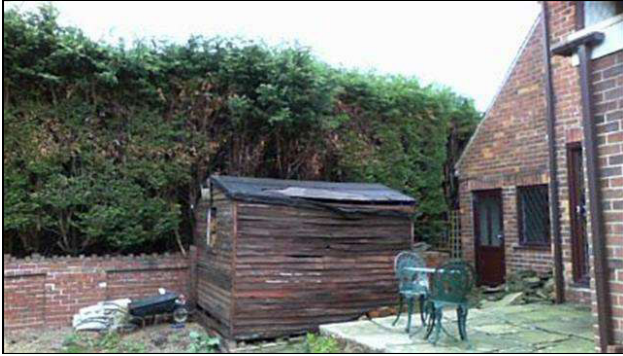
H3 - Cypress

In assessing the extent of damage and the potential drying influence of the vegetation on site, the hedges H1, H2, H3, H4 and T3 (Horse chestnut) are judged to be the dominant features and accordingly we have identified them as the principal cause of the subsidence.

| Tree No. | Species | Age Cat | Approx. Height (m) | Distance to Building (m) * | Ownership | Action | Requirement |
|---|---|---|---|---|---|---|---|
| H3 | Cypress | 1 | 4.5 | 1 | A - Third Party | Maintain as detailed | Remove section of hedge to achieve a minimum clearance of 5m to property. Balance to be maintained on a regular basis to ensure that current dimensions and influence are not exceeded. |

Partial removal and management of the hedges H1, H2, H3 H4 and Removal of T3 (Horse Chestnut) will offer the most certain and reliable arboricultural solution likely to restore long-term stability.

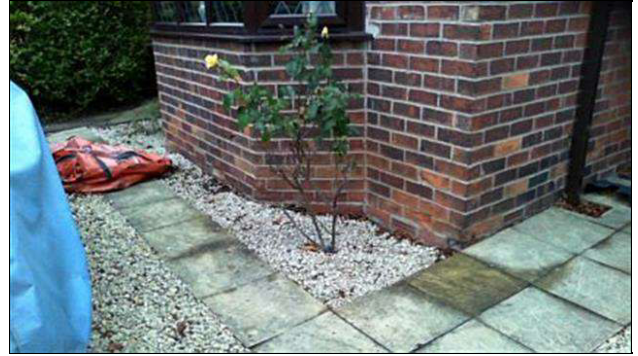
S1 - Rose

| Tree No. | Species | Age Cat | Approx. Height (m) | Distance to Building (m) * | Ownership | Action | Requirement |
|---|---|---|---|---|---|---|---|
| S1 | Rose | 1 | 1.4 | 1 | C - Insured | No action | No works. |

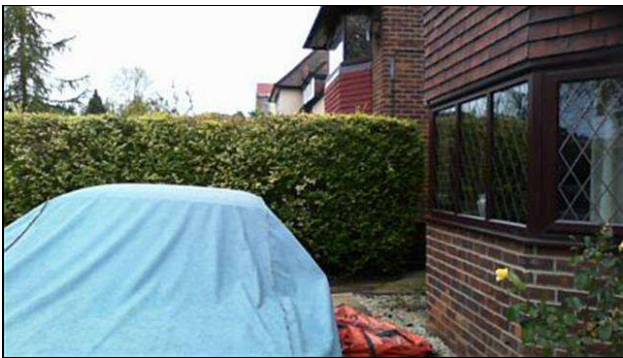
H1 - Privet

| Tree No. | Species | Age Cat | Approx. Height (m) | Distance to Building (m) * | Ownership | Action | Requirement |
|---|---|---|---|---|---|---|---|
| H1 | Privet | 1 | 2.2 | 1.2 | C - Insured | Maintain as detailed | Remove section of hedge to achieve a minimum clearance of 3m to property. Balance to be maintained on a regular basis to ensure that current dimensions and influence are not exceeded. |

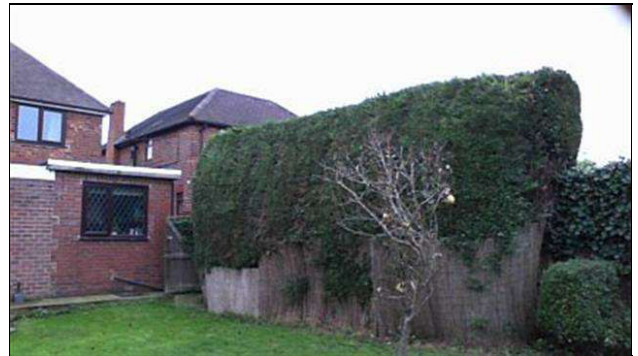
H4 - Cypress

| Tree No. | Species | Age Cat | Approx. Height (m) | Distance to Building (m) * | Ownership | Action | Requirement |
|---|---|---|---|---|---|---|---|
| H4 | Cypress | 1 | 3.3 | 2.1 | C - Insured | Maintain as detailed | Remove section of hedge to achieve a minimum clearance of 5m to property. Balance to be maintained on a regular basis to ensure that current dimensions and influence are not exceeded. |

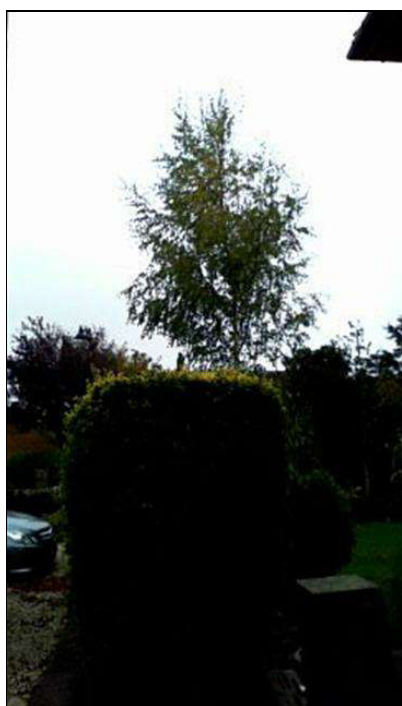
T1 - Birch

| Tree No. | Species | Age Cat | Approx. Height (m) | Distance to Building (m) * | Ownership | Action | Requirement |
|---|---|---|---|---|---|---|---|
| T1 | Birch | 1 | 7 | 7.8 | A - Third Party | Action to avoid future risk | Do not allow to exceed current dimensions by way of regular pruning. |

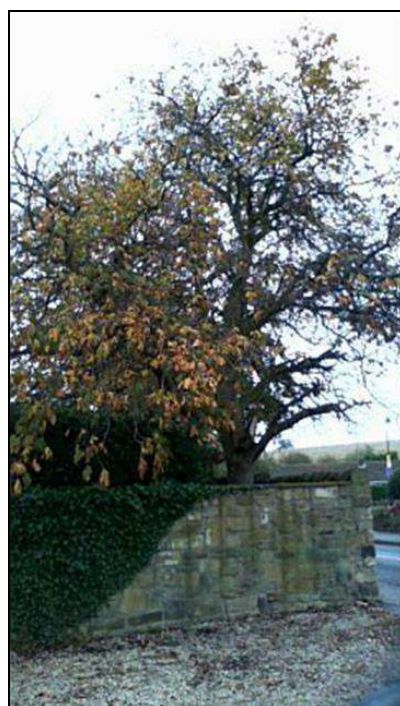
T3 - Horse Chestnut

Site Investigations revealed the presence of roots below foundation level in TP/BH2. These roots were identified (using anatomical analysis) as having emanated from the genus *Aesculus* spp. (Horse chestnuts).

Our survey of the site identified T3 (Horse chestnut), given its position relative to the damage it is our opinion that the roots identified emanate from this tree.

| Tree No. | Species | Age Cat | Approx. Height (m) | Distance to Building (m) * | Ownership | Action | Requirement |
|---|---|---|---|---|---|---|---|
| T3 | Horse Chestnut | 1 | 10.7 | 10.1 | A - Third Party | Remove | Remove close to ground level and treat stump to inhibit regrowth. |

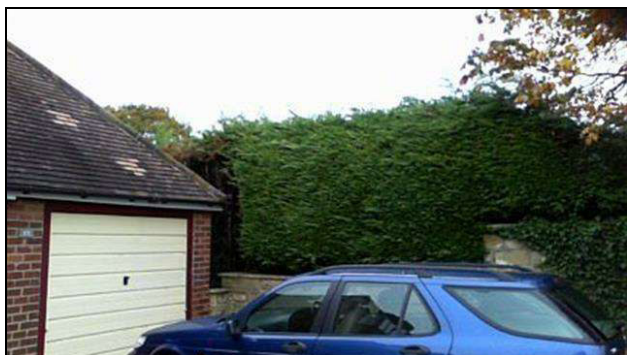
H2 - Cypress

| Tree No. | Species | Age Cat | Approx. Height (m) | Distance to Building (m) * | Ownership | Action | Requirement |
|---|---|---|---|---|---|---|---|
| H2 | Cypress | 1 | 3.5 | 1 | A - Third Party | Maintain as detailed | Remove section of hedge to achieve a minimum clearance of 5m to property. Balance to be maintained on a regular basis to ensure that current dimensions and influence are not exceeded. |

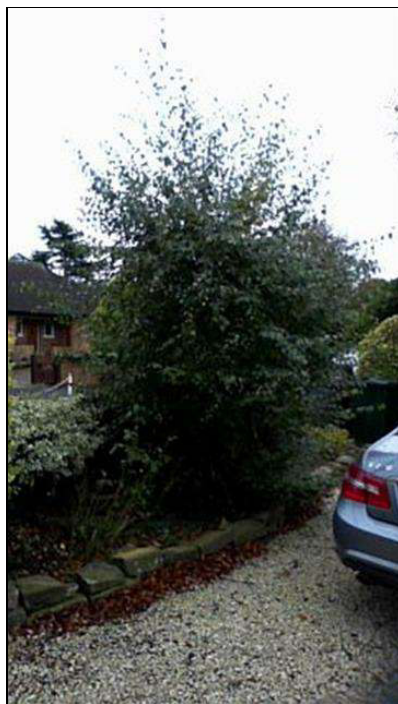
T2 - Birch

| Tree No. | Species | Age Cat | Approx. Height (m) | Distance to Building (m) * | Ownership | Action | Requirement |
|---|---|---|---|---|---|---|---|
| T2 | Birch | 1 | 3.5 | 8.2 | C - Insured | No action | No works. |
