# **ARBORICULTURAL REPORT & Impact Assessment to BS5837:2012 at:**

***Beech Villa  
The Avenue  
Wortley  
South Yorkshire  
S35 7DT***

Date: October 2020

Reference: AWA3423

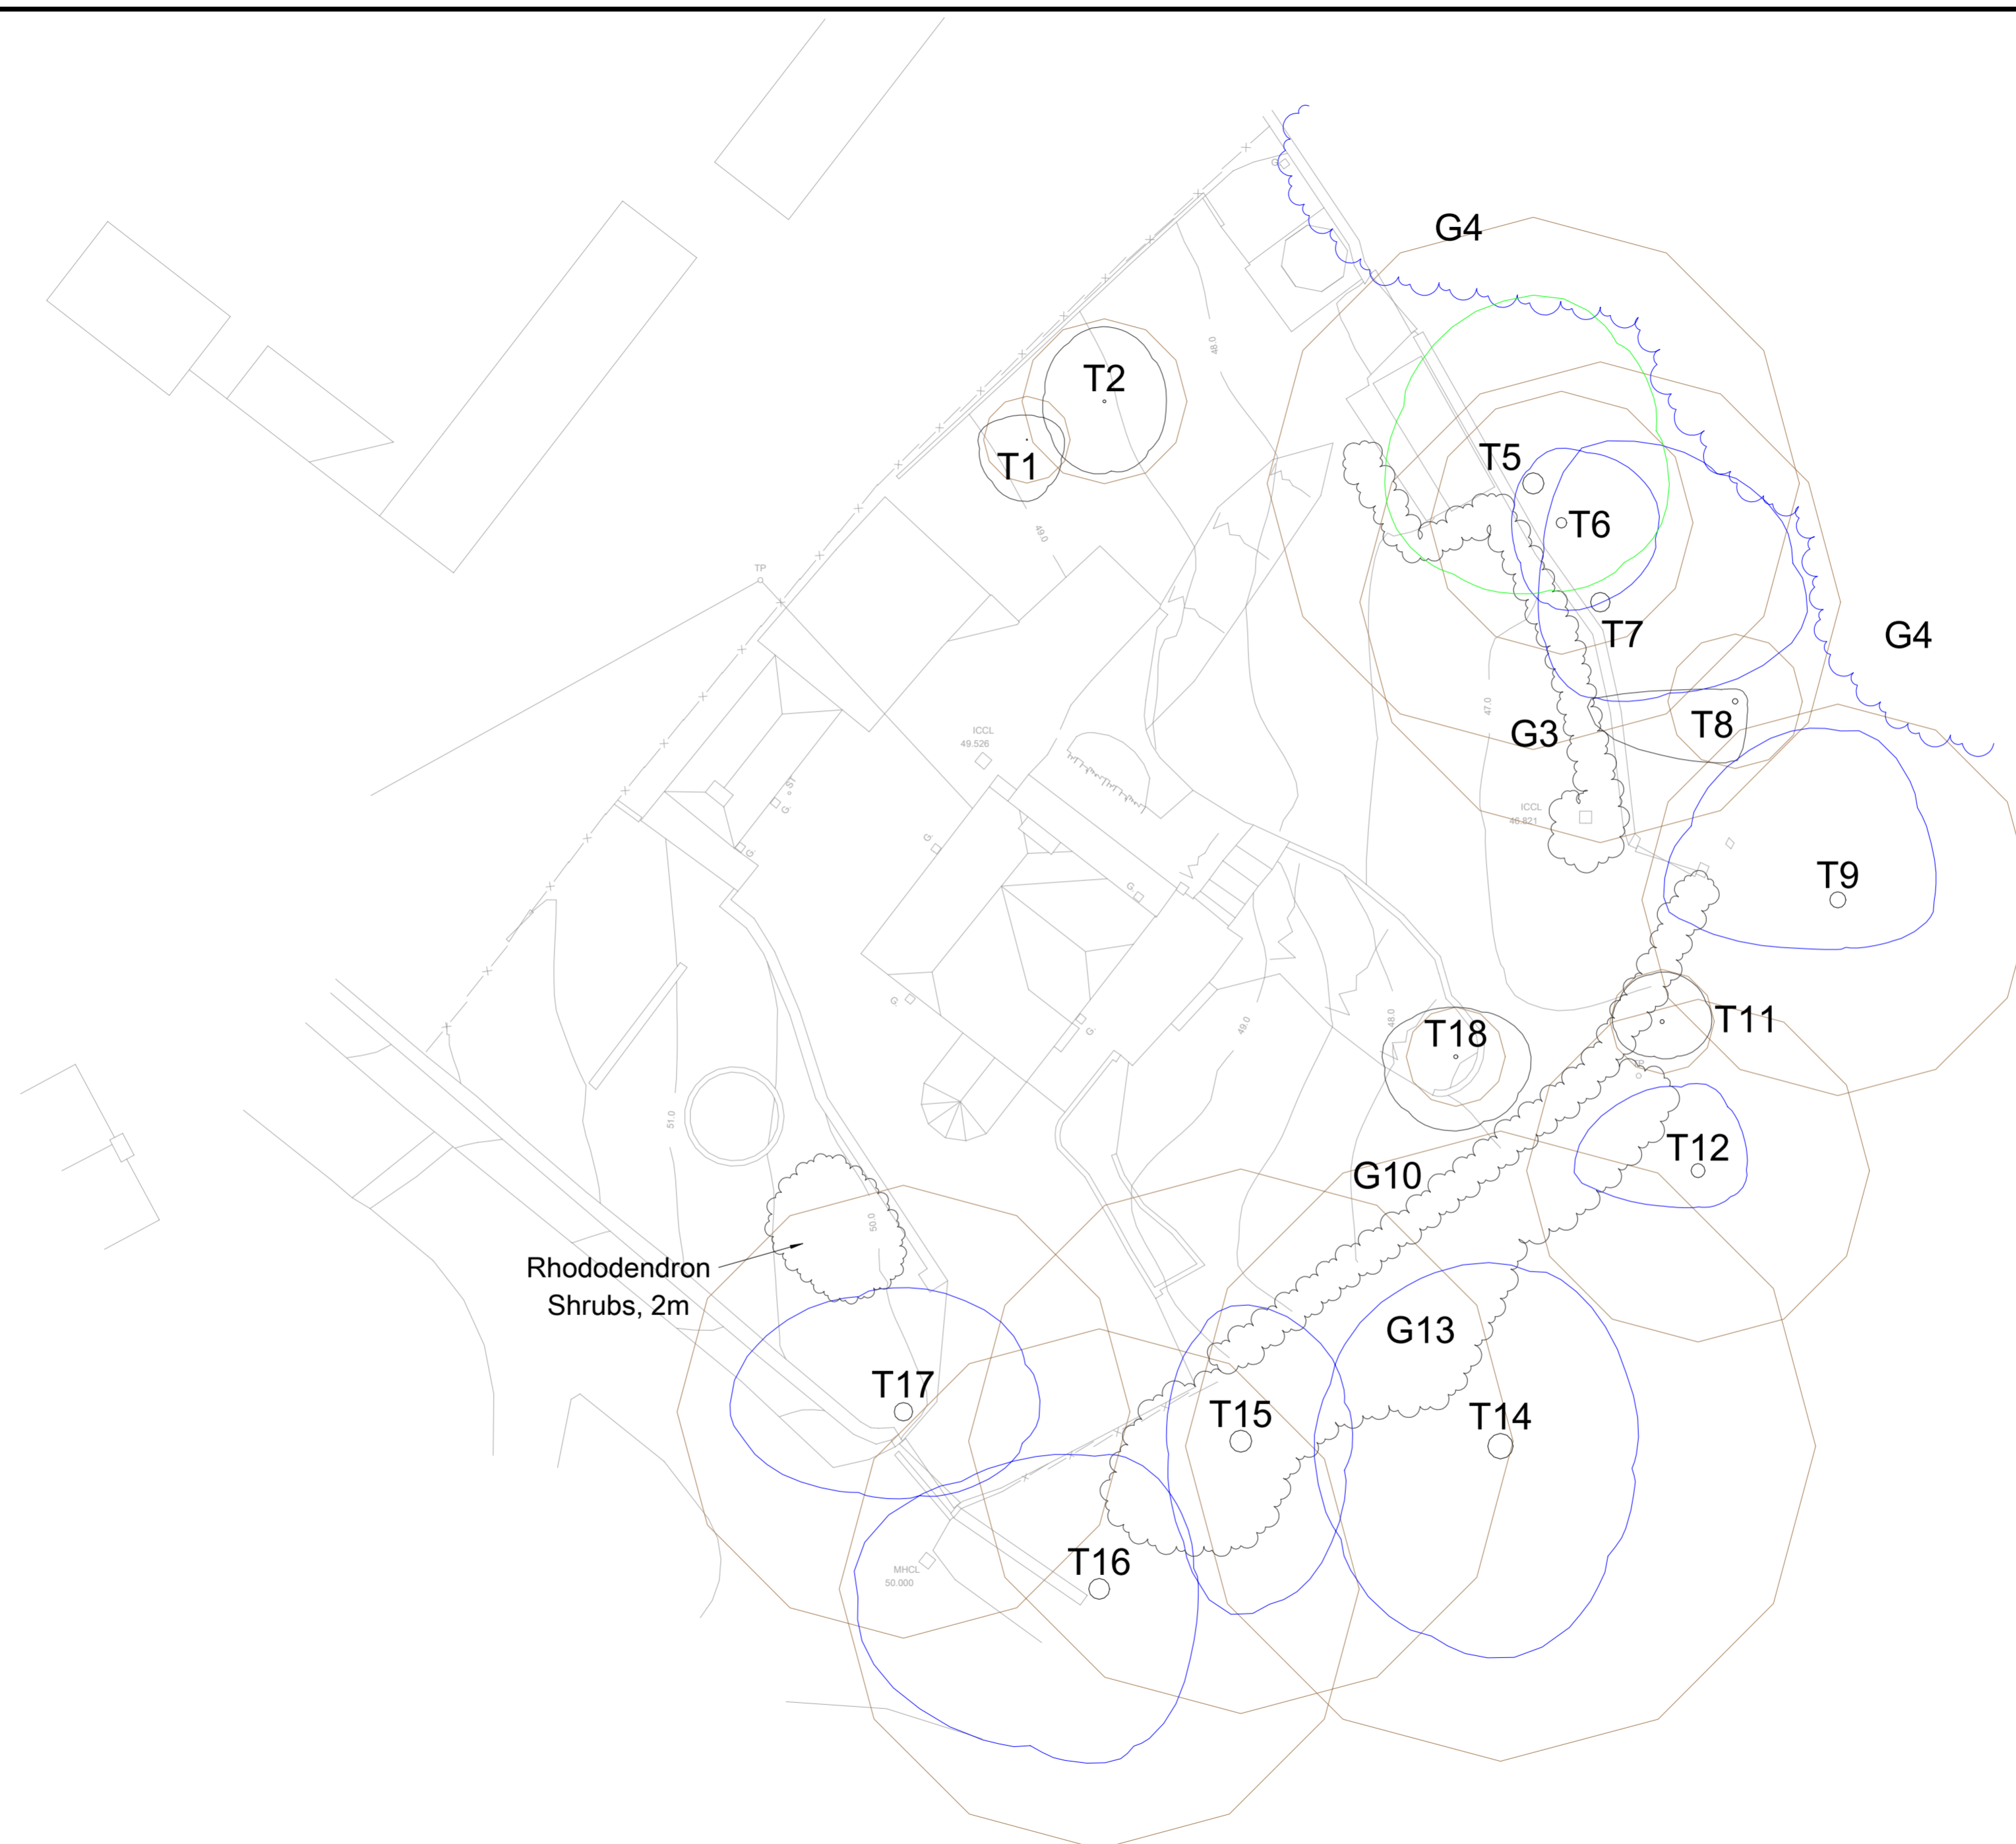
**Appendix 5:**  
**Tree Constraints Plan**  
Beech Villa, Wortley, S35 7DT  
Ref: AWA3423

- 3.2.6 The site's trees had a good age diversity with a mix of semi-mature, early-mature and mature trees.
- 3.2.7 The sites most significant tree is T5, a large mature Sycamore located just beyond the eastern boundary. This tree is visually prominent throughout the site and provides a high level of amenity value.

- 3.2.8 Growing beyond the eastern boundary is the woodland type group G4 and the individual trees T5, T6, T7, T8 and T9. Collectively these tree form a landscape feature of particularly high value. The individual trees have some defects that have the potential to limit their longer term value, as detailed at Appendix 4. In particular the Ash, T8 has a particularly small and sparse crown and a suppressed form. A third stem from the large Ash, T7 has been previously removed, leaving a large stump that has many small fungal fruiting bodies on it. The remaining two stems have various long thin 'increment strips' on their stems, caused by a relatively quick increase in stem diameter, probably to manage the additional exposure from the removal of the third stem.

- 3.2.9 There is a relatively sparse woodland area to the south east of the site with a dense understory of various shrub species similar to those in the group G13. The four trees in this area that have the potential to impact the site have been identified individually as T12, T14, T15 and T16. These trees are visually prominent both from within the site and from the roadside to the south and west, providing a good level of amenity value.

- 3.2.10 Within the site by the driveway is the Sycamore, T17. This tree appears to be in a relatively good overall condition despite its proximity to hard surfaces and various retaining structures that are likely to have been installed since the tree became established. Previous poor pruning practices have resulted in some dead large stubs throughout the crown. As such it is advised that the significant deadwood is removed from the crown of T17 regardless of any future development.

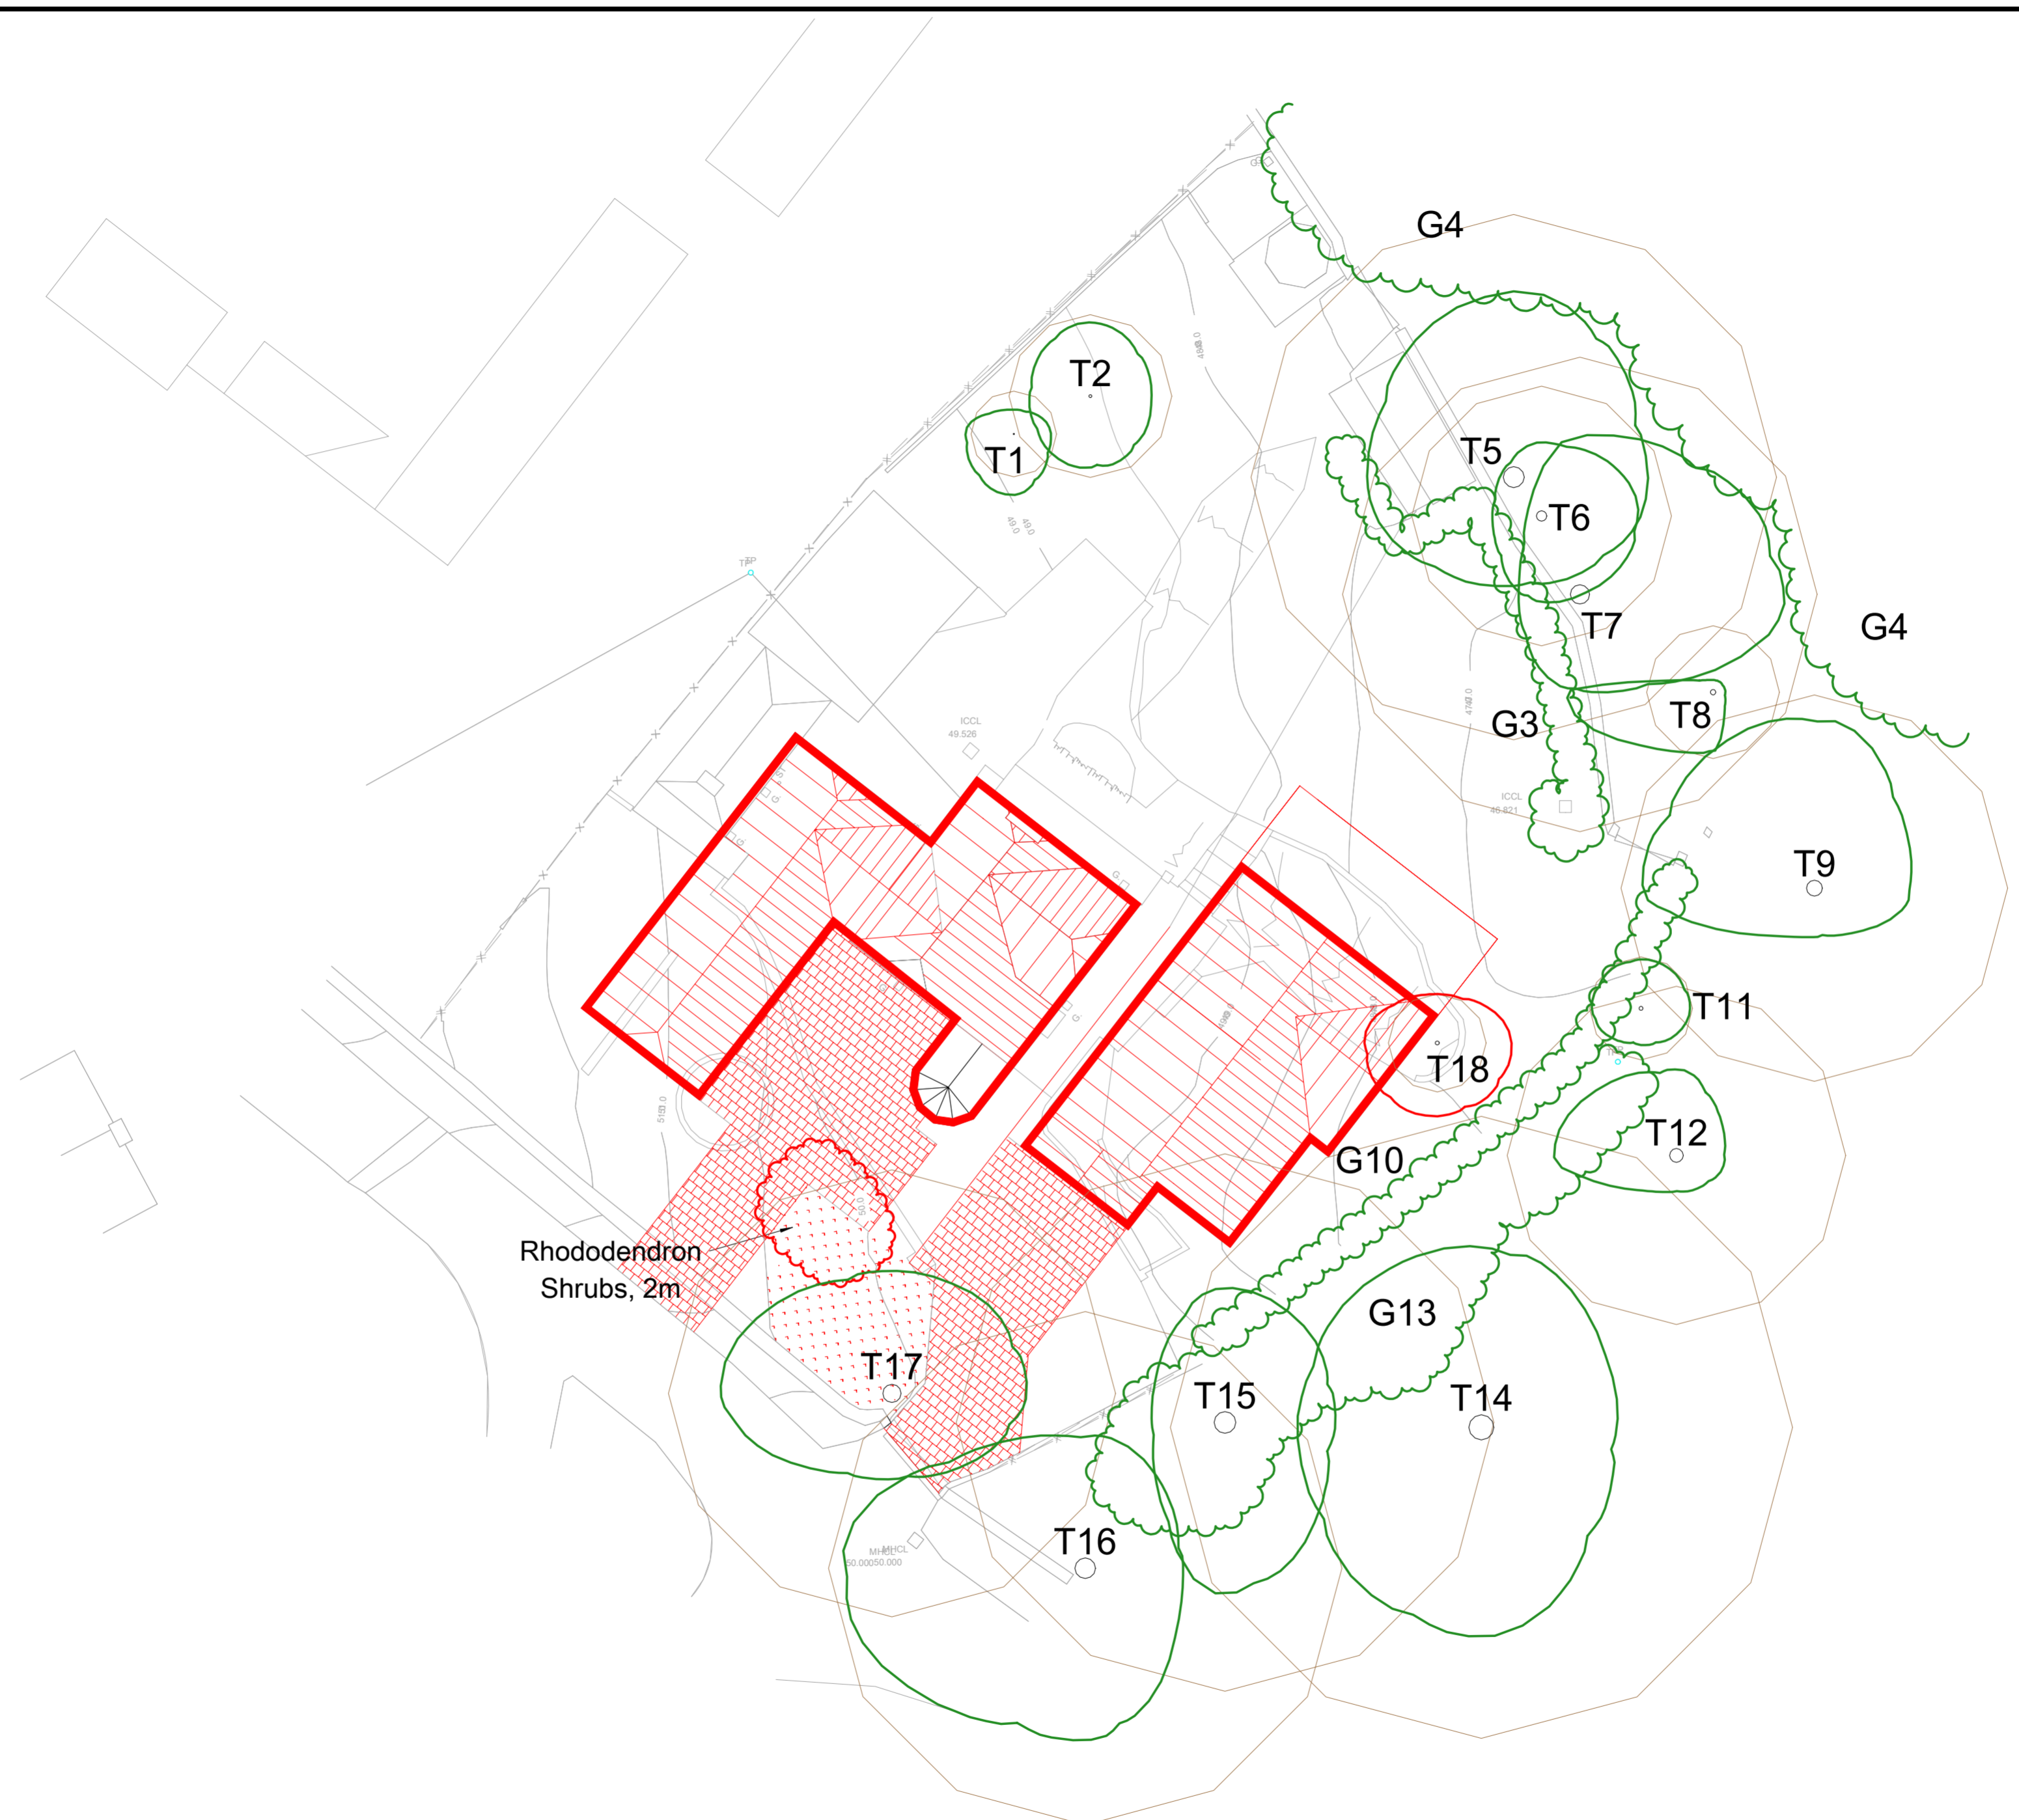
**Appendix 6:**  
**Tree Impacts Plan**  
 Beech Villa, Wortley, S35 7DT  
 Ref: AWA3423  
 BRITISH STANDARD 5837:2012  
 SCALE: 1:200 PAPER: A2

4.2.1 From assessing the new development proposals, the removal of 1 trees will be required as it is situated in the footprint of the structure and its retention and protection throughout the development is not suitable.

4.2.2 The tree that is required to be removed is T1. This small Cotoneaster is growing in a raised bed in the rear garden area and is of negligible value.

4.3.2 Potentially damaging activities are proposed in the vicinity of retained trees. The new development encroaches close to and into the edge of the RPA of T15 and T17. Construction within the RPA, can have negative impacts on tree roots. However, the encroachment is very minor, and the detailed RPA for these trees is likely to be a slightly exaggerated representation of their actual rooting area due to the specific topography of the site. As such, it is unlikely that significant roots will be within these areas and the retained trees should remain largely unaffected by the works, provided care is taken during construction.

4.5.1 The retained trees will require protection by fencing in accordance with BS 5837: 2012, during the development phase.
