# DRAINAGE INVESTIGATION REPORT

CLIENT E2A Designs Ltd

SITE BONDFIELD DAY CENTRE -  
WOMBWELL - S73 8TX

DATE 21/11/2012 JOB No. 4826

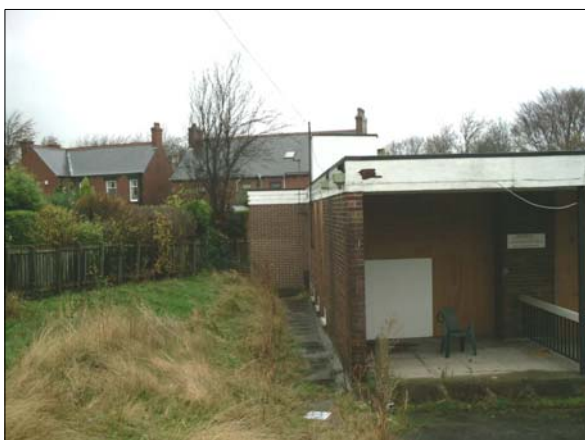
Title: GP19

Description: GENERAL VIEW - BUILDING 2  
(RAIN WATER PIPES - DISCONNECTED)

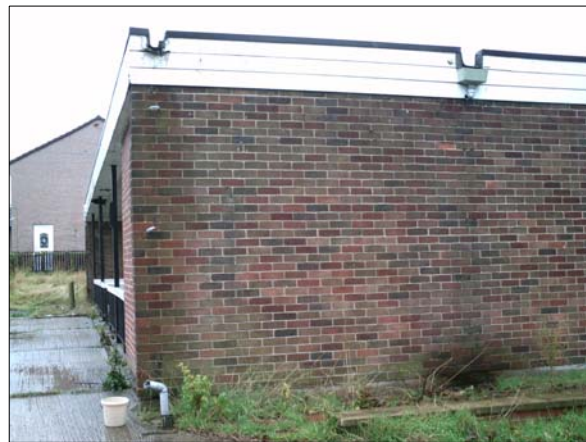
Title: GP30

Description: RWP5 (BLOCKED) - BUILDING 2  
(OFFSET FROM GULLY AT CORNER)

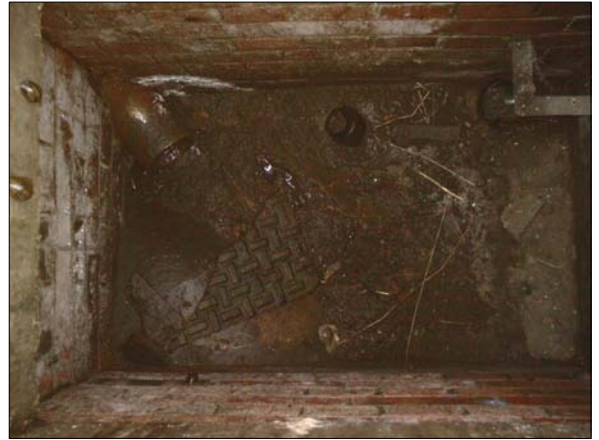
Title: GP38

Description: EDS4 - SILTED

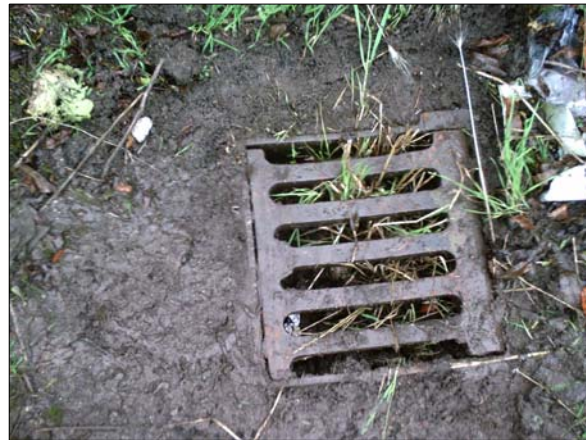
Title: GP42

Description: YARD GULLY (BUILDING 2 NR.  
RWP1) - BLOCKED
