**WESTFIELD HOUSE FARM  
BROCKHOLES LANE  
PENISTONE  
S36 9ZB**

**Project No: 14/392**

**STRUCTURAL INSPECTION  
REPORT**

**KEITH MILLER DESIGN LTD  
ROWAN COTTAGE  
TOOTHILL LANE  
BRIGHOUSE  
HD6 3SE**

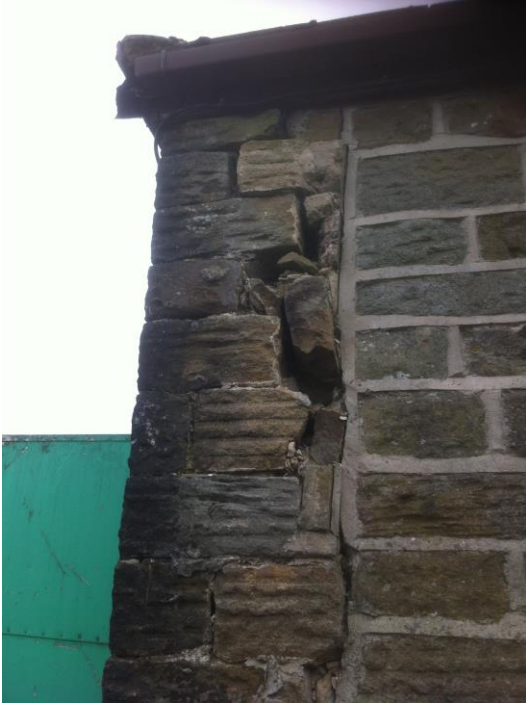
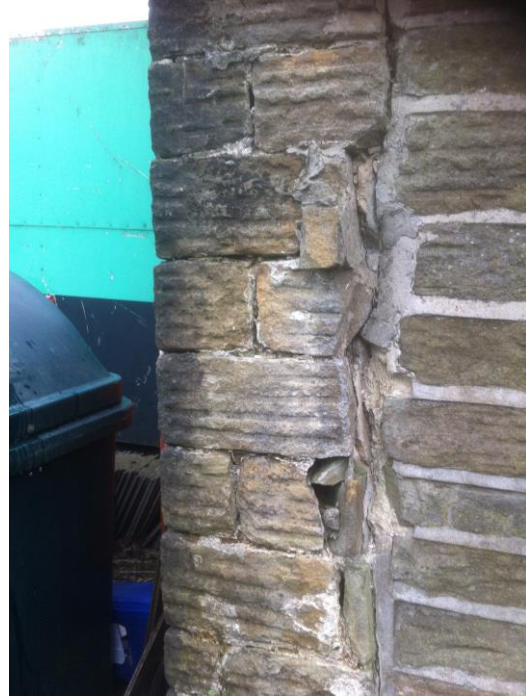
The LHS pier top has moved outwards by approx 10mm and there are loose pieces of masonry which require repair. ( the cause may be impact from farm machinery ). ( photos 1 & 2 )

The piers along the North and West Elevations should be fixed to the adjacent masonry panel by suitable straps and suitable bonding.

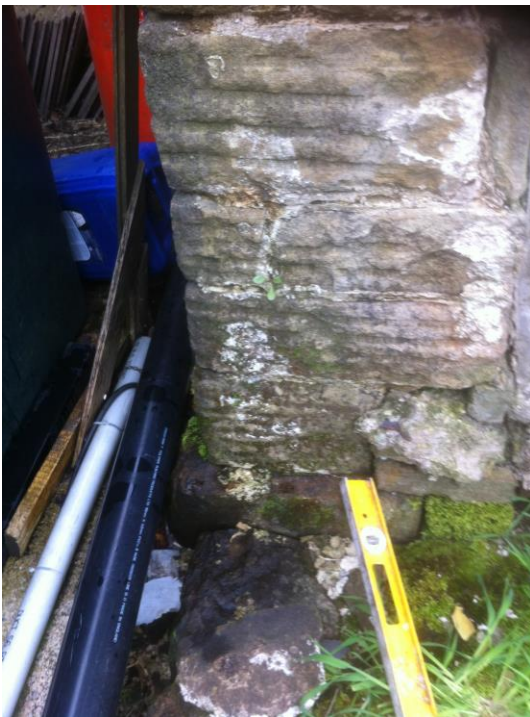
*Photo 3*

Land adjacent to the North elevation has been excavated and revealed shallow concrete foundations and a padstone beneath the LHS pier. ( photo 3 )

The excavation adjacent to the North Elevation has exposed shallow foundations for the existing external wall. Further investigations are necessary

around the perimeter of the building to determine those sections which may need underpinning .

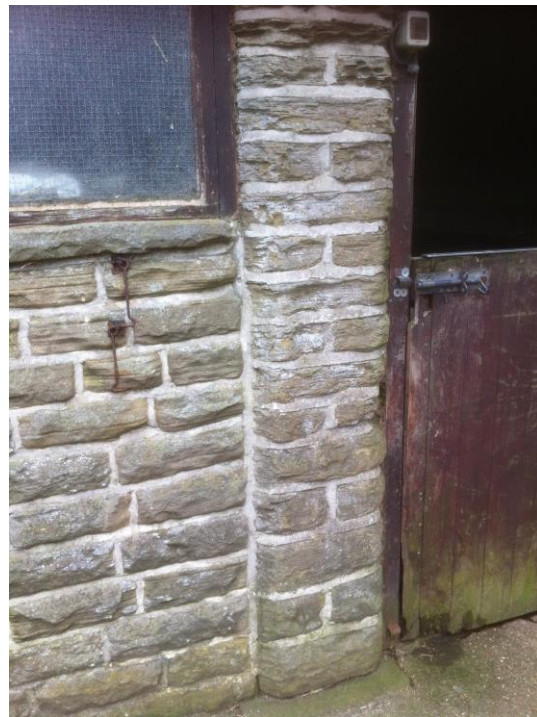
*Photo 4*

The three stables each have access through a stable door. There were isolated stone piers at crosswall locations originally but the external infill wall panels appear to have been constructed at a later date. (photo 4) All the piers and masonry panels are vertical generally ( maximum lean = 10mm outwards at eaves level ). The LHS units form a barn / hay loft. The inner block wall of the external wall in this hay storage area appears sound but has been laid in a stack pattern as opposed to running bond .

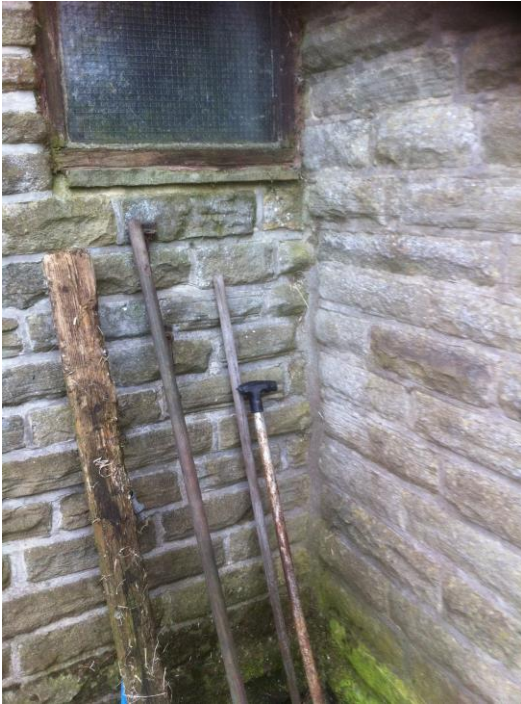
*Photo 5*

The vertical joint between the ( buttressing ) wall and the retaining wall ( South end ) is sound with no sign of movement. (photo 5)

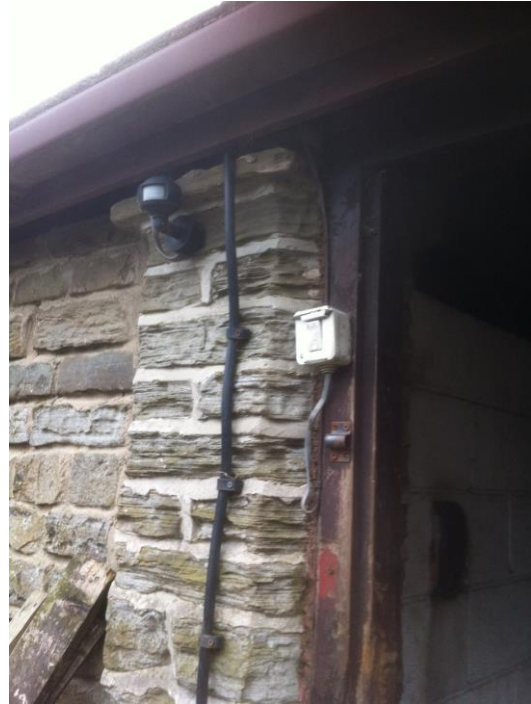
*Photo 6*

Pier 4 ( counting from the North end ) - masonry is heavily de-laminated. (photo 6)

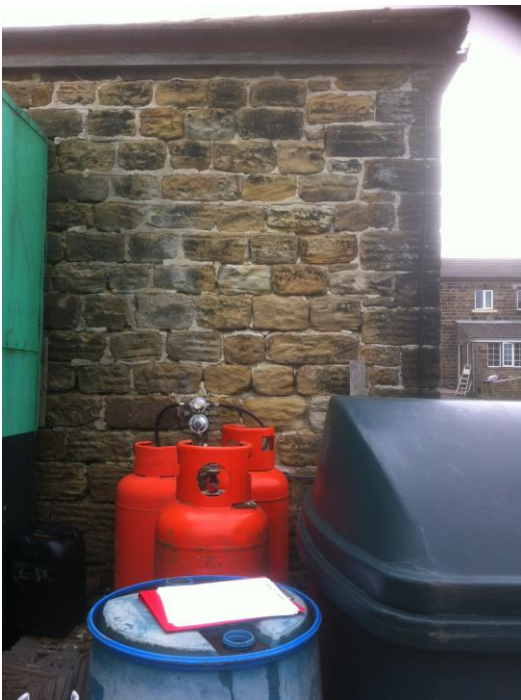
*Photo 7*

The facing stonework is approx 200mm coursing and has experienced a moderate amount of weathering. It appears that the whole elevation would require re-pointing. (photo 7)

The outer wall has a stone outer leaf and a mix of block / stone or no inner leaf. The masonry is in reasonable repair but the east elevation would benefit from the construction of an inner block skin which should be tied to the outer leaf using remedial resin type wall ties. The foundation may need underpinning and extending to pick up the additional inner leaf. The inner leaf should be bonded into the cross walls.

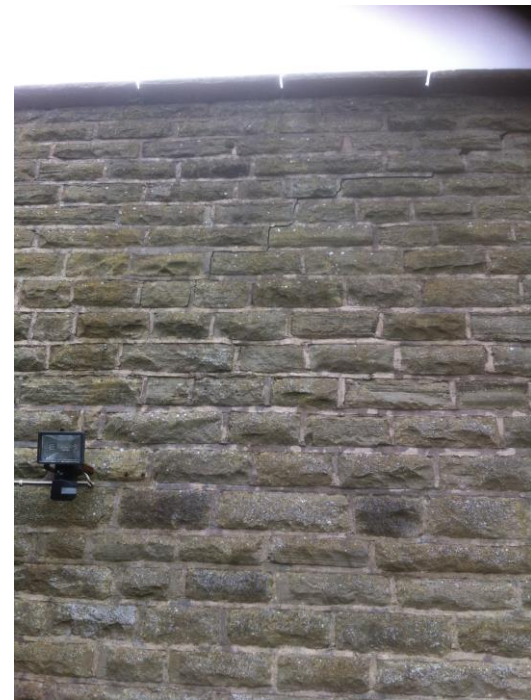
*Photo 8*

The south end of the stable block abuts a stone faced wall retaining approx 3m of the neighbour's garden. The whole elevation of the retaining wall has been re-pointed , but here do not appear to be any weep pipes, open joints or methods of draining the rear of the retaining wall and releasing the water pressure should any build up occur. However the retaining wall alignment is straight with no bulging or deformation. (photo 8)

( Note : No weep pipes are evident through the retaining wall which would provide drainage from the rear of the wall, and the whole face of the wall has been pointed which leaves no open joints to facilitate rear of wall drainage. )

The proposed plans create a passageway between the new dwelling cavity wall and the existing retaining wall. The stable block will be providing some buttressing action to the retaining wall at present. A thorough assessment of the capacity of the retaining wall before and after the proposals should be undertaken to ensure the stability of the wall is assured following the removal of the buttressing stable block walls.

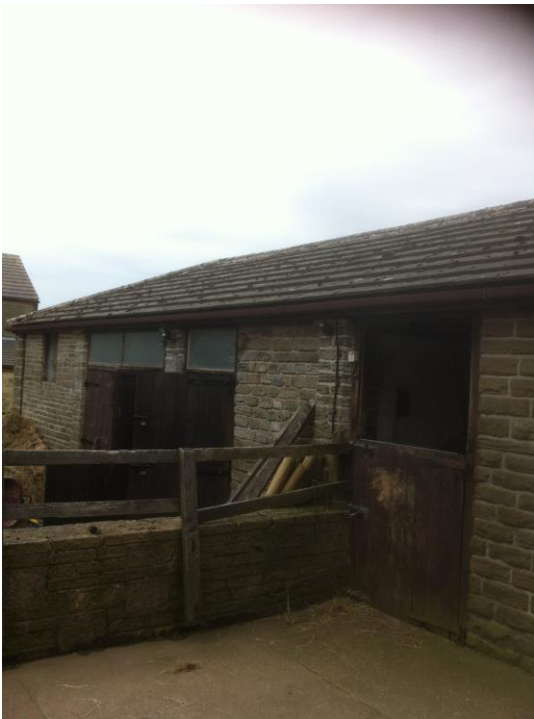
*Photo 9*

The pitched roof has been repaired using roofing felt and flat concrete interlocking tiles approx 15 years ago. The hip and ridge tiles are intact and well pointed, with no sign of undue sagging of the roof profile. The eaves' alignment is good with no significant deviation . (photo 9)

Structurally the roof timbers and cover are in a good state of repair. However a check on the loading capacity of the main roof members will be required should the roof cover be changed to a heavier slate.

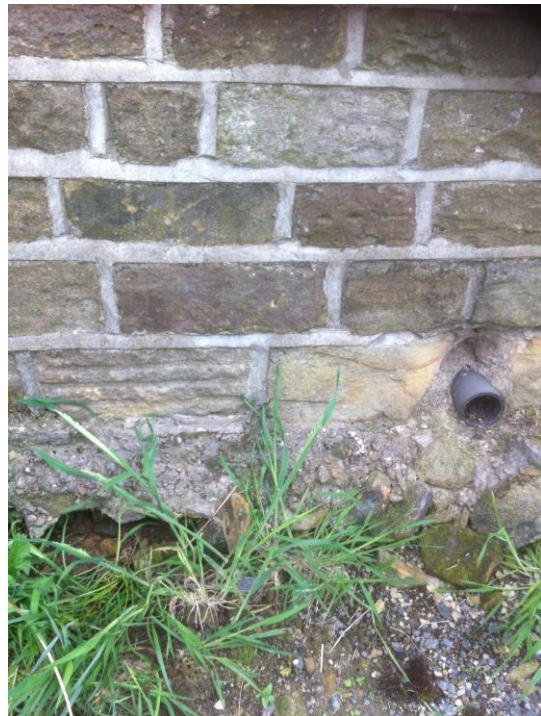
*Photo 10*

Whilst there are no indications of significant foundation movement ( recent or otherwise ), there is a discharge pipe at the north elevation which discharges run-off from the internal ground slab to the ground immediately adjacent to the north elevation wall. (photo 10)

Generally, any such periodic inundation of the ground near to foundations potentially can be a source of movement / subsidence of foundations .We would therefore normally recommend that such drainage and the drainage for surface water run - off be improved to discharge water away from the building , by such as connecting into the public drainage system if possible or if not, by providing a soakaway.
