## **Report for Stud Farm, Carlton, Yorkshire**

### **Extended Phase 1 (including Protected Species) Survey**

**Date of Report – 10<sup>th</sup> September 2010**

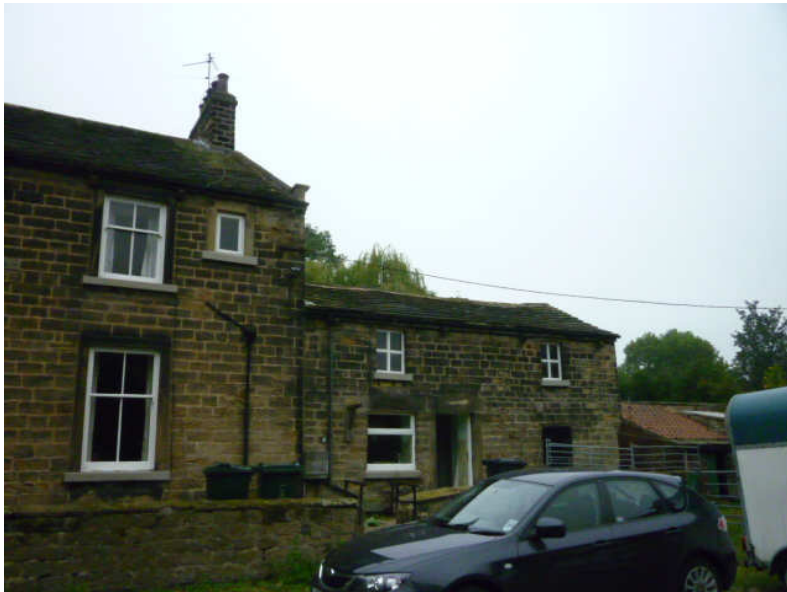
**Photo 1: Main House**

The house was detached, part three-storey and in part two-storey. The walls were stone, and it had a stone roof (stone slabs). The building was aligned in a north/south direction, giving the roof an east/west aspect.

The roof was in sections at more than one height, with gable ends on each section. Timber purlins and rafters supported it, and these in turn were supported by beams in both 'queen' and 'king' post patterns. The beams had some mortised joints that all appeared to be tight fitting and covered in spiders' webs. The roof had equal pitches on each section. There were no missing slabs, but there were gaps under and between some of the slabs, but these were all webbed up. The slabs weren't lined in the three-storey part, being sealed with cement torching. The rears of the slabs were clearly visible for survey.

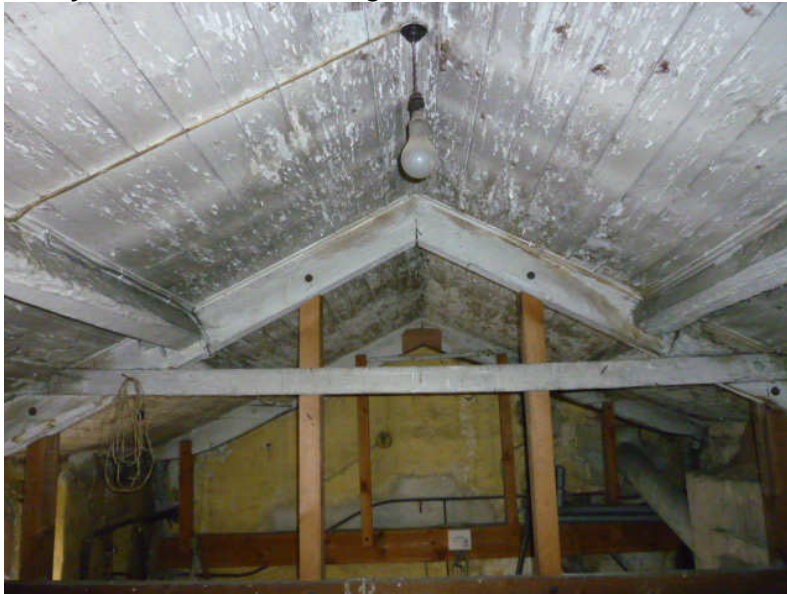
**Photo 3: Wooden sarking lining roofing slabs**

In the two-storey part, the roof had wooden tongue and groove sarking lining the slabs. The rear of the slabs could not be seen, and there may have been a cavity between the sarking and the roof slabs.

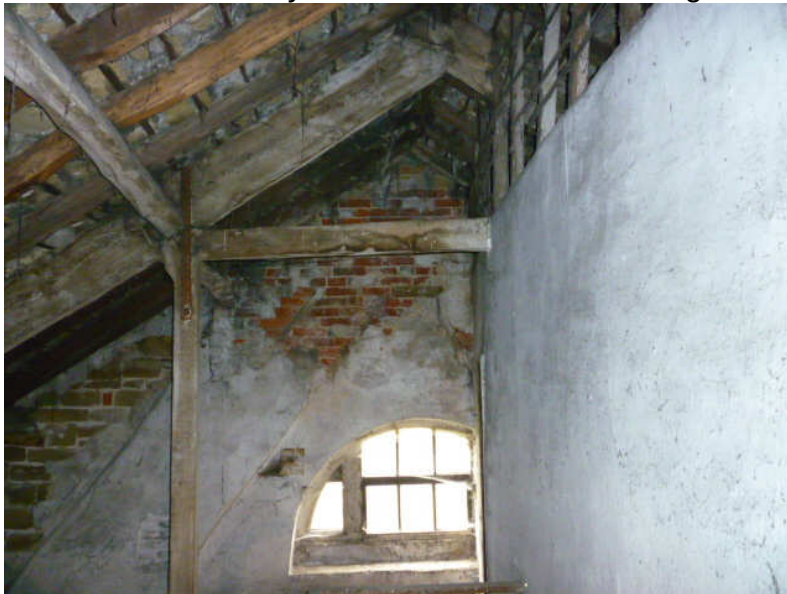
**Photo 4: Windows in attic**

There were 2 attics forming the upper storey in each section, which were fully accessible for survey. Both had windows, making them well lit.

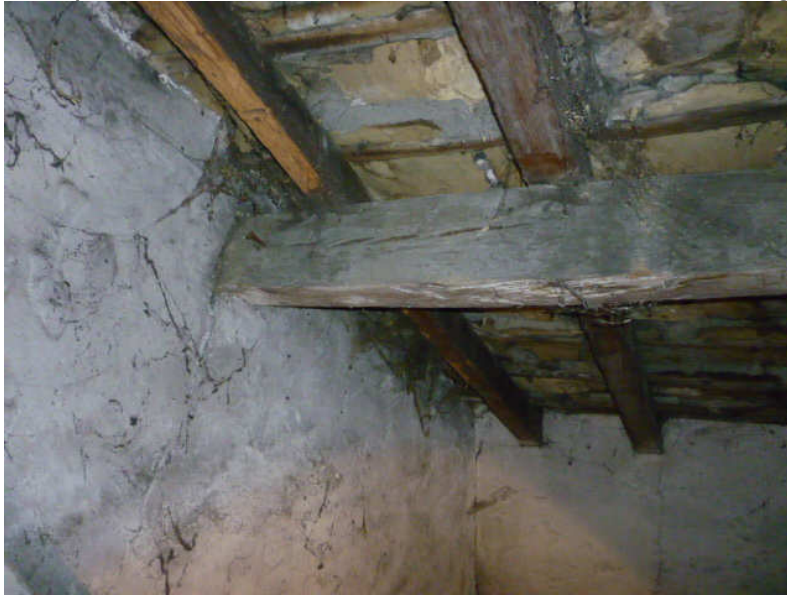
**Photo 5: Showing level of webbing in roof timbers**

There were many webs in these attics, indicating that nothing had disturbed the space for some time, these webs were from the ridge board to the joists.

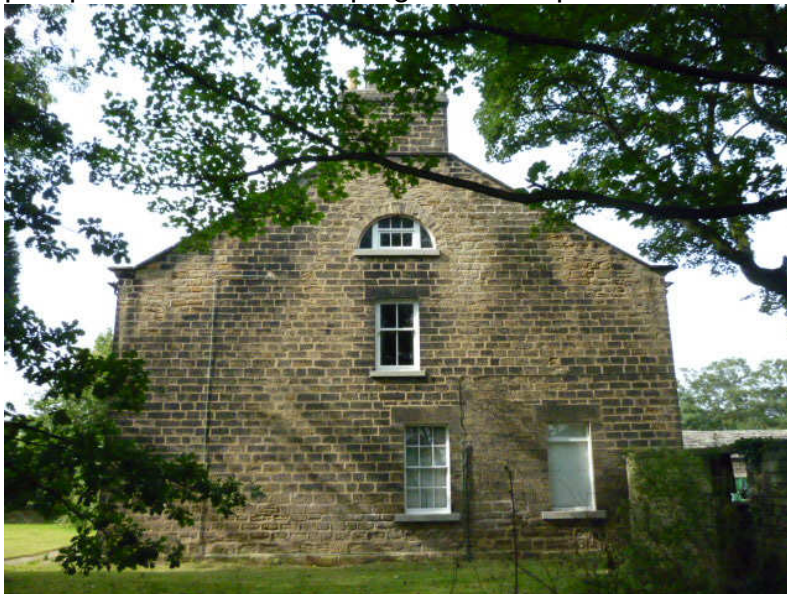
**Photo 6: Gable end of House**

The ridge tiles were all in place, and there were some gaps under them. There were wooden soffits and fascias, and there were some gaps under these. The eaves were covered in spiders' webs. There were wooden framed windows and doors, and there were no gaps or cavities around these. The lead flashing over the chimney joint was tightly fitted with no gaps or cavities, and the lead flashing over the various joints between the roof sections had no gaps. There were cavities in some of the stone work, but these were full of webs. There were no gaps or cavities in the pointing on the gable ends and the gables had parapets with all their coping stones in place.

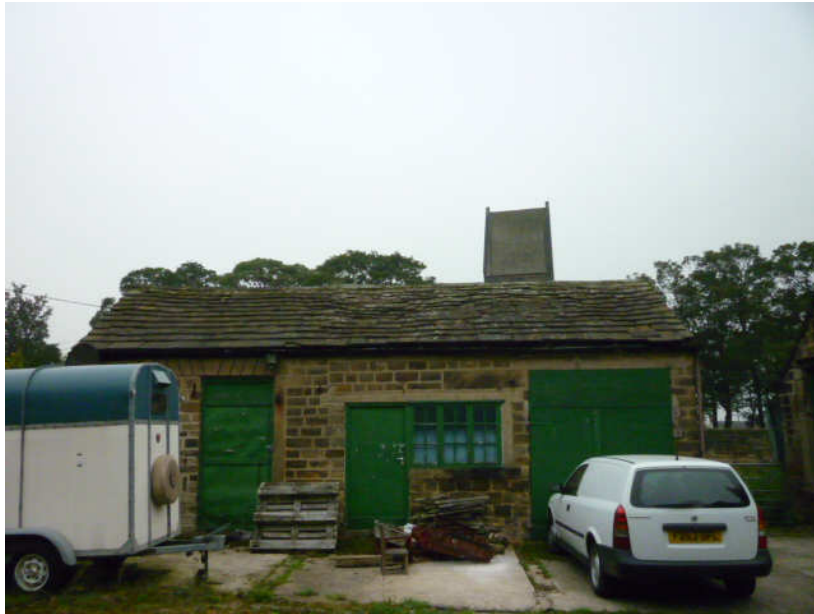
**Photo 7: Outbuilding a**

This outbuilding was a detached single-storey building. The walls were stone, and it had in part a stone roof (stone slabs), in part corrugated steel and in part composite pan tiles. Some of the building was open fronted and some had been used as a butchery. The building was aligned in an east/west direction, giving the roof a north/south aspect.

The roof was in sections at more than one height, with gable ends on each section and valleys between the sections. The roof had equal pitches on each section. There were no missing slabs or tiles, but there were gaps under and between some of the slabs and tiles, but these were all webbed up. There was a roof void, which was not accessible for survey.

The ridge tiles were all in place, and there were some gaps under them. There were no soffits or fascias. The eaves were covered in spiders' webs. There were wooden framed windows and doors, and there were no gaps or cavities around these. There were cavities in some of the stone work, but these were full of webs. There were no gaps or cavities in the pointing on the gable ends.

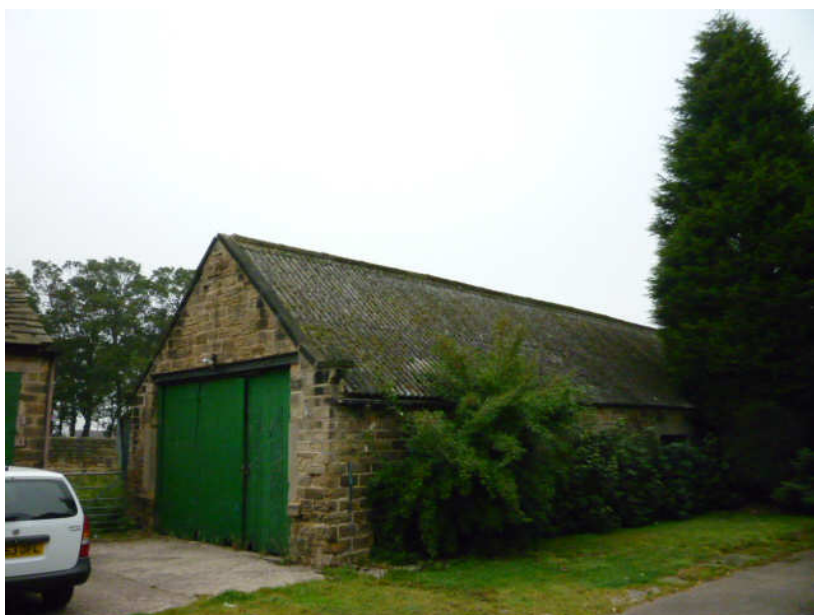
**Photo 8: Outbuilding b**

This outbuilding was a detached single-storey building. The walls were stone, and it had a corrugated asbestos (type) sheeting roof. The building was aligned in an east/west direction, giving the roof a north/south aspect. The roof was at one height, with gable ends and equal pitches on each side. There were no missing sheeting, but there were gaps under and between some of the sheets, but these were all webbed up.

The roof was supported by wooden purlins, rafters and beams and these were in the main visible for survey, although one section had a ceiling which was in a poor condition, and the roof timbers weren't totally open for survey. The roof timbers that were visible were webbed over, including all the mortised joints. The ridge tiles were all in place, and there were some gaps under them. There were no soffits and fascias. The eaves were covered in spiders' webs. There were wooden framed windows and doors, and there were no gaps or cavities around these. There were cavities in some of the stone work, but these were full of webs. There were no gaps or cavities in the pointing on the gable ends and the gables had parapets with all their coping stones in place.

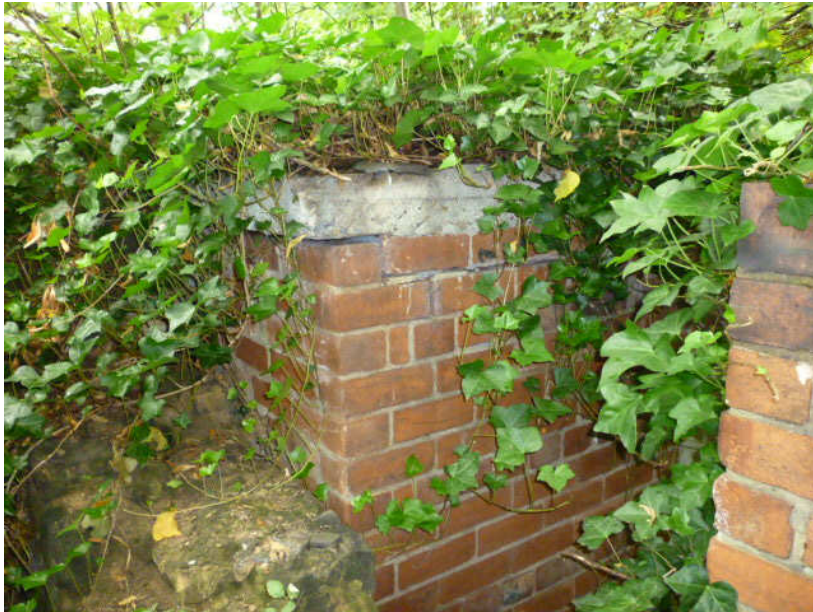
**Photo 9: Air-raid shelter**

There was a brick walled shelter, with a solid concrete block roof in the garden to the rear of the greenhouses. It was covered in ivy. It was open for inspection on the inside.

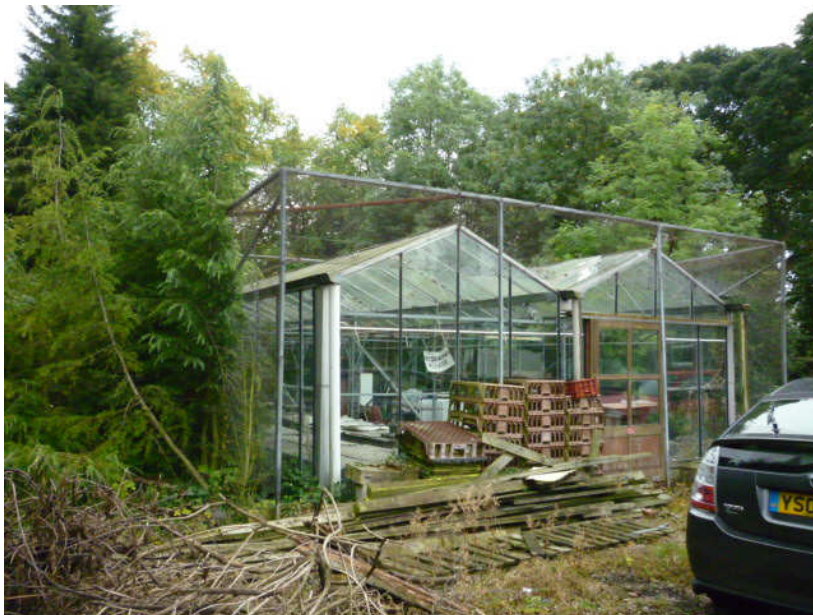
**Photo 10: Greenhouses**

These were aluminium framed glass houses, and would be unsuitable as bat roosts.

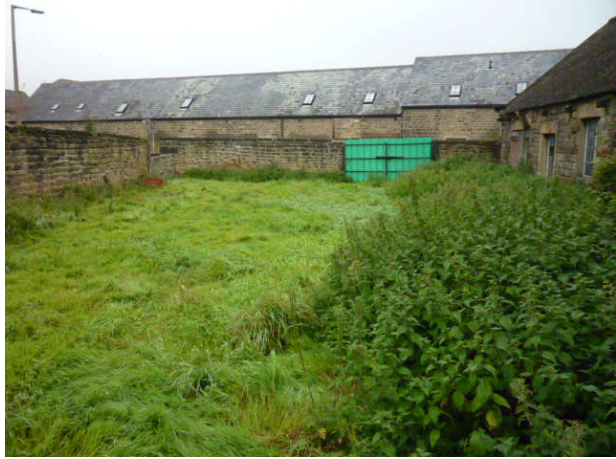
| Note | Legend | Photograph |
|---|---|---|
| 1<br>Field a | This field was improved grassland and appeared to be managed for a hay crop. See note 1, after table for species list of plants in the fields. | |

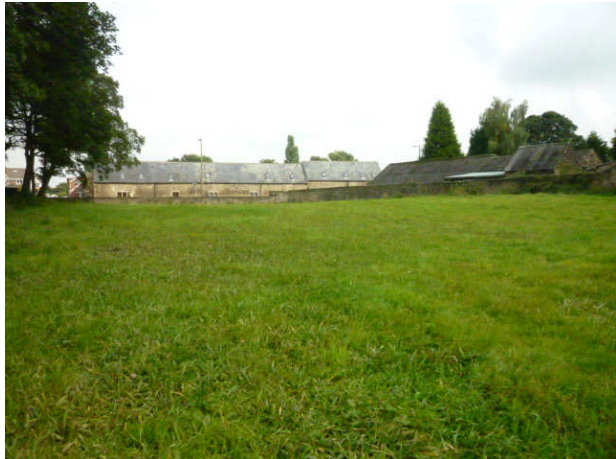
| Note | Legend | Photograph |
|---|---|---|
| 2<br>Field b | This field was also improved grassland and appeared to be managed for a hay crop. See note 1, after table for species list of plants in the fields. | |

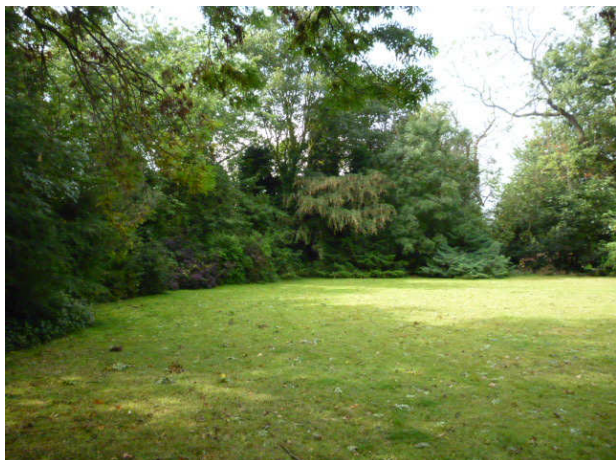
| Note | Legend | Photograph |
|---|---|---|
| 3 | The garden was mainly closely mown amenity grass, with trees and (mainly) introduced shrubs in borders, just inside the garden boundaries. There was some tall ruderal growth within the borders. See note 2, after table for species list of plants in this area. | |

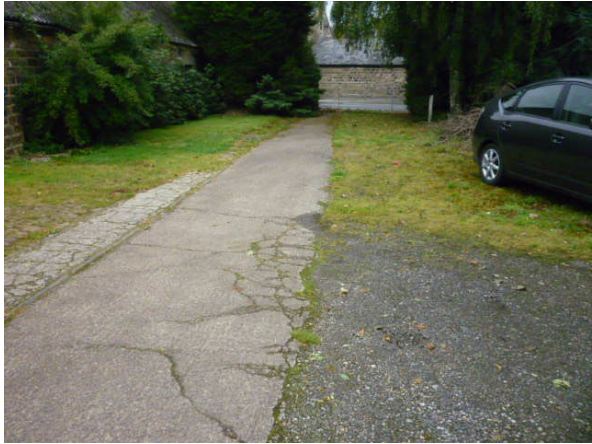
| Note | Legend | Photograph |
|---|---|---|
| 4 | <p>The area to the east of the house was hardstanding (compacted gravel), with some annual growth and self-sown tree seedlings. See note 3, after table for species list of plants in this area.</p> | |

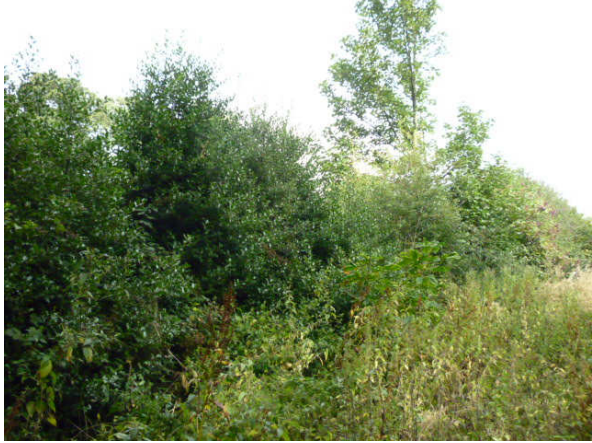
| Note | Legend | Photograph |
|---|---|---|
| 5 | <p>The hedge between the garden and field was a large overgrown defunct hedge, about 50m in length with hawthorn, holly, ash, rowan, sycamore and elder all present (see note 4 after table for scientific names of hedgerow species).</p> | |

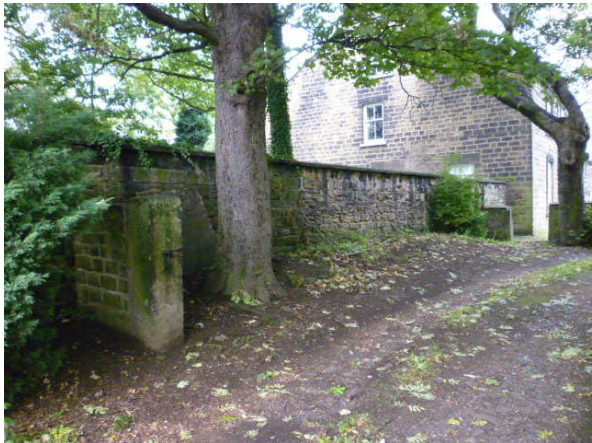
| Note | Legend | Photograph |
|---|---|---|
| 6 | <p>Most other boundaries on the site were cemented stone walls, with coping stones cemented in place. There were very few cavities within these as the pointing was mostly in good order. There were also some fences on some boundaries.</p> | |

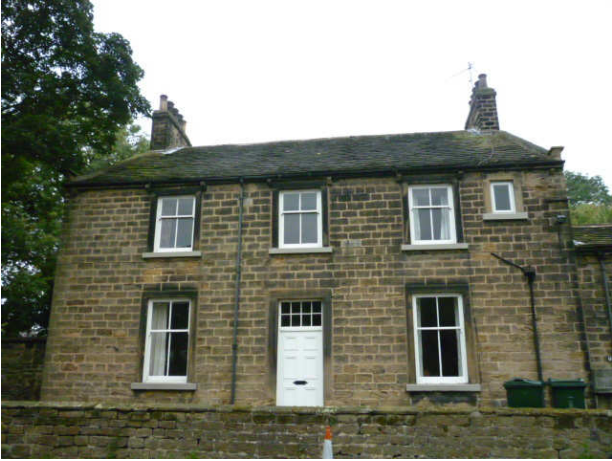
| Note | Legend | Photograph |
|---|---|---|
| 7 | <p>There were a range of buildings on the site, including the house and several outbuildings. No evidence of bats was found in any of these, but there were many nooks and crannies where bats could roost. There were also several old nests in the buildings, particularly the outbuildings, but none were active</p> | |

- 3) Further surveys on bats would be beneficial before any works were carried out on the buildings or site, so that bat activity on the site could be monitored. Emergence/re-entry surveys would be best, which can only be undertaken in the bats' active period (May – September). Each emergence/re-entry survey takes about 2-3 hours and consists of people positioning themselves so that all the buildings, in their entirety, can be observed, particularly the roofs, the surveyors then observe bat activity with the aid of a bat detector and record any activity. These surveys are undertaken either at dusk or dawn, and it is recommended that at least one survey incorporate a dusk and dawn survey in the same 24-hour period. Please note that up to 3 emergence/re-entry surveys may be required as recommended in *Bat Surveys Good Practice Guidelines 2007* produced by the Bat Conservation Trust, which is the recommended standard bat survey text. These surveys cannot be undertaken unless the weather conditions are suitable (preferably warm and dry). As the buildings are also near the best foraging areas for the bats, this should also adequately monitor the use of the site by bats.

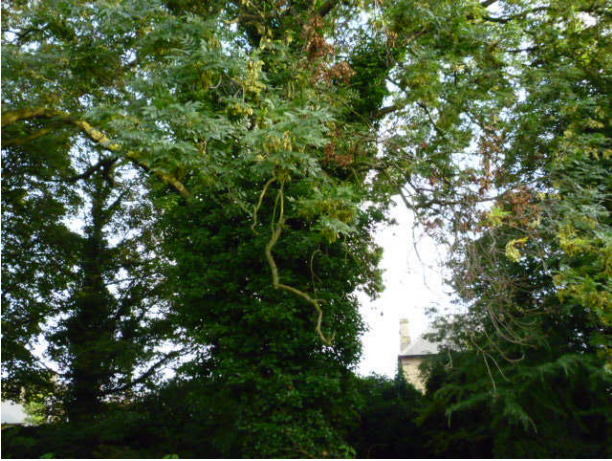
| Note | Legend | Photograph |
|---|---|---|
| 8 | <p>There were many trees and shrubs on the site, which would provide suitable roost sites for bats and nest sites for birds, and there were many old nests found during the survey, but none were active. See Table 3, for notable tree list.</p> | |
