Interior design

19 06/02/2019 Not attributed No deadline Not completed No final discharge

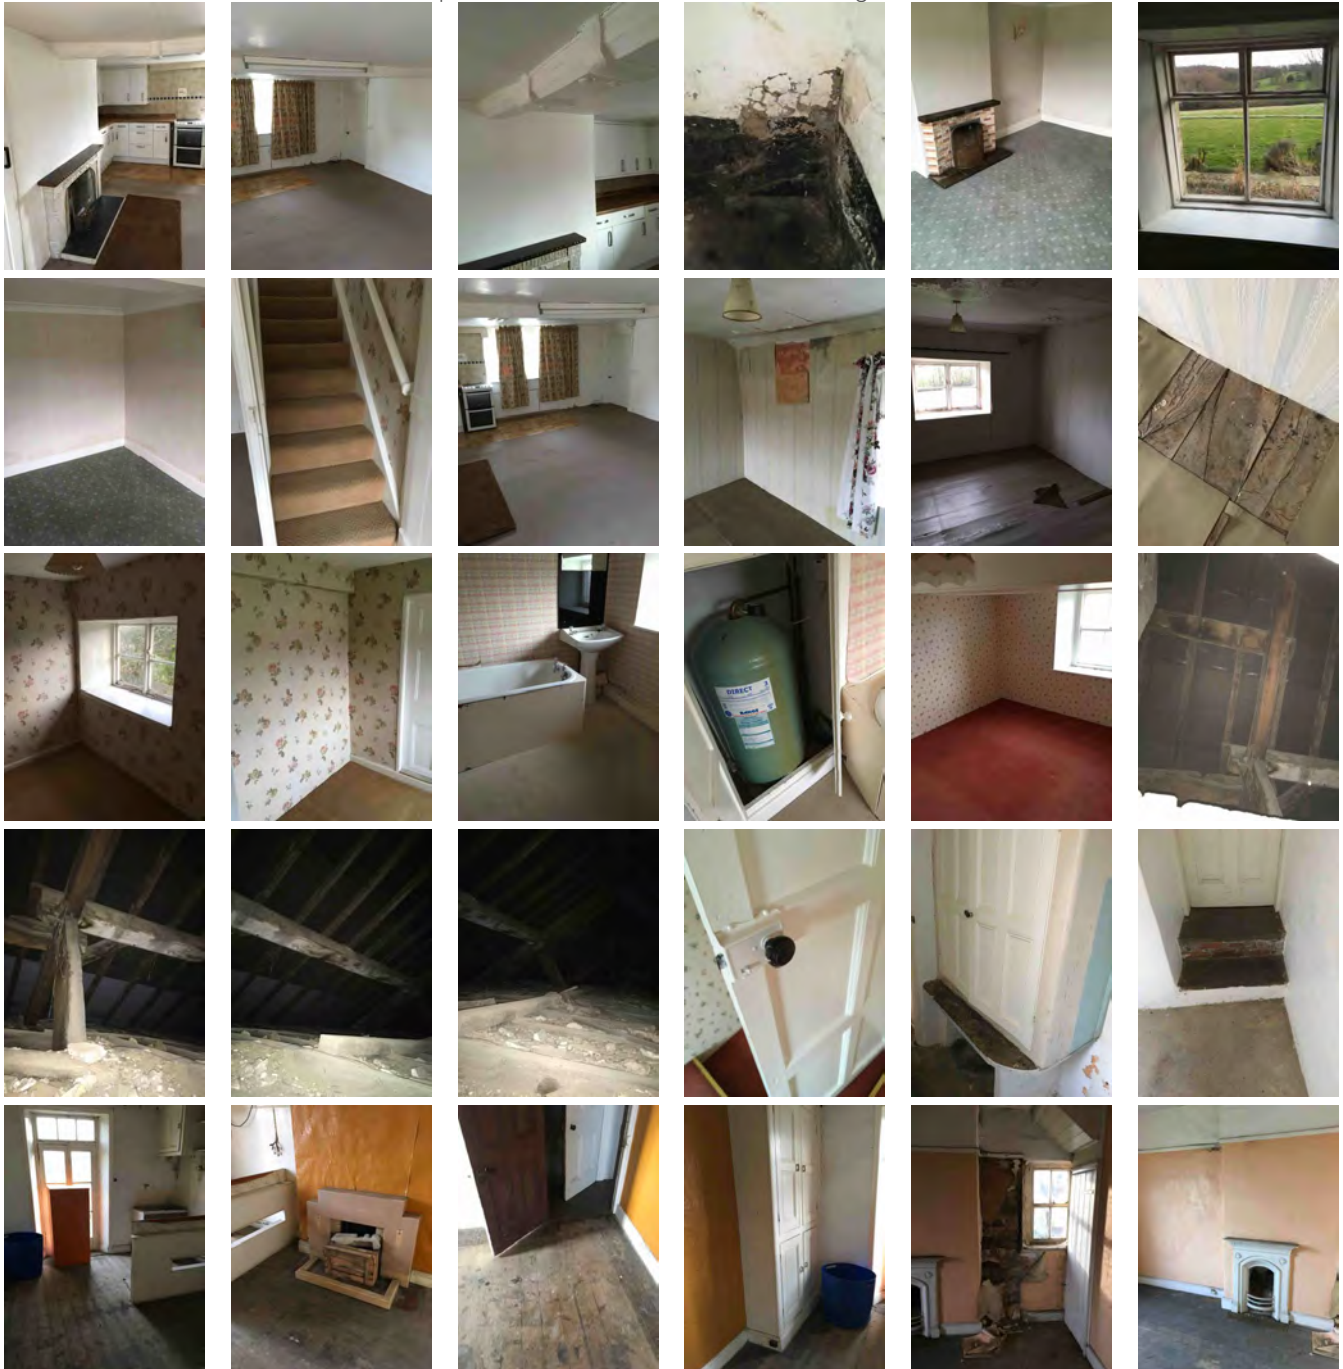
Original house - built pre 1840's low ceiling heights with low beams running through ground floor. Visible repair work and bracing to timber beam, visible drop in area. Potential damp issues to living room and kitchen external walls due to lower floor level than external ground level. Upstairs - low ceiling heights in places with low doors. Old style panel doors in areas. Compromised bedrooms due to height of main roof structure. Possible to open up. Original wide plank flooring in larger bedroom to be retained and re-used. Visible damp in larger room due to connecting roof and missing lead work. Roof structure appears to be in good condition - limited access.

Newer victorian style building - more solid construction and more generous floor to ceiling heights. Large basement under property. Original fire place on first floor, original doors and pantry's in rooms. Attic floor showing signs of serious water ingress and mortar wash out. Chimney requires immediate attention - visible lean to top section of brickwork, visible daylight through main stack from internal and external inspections. Remainder of roof timbers in good condition
