8<sup>th</sup> November 2024

**Summary Comments on T1 and T4, Sycamores trees at 10 Thurnscoe Hall Mews, High Street, Thurnscoe, S63 0AF**

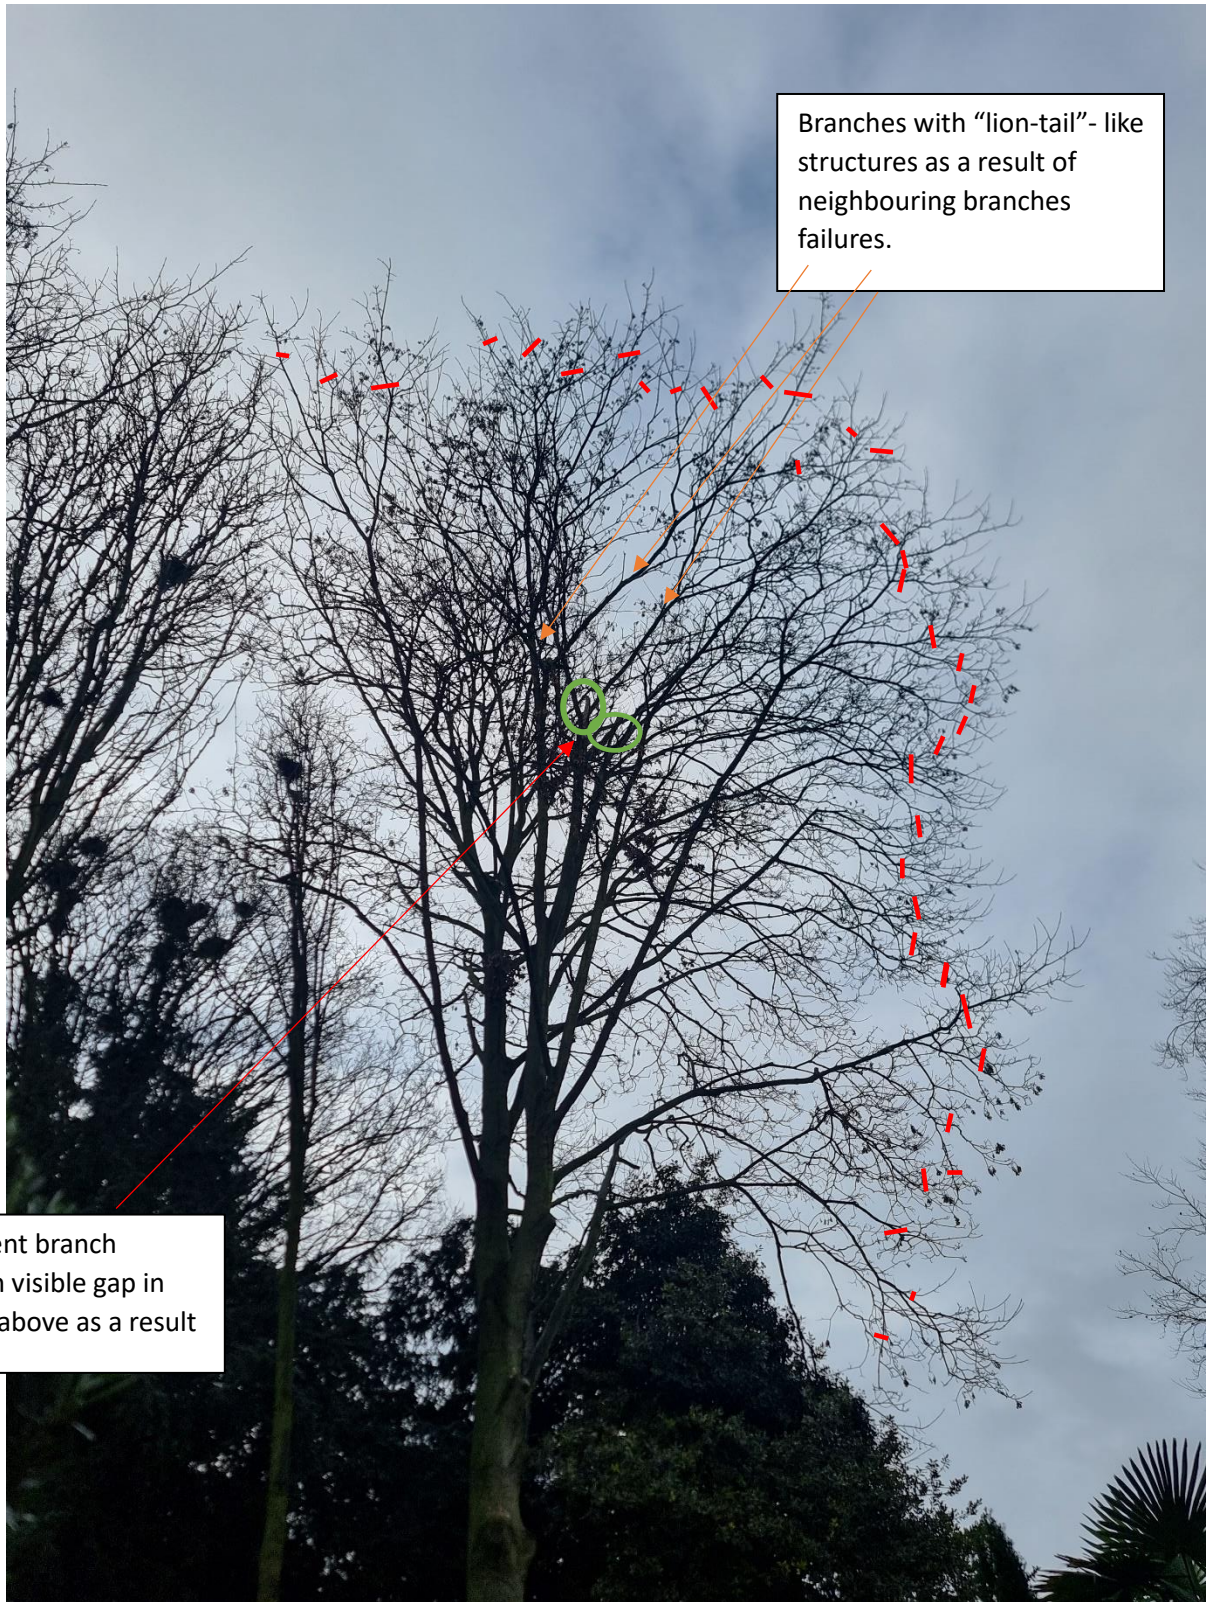
Two large branches failed in the upper part of the crown at around 14m on the 23<sup>rd</sup> August 2024. Minor hanging broken branches are also present in the northern side of the canopy.

The two branches that failed were within the western upper section of the canopy of tree T1. They failed at branch unions.

As observed from ground level, the wounds appear clean but are situated close to branch unions of branches still present.

The remaining branches that are still attached to the unions that failed, have "lion- tail" - like structures, and the wounds at the unions elevate a risk of decay at these areas.

Branches with “lion-tail”- like structures as a result of neighbouring branches failures.

Area of recent branch failures with visible gap in the canopy above as a result

Figure 1: tree T1 with proposed pruning points to suitable union approximately illustrated by red lines. These are indicative and the final pruning points will be determined by the arborist on site during the climb. The wounds of the recent branch failures are indicated in blue circles.

A minor crown reduction by 0.5m- 1m of the upper and western canopy of this tree to suitable pruning points is proposed, to reduce these remaining branches with "lion-tail" structures to reduce the wind loading on them, considering the wounds at the unions. This is to reduce the likelihood of them failing onto targets below.

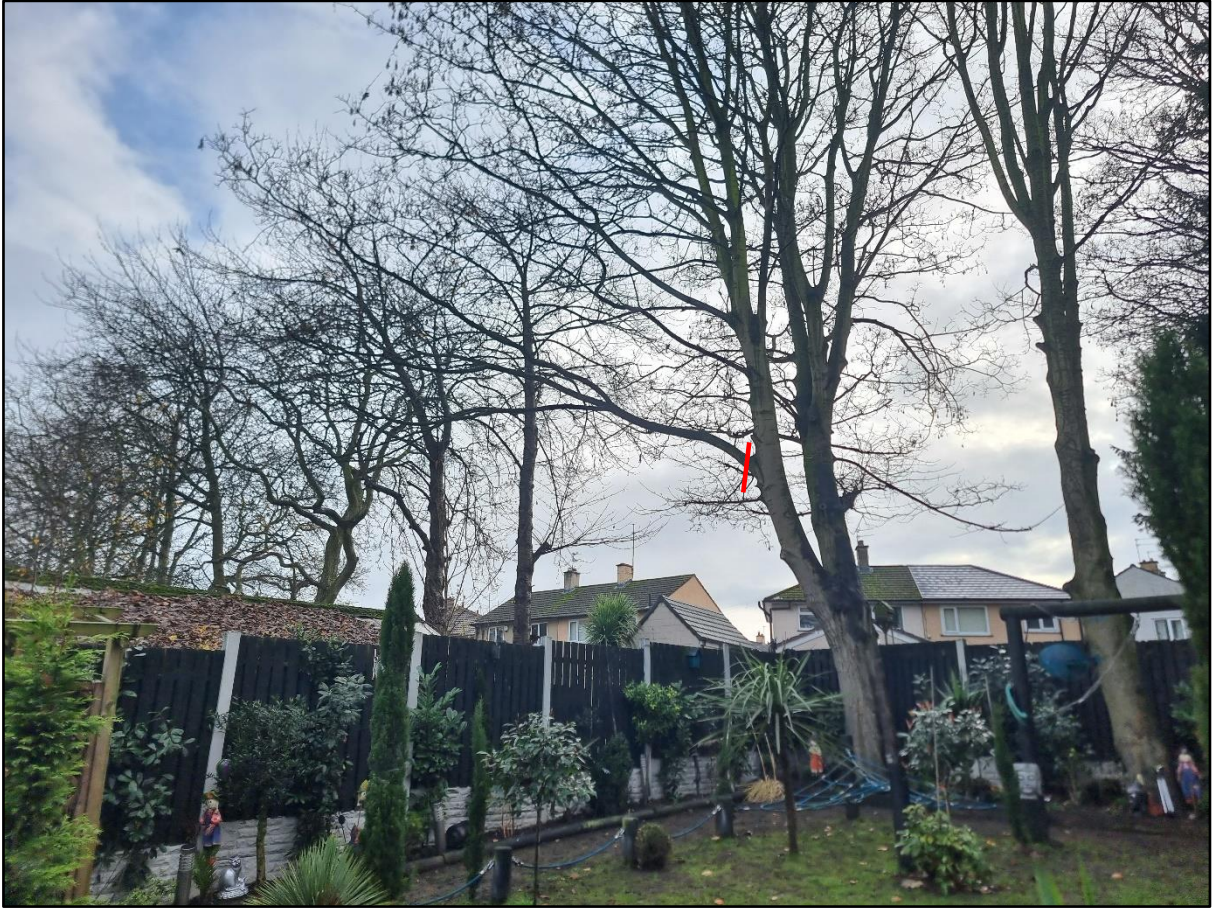
## Tree T4- Sycamore

*Figure 2: Tree T4 with branch proposed to be crown lifted indicated. Pruning point indicated by red line.*

One branch on the northeast of T4 @ around 4m above ground level is proposed to be crown lifted for clearance above neighbouring garage. This branch is becoming over-extending beyond the extremities of the canopy (Figure 2)

Pruning work must be carried out to suitable pruning points as per BS998:2012 by a suitably qualified and experience arborist.
