Ref: Dit/23/066

REF: Fairfield Garages – Masonry Boundary Wall – Structural Report

Site Photos – 5th December 2023

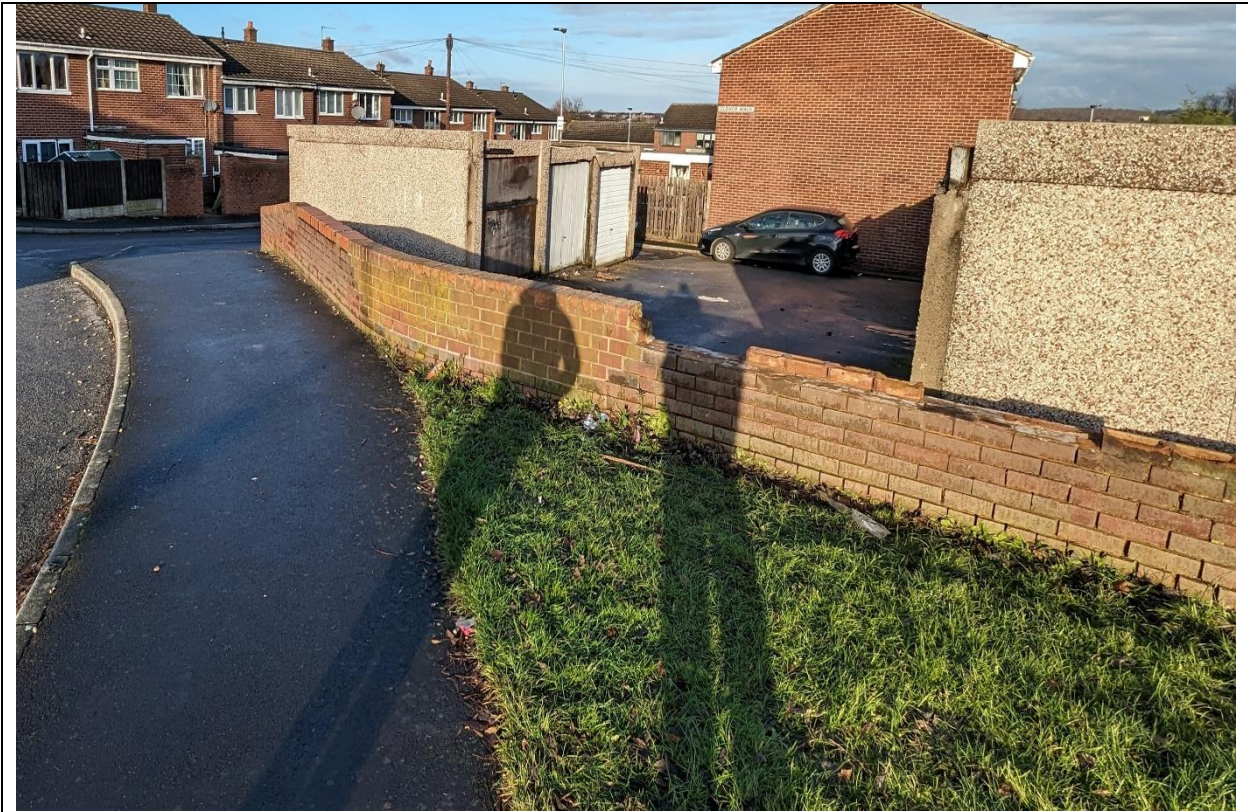
Photo – 1 – View on Wall and garages

There is a solid 9" masonry wall on the boundary to Fairfield. The wall is approx. 1300mm above the low parking area, and retains approx. 600mm of the pavement and grass verge on the upper corner. The wall extends approx. a max 700mm above the pavement and verge on the top side, and curves following the line of the road. Refer to photos 1, 2 & 3.

Sections of the masonry wall towards the grassed verge are damaged with the top 2 courses removed, refer to photo 1 & 2. These should be replaced. We also suggest that to increase the integrity of the wall that sections will require repointing.

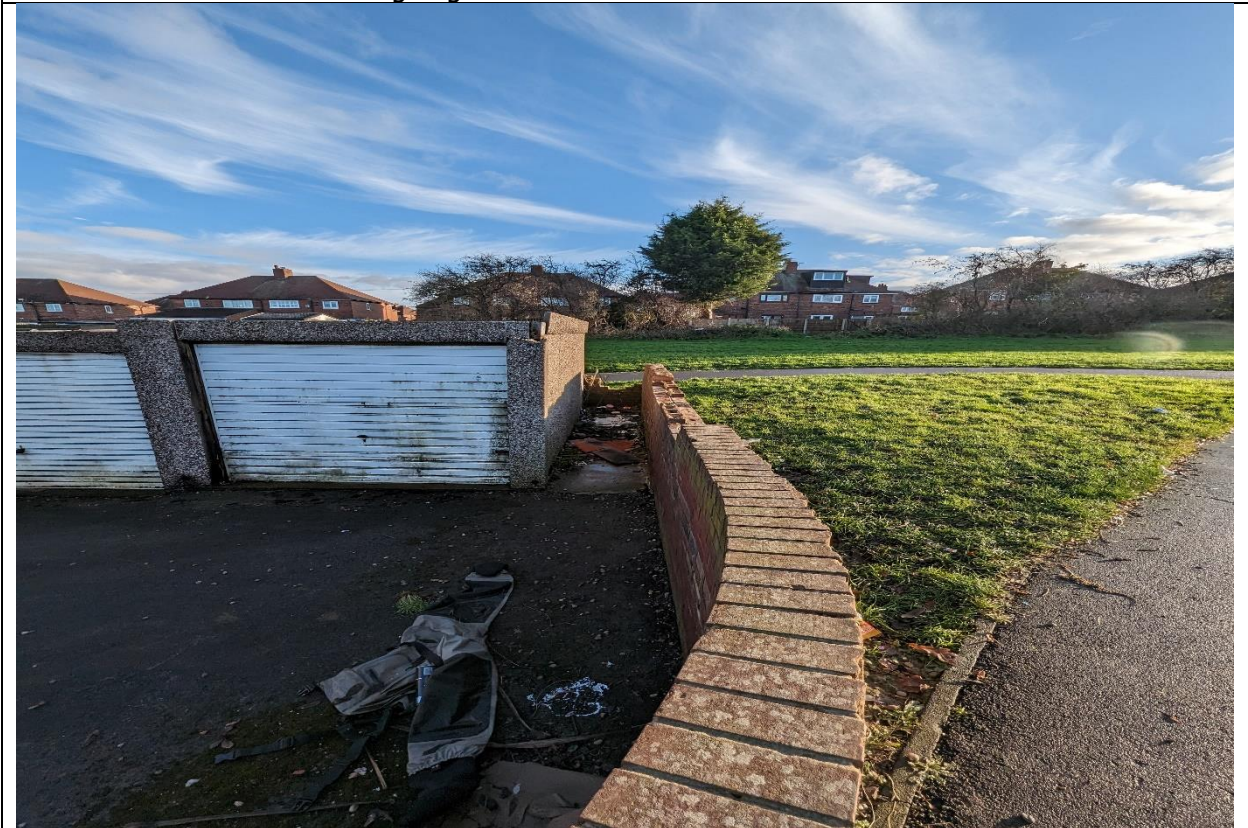
Photo 2 – Showing curve on wall and retained path and grass verge and missing section to top of wall

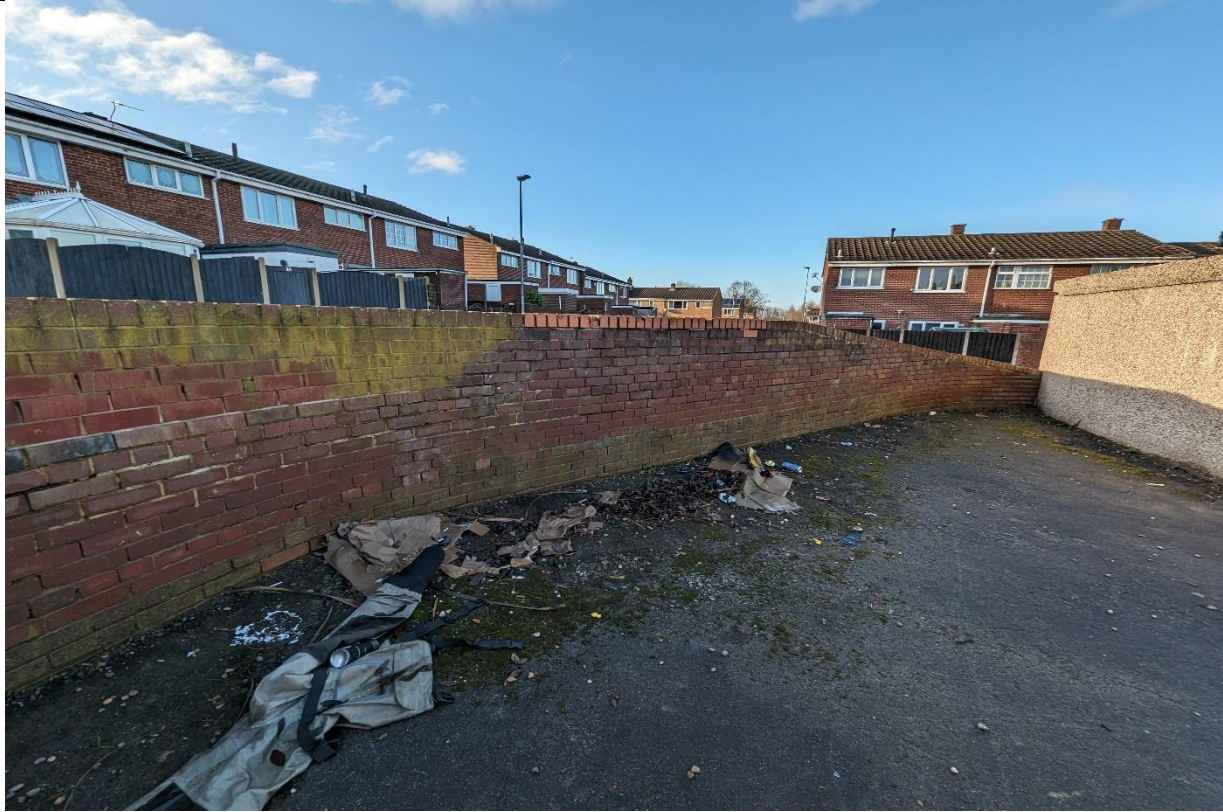
Photo 3 – View on Low side of wall

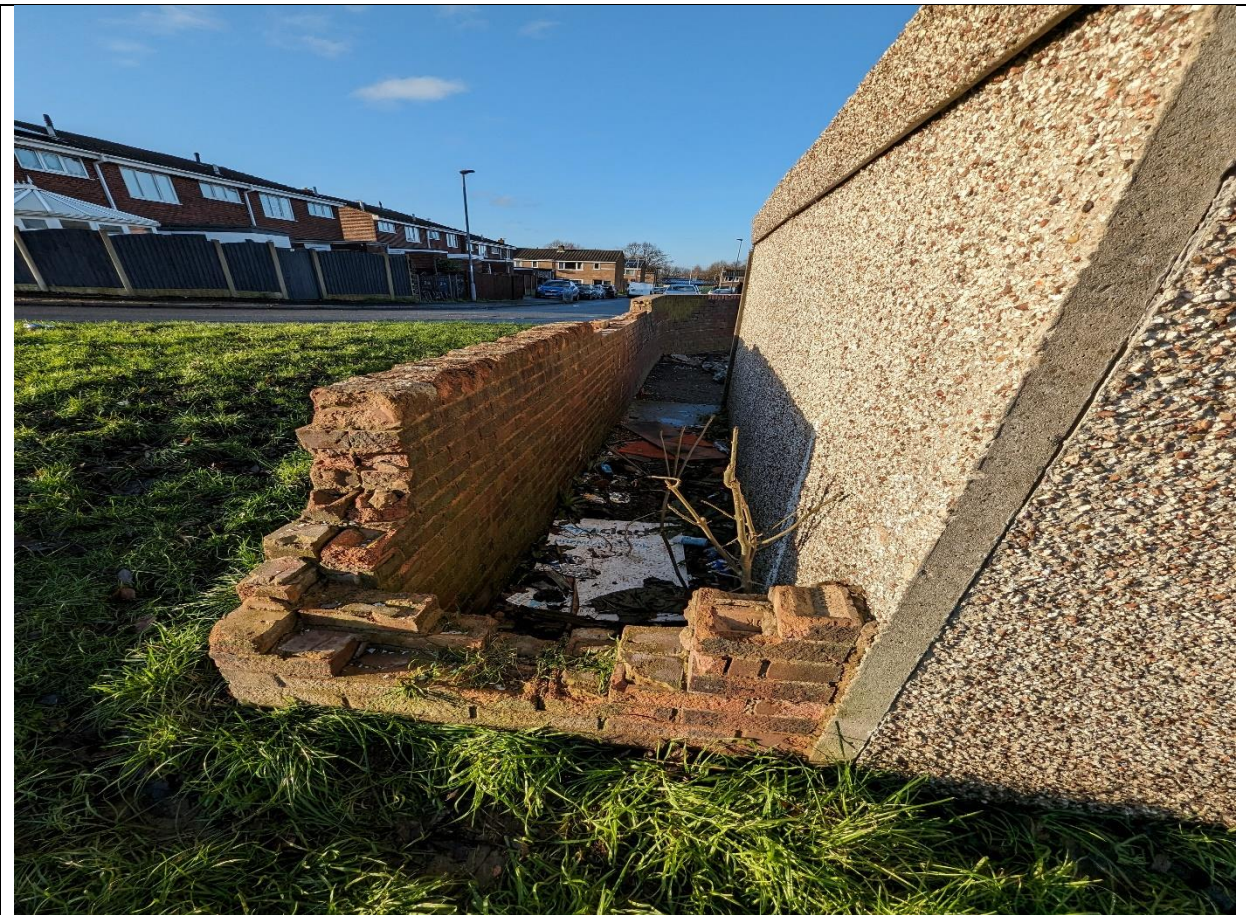
The return corner of the wall, up to the backs of the garages, photo 4, requires rebuilding to restrain the main section of wall. Once the garages have been removed the wall may also need extending and tapering down. The grass verge can also be graded from the footpath to the level of the new tarmac / garages bases to remove level differences and trip hazards. Refer to photo 5.

Photo 4 – View on return corner of wall showing damage

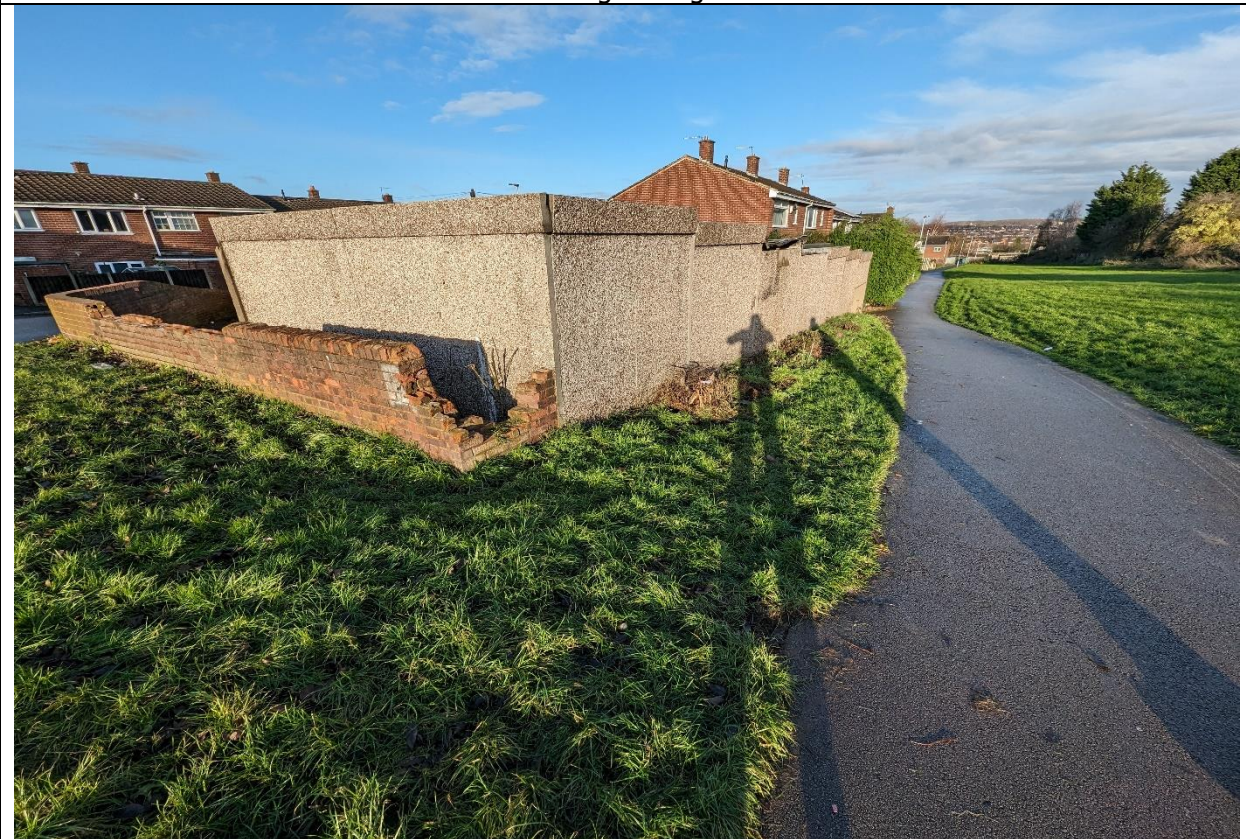
Photo 5 – View on rear of garages, on wall return, showing grass verge and path level
