# High Street/ Crabtree Drive, Great Houghton – Dilapidation Survey

Carried out 03.12.2025

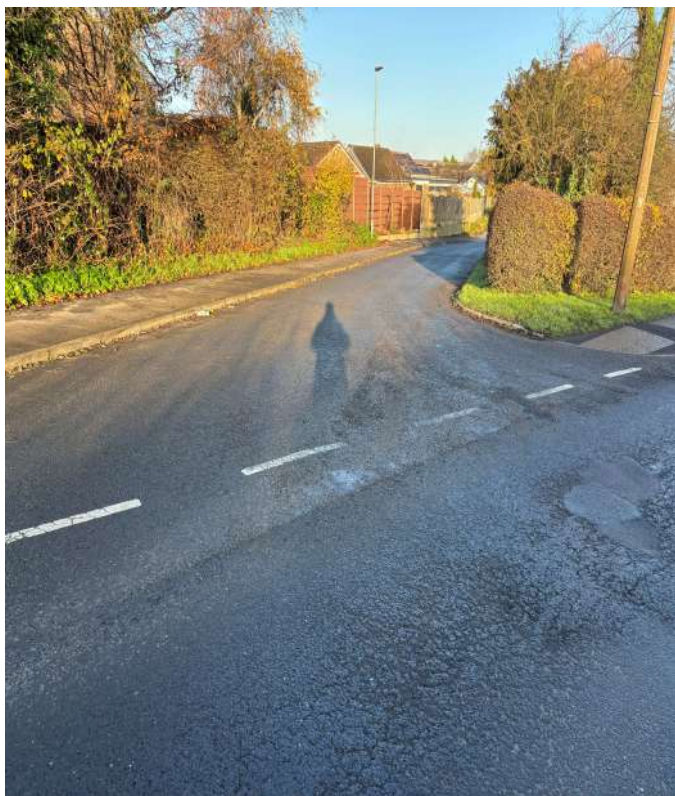
**1** – Entrance to bus stop off High Street onto Crabtree drive.

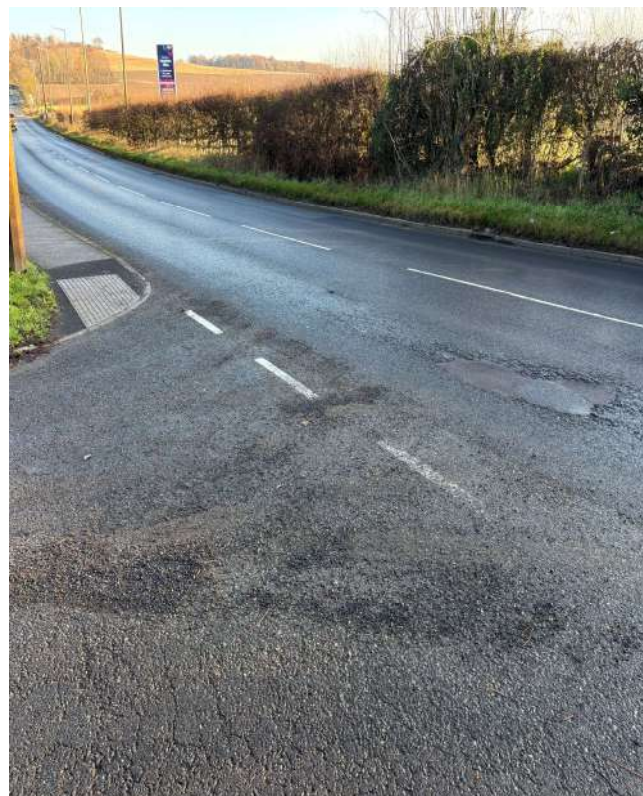
**2** – Patches of reinstated tarmac highway cracking and rutting.

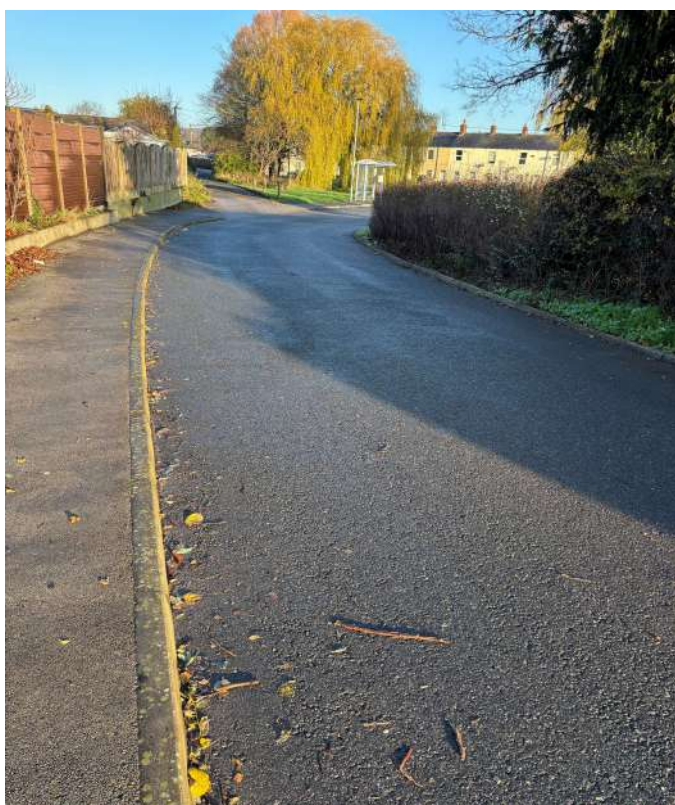
**3** – Highway and Footpath in good condition.

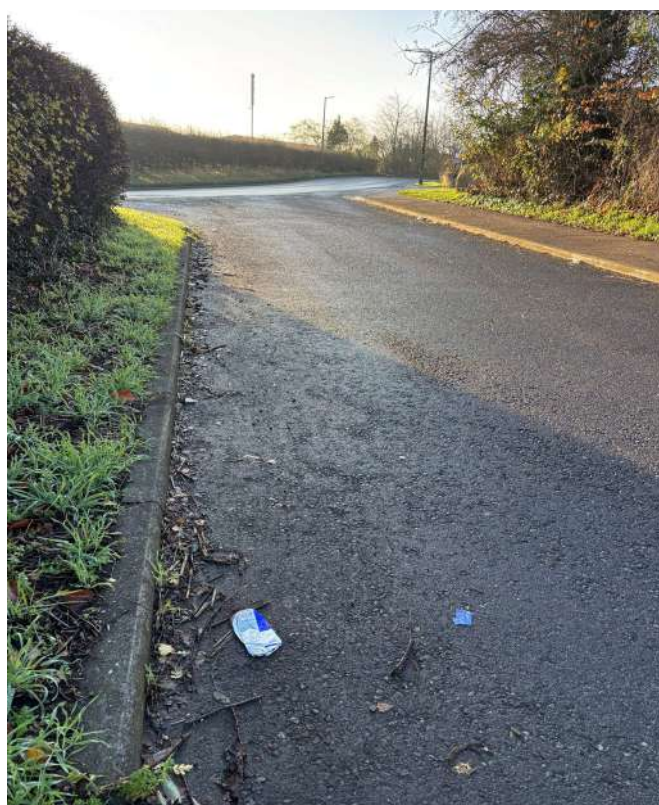
**4** – Highway and Kerb line in good condition.

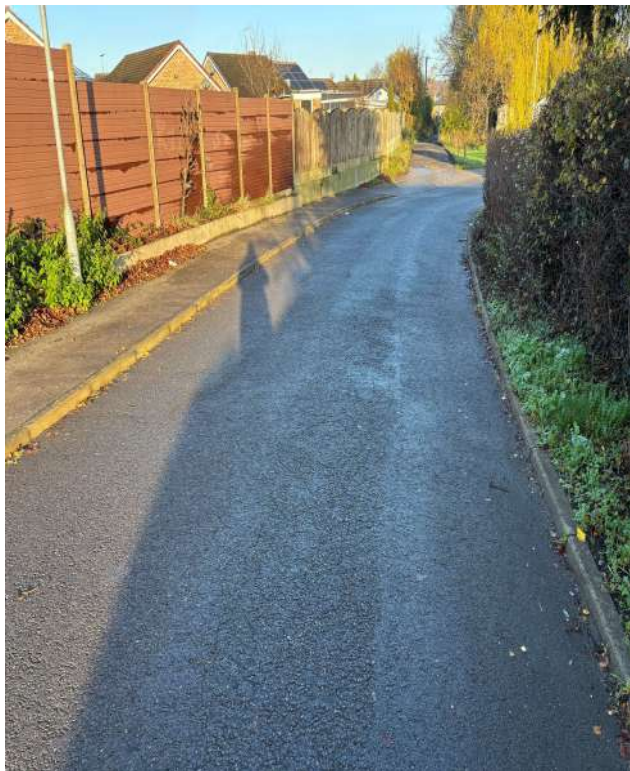
**5** – Carriageway generally in good condition.

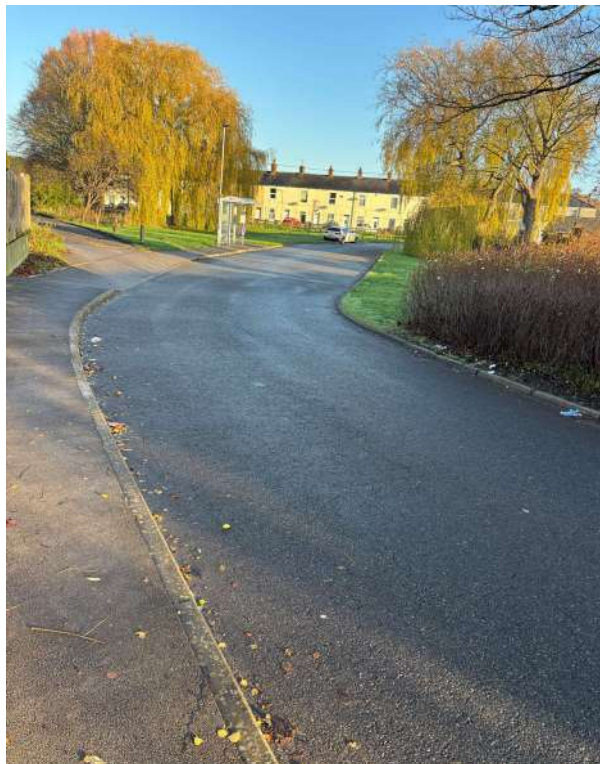
**6** – Very Minor Cracking along centreline of highway.

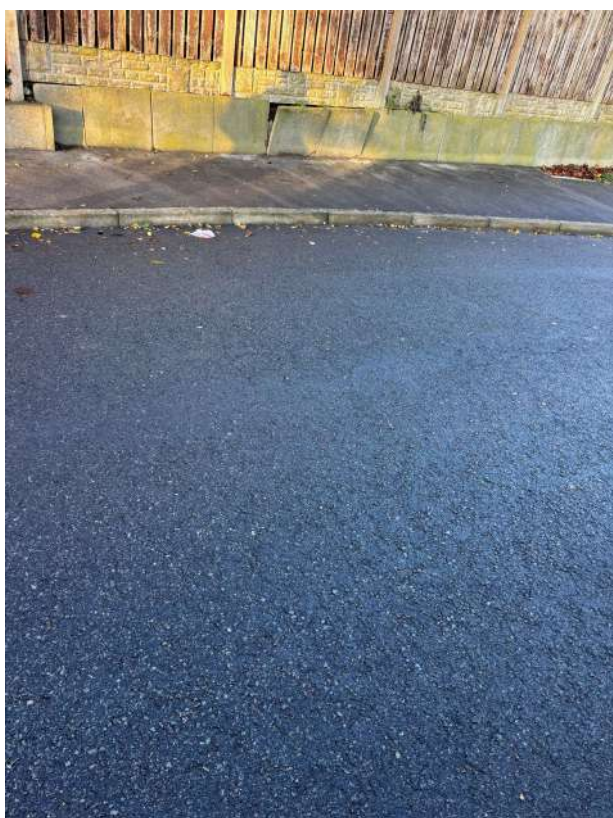
**7** – HRW flags leaning onto Footpath.

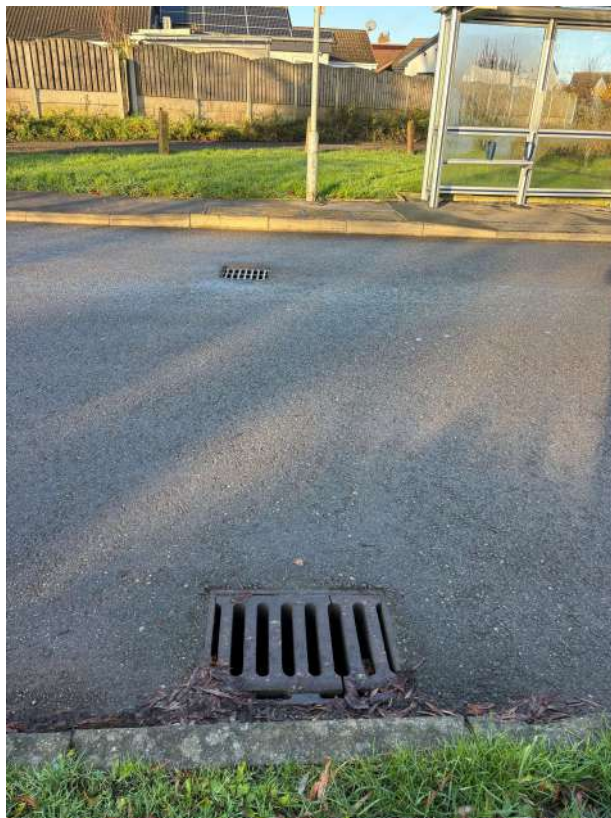
**8** – Gully lids to receive heavy traffic, in fairly good condition.

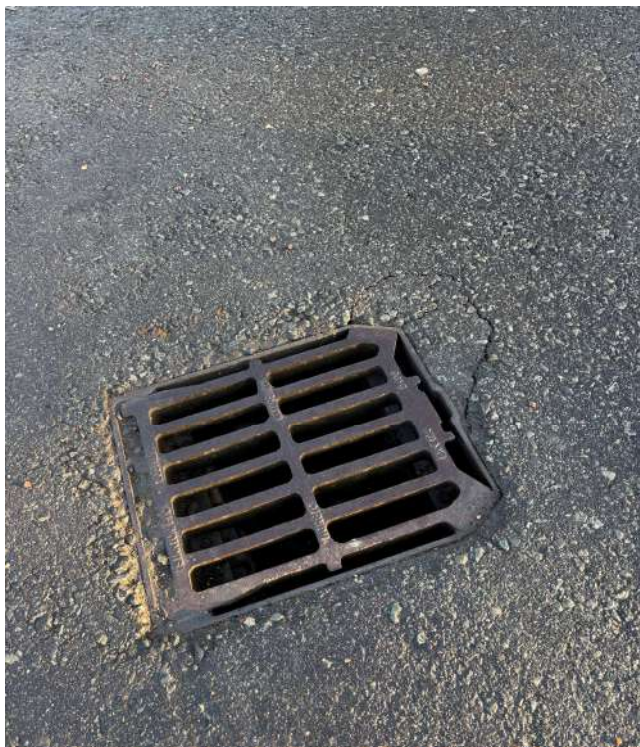
**9** – Further photo of gully, crack in tarmac to the side of lid.

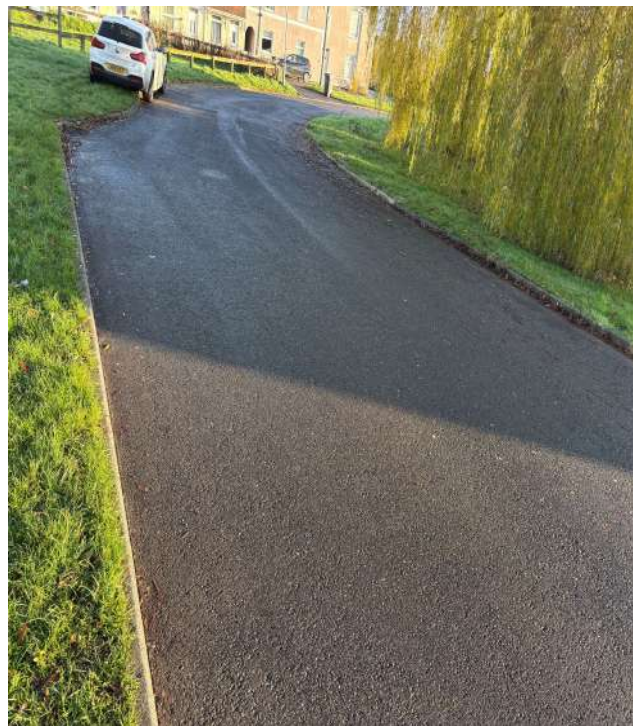
**10** – Carriageway in good condition.

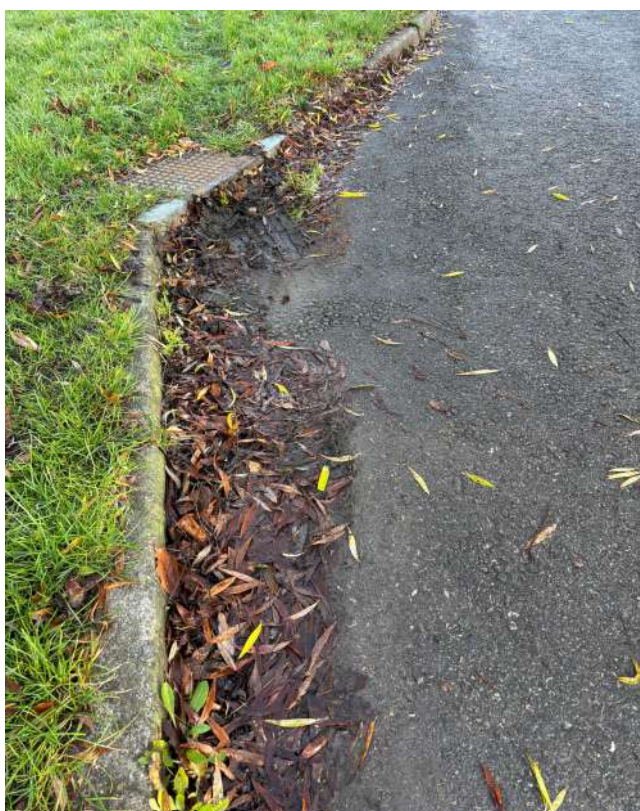
**11** – Gully blocked, needs to be cleared from debris.

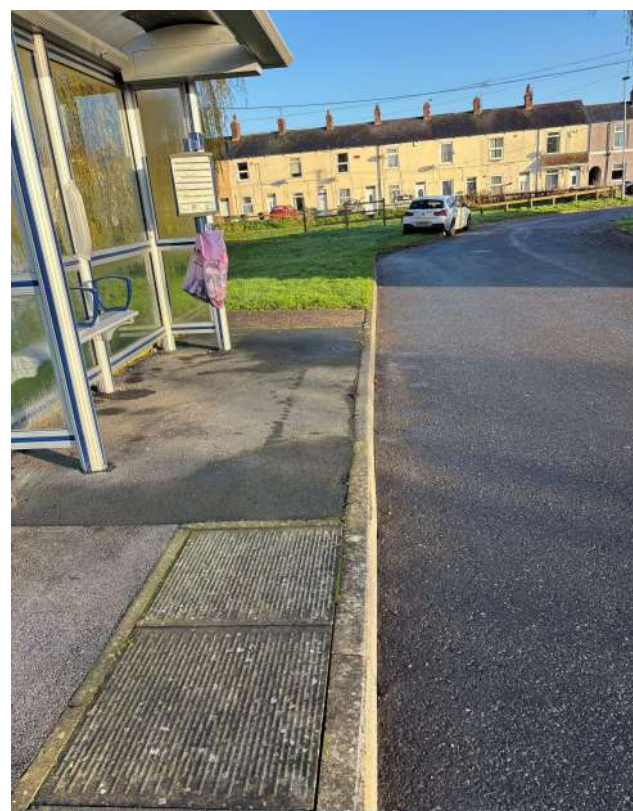
**12** – Kerb line at bus stop in good condition, minor chipping.

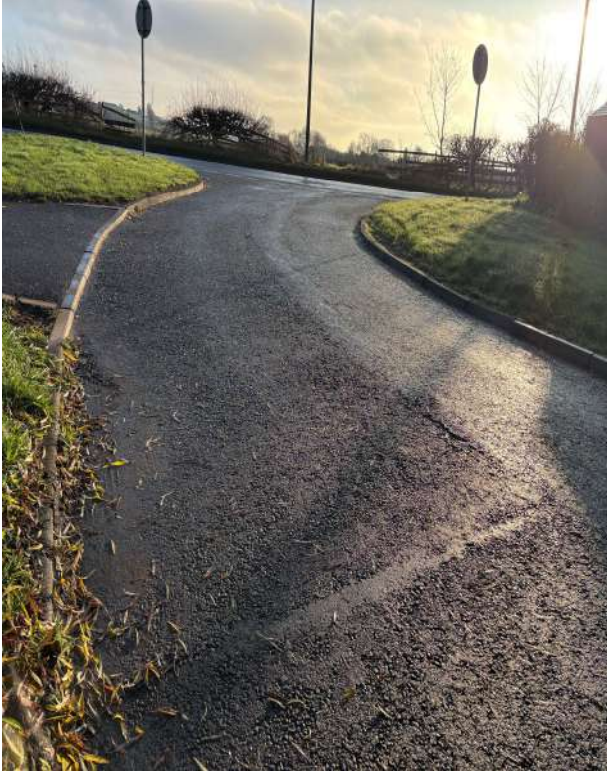
**13** – Existing Joint in tarmac, minor cracking.

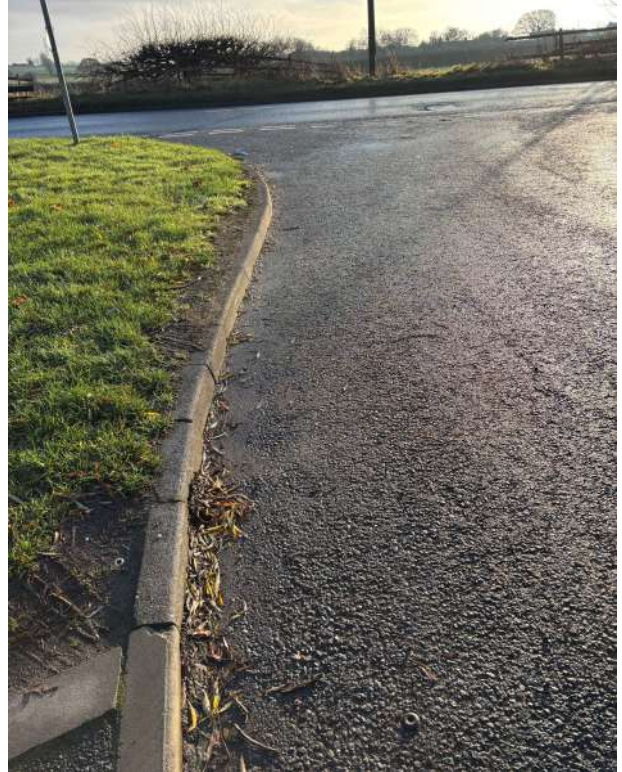
**14** – Chipping to kerbs at vehicle crossing.

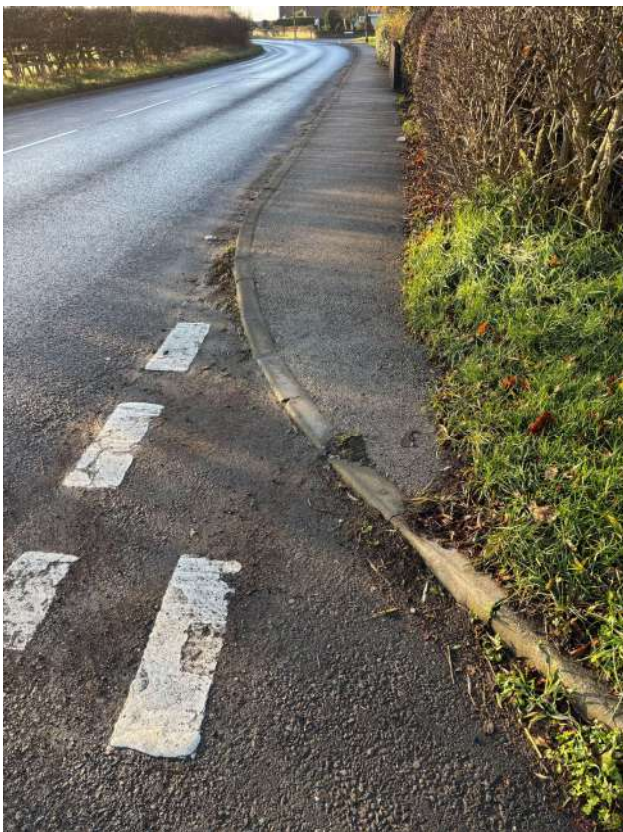
**15** – Minor damage to kerbs at drop crossing from the south.

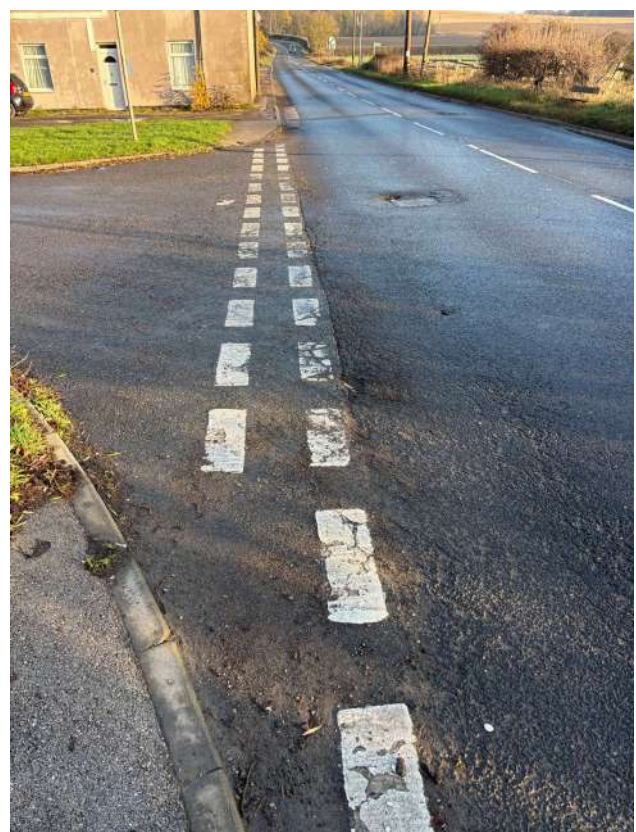
**16** – White lining has deterioration, to receive heavy traffic.

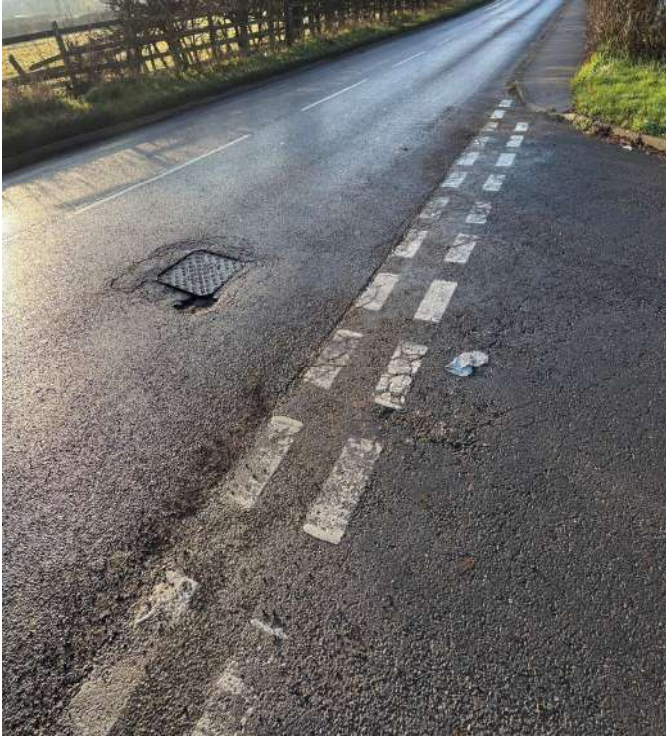
**17** – Manhole lid in wheel line, in poor condition lid rocking.

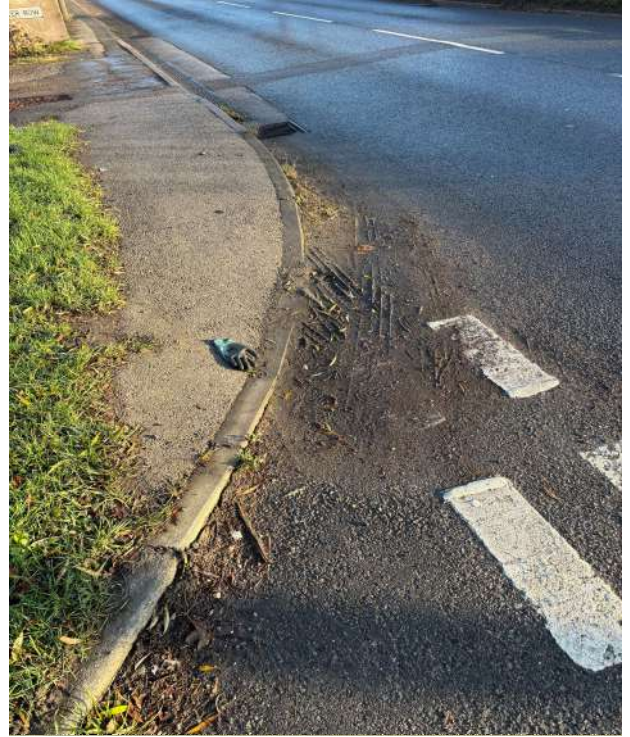
**18** – Drop crossing to North in good condition.
