## **SHAW LANE, CARLTON, S278 WORKS**

**Combined Stage 1 and Stage 2 Road Safety Audit**

**Client: Vistry Group**

**19/08/2026**

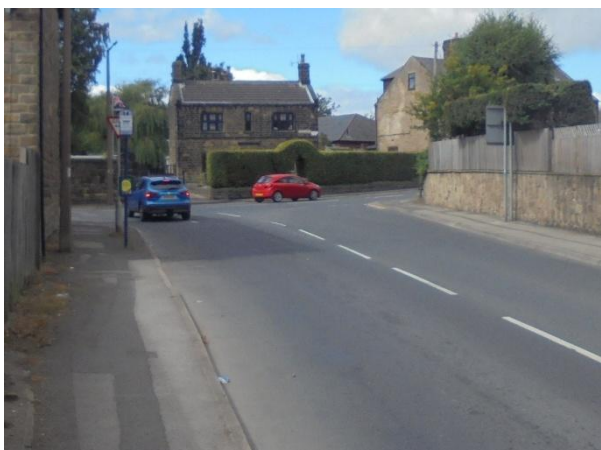
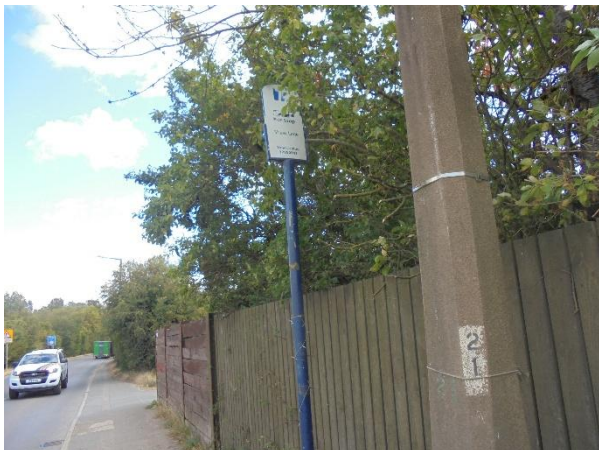
| PROBLEM 2.1.1 | |
|---|---|
| <b>Location</b> | Shaw Lane, redundant bus stops adjacent to: <ol style="list-style-type: none"> <li>1. Fish Dam Lane junction</li> <li>2. Site access junction.</li> </ol> |
| <b>Summary</b> | Possible hazards associated with a waiting bus at a bus stop near a junction. |
| <p>There are two redundant pairs of bus stops in Shaw Lane:</p> <ul style="list-style-type: none"> <li>• westbound and eastbound bus stops near the proposed Fish Dam Lane traffic signals; and</li> <li>• westbound and eastbound bus stops adjacent to the proposed site access junction.</li> </ul> <p>If these bus stops are brought back into use, stopped buses could restrict visibility on the approach to traffic signals and / or become a hazard for turning traffic at site access junction.</p> <div style="display: flex; justify-content: space-around;"> </div> | |

| PROBLEM 2.1.1 | |
|---|---|
| It is recommended that the redundant bus stop poles / flags are removed. | |

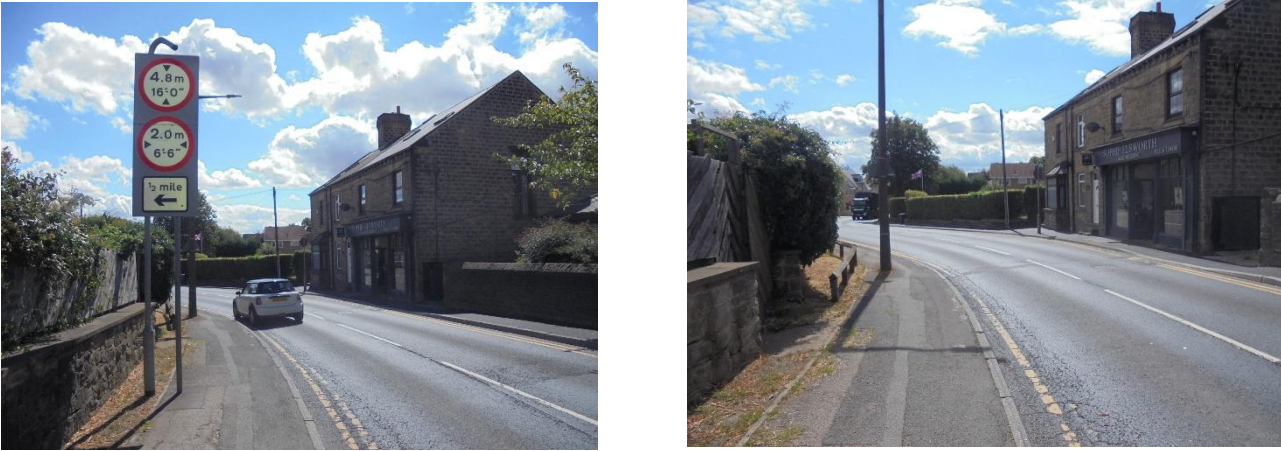
| PROBLEM 2.2.1 | |
|---|---|
| <b>Location</b> | Church Street southbound approach to Fish Dam Lane / Shaw Lane traffic signals. |
| <b>Summary</b> | Potential for heavy braking and shunts. |
| <p>There is a 'twisty' alignment on Church Street's southbound approach to the Shaw Lane junction and queuing traffic from the new stop line may be partially hidden from drivers' view. A temporary advisory sign is proposed however this may not be adequate warning, with both the frequency and duration of queuing traffic increasing as a result of the introduction of traffic signal control. There is potential for heavy braking and shunts.</p> | |

| PROBLEM 2.2.1 | |
|---|---|
| <p>It is recommended that there is a suitable warning sign e.g. 'traffic signals ahead' on the southbound approach to the junction.</p> | |

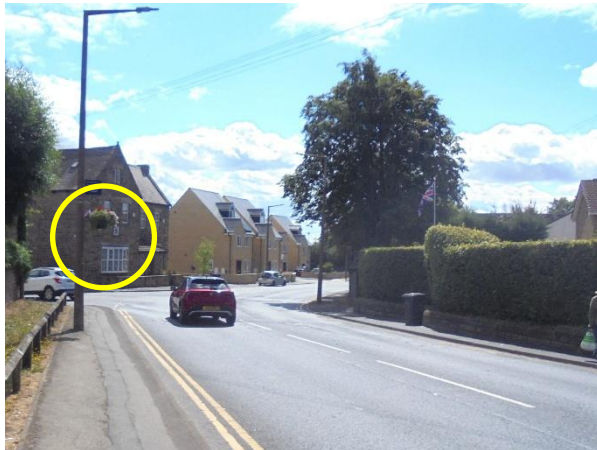
| <b>PROBLEM 2.2.2</b> | |
|---|---|
| <b>Location</b> | Church Street southbound approach to Fish Dam Lane / Shaw Lane traffic signals. |
| <b>Summary</b> | Potential for heavy braking and overshoots. |
| <p>A lighting column and hanging basket in the eastern footway of Church Street are likely to obscure the southbound primary signal. If drivers do not have a clear view of the traffic signals, there is potential for heavy braking and overshoots.</p> | |

| <b>PROBLEM 2.2.2</b> | |
|---|---|
| It is recommended that there is adequate forward visibility to southbound primary traffic signal head. | |

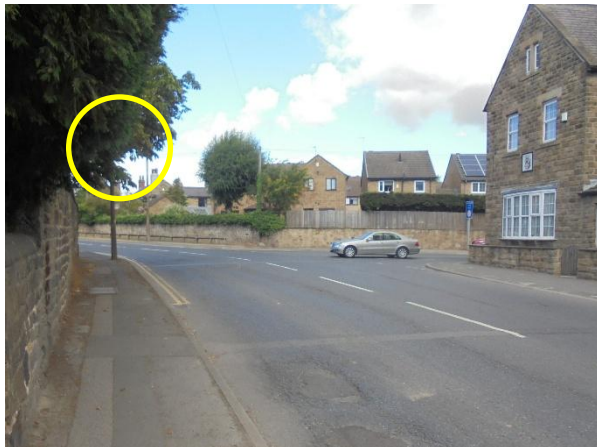
| <b>PROBLEM 2.2.3</b> | |
|---|---|
| <b>Location</b> | Fish Dam Lane northbound approach to Church Street / Shaw Lane traffic signals. |
| <b>Summary</b> | Potential for heavy braking and overshoots. |
| <p>Overgrowing vegetation from a residential property<sup>1</sup> boundary is likely to partially restrict visibility to the Fish Dam Lane northbound primary signal head. If drivers do not have a clear view of the traffic signals, there is potential for heavy braking and overshoots.</p> | |

<sup>1</sup> Assumed to be No.12 Manor Farm Close.

| <b>PROBLEM 2.2.3</b> | |
|---|---|
| It is recommended that there is adequate forward visibility to northbound primary traffic signal head. | |

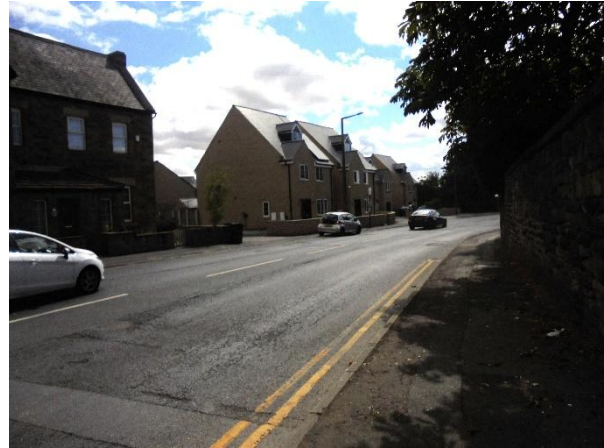
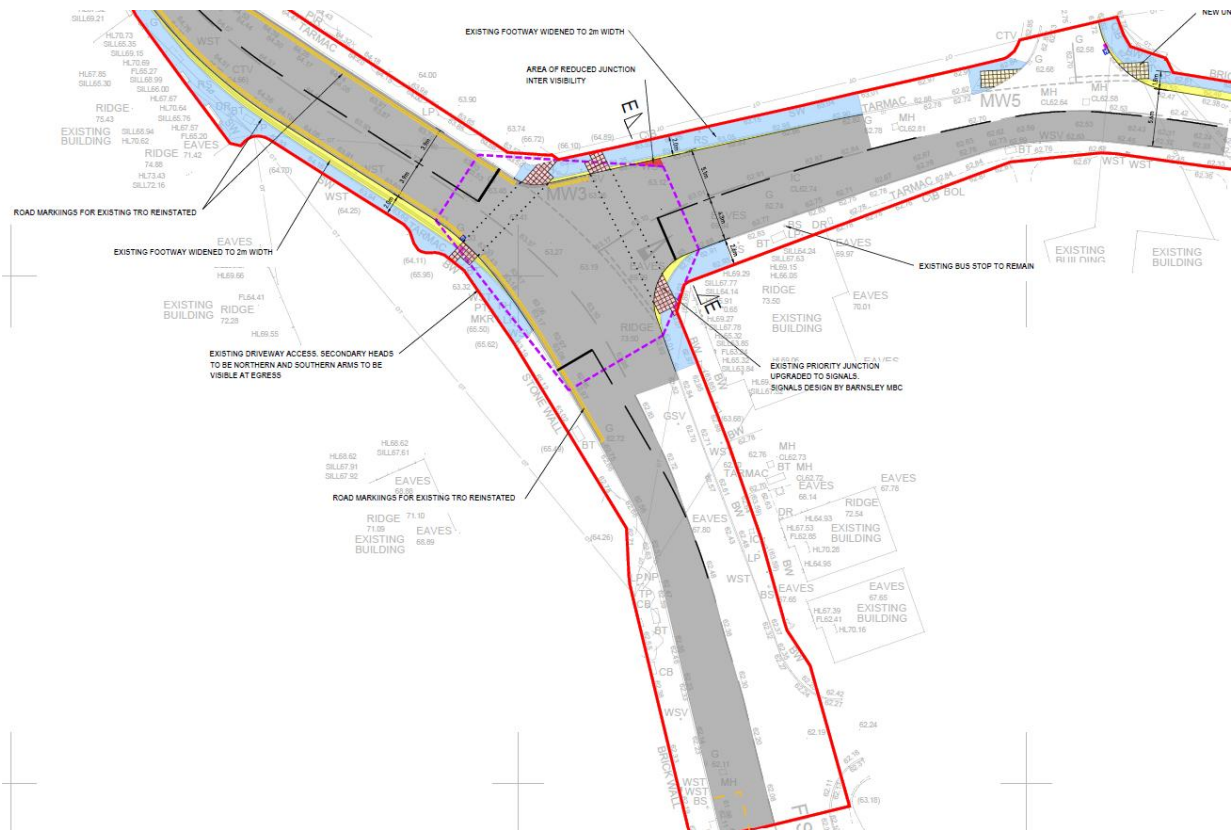
| <b>Location</b> | Church Street / Fish Dam Lane / Shaw Lane traffic signals. |
| <b>Summary</b> | Potential for head-on conflicts. |

Like-for-like double yellow lines will be reinstated at the junction following installation of the new traffic signals. Nevertheless, inconsiderate on street parking in Fish Dam Lane or Shaw Lane could cause conflicts, as drivers go into the opposing lane to make progress. Furthermore, vehicle detection and junction capacity may not operate as intended, with vehicles parked on-street.

It is recommended that at least 40m from stop line of 'no waiting at any time' is provided for both Fish Dam Lane and Shaw Lane.

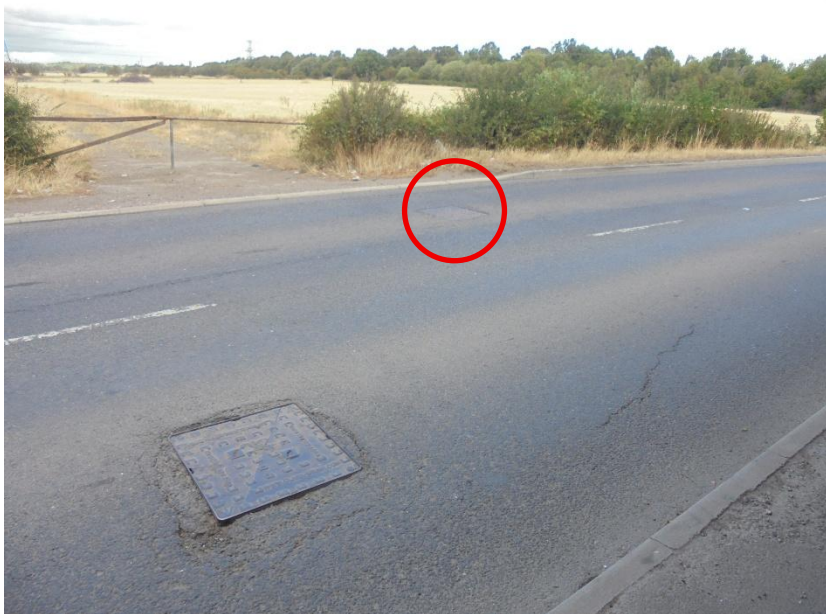
| <b>Location</b> | Proposed Toucan crossing in Shaw Lane. |
| <b>Summary</b> | Potential trip hazard. |
| <p>The inspection cover (eastbound lane) is a possible trip hazard for pedestrians using the Toucan crossing.</p> | |

| <p>It is recommended that either the crossing or the manhole are relocated. If this is not practical, it is recommended that a non-slip cover is installed and that the surrounding carriageway is suitably reinstated.</p> | |

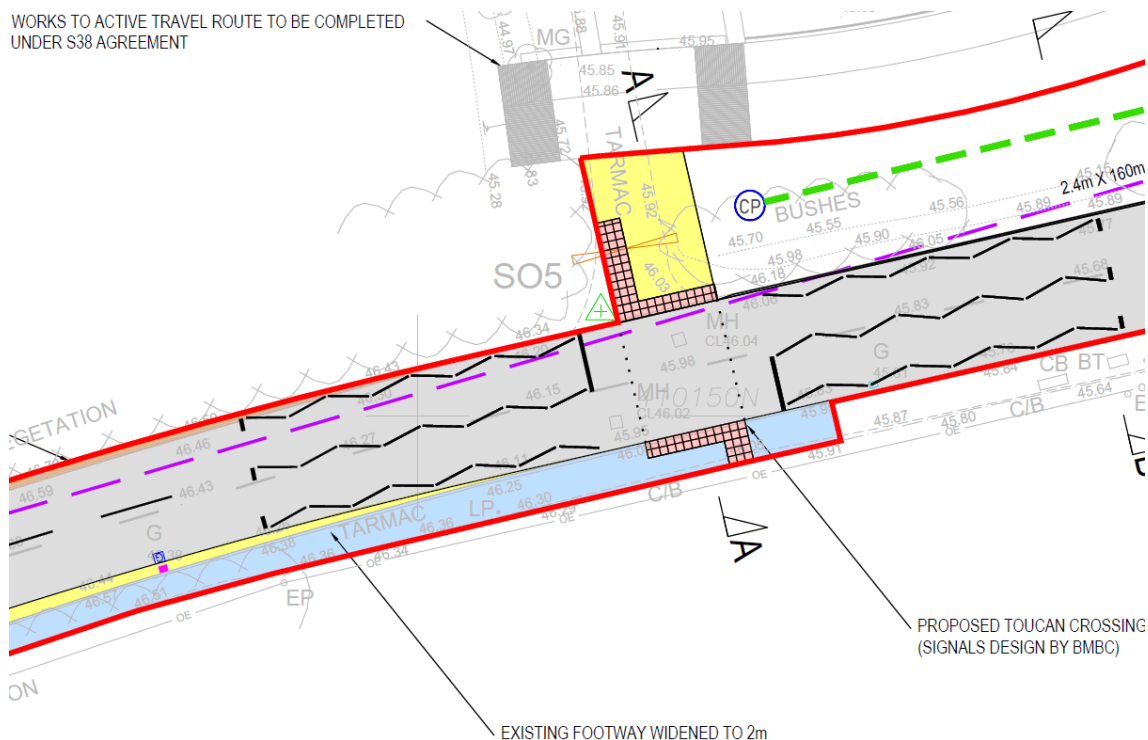
| <b>Location</b> | Proposed Toucan crossing in Shaw Lane. |
| <b>Summary</b> | Potential for a vehicle / pedestrian (or vehicle / cyclist) collision. |

**There is insufficient footway width on the south side of the new Toucan crossing for shared use by pedestrians and cyclists. Consequently, it is possible that a pedestrian or cyclist will encroach the adjacent carriageway, potentially leading to a collision. In any case, there is no onward route for cyclists on the south side of Shaw Lane.**

**It is recommended that a Puffin crossing is installed and that the proposed crossing facility is for pedestrians only e.g. a sign could be erected CYCLISTS DISMOUNT OR REJOIN CARRIAGEWAY.**

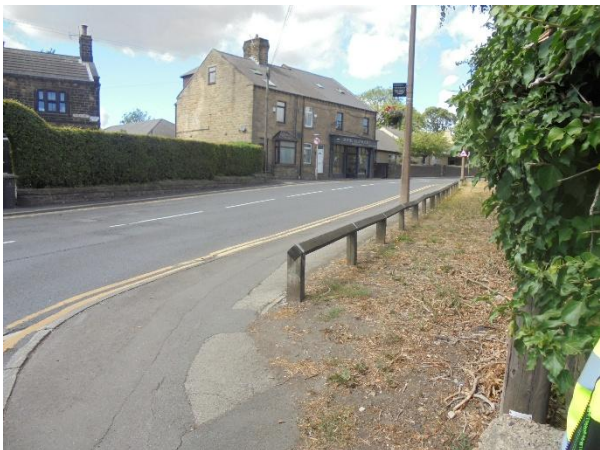
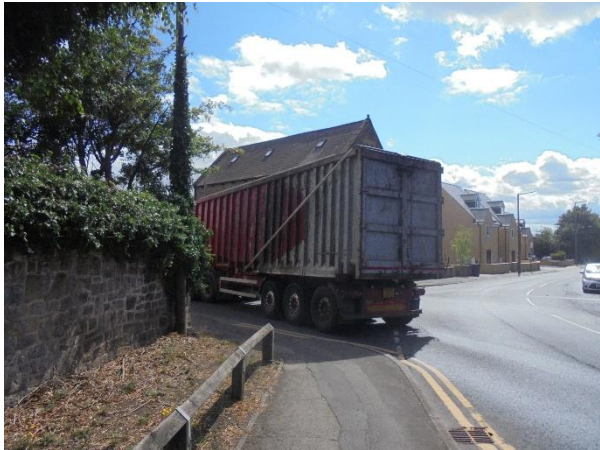
| <b>Location</b> | Church Street / Fish Dam Lane / Shaw Lane traffic signals. |
| <b>Summary</b> | Potential for a vehicle / pedestrian conflict. |
| <p>Visibility for pedestrians crossing Shaw Lane north to south at the proposed signalised crossing is restricted by a boundary wall and vegetation. This may lead to a vehicle / pedestrian conflict.</p> <div style="display: flex; justify-content: space-around;"> </div> | |

| <p>It is recommended that, subject to a swept path check, the northern footway of Shaw Lane is widened to improve sight lines. It is also recommended that any vegetation overgrowing from adjacent boundary wall is cut back.</p> | |
