ARBORICULTURAL REPORT

& Impact Assessment

Land at
Hall Gardens
Brierley
Barnsley
South Yorkshire
S72 9FF

Reference: AWA2943

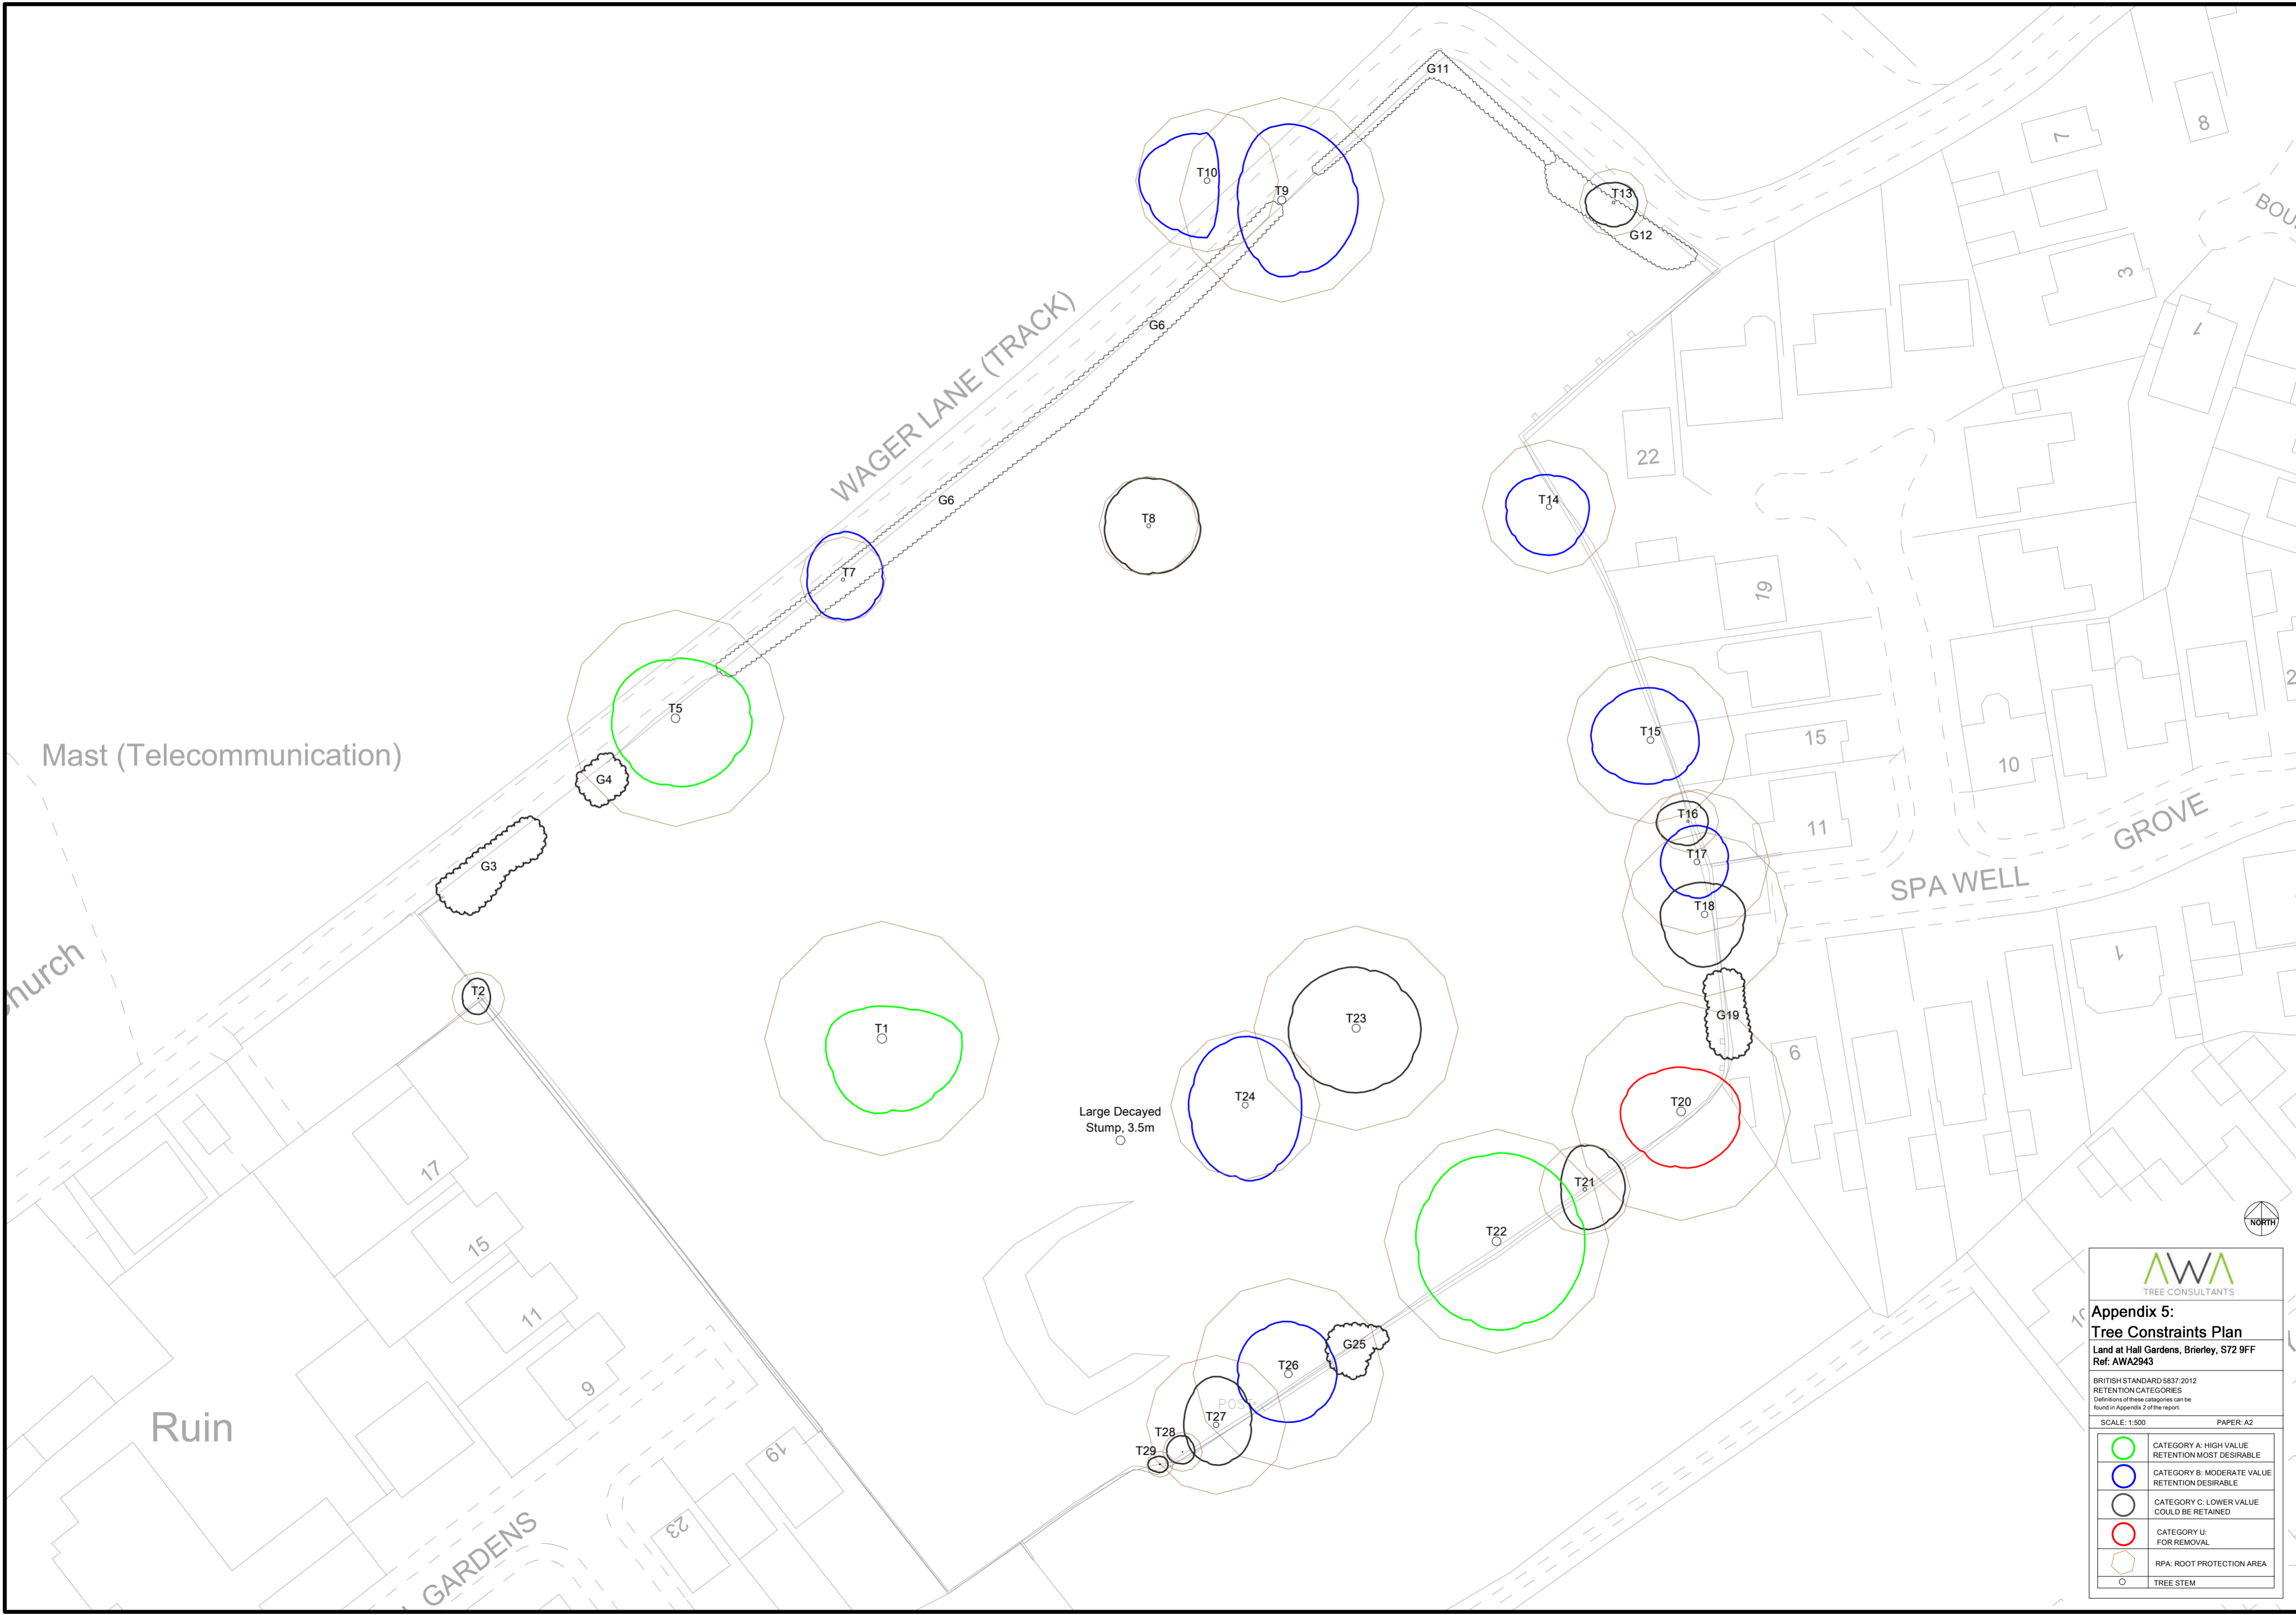
**Appendix 5:
Tree Constraints Plan**
Land at Hall Gardens, Brierley, S72 9FF
Ref: AWA2943

- 3.2.6 Close to the northern corner of the site are the Ash trees T9 and T10. Both trees have some crown dieback and large sections of deadwood within their canopies. Due to the prevalence of Ash Dieback in the wider area, the observed defects could be the result of this disease. The trees currently provide some good amenity to the site and the surrounding areas; however, their prospects are likely to be limited. It is advised that the significant deadwood is removed from both trees and that T9 is reduced in height by approximately 5m, regardless of any future development. This will allow the trees to be retained in the current context of the site and extend into the future their suitability for retention within a development. While not within the site boundaries it may also be appropriate for T10 to be similarly pruned in the future.

neighbouring residential properties. The Sycamore, T18 has a large cavity at the base. To reduce the loading of the potentially weakened stem it is advised that the tree is reduced in height by approximately 3.5m, regardless of any future development. It is recommended that a full inspection and risk assessment is also carried out in the future to assess the trees suitability for retention due to the cavity and associated decay.

- 3.2.11 The tree Root Protection Area (RPA) detailed on the Tree Constraints Plan at Appendix 5, has been used as a layout design tool, to inform on the area around a tree where the protection of the roots and soil structure is treated as a priority.

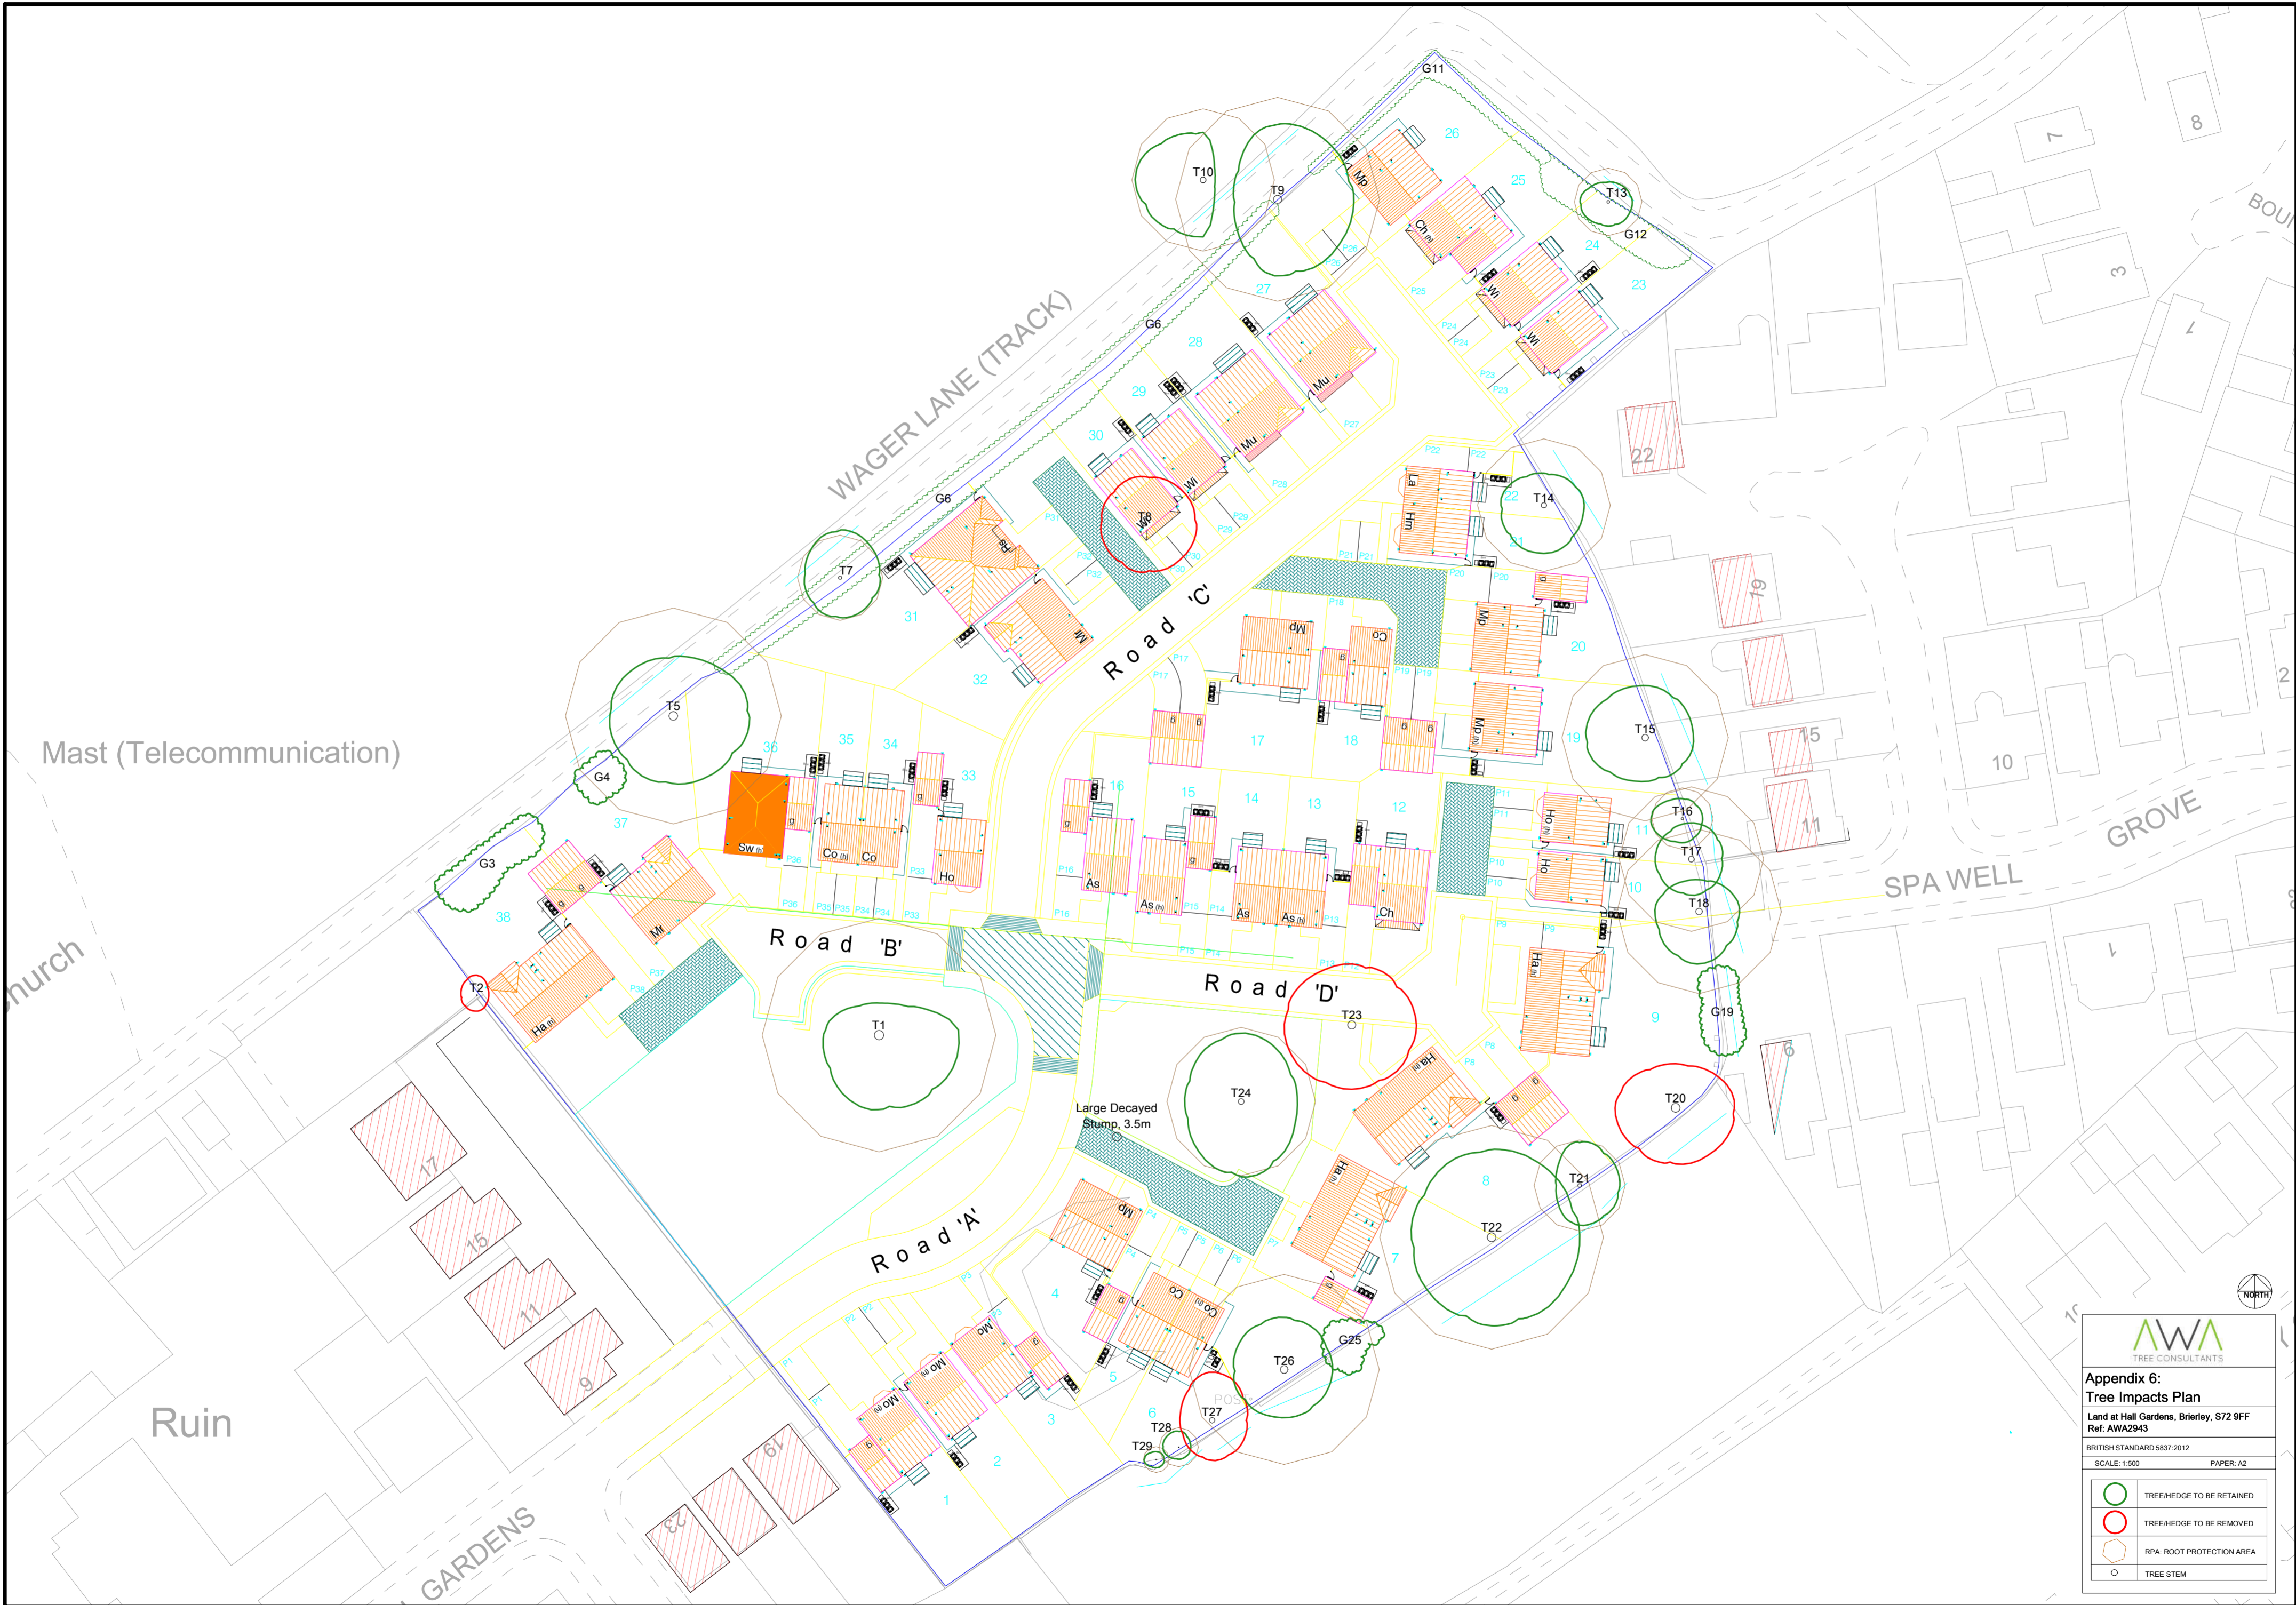
Appendix 6:
Tree Impacts Plan
Land at Hall Gardens, Brierley, S72 9FF
Ref: AWA2943

4.2.1 From assessing the new development proposals, 4 trees will require removal as they are situated in the footprint of the structure or their retention and protection throughout the development is not suitable.

4.2.2 The trees that require removal to facilitate the development are T2, T8, T23 and T27.

4.2.3 All four trees that require removal are of relatively low value, retention category 'C'. The Elder, T2 is of negligible value, while the Walnut and Horse Chestnut trees T8, T23 and T27 have significant defects that limit their value and future prospects.

- 4.3.2 Potentially damaging activities are proposed in the vicinity of retained trees. The new development encroaches close to and into the edge of the RPA of T9, T15 and T24. Construction within the RPA, can have negative impacts on tree roots. However, the encroachment is very minor, and the detailed RPA for these trees is likely to be a slightly exaggerated representation of the trees actual rooting area, due to previous management, and in the case of T9, the works recommended in this report. As such, it is unlikely that significant roots will be within these areas and the retained trees should remain largely unaffected by the works, provided care is taken during construction.

- 4.3.3 New landscaping in the form of access roads and driveways is proposed that encroaches into the edge of the RPA of T1, T14 and T26. The construction of hard surfaces within the RPA can have negative impacts on tree roots. However, the potential negative impacts can often be overcome or minimised by employing a 'no-dig' type construction methods with a porous final surface.

- 4.3.4 The new development encroaches into the RPA of T5, T22 and T26. The construction within the RPA may have negative impacts on tree roots. However, it should be possible to employ special foundation design such as mini/micro pile and suspended beam or a cantilevered foundation, in order to overcome or minimise any negative impact on the tree roots.
