# ARBORICULTURAL REPORT

to BS 5837:2012 at:

***The Firehouse Group,  
Heritage House,  
Heritage Court,  
Hemingfield,  
Barnsley,  
S73 0HZ***

Reference: AWA4588

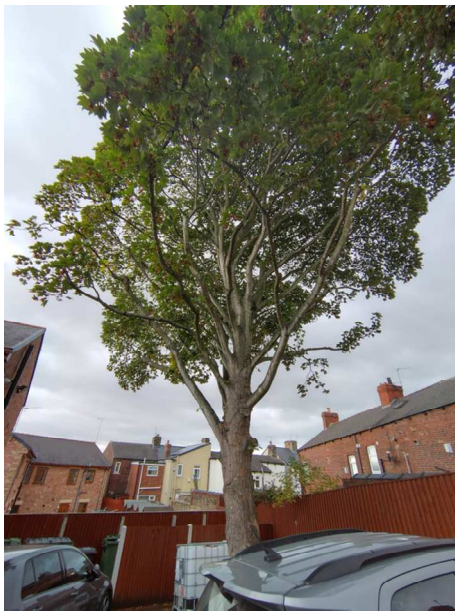
- 3.2.5 The sites most significant tree is T1, an early-mature Sycamore. Situated to the South West of the site. This tree is prominent throughout the entire site and surrounding area, providing a moderate level of amenity value. The tree has received previous crown lifting and reduction to provide clearance from the building to its South East and adjacent property to the West; leaving some moderate pruning wounds and somewhat reducing its value.

Photo 1: T1 looking South West

| Tree ID | Tree Species | | Maturity | Measurements | | | | Crown (m) | | | | Tree Condition | | | | | | Value | | Management | | |
|---|---|---|---|---|---|---|---|---|---|---|---|---|---|--|---|---|---|---|---|---|---|---|
| T1 | Sycamore | <i>Acer pseudoplatanus</i> | Early-mature | 13 | 1 | 630 | No | 4.5 | 6.5 | 6 | 4.5 | 6 | No visual defects | Single stemmed. Vertical. Old pruning wounds. Epicormic growths. Pruning wounds from crown lifting. 3 10-15cm pruning wound on stem from crown lifting. | Normal. Well developed crown. Minor deadwood. Old pruning wounds. Overhanging adjacent land | In planter surrounded by tarmac carpark. Fine gravel laid over planter bed with permeable mat underneath and concrete laid in South Eastern corner. Ground slopes slightly, lower to South East. South Eastern crown just overhangs building and crown has been reduced to provide clearance, also reduced on North Western side to provide clearance from neighbouring garden. | Good | Good | >40 yrs | Moderate | B | None required in current site context |

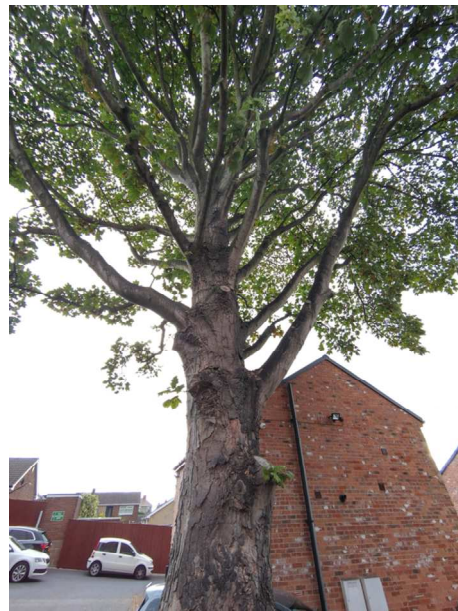
Photo 2: T1 looking East

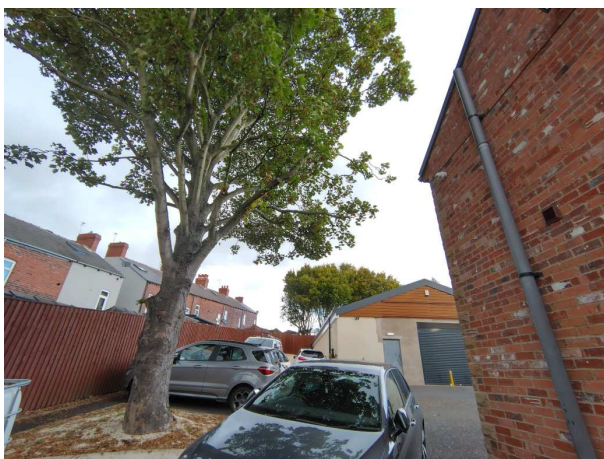
Photo 3: T1 looking North

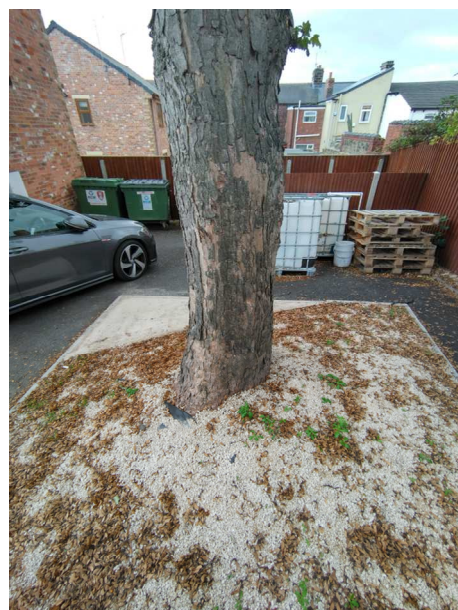
Photo 4: T1 stem looking South

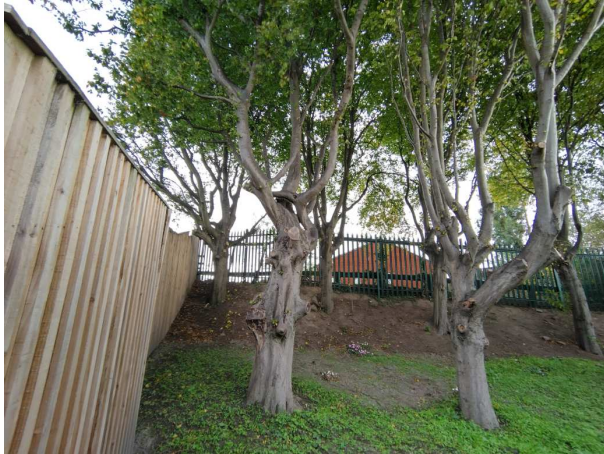
- 3.2.6 The group Hornbeam trees T2-T8 are situated at the Northern end of the site and are of lower arboricultural significance, though collectively they do provide some screening value. Several trees have been recently removed in a group thinning and all have been crown lifted, slightly reducing their

value. Additionally, there has been a minor increase in soil level in their rooting area and at the stem bases, slightly covering some stem tapers.

Photo 5: T2-T7 looking North

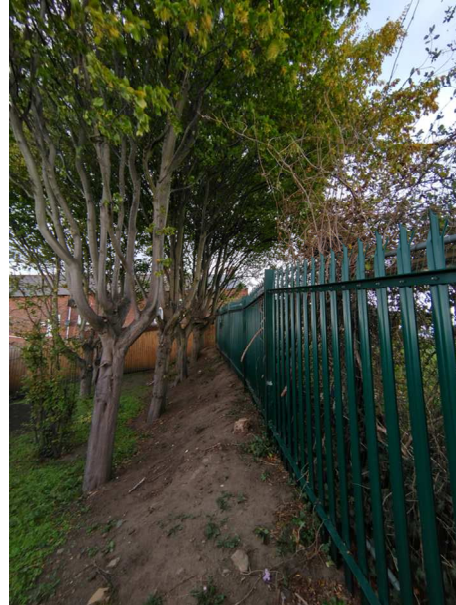
Photo 6: T2-T8 looking West
