# **ARBORICULTURAL REPORT & Impact Assessment** to BS 5837:2012 at:

***Bank View,  
Green Moor Road,  
Green Moor,  
Wortley,  
South Yorkshire  
S35 7DQ***

Prepared for:  
***Garry Greetham Associates***

Reference: AWA4583

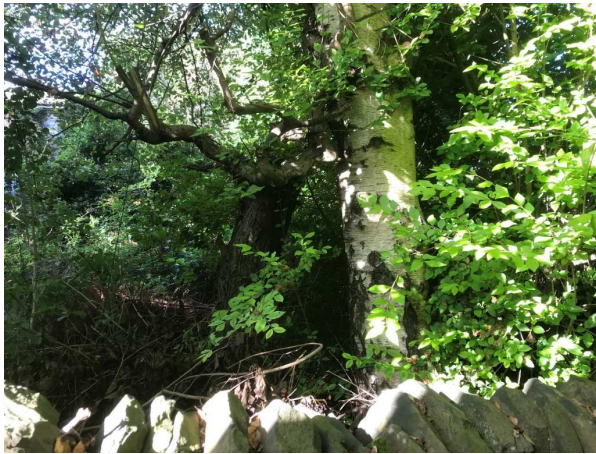
- 3.2.8 T2, T3 and T5 from a row of early mature Birch situated in adjacent land beyond the site's western boundary wall. A public footpath is situated between the trees and the site. The trees were inaccessible and so were only given cursory inspection with measurements estimated and condition values indicative only. T2 and T3 appear in fair condition, but have minor cavities and poor pruning back to the boundary resulting in profuse epicormic growths and wounding on their stems and branches. T5 is in poorer condition, with a moderately sized cavity in the stem at 4 metres. This tree has previously been topped and regrowth from original stem has reduced the tree's crown weight. These trees have limited long term value and prospects, but within the adjacent boundary group, provide useful screening and green infrastructure for the site.

Photo 1: T3 from east

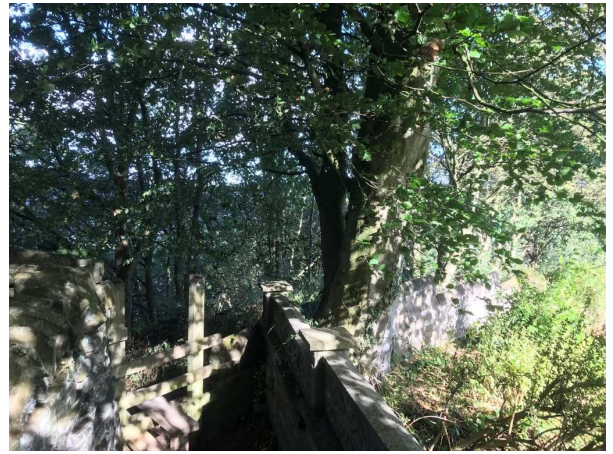
- 3.2.4 The site's most significant tree is Beech T6, situated at the corner of boundary walls at the site's western boundary. T6 is a large mature tree in good overall condition. The tree is of multiple stemmed form and is pushing into the retaining wall to the south west.

Photo 2: T6 stem from south

- 4.3.7 It should be possible to employ special foundation design such as mini/micro pile and suspended beam or a cantilevered foundation, in order to overcome or minimise any negative impact on the tree roots of T6 for the new dwelling.

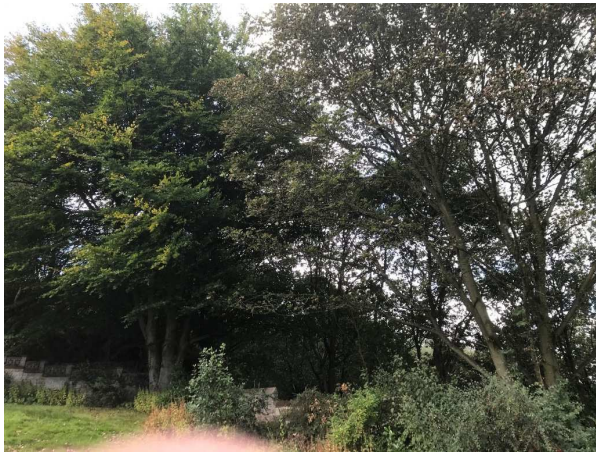
- 3.2.5 G18 forms an adjacent high value mature woodland group situated in adjacent land beyond the site's north western boundary. The group is

Photo 3: T6 and G18

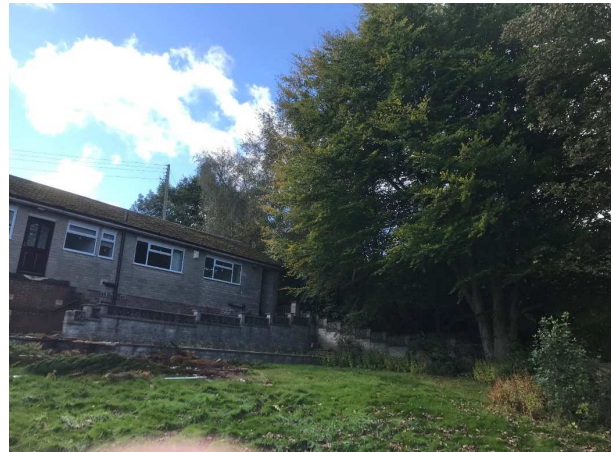
Photo 4: T6, T2-T3 and T5

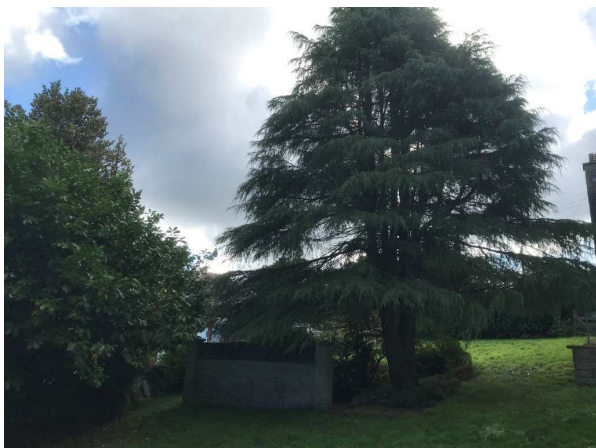
- 3.2.6 Cedar T13 is a moderate value tree situated to the site's eastern boundary which is in good overall condition with no significant visible defects. While prominent from within the site, the tree is not visible from any easily accessible public vantage points and provides little amenity value outside of site boundaries.

Photo 5: T13 from north west

- 4.2.2 The trees and tree groups that require removal to facilitate the proposed new development are T10, T13, G14, G15 and T16.
- 4.2.3 Cedar T13 is of moderate value retention category 'B' and while its removal will have some negative impact from within the site, the tree is not prominently visible from any easily accessible public vantage points and provides little amenity value outside of the site boundaries.

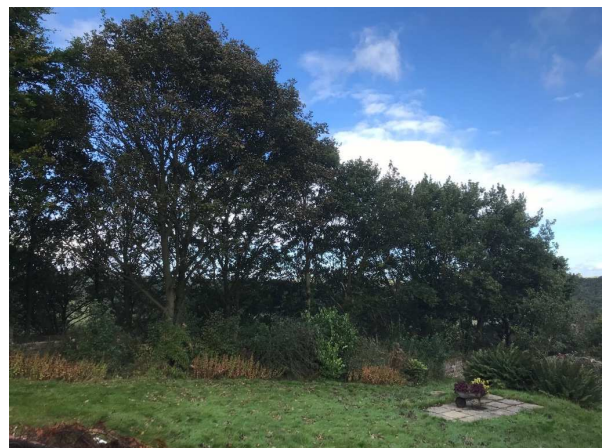
predominantly comprised of Oak with several Sycamore and occasional Birch and Rowan.

Photo 6: G18 from south
