## **Project**

**Project Name:** TRINITY SCHOOL, BARNSELEY  
**Project Date:** 21/09/2021  
**Inspection Standard:** MSCC5 Sewers & Drainage GB (SRM5 Scoring)

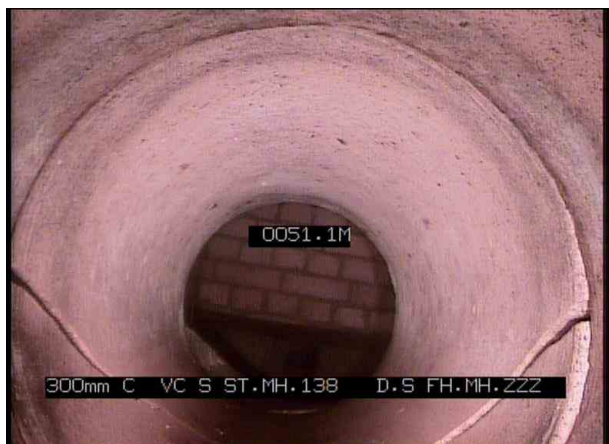
| Section | PLR | Grade | Description |
|---|---|---|---|
| 1 | 138X | 3 | Fracture, circumferential at joint from 3 o'clock to 9 o'clock |

| No. | m+ | Code | Observation |
|---|---|---|---|
| 3 | 51.10 | FCJ | Fracture, circumferential at joint from 3 o'clock to 9 o'clock |

137X\_a8ed3296-1cac-4ba0-9d41-4840c77ce783\_20210921\_105322\_318.jpg, 00:05:09, 51.10 m  
 Fracture, circumferential at joint from 3 o'clock to 9 o'clock

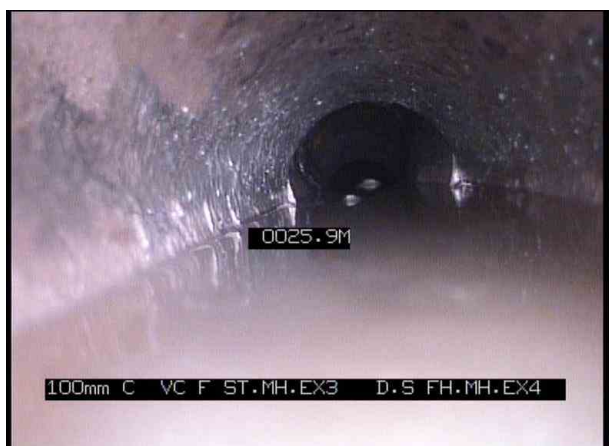
| Section | PLR | Grade | Description |
|---|---|---|---|
| 4 | EX3X | 4 | Joint displaced, large |

| No. | m+ | Code | Observation |
|---|---|---|---|
| 4 | 25.90 | JDL | Joint displaced, large |

EX3X\_e2e1af9d-0306-4e1a-a8ba-baeb2eef8172\_20210921\_1  
 30005\_350.jpg, 00:01:43, 25.90 m  
 Joint displaced, large

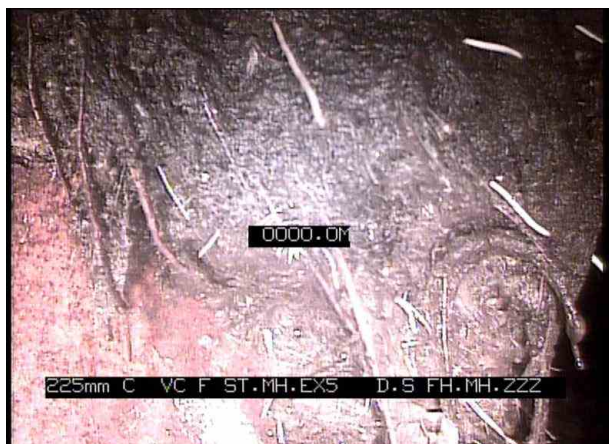
| Section | PLR | Grade | Description |
|---|---|---|---|
| 5 | EX5X | 5 | Roots, mass, 70% cross-sectional area loss |

| No. | m+ | Code | Observation |
|---|---|---|---|
| 3 | 0.00 | RM | Roots, mass, 70% cross-sectional area loss |

EX5X\_e50434e0-c8c7-4e02-a09a-3fd6348ed68e\_20210921\_134037\_627.jpg, 00:00:09, 0.00 m  
 Roots, mass, 70% cross-sectional area loss

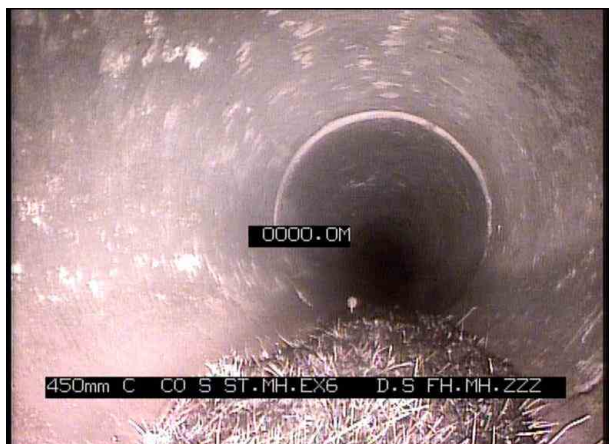
| Section | PLR | Grade | Description |
|---|---|---|---|
| 6 | EX6X | 3 | Roots, mass, 15% cross-sectional area loss |

| No. | m+ | Code | Observation |
|---|---|---|---|
| 3 | 0.00 | RM | Roots, mass, 15% cross-sectional area loss |

EX6X\_e8231c62-5b60-473f-8366-1a05f44a57ea\_20210921\_1  
 35013\_769.jpg, 00:00:10, 0.00 m  
 Roots, mass, 15% cross-sectional area loss

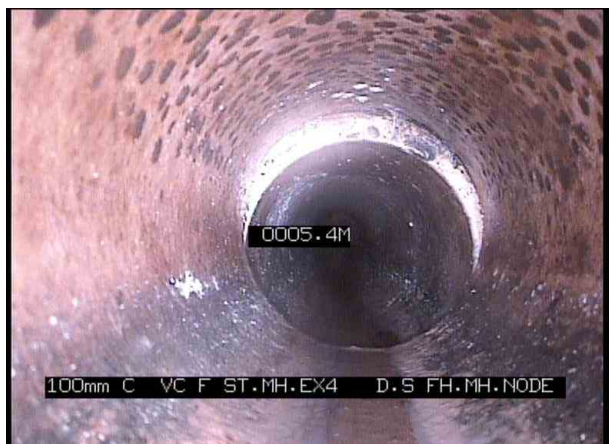
| Section | PLR | Grade | Description |
|---|---|---|---|
| 9 | EX4X | 3 | Joint displaced, medium |

| No. | m+ | Code | Observation |
|---|---|---|---|
| 4 | 5.40 | JDM | Joint displaced, medium |

EX4X\_0ecc9e45-33a7-497c-b540-4debd08834fc\_20210921\_145125\_070.jpg, 00:00:46, 5.40 m  
 Joint displaced, medium

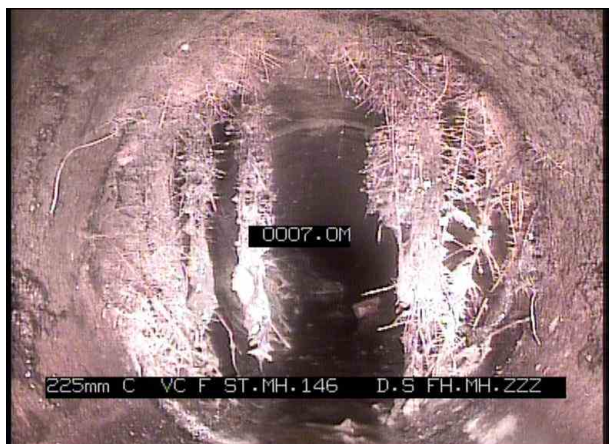
| No. | m+ | Code | Observation |
|---|---|---|---|
| 4 | 7.00 | RMJ | Roots, mass at joint, 20% cross-sectional area loss |

146X\_250f062f-a501-4029-bb82-d4f1a554d51f\_20210923\_09  
 4515\_705.jpg, 00:00:58, 7.00 m  
 Roots, mass at joint, 20% cross-sectional area loss

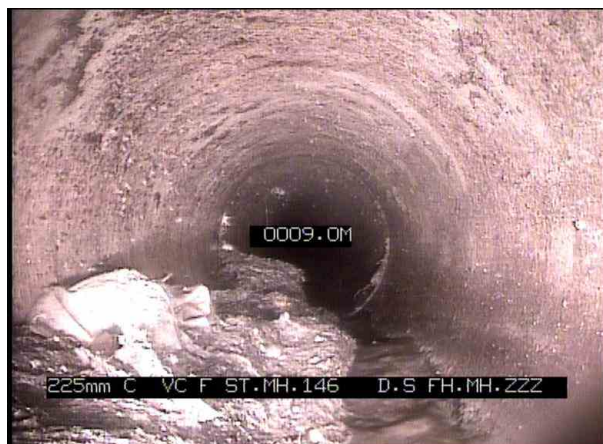
| No. | m+ | Code | Observation |
|---|---|---|---|
| 5 | 9.00 | RM | Roots, mass, 25% cross-sectional area loss |

146X\_b49e6835-9183-42c0-89ac-85fd8a292636\_20210923\_0  
 94543\_089.jpg, 00:01:21, 9.00 m  
 Roots, mass, 25% cross-sectional area loss

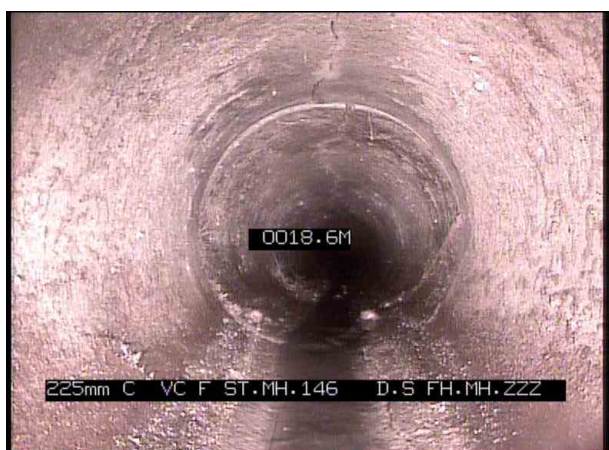
| No. | m+ | Code | Observation |
|---|---|---|---|
| 6 | 18.60 | FL | Fracture, longitudinal at 12 o'clock |

| Scale: | 1:671 | Position [m] | Code | Observation | MPEG | Photo | Grade |
|---|---|---|---|---|---|---|---|
| | FL | Fracture, longitudinal at 12 o'clock | 00:02:19 | 146X_e4c12ad6-a9f6-4cfe-825 | 3 / 2 | | |

146X\_e4c12ad6-a9f6-4cfe-8253-43950971168f\_20210923\_09  
 4645\_410.jpg, 00:02:19, 18.60 m  
 Fracture, longitudinal at 12 o'clock

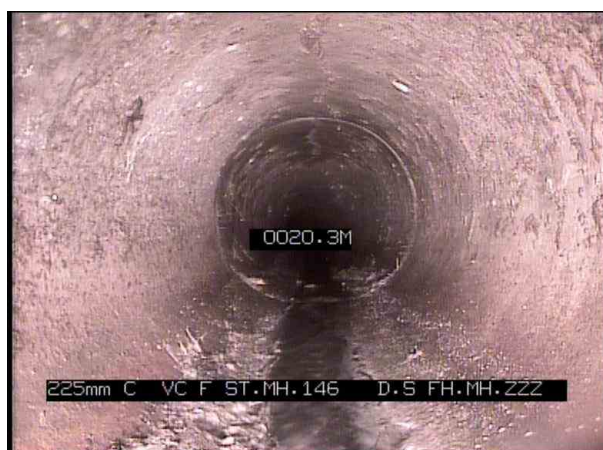
| No. | m+ | Code | Observation |
|---|---|---|---|
| 7 | 20.30 | FL | Fracture, longitudinal at 6 o'clock |

| Scale: | 1:671 | Position [m] | Code | Observation | MPEG | Photo | Grade |
|---|---|---|---|---|---|---|---|
| | FL | Fracture, longitudinal at 6 o'clock | 00:02:43 | 146X_81b8881c-ab65-40b9-a9f | 3 / 2 | | |

146X\_81b8881c-ab65-40b9-a9f1-5c5a30919911\_20210923\_0  
 94713\_906.jpg, 00:02:43, 20.30 m  
 Fracture, longitudinal at 6 o'clock

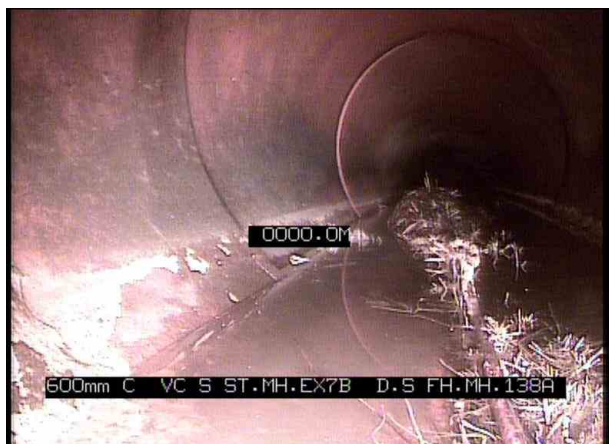
| No. | m+ | Code | Observation |
|---|---|---|---|
| 3 | 0.00 | RM | Roots, mass, 10% cross-sectional area loss |

137BX\_c6131b60-c190-4d2c-a1f4-2646fa072b78\_20210923\_113649\_385.jpg, 00:00:00, 0.00 m  
 Roots, mass, 10% cross-sectional area loss

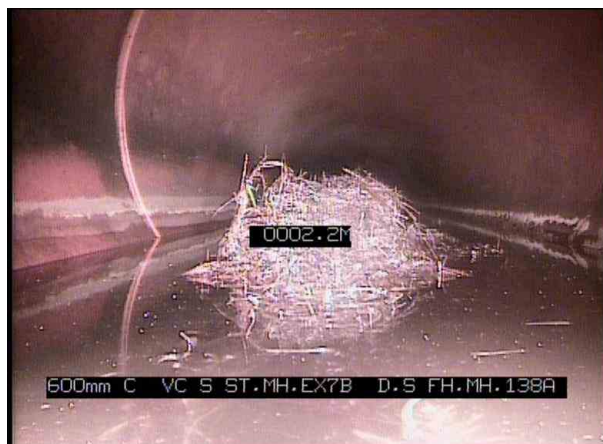
| Section | PLR | Grade | Description |
|---|---|---|---|
| 14 | 137BX | 5 | Roots, mass, 20% cross-sectional area loss |

| No. | m+ | Code | Observation |
|---|---|---|---|
| 4 | 2.20 | RM | Roots, mass, 20% cross-sectional area loss |

137BX\_c5f92405-0081-4295-9ede-4fb2628d24ff\_20210923\_113910\_768.jpg, 00:01:35, 2.20 m  
 Roots, mass, 20% cross-sectional area loss
