**Arboricultural Impact Assessment
(including Tree Survey)**

**Land South of Halifax Road,
Penistone**

Report reference: AR-3706-02.02
May 2021

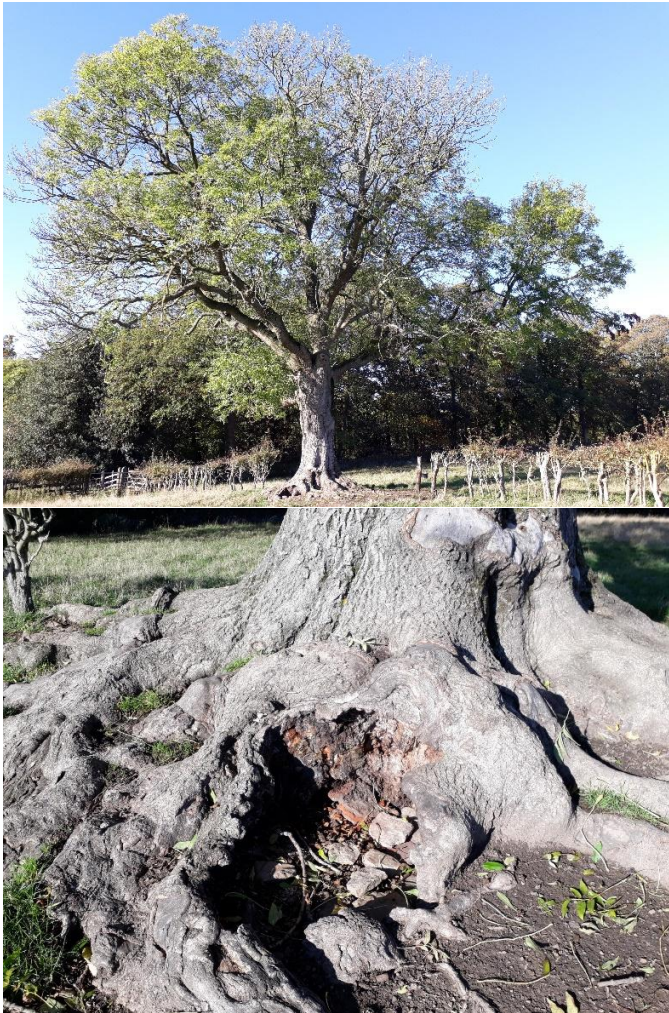
Figure 2

65. The largest tree in the survey and within the Site, T4 ash, has features which indicate that it qualifies as an early ancient tree or fully mature transition veteran which should be retained within development under National Planning Policy Framework 2018. Features present on T4 include rot site, dead branches, live stubs and fungal fruit bodies (Figures 1-3). Although a section of root flare is hollow with decay, this decay may not have reached the main stem. The stem shows slight adaptive growth (thickening of the stem) at 2-3m which may suggest decay here. Typical practice for retaining trees in the late maturity/early ancient phase safely within development is to limit close access with a local type of fencing or walling around the extent of the root protection area or canopy extent, whichever is the greater. This tree should be monitored annually. Further ground compaction around the RPA, changes of level and development within the RPA should be avoided.

The northern side of T4 ash (with woodland outside the Site boundary in the background). Decline in part of the crown is evident.

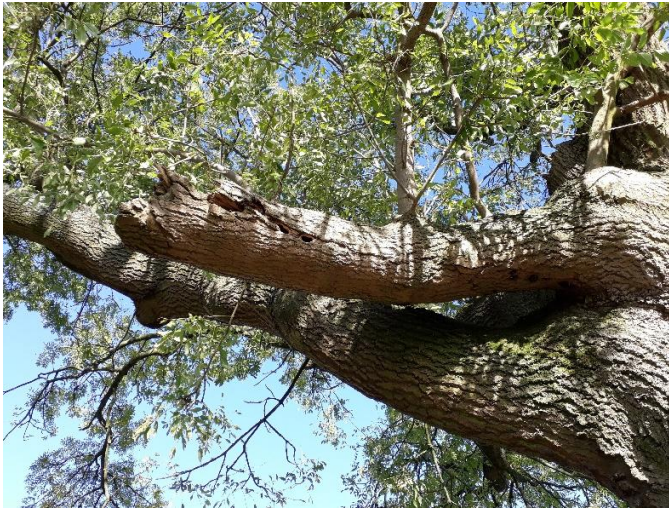
Figure 4

T4 ash with a stub of naturally fractured branch and live growth. Branch fungus *Daldinia concentrica* is evident on the underside.

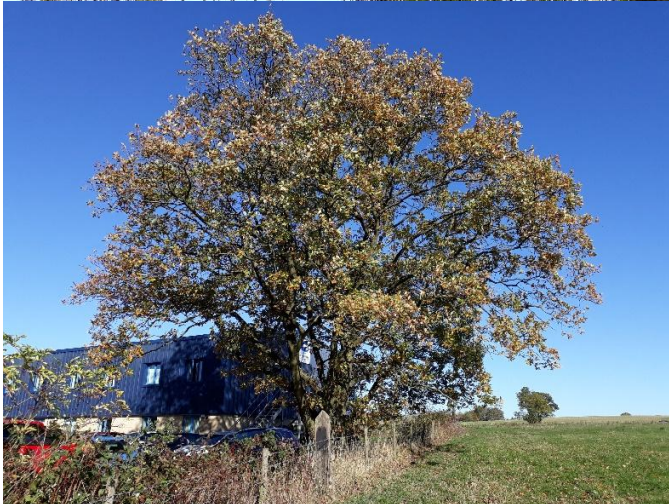
Figure 5

T15 oak located just outside the Site boundary fence and overhanging the Site. This tree should be protected from damage during development.

66. Several trees are located just outside the Site boundary though canopies and RPA's may extend into the Site. Protection from damage should be given to these trees, particularly T15 oak, close to the western Site boundary, which is assessed as retention category 'A' (Figure 4). Protection would include tree protection barriers around the RPA or canopy, whichever is the greater, during construction. Buildings and changes to ground level should be avoided within the RPA also.
