Barnsley West

Arboricultural Report

B028734

June 2021

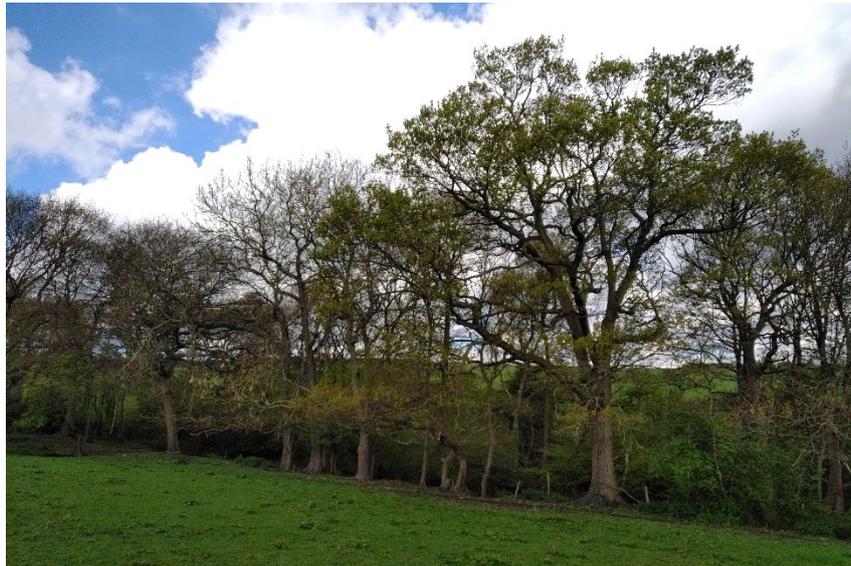
Image 1: Oak T125 on the southern edge of woodland G22 (A category).

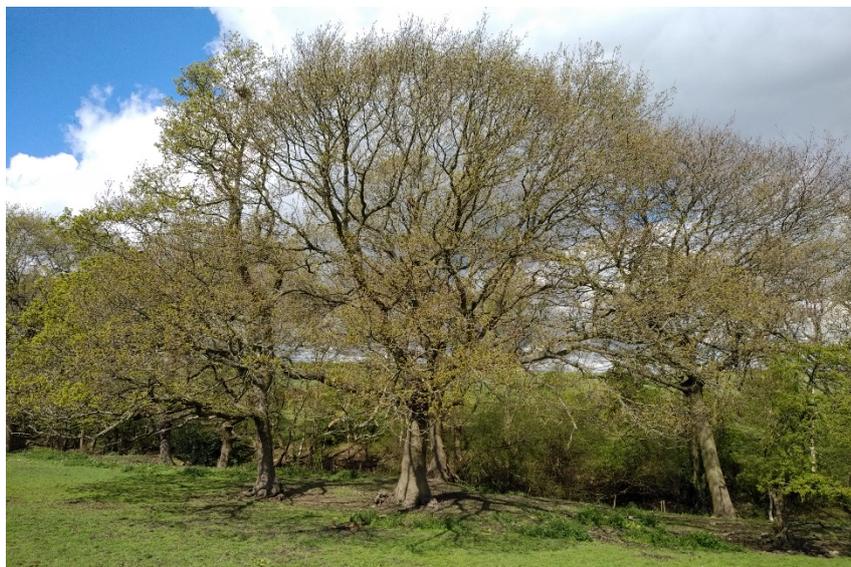
Image 2: Oak trees T115-120 (A/B categories) on the southern edge of woodland G22 (A category).

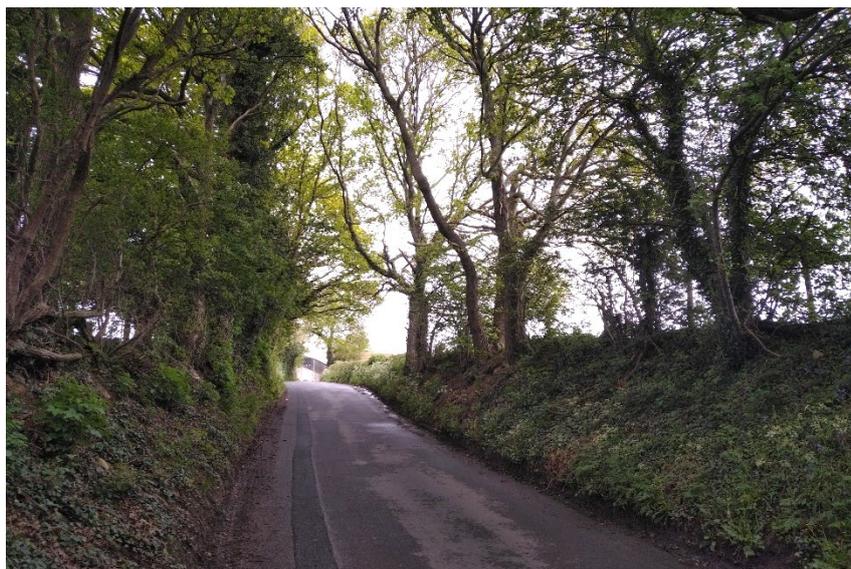
Image 3: Oak trees T69-89 along Hermit Lane (A/B categories).

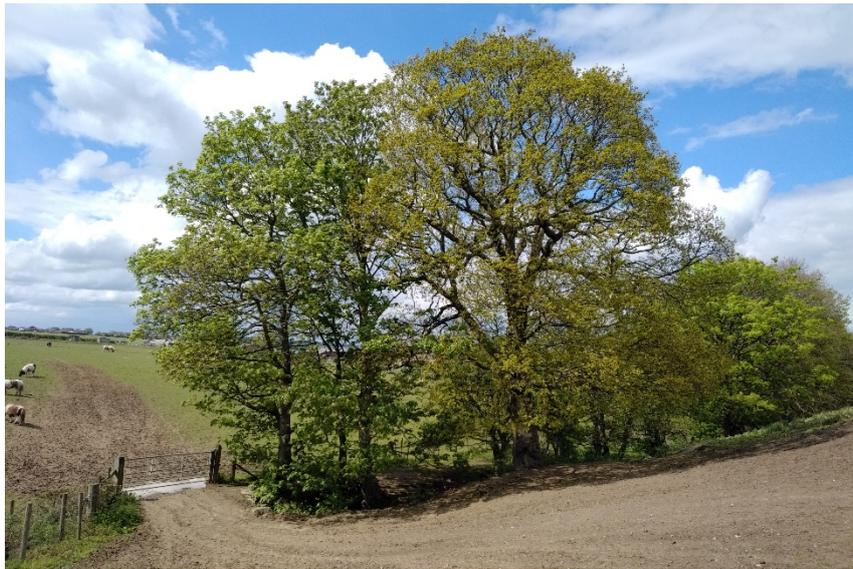
Image 4: Southern end of woodland G17 (A category), with prominent oak T38 (centre) (U category).

5.2.7 In addition to the trees to be felled to implement the scheme, it is proposed to fell the oak tree T38 with extensive stem bark browsing damage. Alternatively, this tree could be cut at 7m and retained as a monolith deadwood habitat feature within the retained woodland. T22 is a dead tree recommended for felling, however, this lies offsite.

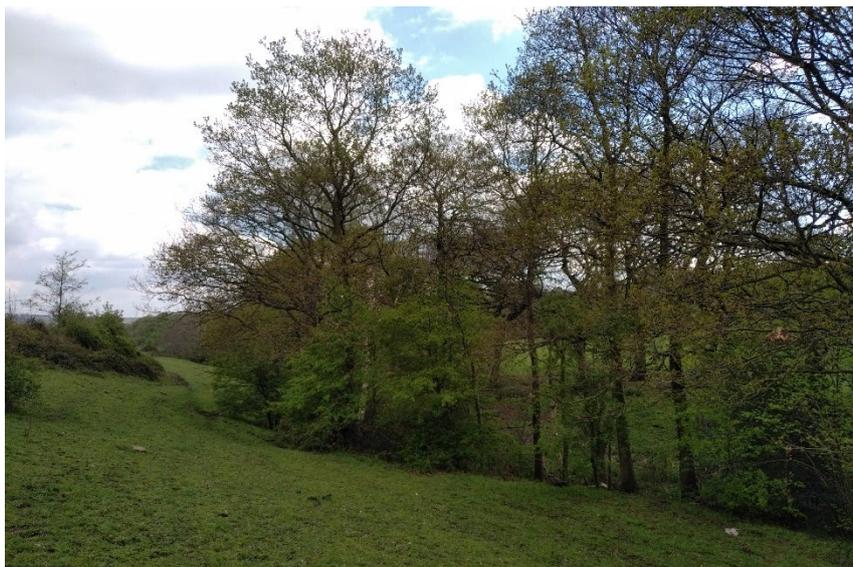
Image 5: Woodland G22, viewed from the west (A category).

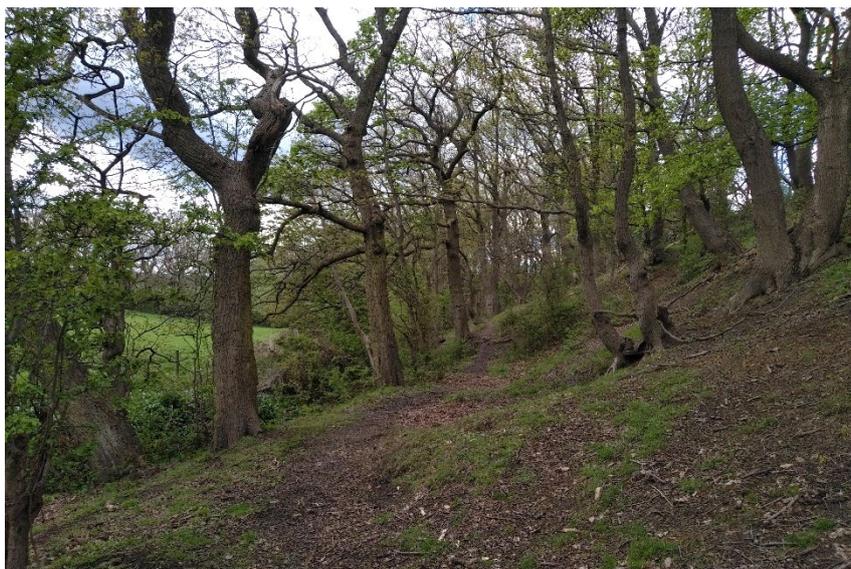
Image 6: Interior of woodland G22 (A category).

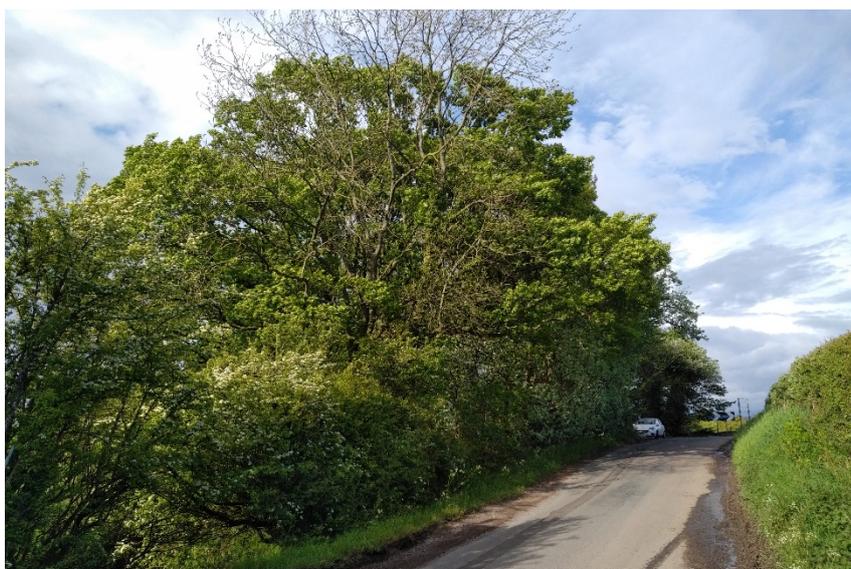
Image 7: Roadside copse G1 (A category), with row of trees G18 to front (C category).

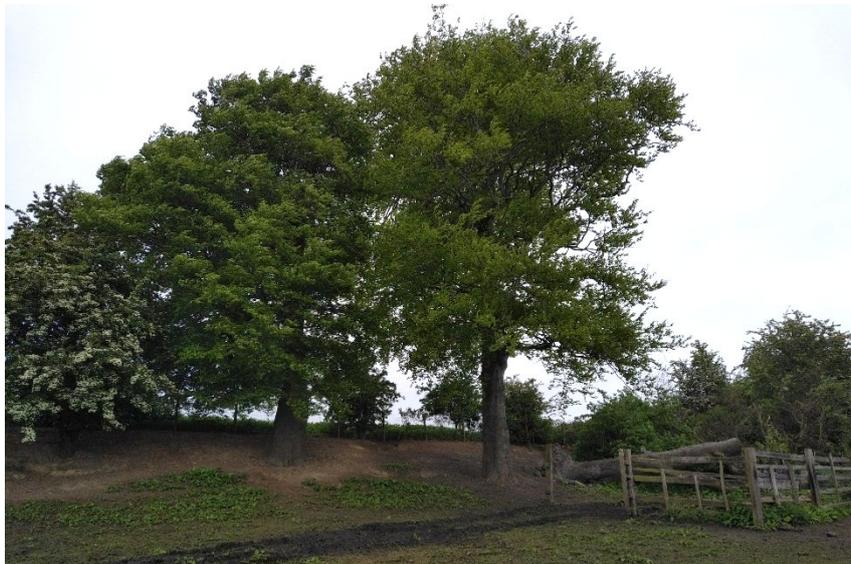
- 4.2.21 Notable amongst the trees classified as of moderate quality is T24, a mature beech tree which was formerly part of a row of three similar trees. One of the other trees (T23) has failed since the previous survey, and the other (T25) was found to be in such poor condition that it has been recommended for removal. It was noted during the survey that bulging that might be indicative of internal decay was evident at the base of T24. If the tree is proposed for retention, it is recommended that further investigations are carried out into the condition of T24 to clarify its suitability for retention within the context of the development, and if retained, to inform a possible management plan for the tree.

Image 8: Beech T24 (centre) (B category) and beech T25 (left) (U category).

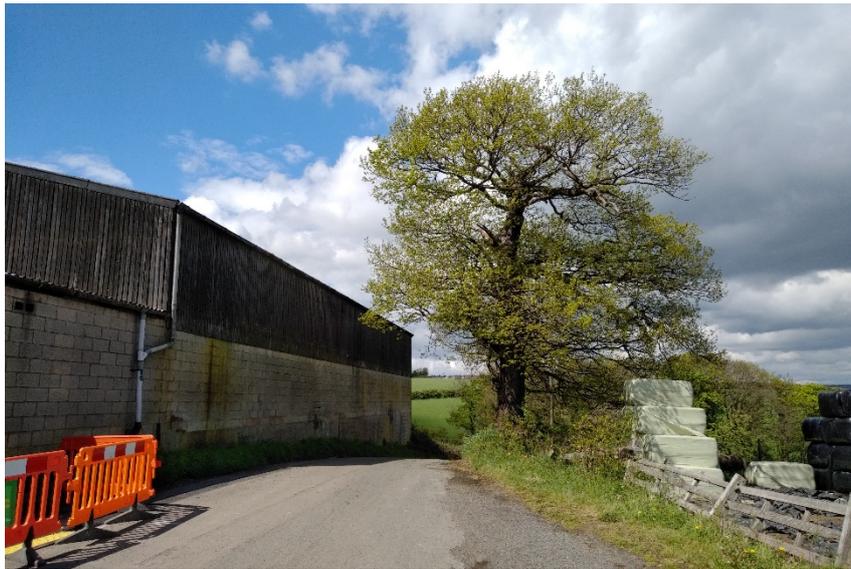
Image 9: Oak T91 beside Hermit Lane (B category).

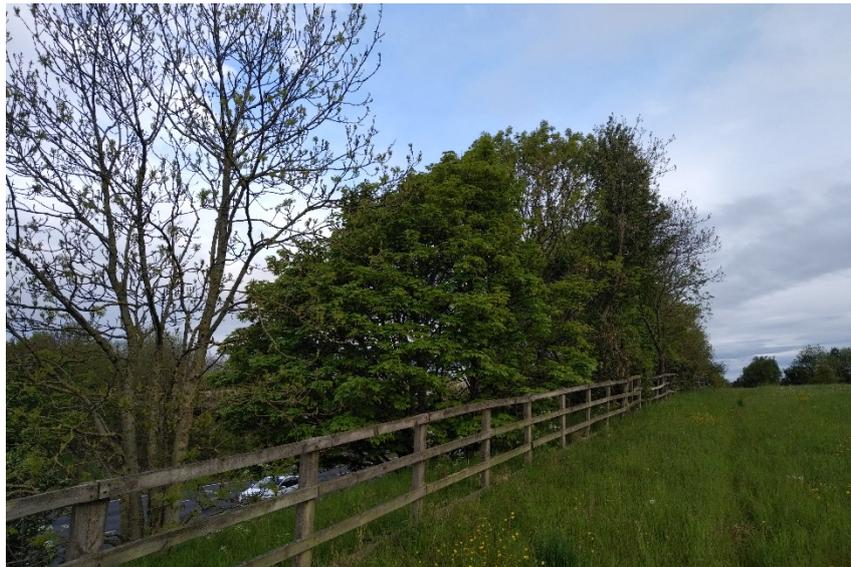
Image 10: Offsite plantation G5 on the verge of the M1 motorway (B category).

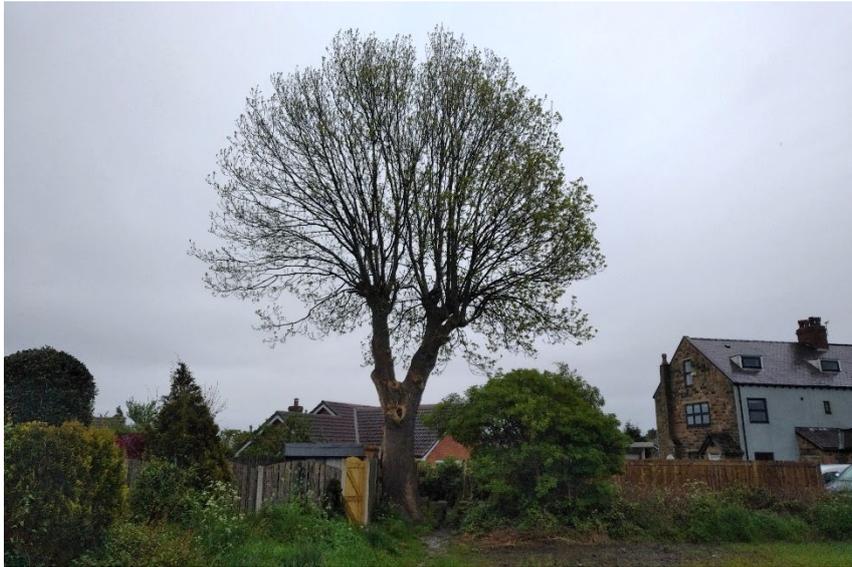
- 4.2.25 Tree T3 is a mature ash tree on the site boundary which has been assigned to this category. The tree has been heavily pollarded in the past and branches are vulnerable to collapse as they regrow from weakened attachment points. The tree also shows evidence of stem decay. The tree requires repollarding if it is retained.

Image 11: Previously pollarded ash T3 on the boundary (C category).

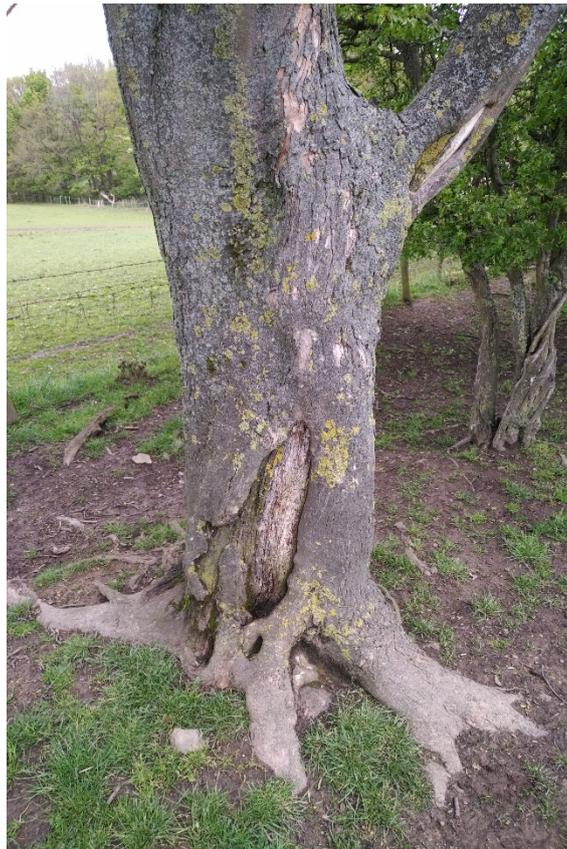
Image 12: Sycamore T30 with significant stem bark damage (C category).

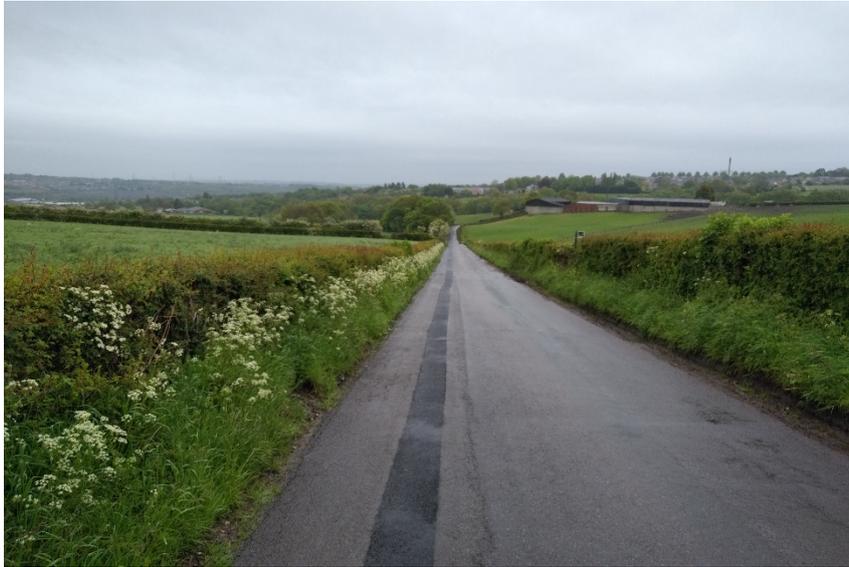
Image 13: Trimmed hawthorn hedges H25 and H26 along Hermit Lane (C category).

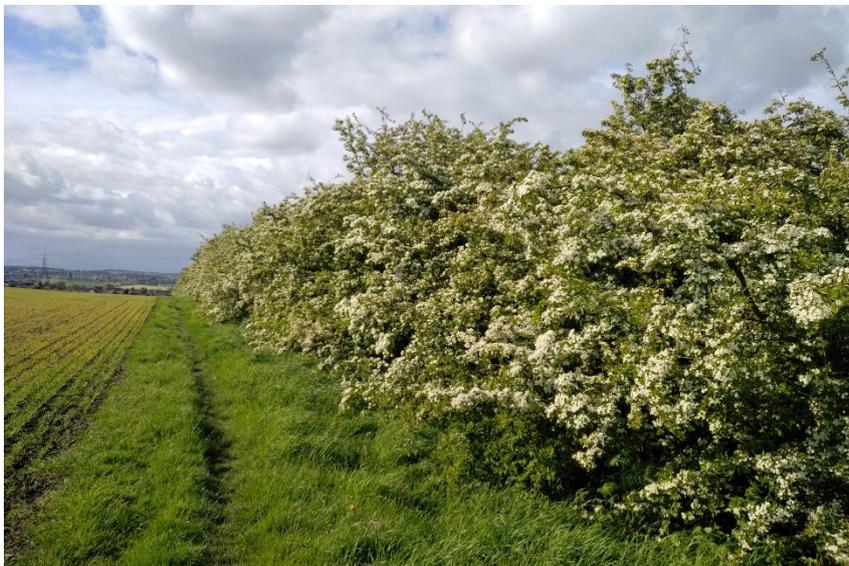
Image 14: Untrimmed hawthorn hedge H28 (C category).

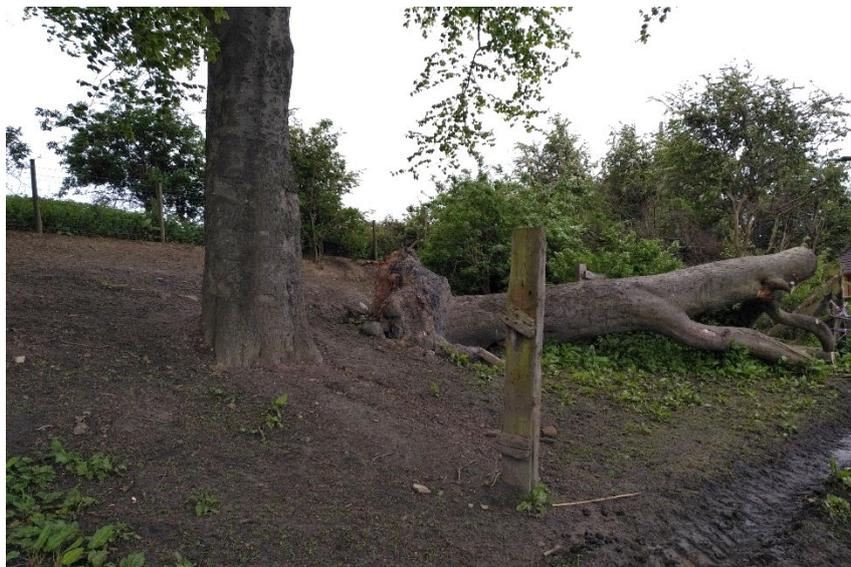
Image 15: Fallen beech T23 (right) (U category) and beech T24 (left) (B category)

T23	Beech	<i>Fagus sylvatica</i>	Mature	No	108	N/A	N/A	N/A	N/A	N/A	N/A	Dead	Fallen tree with stem remaining. Previously recommended for felling in 2018 survey.	Remove collapsed tree stem if site developed.	0	U	N/A	N/A
T24	Beech	<i>Fagus sylvatica</i>	Mature	No	110	19.0	3.0	5.0	12.0	7.0	9.5	Fair	Fibre buckling or reactive growth at base likely to be indicative of decay. Further investigation necessary. Tree exposed by recent collapse of neighbouring beech tree.	Carry out further investigation of potential basal decay to determine the extent and implications of decay, and the suitability of retention in context of development. Retention category provisional.	20-40	B3	13.20	547

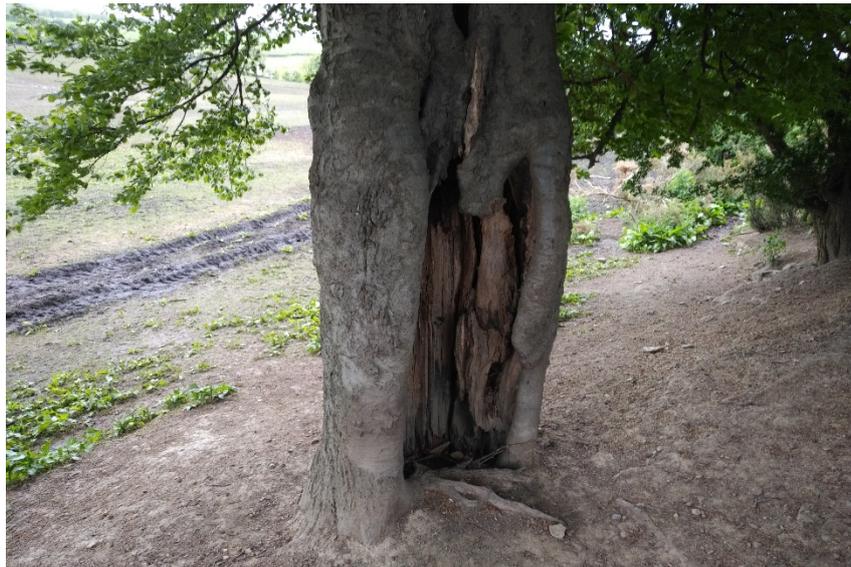
Image 16: Decayed cavity in beech T25 (U category).

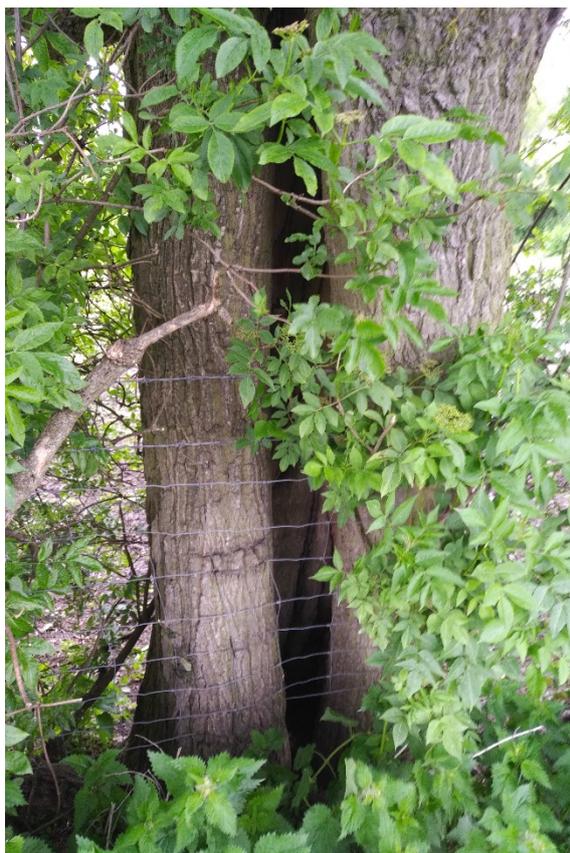
Image 17: Decayed cavity in oak T21 (U category).

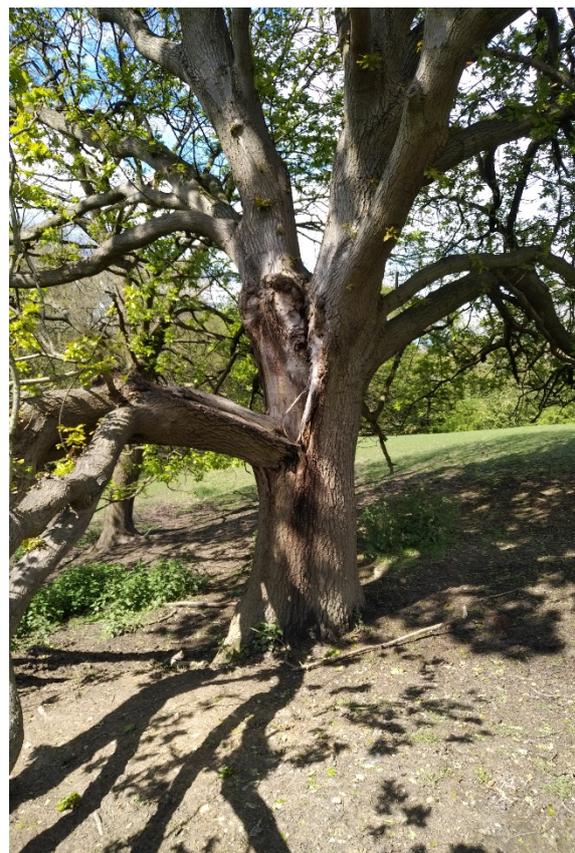
Image 18: Split oak T60 (U category).
