Dilapidation Survey

OLD MILL LANE, BARNESLEY

DILAPIDATION SURVEY

Project no: AMA-40028-DL001

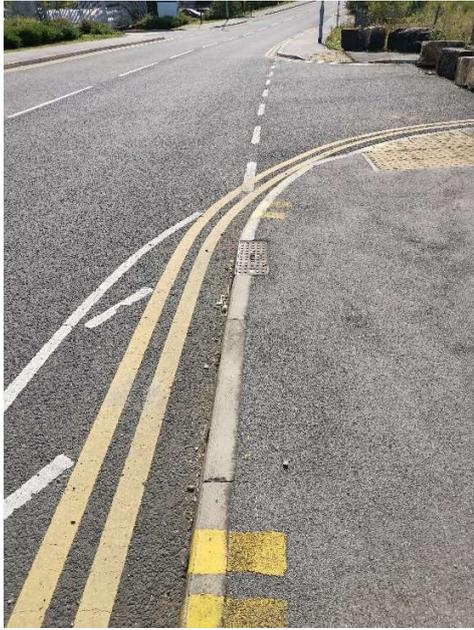
Photo 1

PHOTO REFERENCE	AREA OF HIGHWAY	DEFECT/ COMMENT
001	Footway	Wear to surface course
001	Kerbline	Gaps between kerbstones
002	Footway	Vegetation growing between tactile paving
003	Carriageway	Wear to surface course
004	Footway	Vegetation growing between tactile paving
005	Footway	Wear to surface course due to corrosive bird faeces
006	Footway	Vegetation growing between tactile paving
007	Footway	Wear to surface course due to corrosive bird faeces
008	Carriageway	Pooling water around roundabout
009	Footway	Wear to surface course
010	Kerbs	Damage to kerbline
011	Footway	Wear to surface course
012	Footway	Trench Scaring
013	Kerbs	Gaps between kerbstones
014	Footway	Surface course sunken and fracturing around utilities
015	Footway	Wear to surface course

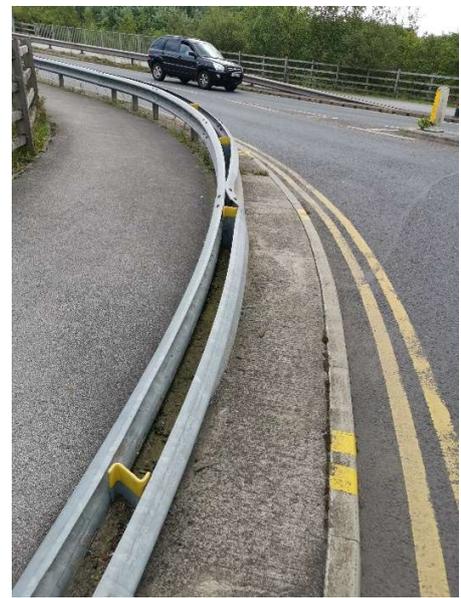
Photo 16

016	Footway	Damage to vehicle restraint barrier
017	Footway	Oil spillage on footway
