### **Trinity Academy Sports Pitches – Coal Mining Assessment**

Further to the completion of the intrusive investigation on the proposed Trinity Academy Sports Pitches we have pleasure in submitting our specific report in relation to the Coal Mining legacy on the site as follows.

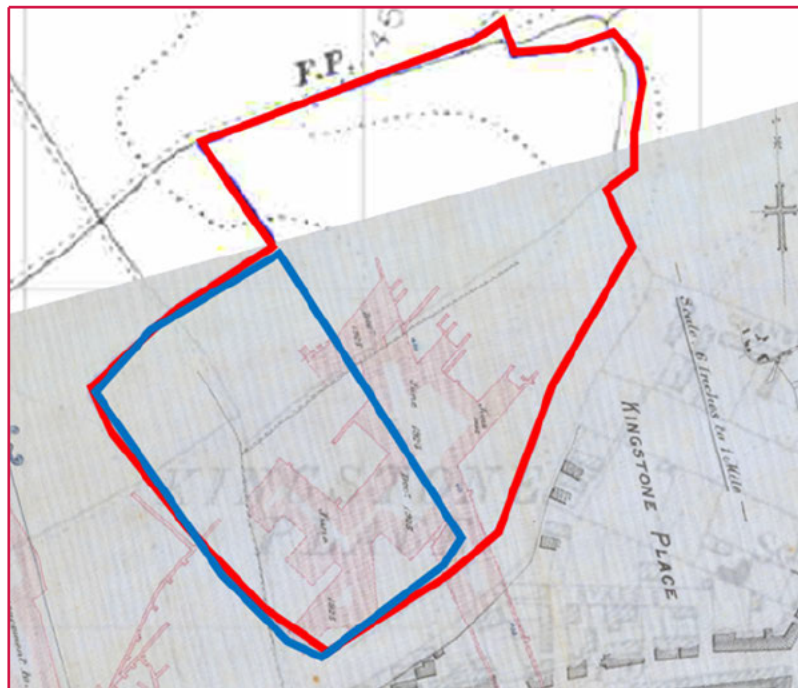
**Figure 3** – Abandonment plans approximately overlayed on the site boundary (blue) and wider site boundary (red)

- § 3.5 The Coal Authority Report indicates that the Barnsley Coal has been worked between 10m and 21m below the site dipping to the east. The thickness is approximately 2.74m and it has been last worked in 1925.
- § 3.6 Abandonment plans obtained from the Coal Authority report indicates that workings of the Barnsley Coal underlie the site as shown on Figure 3.

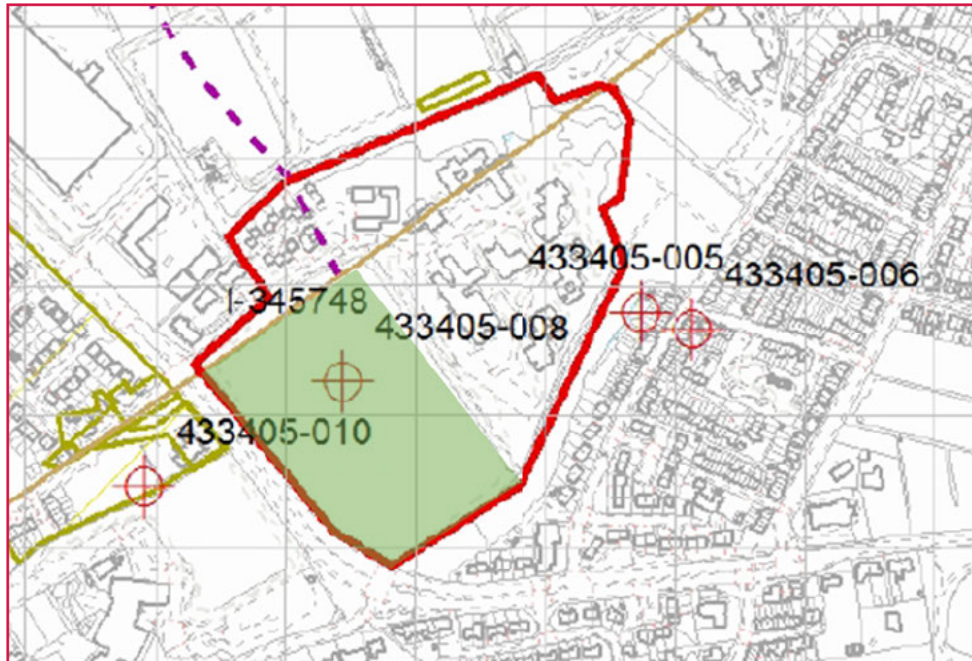
**Figure 4 – Mine Shaft Record Plan (Site shaded green)**

- § 3.7 Records also suggest that an unnamed colliery located on the Sports Pitches site mined the Barnsley Coal. This record also stated that the seam had a dip of 5° to 7.4° to the east; this is possibly the Keresforth Hill Pit.
- § 3.8 A geological fault is present within the site boundary along the northern boundary of the sports pitches striking in a south-west to north-east direction with a downthrow to the south-east.
- § 3.9 The Coal Authority record shaft no. 433405-010 on the site as shown on Figure 4 below. There are no records of its depth, diameter and whether it has been treated.

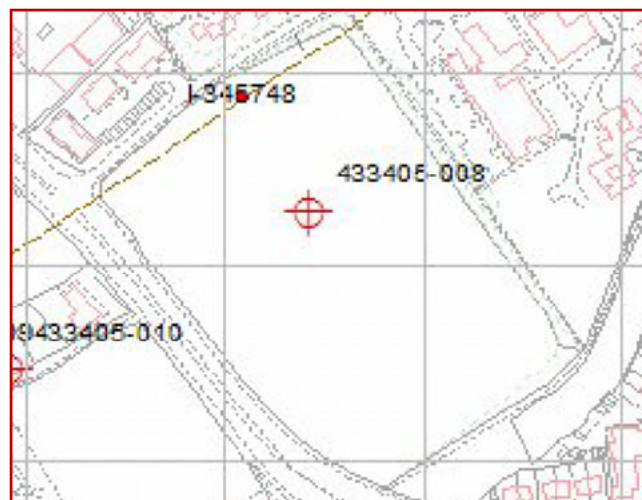
**Figure 5 – Location of Feature 1-345748 requiring Remedial Action**

- § 3.10 Remedial works have been undertaken on the site by the Coal Authority further to the compilation of a Surface Hazard Incident Report. An area of collapse of 182 cm diameter (assumed although unitless in the Coal Authority report) was located to the north of the site as shown by reference 1-345748 on Figure 5 below.

- § 3.11 The Surface Hazard Incident Report has been obtained and it provides information about the work undertaken. The area of collapse has been treated by opening out the collapse to 2.2m by 1.5m and excavating to a depth of 4.5m below the surface to the base of the workings. A total of three potential roadways could be seen to run off from the base of the excavation in a north-east, south-east, and south-westerly direction.

- § 3.12 Remedial works comprised the placing of 12 Tonnes of clean 75mm to 150mm sized limestone compacted in layers not exceeding 300mm to within 1.5m of the surface. A layer of geo-textile has been placed across the fill and around the exposed sides. The as-dug sandy clay spoil has been then placed and compacted in layers not exceeding 150mm thickness to the underside of the existing turf. Finally, the existing topsoil was used to reinstate the surface to the pre-existing field profile.

- § 5.6 The previously mentioned Surface Hazard Incident Report identified the presence of shallow tunnels at around 4.5m below ground level on the northern boundary. Further investigation has shown that the remedial works undertaken has not completely addressed these voids and further investigation and remedial action will be required due to the proximity of the tunnels to the ground surface.

- § 5.8 It is recommended that initially the site is subjected to a geophysical survey to a) determine the extent of any tunnel network on the northern boundary and b) assess the site for possible unrecorded shafts.

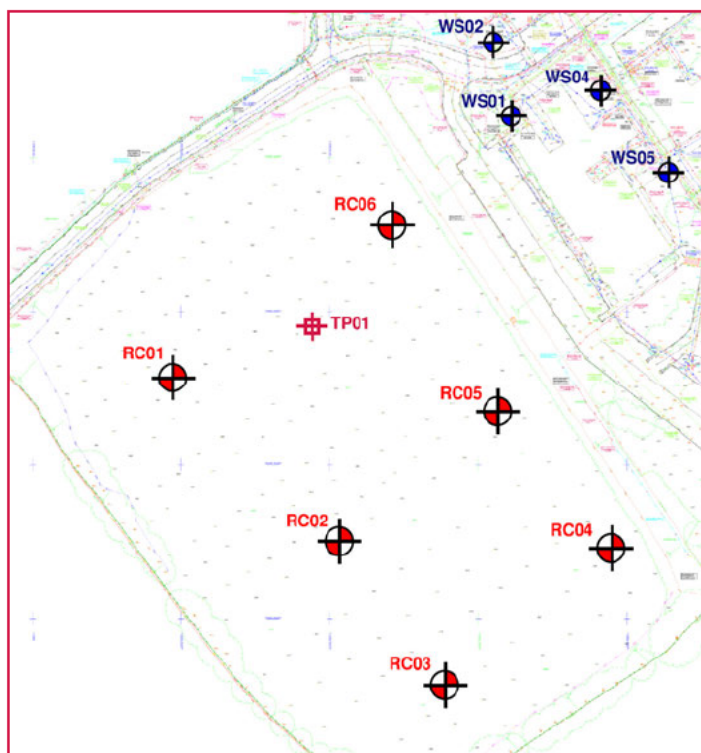
**Figure 5 – Exploratory Hole Location Plan**

- § 4.6 Figure 5 shows the location of the rotary cored boreholes and shaft location trial pit. It should be noted that the playing fields were raised around 1966, the depth of fill being unknown. This may complicate the accurate determination of depth to workings and confirmation of dip.
- § 4.7 However, with interrogation of the boreholes logs as summarised within Table 1, solid strata are determined to generally dip to the east.

- § 4.8 Coal, thought to be the Barnsley Coal seam was observed in exploratory holes RC01, RC02, RC03, RC04, RC05 and RC06; this is summarised in Table 3.

- § 4.9 The ground investigation does not conclusively prove workings in the Barnsley Coal due to variation in seam thickness and disposition, but it is considered likely in 50% of the exploratory holes and possible in the remainder. This suggests that unrecorded workings extended further north and west.
- § 4.10 Shaft record, Coal Authority no. 433405-010 was located by trial pit TP01 as shown in Figure 6 below.

- § 5.5 The final sports pitch surface construction should incorporate one or two layers of geogrid, to be designed by an specialist. This will provide some mitigation in minimising any settlement at the ground surface mobilised by any collapse of the Barnsley Coal workings. It is also recommended that a periodic inspection of the pitches in undertaken by a suitably qualified person.

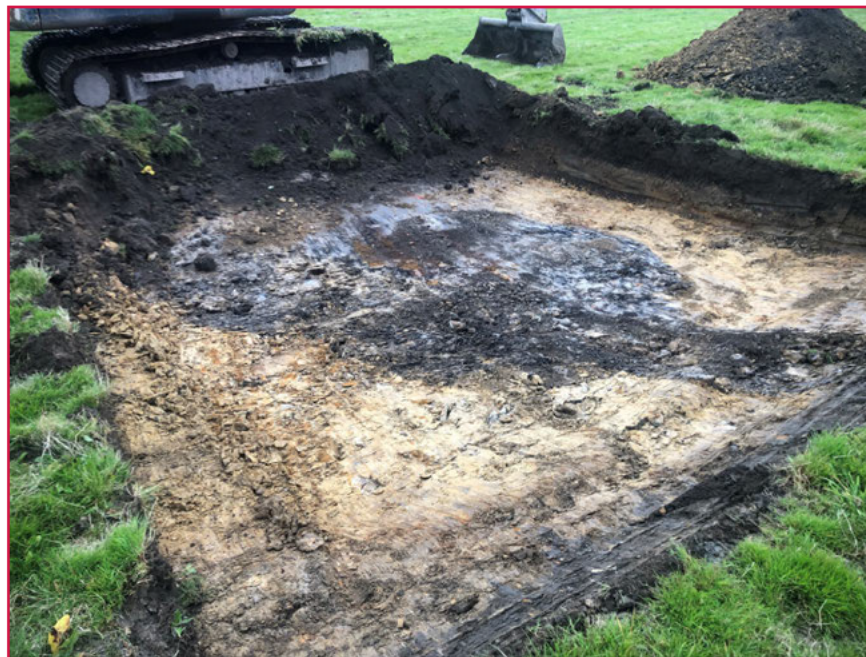
**Figure 6 – Encountered Mine Shaft**

- § 5.7 The shaft recorded by the Coal Authority reference no. 433405-010 has been located on site. Failure of shaft infill and or collapse of the shaft (both recorded and unrecorded) could result in a catastrophic impact.

- § 5.9 Should non-intrusive works prove to be inconclusive, intrusive works should be undertaken.
- § 5.10 All shafts are to be treated appropriately; CIRIA document C758D Abandoned mine workings manual (Ref.3) is recommended for reference and guidance.
