# Thurnscoe Bridge Lane- Dilapidation Survey

Carried out 26.08.2026

Avant Homes (North East), Investor House, Colima Avenue,  
Sunderland Enterprise Park, Sunderland SR5 3XB

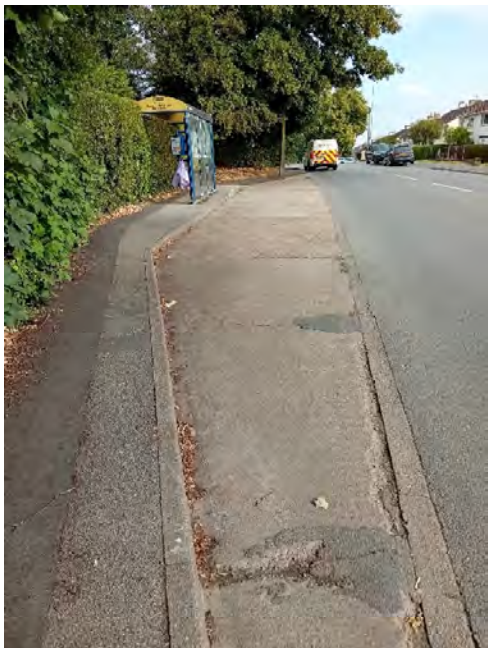
**1** - Bus stop layby near site entrance

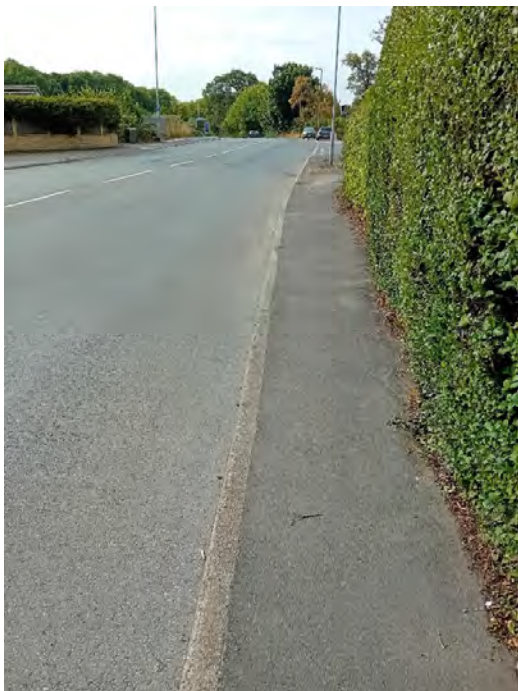
**3** - Highway and Footpath in okay condition.

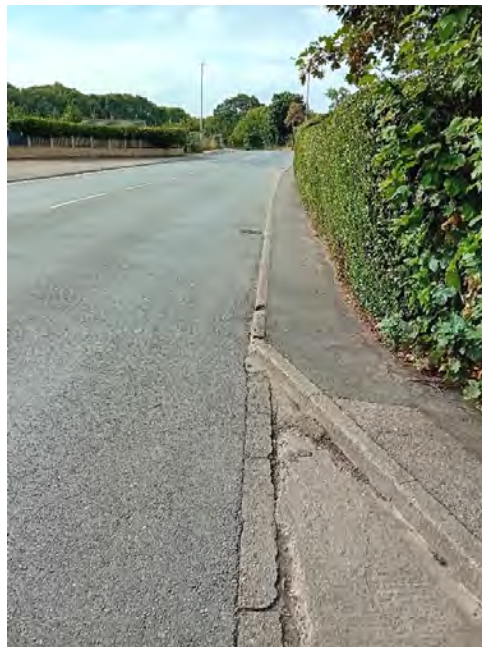
**2** - Looking towards site entrance .

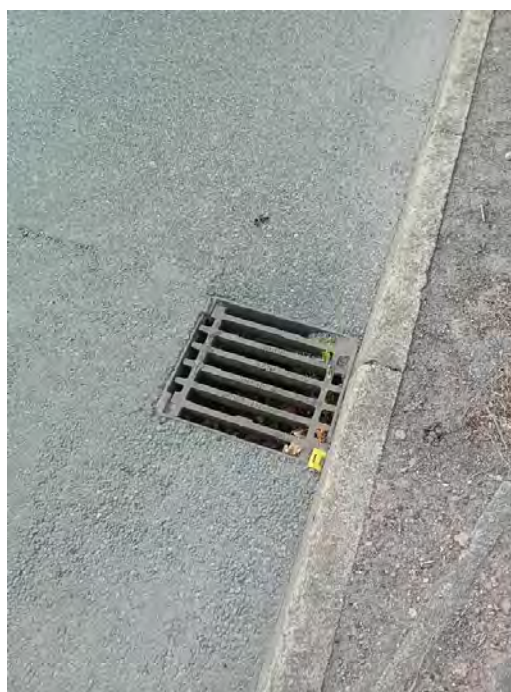
**4** - Gully in good condition before radius to junction into site.

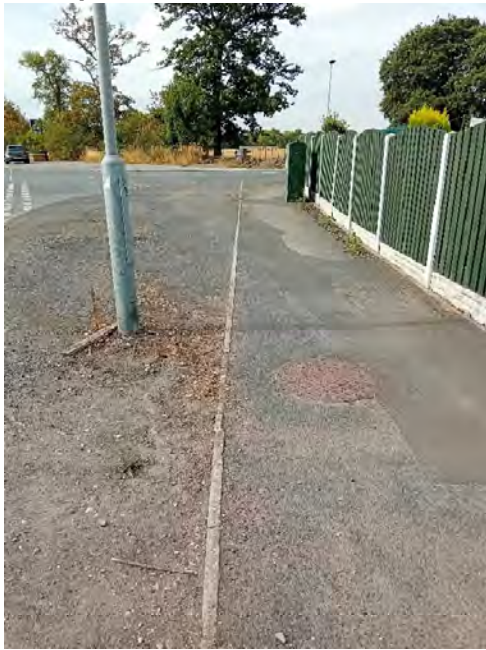
**5** - Lamp post, MH lid and patches

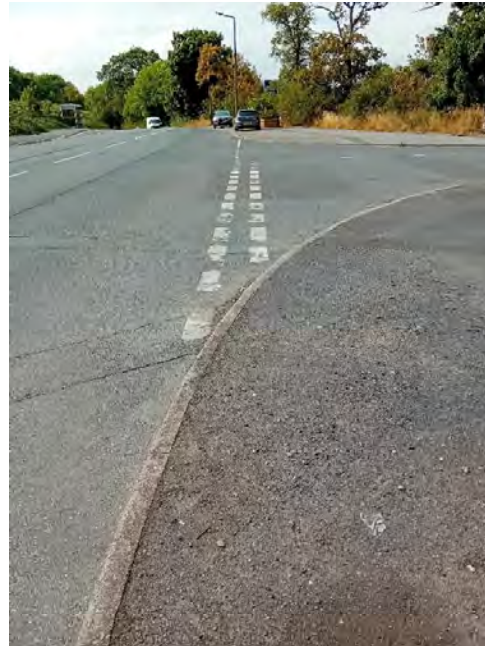
**6**- White lining into Derry grove thunscoe bridge lane junction

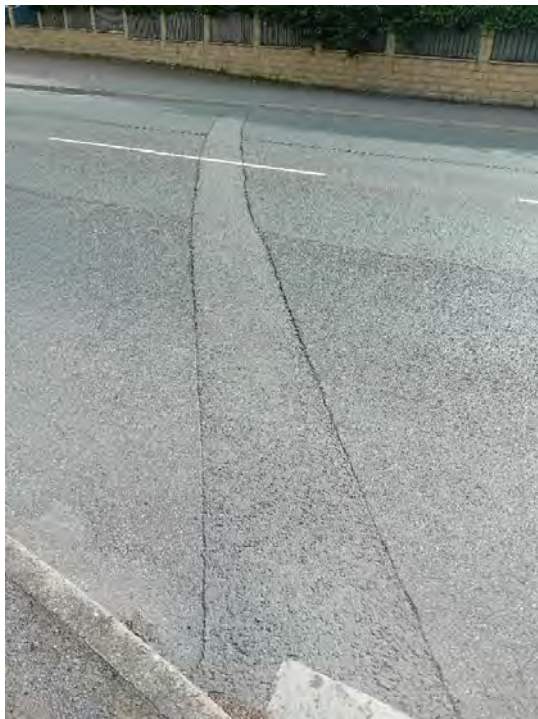
**7** - scar which will be taking considerable loadings from delivery's

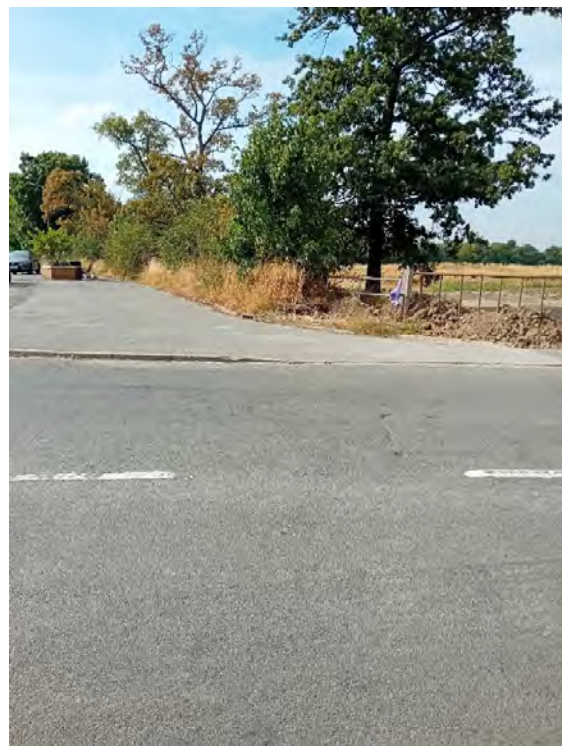
**8** - Gully lids to receive heavy traffic, in fairly good condition.

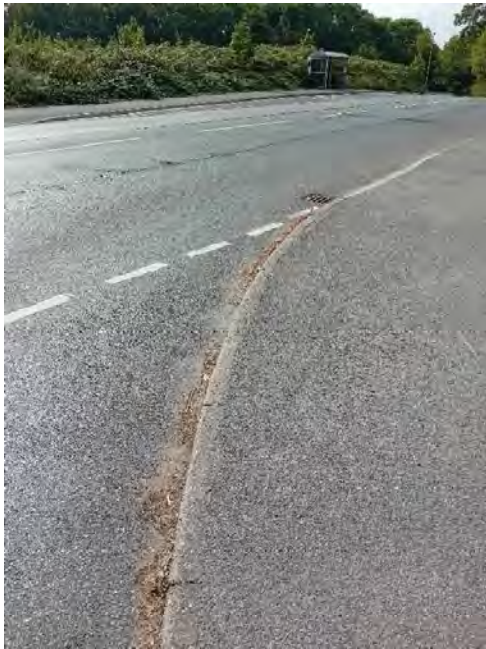
**9-** Gully on radius into Derry Grove

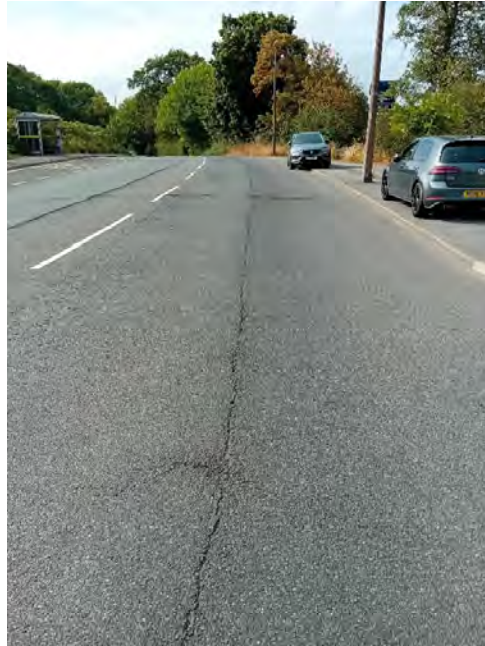
**10 -** jointing cracks

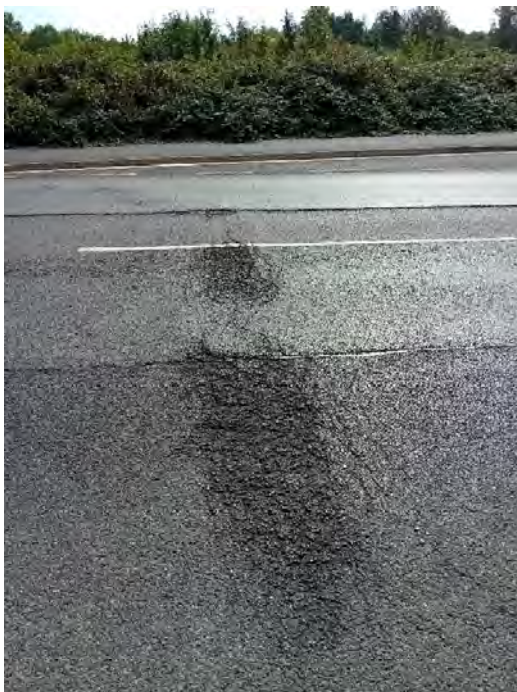
**11 -** crocodile patches which will get worse over time.

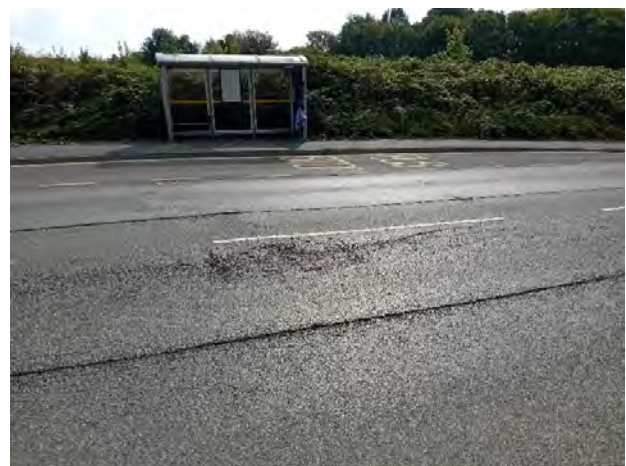
**12 -** More crocodile patches

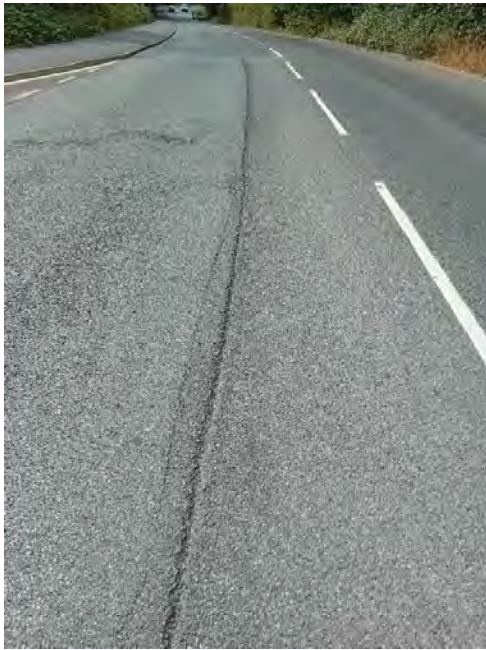
**13** - Joint cracks both sides of road.

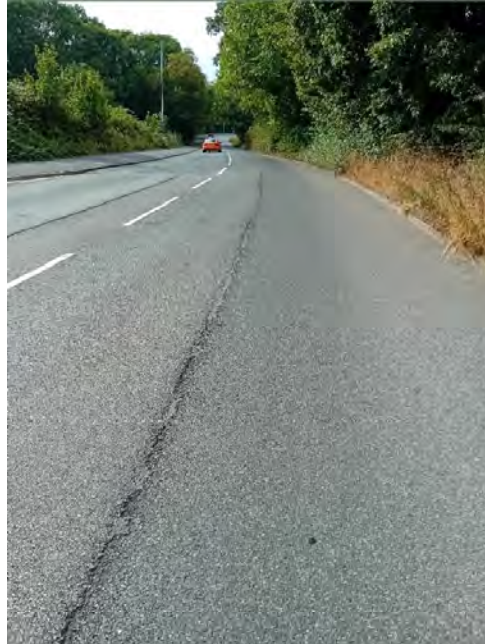
**14** - more jointing cracks  
Looking down TBL

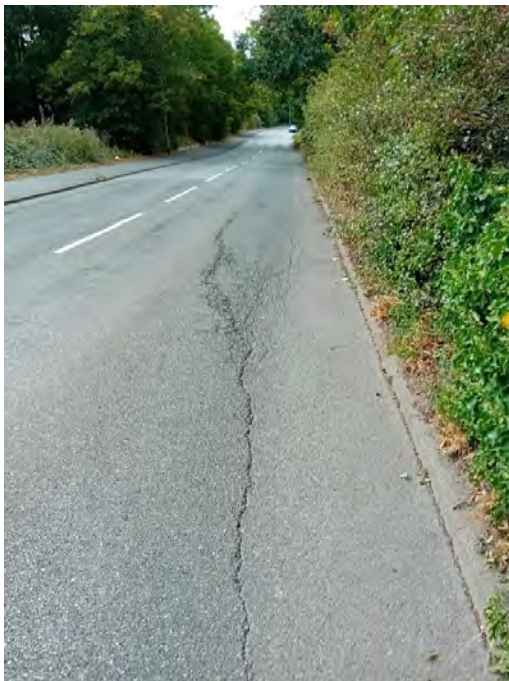
**15** - potential root damage  
from mature trees in the verge

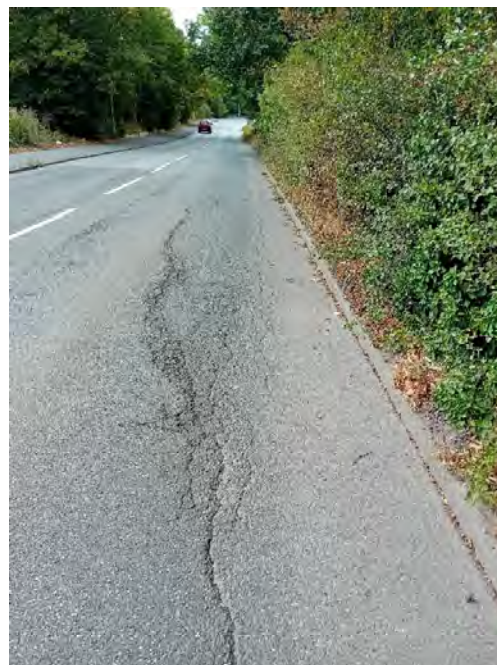
**16** - another photo from root  
possible root damage

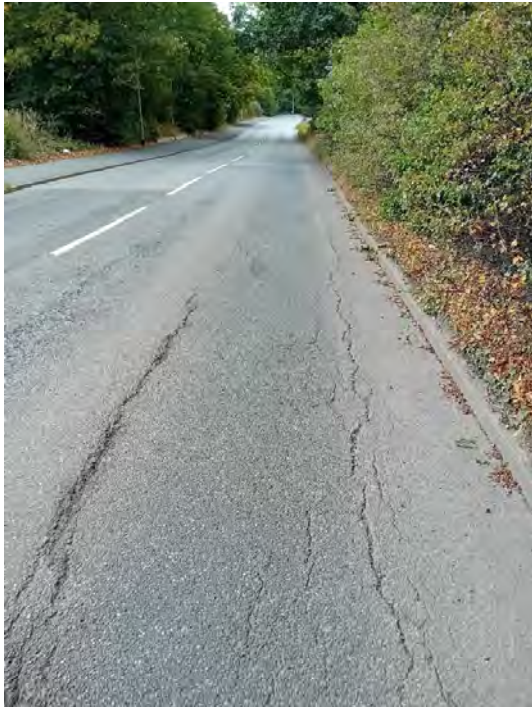
**17** - Highway in poor condition .

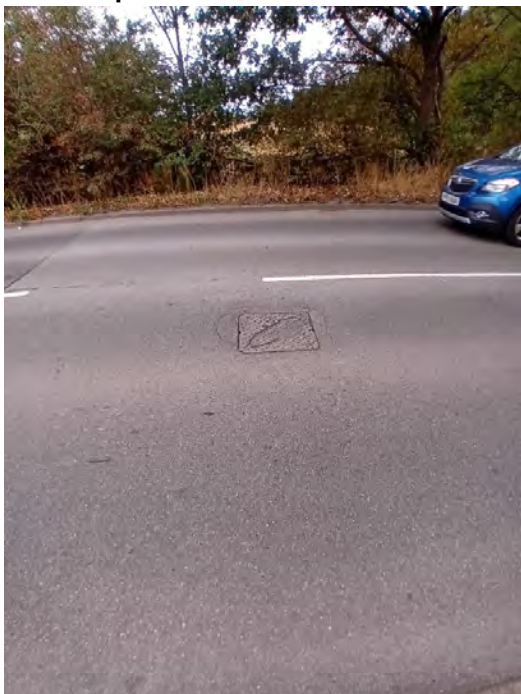
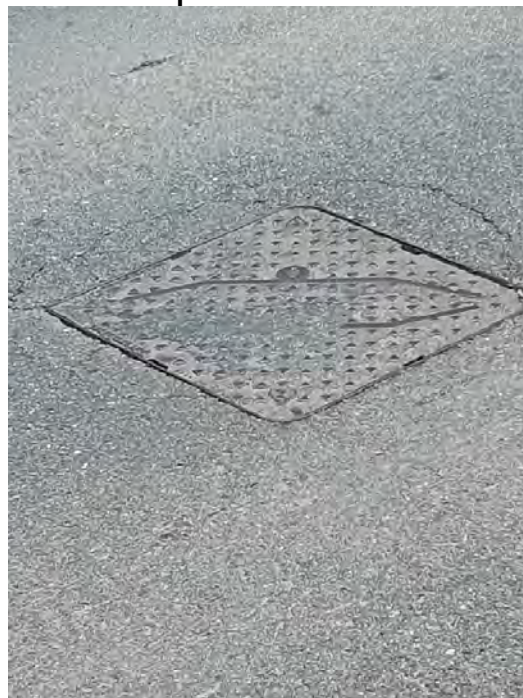
**19** - Manhole lid in wheel line, in poor. **20** - Manhole lid in wheel line, in poor condition.

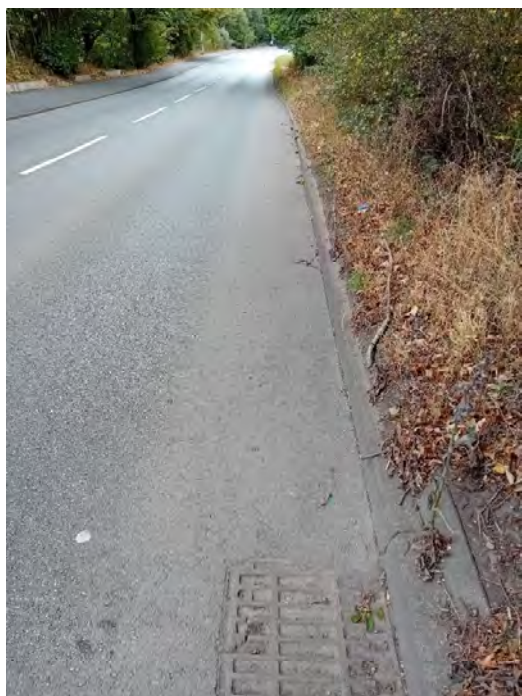
### **21**- Blocked gully

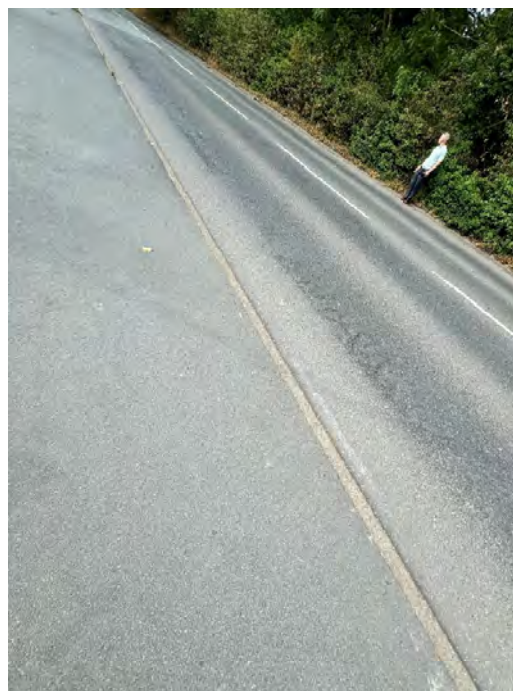
## **22** - Crocodile patches

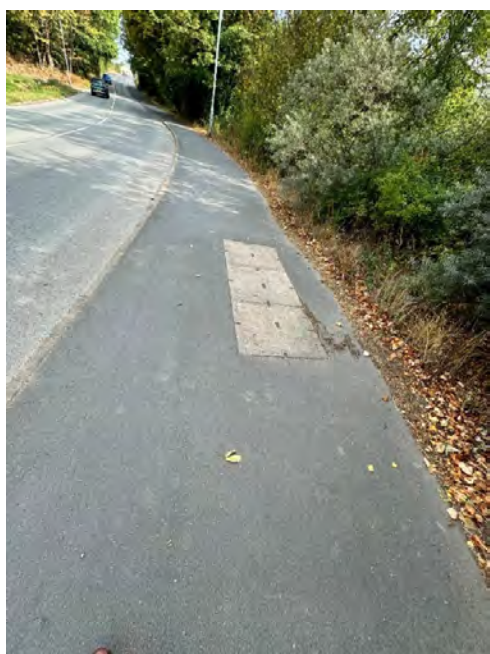
### **23** - BT junction box in footway Good condition

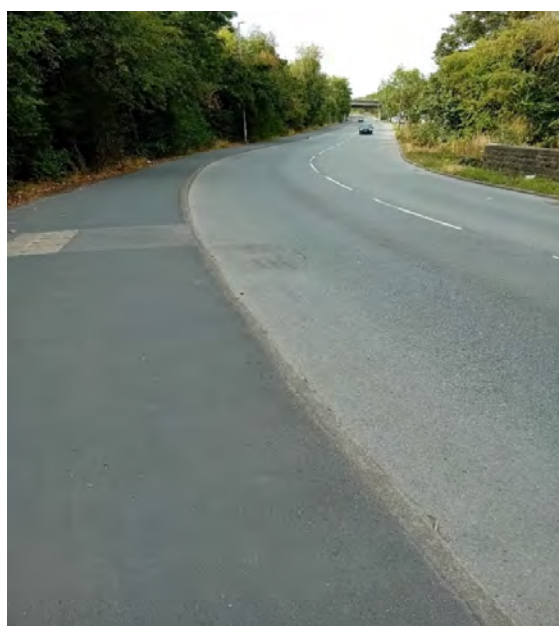
### **24** - corner on TBL with patch to bt and several manifold, meter chambers

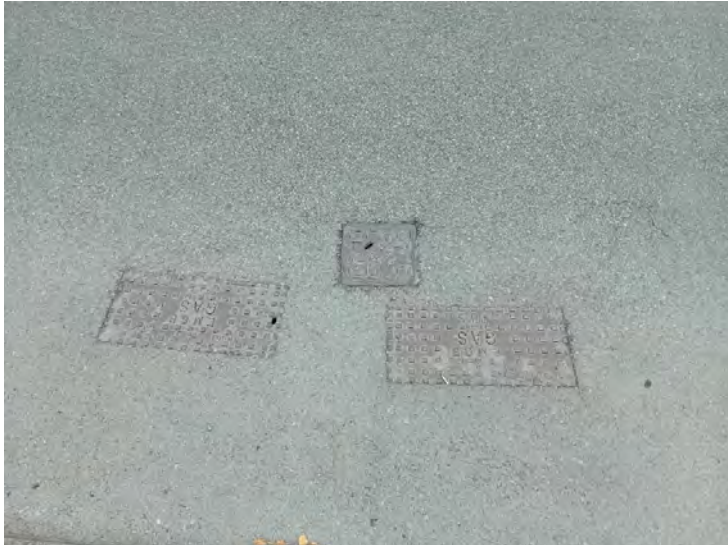
**25** -Close up of the manifolds  
in good condition

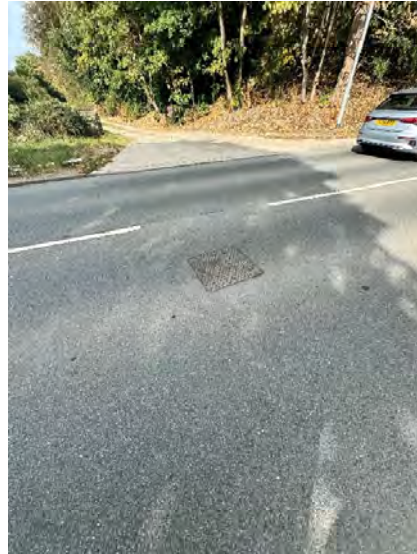
**26** - Manhole lid in wheel line,  
good condition

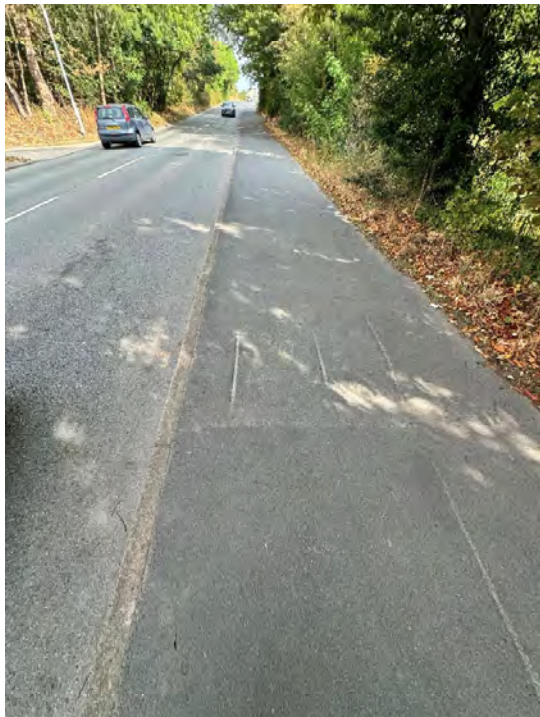
**27** - Damage to footpath **28** - Looking back up towards derry grove

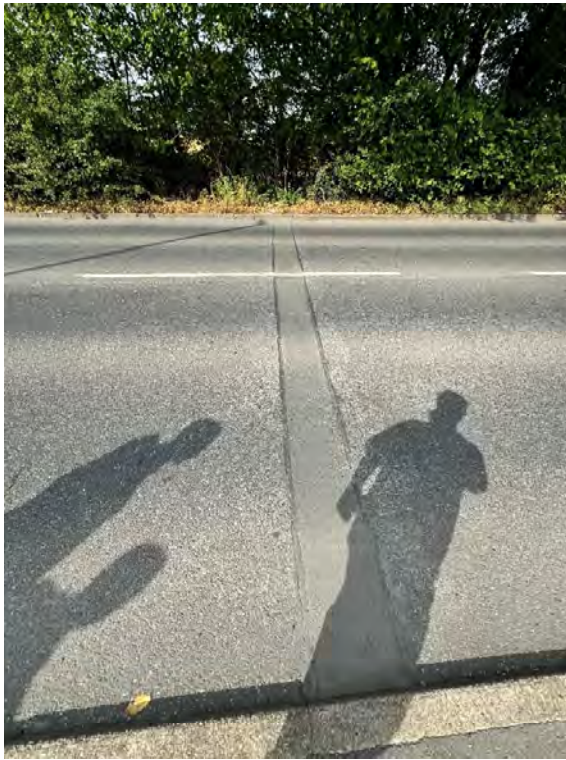
**29** Scar to BT box sealed and tidy. **30** Walking back up TBL- okay

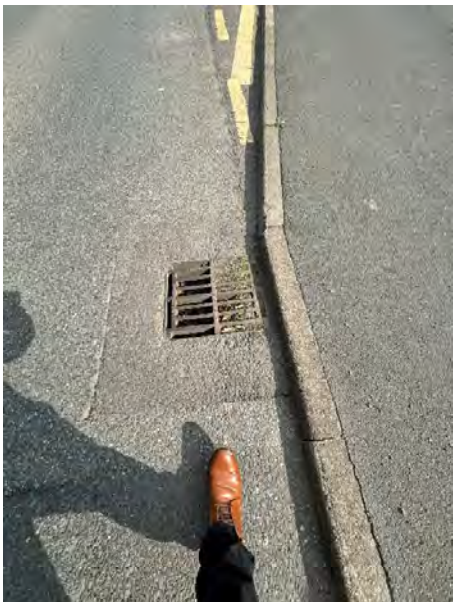
**31** - First gully in bus layby ,  
Decent condition.

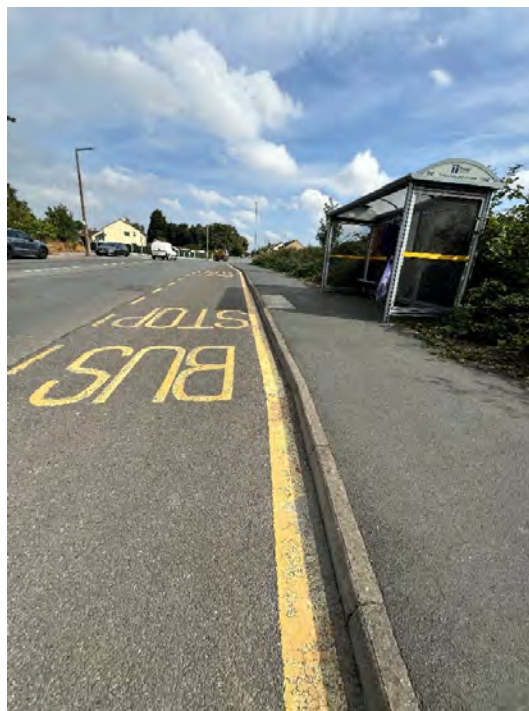
**36 - Bus layby -good condition**

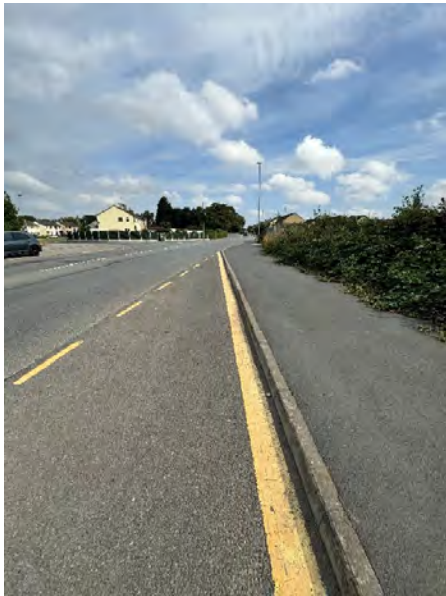
**37-** Bus layby Good condition

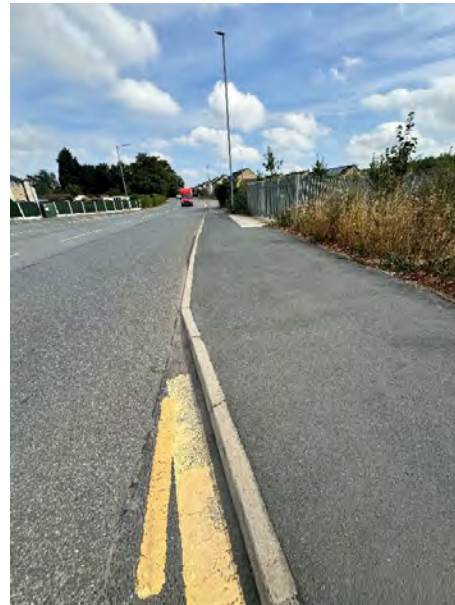
38- End of layby- good condition

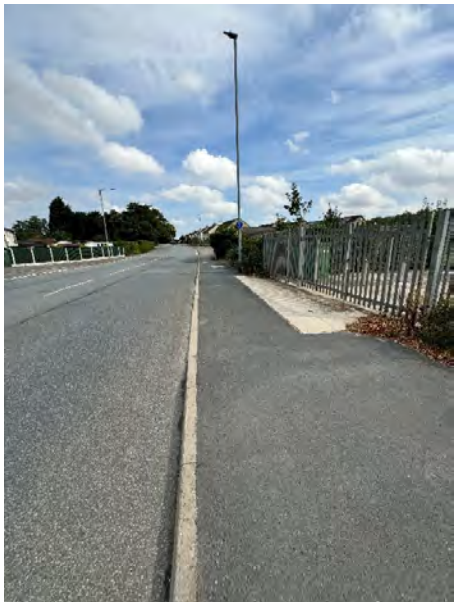
**39** - Footway opposite DG  
Good condition .

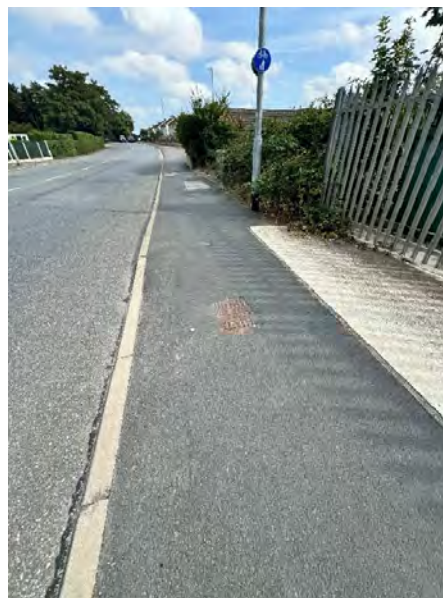
**40-** Manifold in good condition

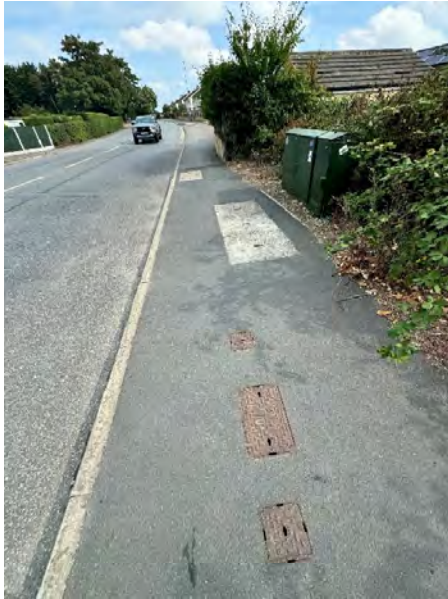
**41** Close up of manifolds  
Bt chambers in good condition

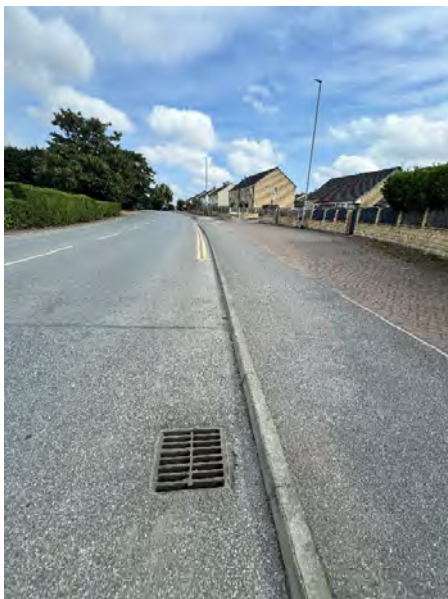
**43-** Gully. Good condition

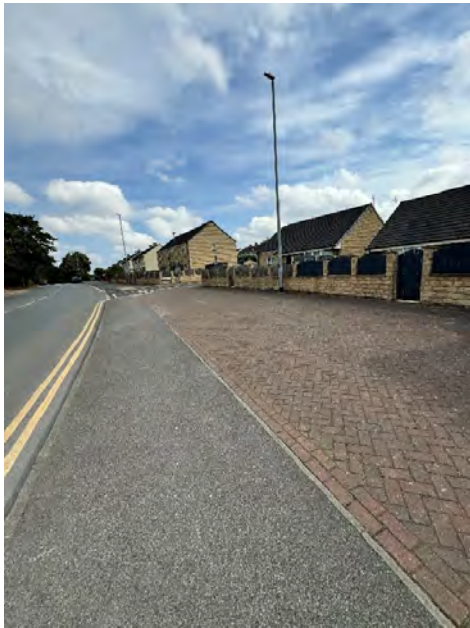
**45** - Block paving/footpath  
in good condition .

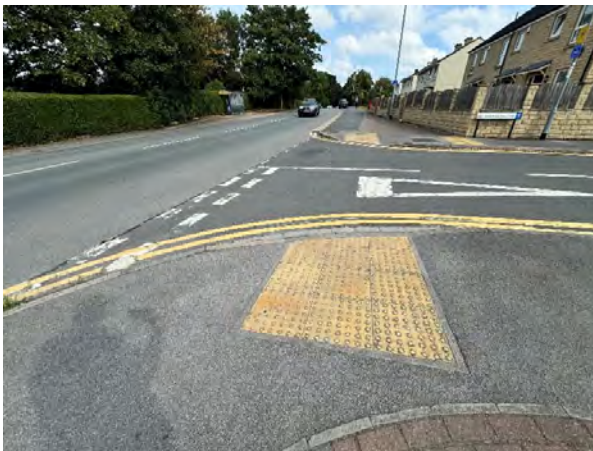
**47** - Both tactiles in good condition
