**Bolton Hall**

**Rotherham**

**DEMOLITION SURVEY**

Job No. LP16-00070

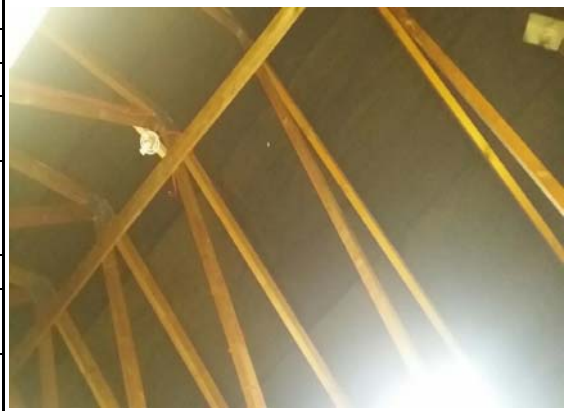
| Sample No: LP16-00070-1 | | | |
|---|---|---|---|
| <b>Asbestos Type:</b> | NAD | <b>Condition:</b> | Low Damage |
| <b>Surface Treatment:</b> | Bitumen | | |

| Sample No: LP16-00070-1 | | | |
|---|---|---|---|
| <b>Recommendations:</b> | N/A | | |

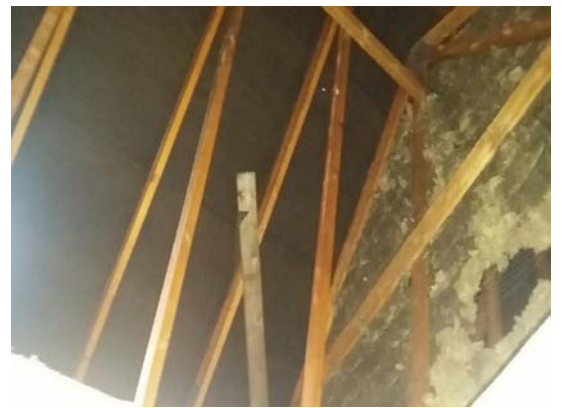
| Sample No: LP16-00070-2 | | | |

| Sample No: LP16-00070-2 | | | |
|---|---|---|---|
| <b>Asbestos Type:</b> | NAD | <b>Condition:</b> | Low Damage |
| <b>Surface Treatment:</b> | Bitumen | | |

| Sample No: LP16-00070-2 | | | |
|---|---|---|---|
| <b>Recommendations:</b> | N/A | | |

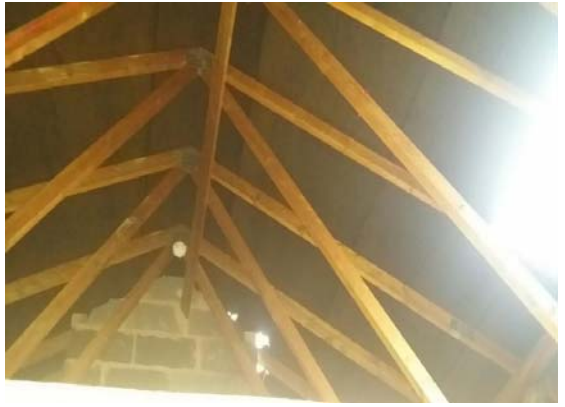
| Sample No: | | LP16-00070-3 | |

| Asbestos Type: | NAD | Condition: | Low Damage |
| Surface Treatment: | Bitumen | | |

| Recommendations: | N/A | | |

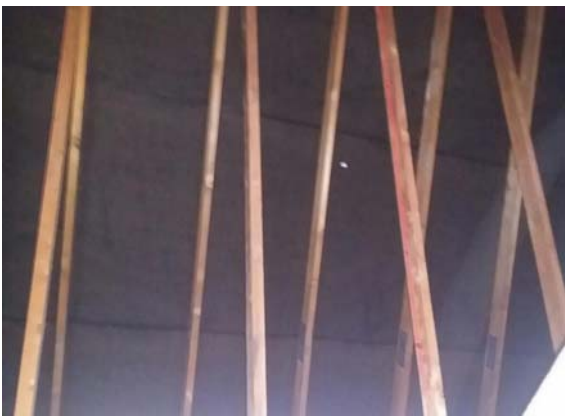
| Sample No: | | LP16-00070-4 | |

| Asbestos Type: | NAD | Condition: | Low Damage |
| Surface Treatment: | Bitumen | | |

| Recommendations: | N/A | | |

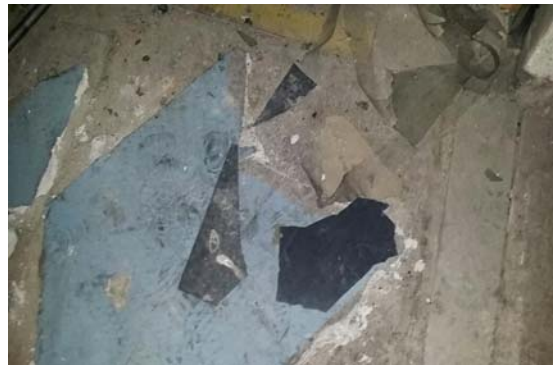
| Sample No: | | LP16-00070-5 | |

| Asbestos Type: | NAD | Condition: | High Damage |
| Surface Treatment: | Cement | | |

| Recommendations: | N/A | | |

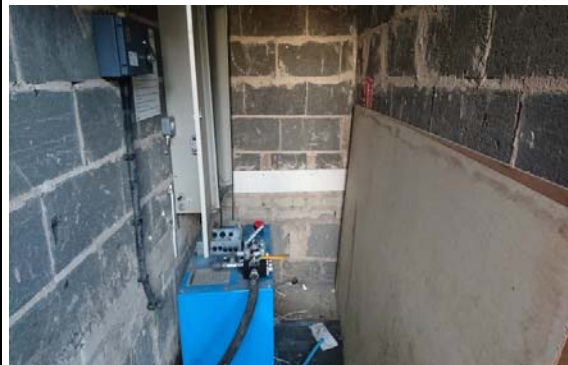
| Sample No: | | LP16-00070-7 | |

| Asbestos Type: | NAD | Condition: | Low Damage |
| Surface Treatment: | Insulating board | | |

| Recommendations: | N/A | | |

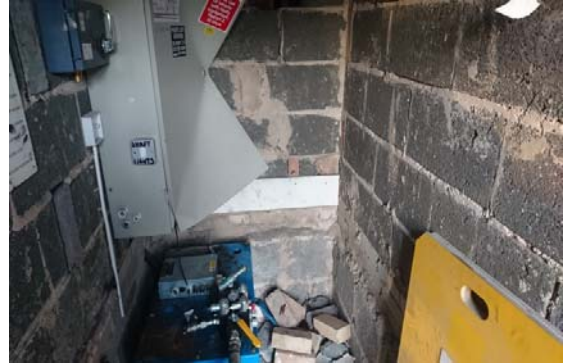
| Sample No: | | LP16-00070-8 | |

| Asbestos Type: | NAD | Condition: | Low Damage |
| Surface Treatment: | Insulating board | | |

| Recommendations: | N/A | | |

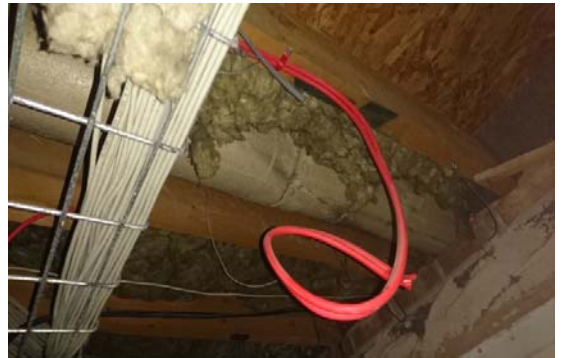
| Sample No: | | LP16-00070-6 | |

| Asbestos Type: | NAD | Condition: | Low Damage |
| Surface Treatment: | Bonded materials | | |

| Recommendations: | N/A | | |

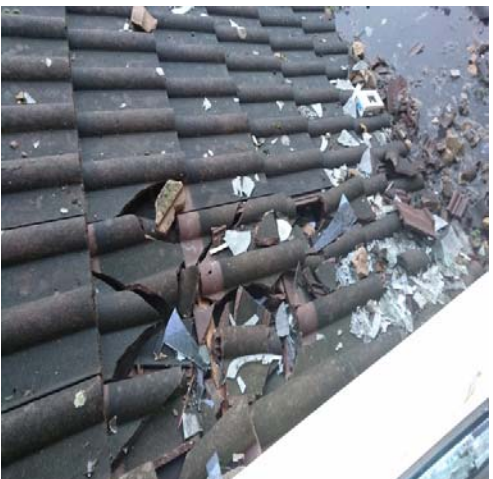
| <b>Reason for Exclusion:</b> | No access to these areas as they were too high to access and the roof is in a poor state of repair with large holes and tiles sliding off. An inspection should be undertaken by a suitably trained competent person once safe access can be gained. | |
