PR/AJK/41899-001

28 September 2017

**Heelis Street, Barnsley**  
**Coal Mining Risk Assessment**

# CON29M Non-Residential Mining Report

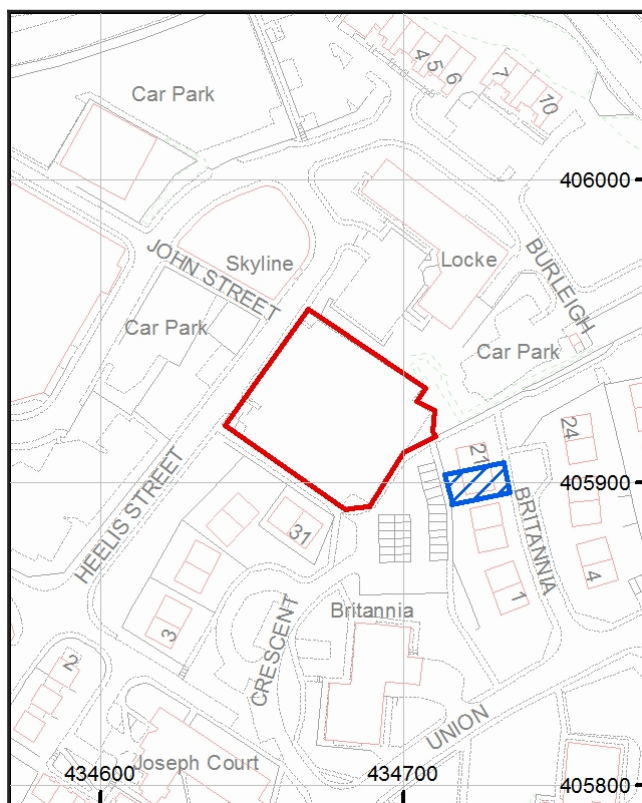
# Enquiry boundary

There are 1 claim(s) within 50 metres of the property boundary that do not match the property address. These are shown on the enquiry boundary plot.
