SF3387 CMS Rockingham

ARBORICULTURAL SURVEY REPORT | BS 5837:2012

Revision D - November 2023

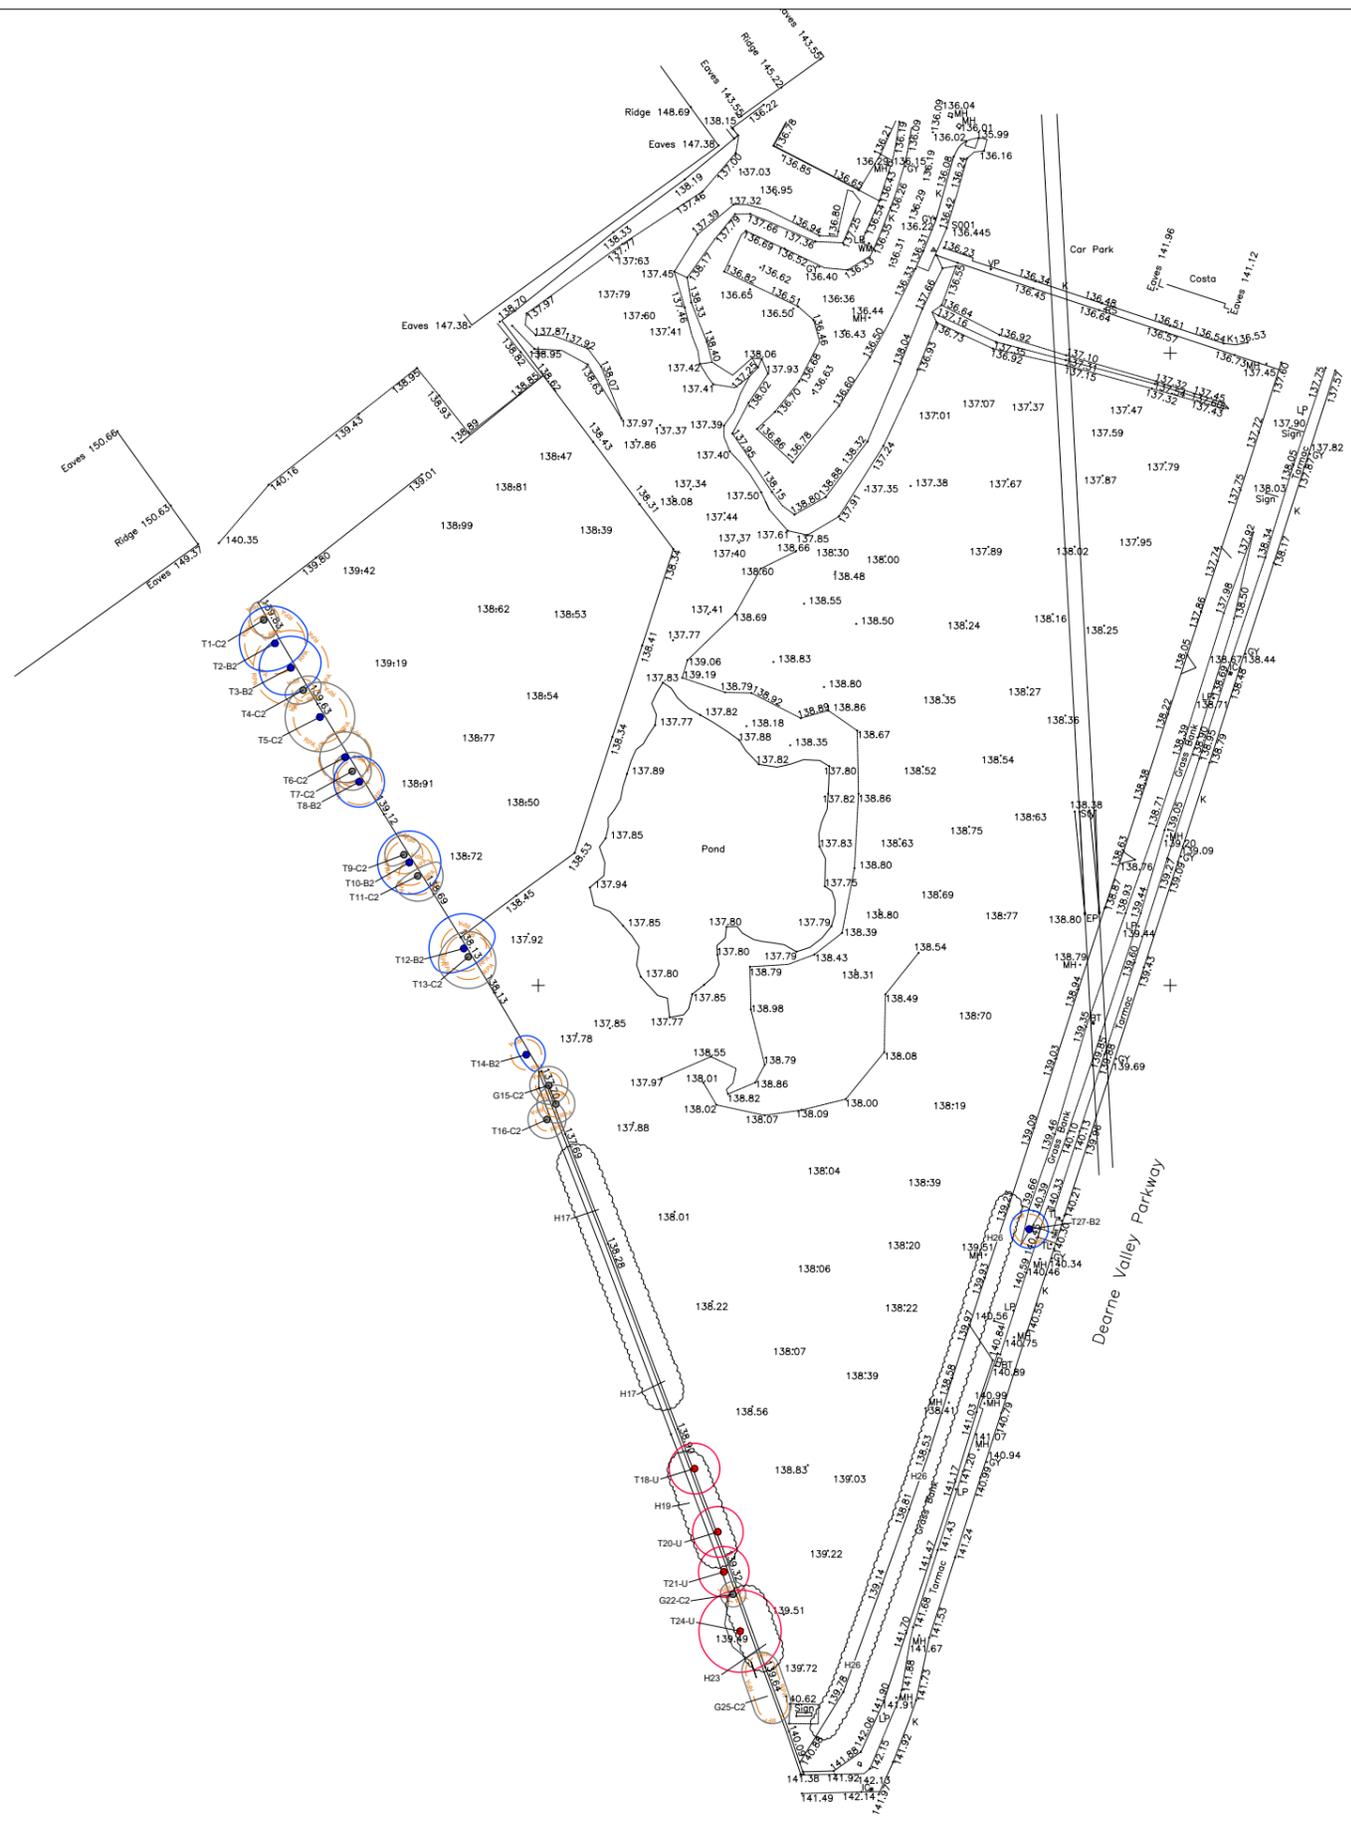
SF3387 TS01 Tree Survey Plan

- 4.1 The potential for retaining trees on a development site includes the extent of the influence of the tree at the time of survey. Consideration is also given to the effects of future growth within the context of the proposed development. In addition, the potential nuisance caused by shading to new buildings both after construction and also once trees reach their ultimate size is also considered.
- 4.2 The extent to which a tree may represent a constraint to development will depend both upon the location of the trunk and size and nature of the canopy and also the extent of the roots below ground. The tree constraints drawing (SF3387 TS01) plots the location and extent of the tree above ground.

- 5.3 The tree constraints drawing (SF3387 TS01) plots the location and extent of the tree below ground through application of the calculation provided in section 4.6 of the BS5837:2012 Trees in relation to design demolition and construction – Recommendations.

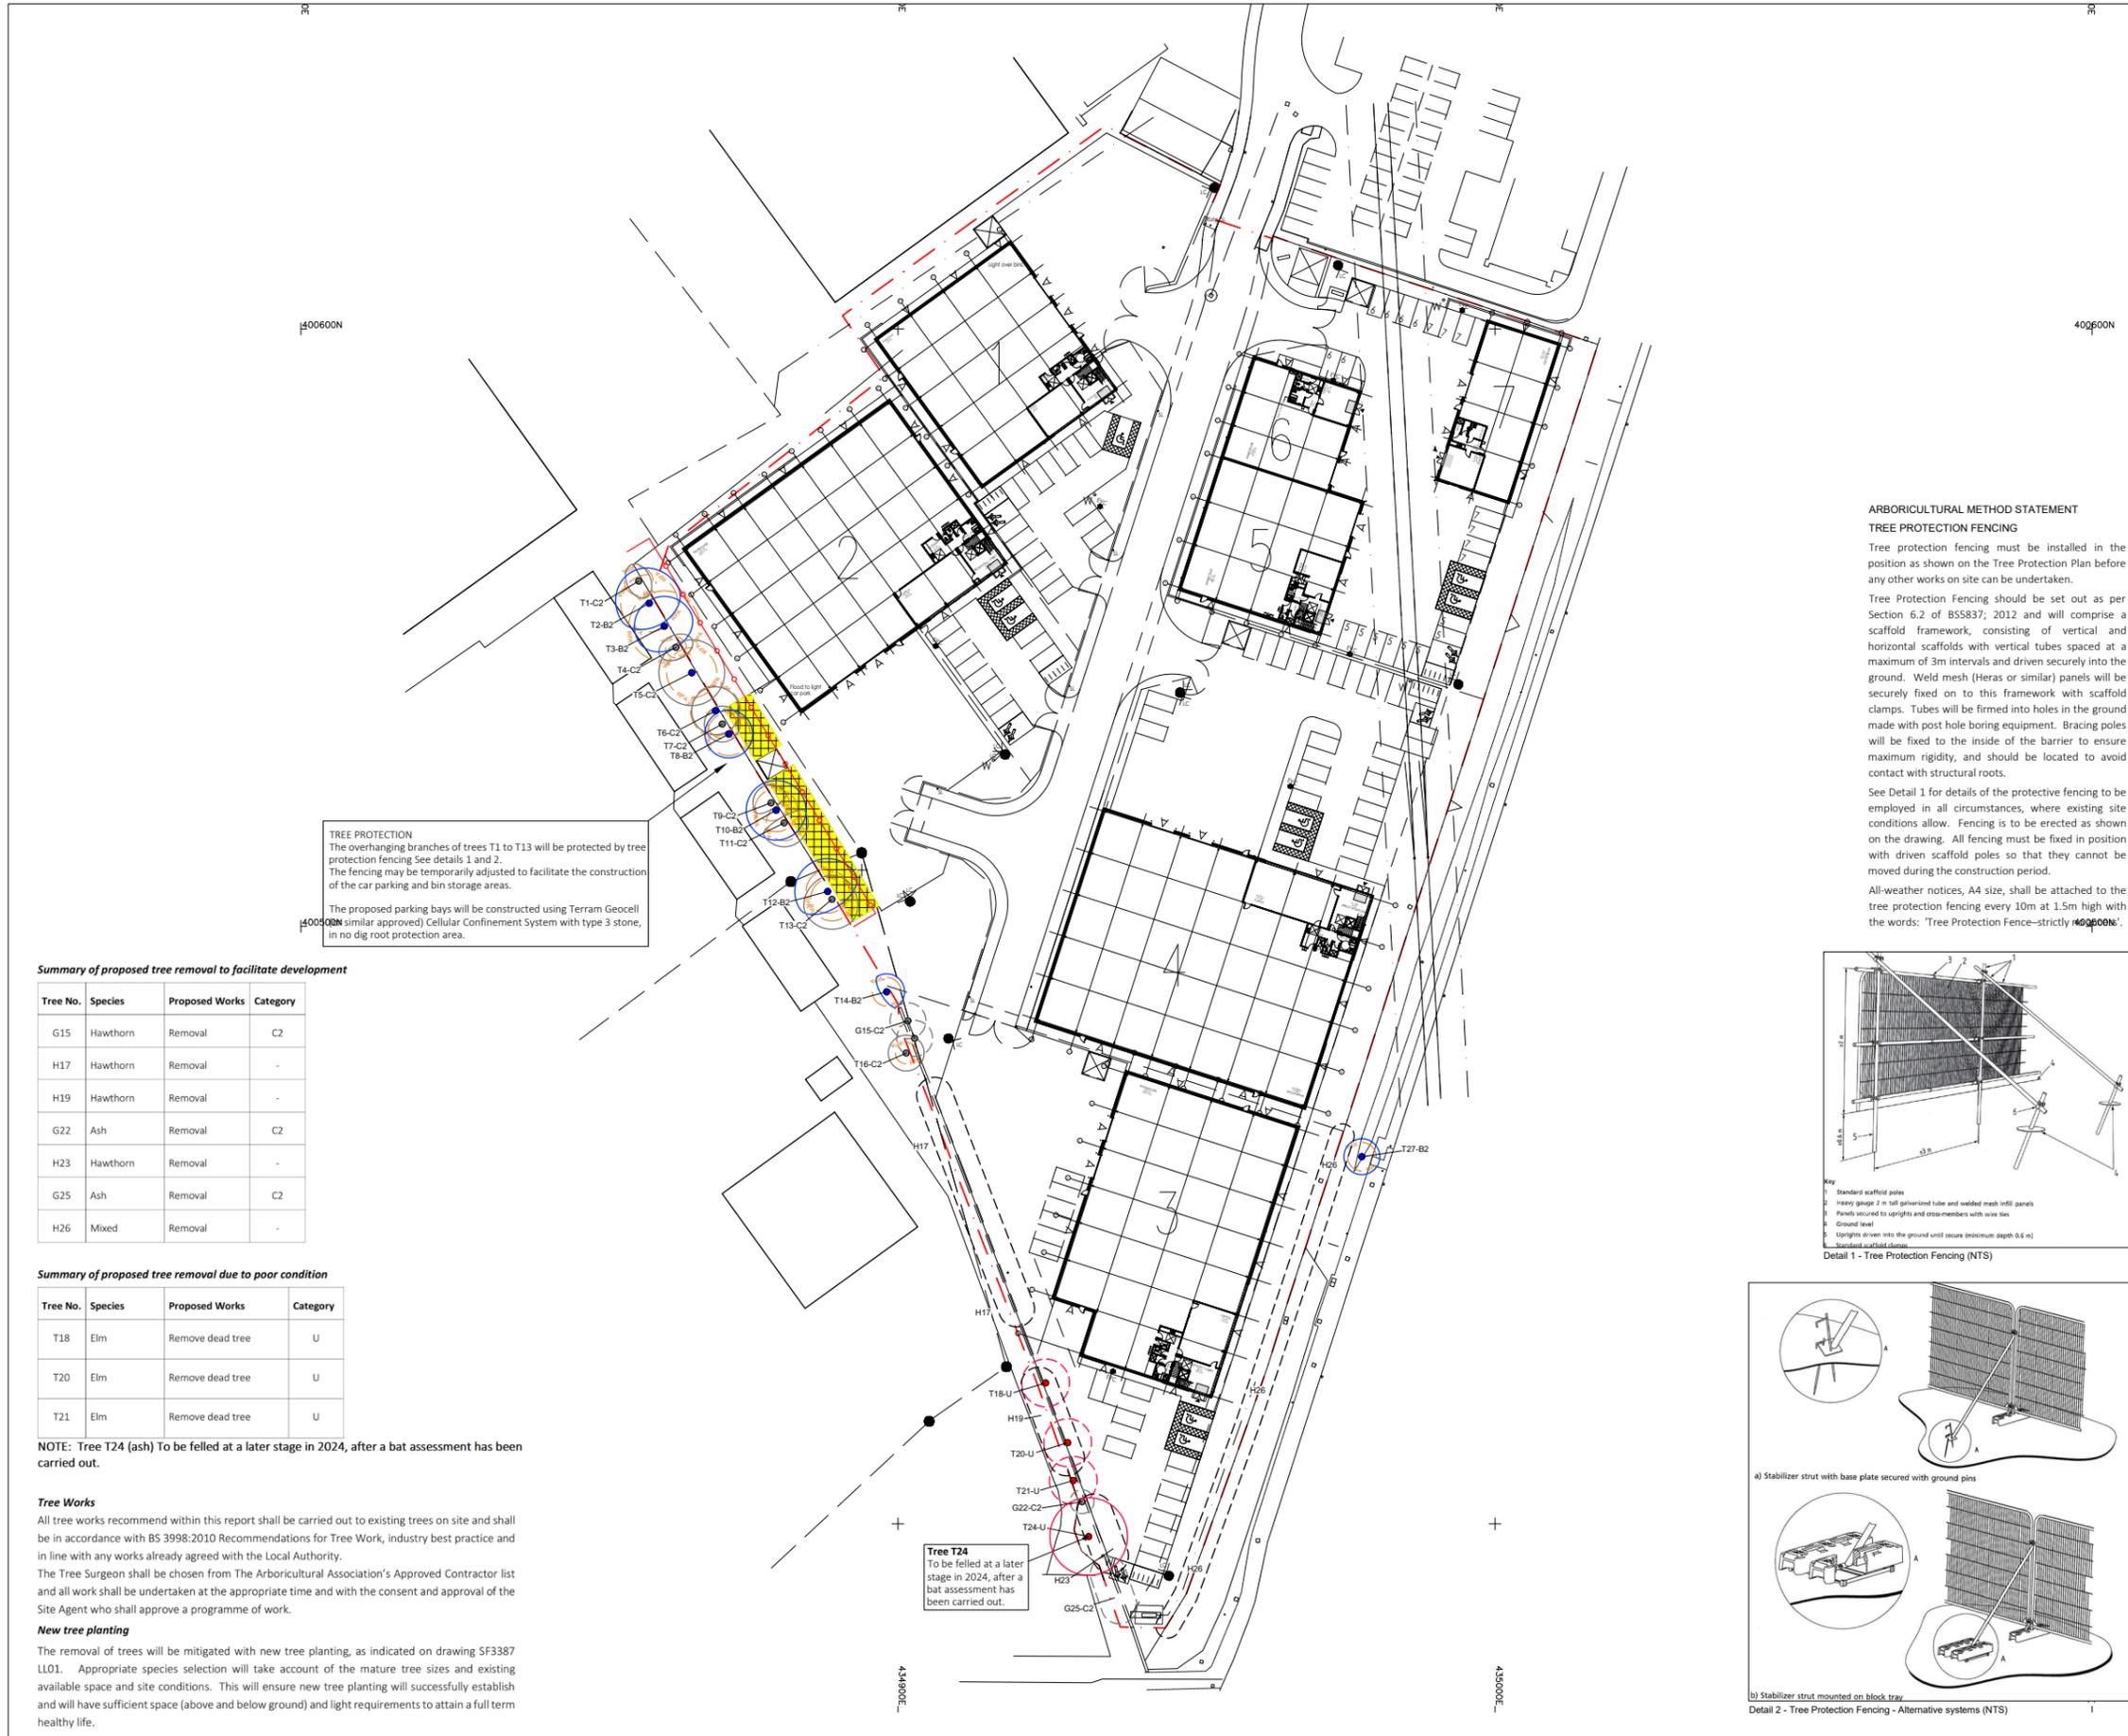
SF3387 AIA01 Arboricultural Impact Assessment Plan

6.1 The proposed development produced by William Saunders has been assessed in relation to the existing trees on drawing SF3387 AIA01 (Appendix C).

Tree No.	Species	Proposed Works	Category
G15	Hawthorn	Removal	C2
H17	Hawthorn	Removal	-
H19	Hawthorn	Removal	-
G22	Ash	Removal	C2
H23	Hawthorn	Removal	-
G25	Ash	Removal	C2
H26	Mixed	Removal	-

Tree No.	Species	Proposed Works	Category
T18	Elm	Remove dead tree	U
T20	Elm	Remove dead tree	U
T21	Elm	Remove dead tree	U

**TREE PROTECTION**  
The overhanging branches of trees T1 to T13 will be protected by tree protection fencing. See details 1 and 2. The fencing may be temporarily adjusted to facilitate the construction of the car parking and bin storage areas.  
The proposed parking bays will be constructed using Terram Geocell (or similar approved) Cellular Confinement System with type 3 stone, in no dig root protection area.

**NOTE:** Tree T24 (ash) To be felled at a later stage in 2024, after a bat assessment has been carried out.
