ARBORICULTURAL REPORT & Impact Assessment to BS 5837:2012 at:

***Stairfoot Roundabout - Area B,
Stairfoot,
Barnsley,
S71 5DS***

Prepared for: ***Barnsley Metropolitan Borough Council***

Reference: *AWA7182*

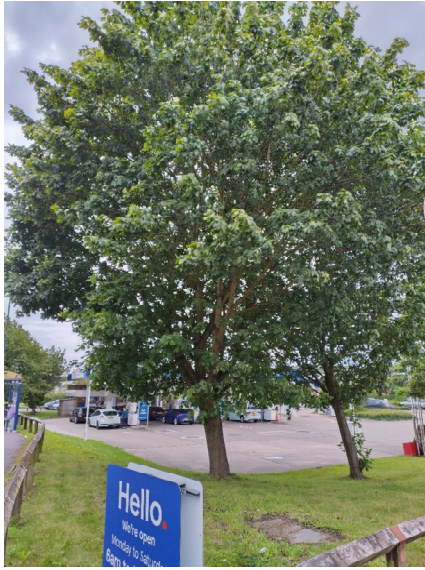
Photo 1: T6 from north.

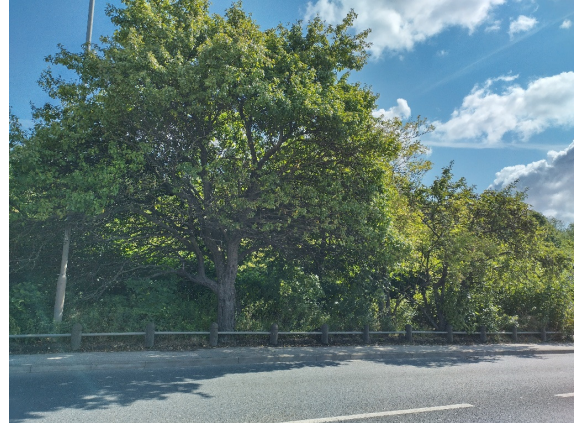
Photo 2: T21 from west.

T21	Apple	<i>Malus domestica</i>	Mature	7	1	480	No	1.5	4.5	4.5	4	4	No visual defects	Single stemmed. Epicormic growths. Old pruning wounds. Stubs. Tight union. Partially included bark. Minor cavities. Minor decay	Minor dieback. Moderate deadwood	Road and pavement to southwest. Crown raised over road. Lower crown over pavement mostly dead.	Fair	Fair	20 to 40 yrs	Moderate	C	No works required
G22	Elder, Apple	<i>Sambucus nigra, Malus domestica</i>	Semi-mature	5	6	150 avg	Yes	0.5	See plan				Group of Elder and Apple. Pavement 1m to southwest.				Fair	Fair	10 to 20 yrs	Low	C	No works required

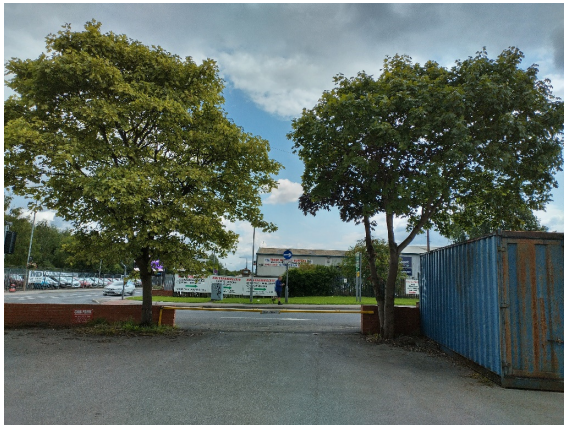
Photo 3: T41 and T42 from northwest.

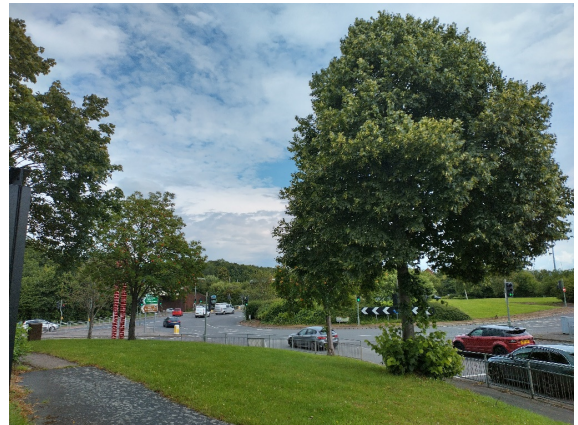
Photo 4: T45, T46 and T47 from southwest.

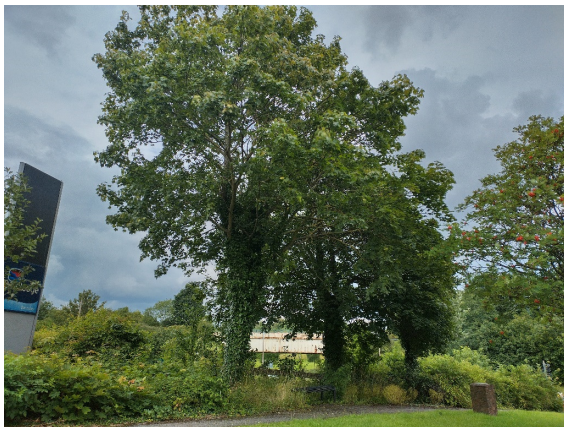
Photo 5: T49 and T50 from south.

T50	Norway Maple	<i>Acer platanoides</i>	Semi-mature	9	1	470	No	2	5	4.5	4.5	4	No visual defects	Single stemmed. Vertical. Ivy covered	Ivy covered. Minor deadwood	Overhanging pavement to south. Carpark 0.5m to north.	Good	Good	>40 yrs	Moderate	B	Removal required to facilitate the development
T51	Whitebeam	<i>Sorbus aria</i>	Early-mature	6	1	280	No	2	3	3	2.5	0.5	Limited access around base	Single stemmed. Slight lean. Ivy covered	Ivy covered	Ivy prevented detailed inspection. Slight lean to east.	Good	Fair	10 to 20 yrs	Low	C	Removal required to facilitate the development

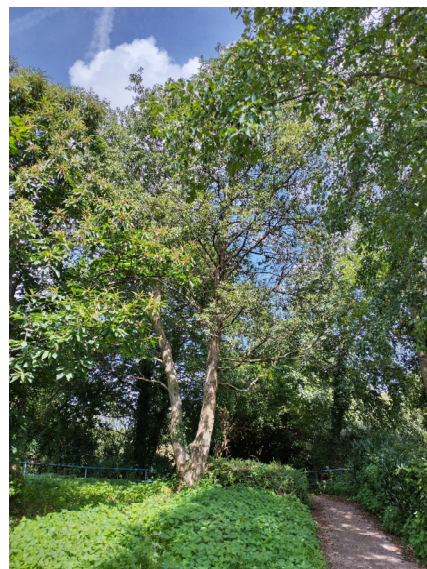
Photo 6: T71 from south.

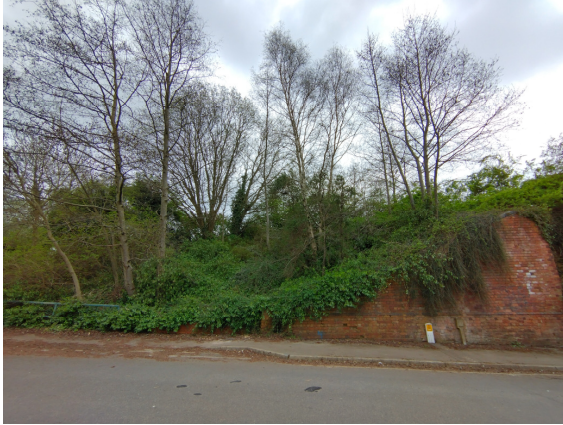
Photo 1: Northern edge of G78 from north.

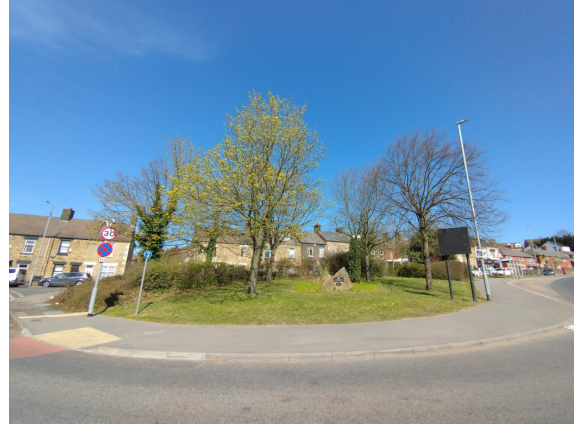
Photo 2: T153 to T156 from west.

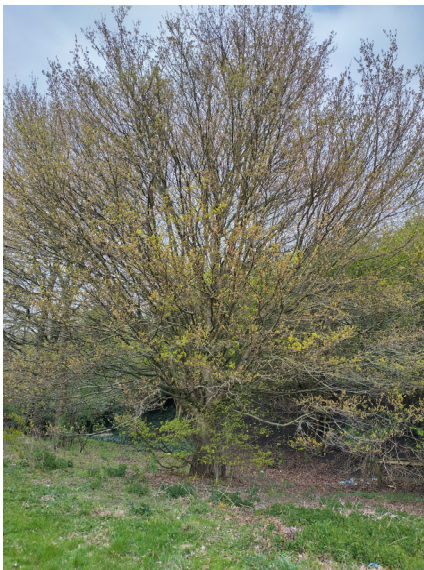
Photo 3: T226 from south

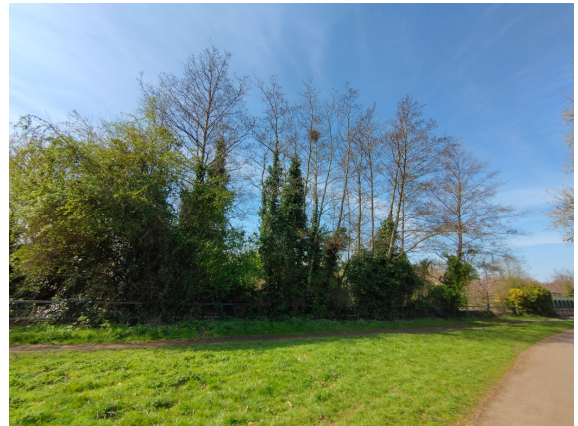
Photo 4: G77 from southeast.

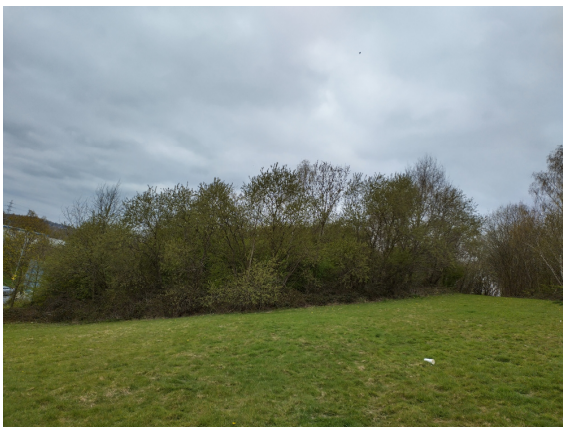
Photo 5: G247 from south.

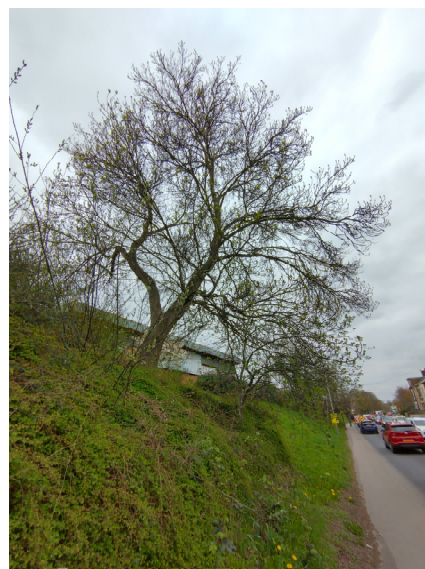
Photo 6: T242 from south.
